**Manor House Farm, Troutsdale
Preliminary Bat Survey Report**

September 2015

**Survey of Farm Buildings
at Manor House Farm, Troutdale.**

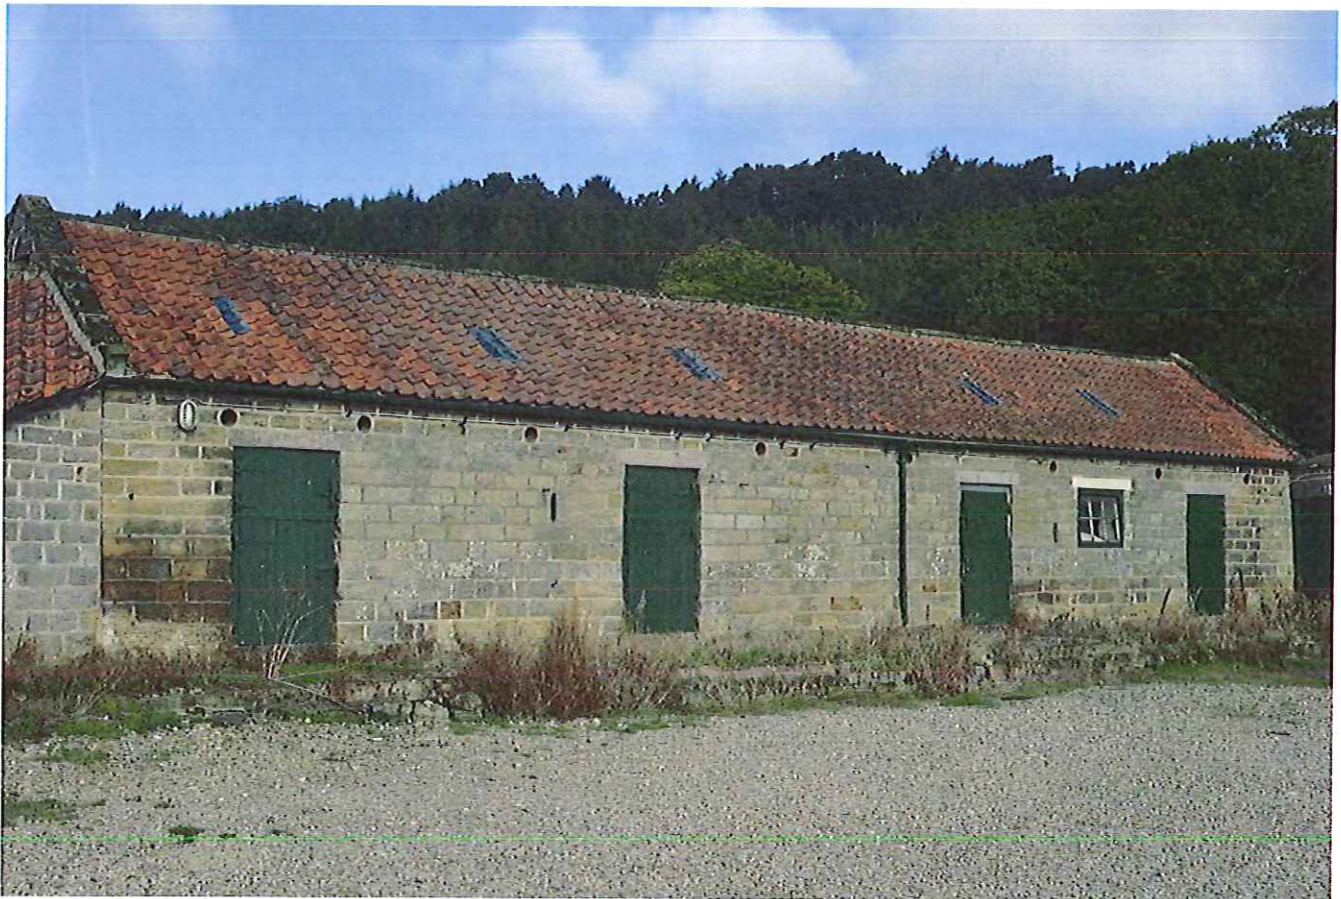
Photo 3: Disused Stable Block/Cow Byre

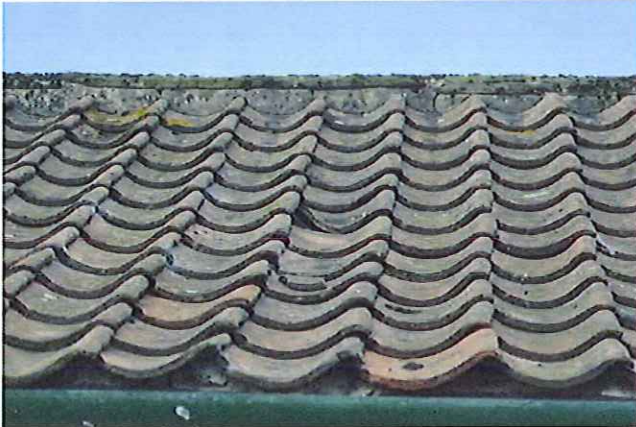
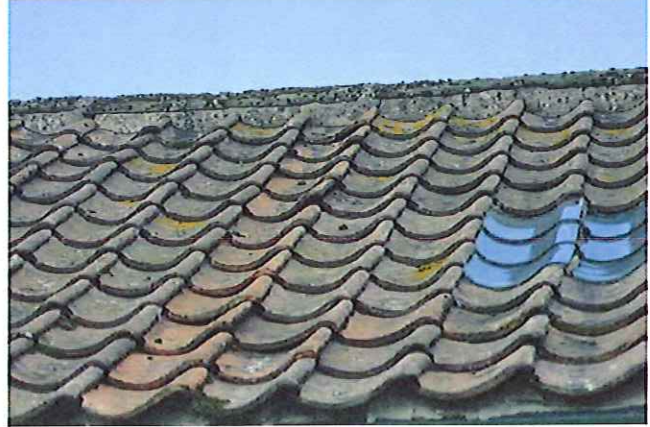
The building is constructed of dressed sandstone with a felt lined, close fitting, clay pantile roof that is in generally good repair however there are some gaps caused by raised and broken tiles (Appendix 4, photos 4 and 5). The ridge tiles are well fitted and the mortar is intact for the length of the ridge. The current condition of the roof suggests it has been reroofed at some point in the past.

Photos 4 and 5: Photos of roof showing some raised and broken tiles, but intact ridge tiles and pointing.

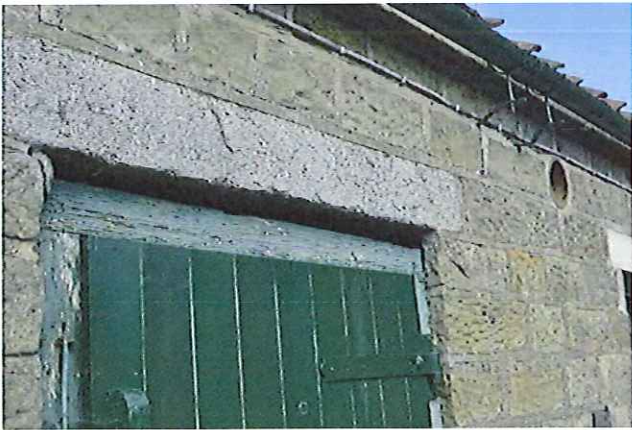
The south east aspect of the building is in a good state of repair, with very little damage to the mortar. There are 4 doorways into the building, each of which has a poorly fitting door and doorframe, with some large gaps between the wood and stone work (Appendix 4, photo 6). There are also a number of ventilation pipes (Appendix 4, Photo 7) just below the eaves and a six pane window, two of the panes are missing.

Photo 6: Gaps above doorframe

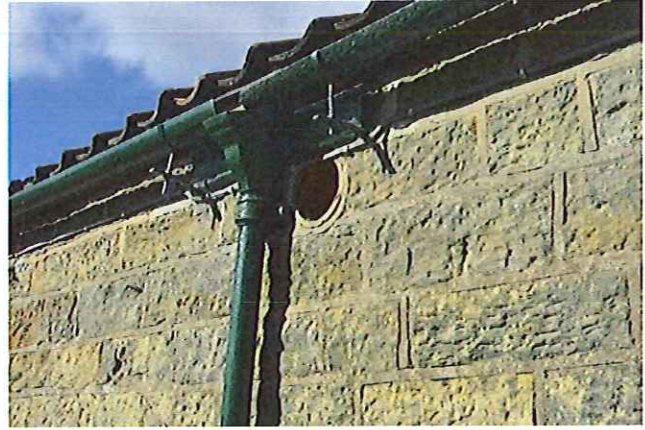
Photo 7: Ventilation holes

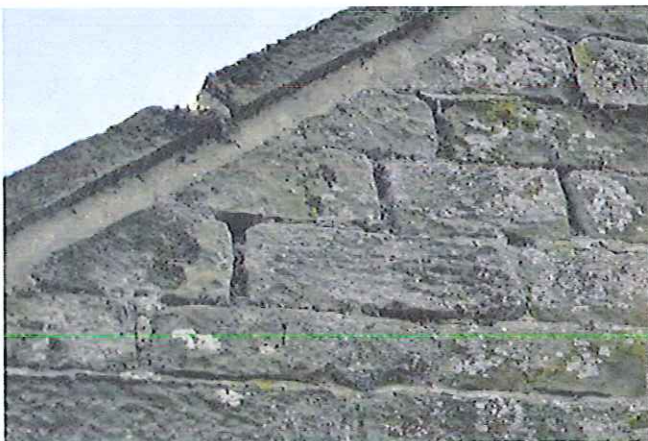
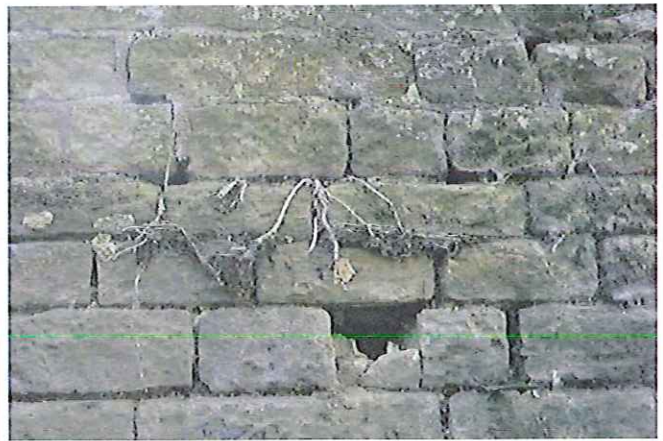
The gable end wall is in much poorer condition, with some large cracks developing (Appendix 4, photos 8 and 9); the northern corner of the building has the largest cracks with some areas of the wall failing as shown in appendix 4, photos 10 and 11. The rear wall of the building is generally in good condition, however there are some places where the mortar has failed and stones have collapsed (Appendix 4, photo 12).

Photo 8 and 9: Cracks and holes in gable end wall.

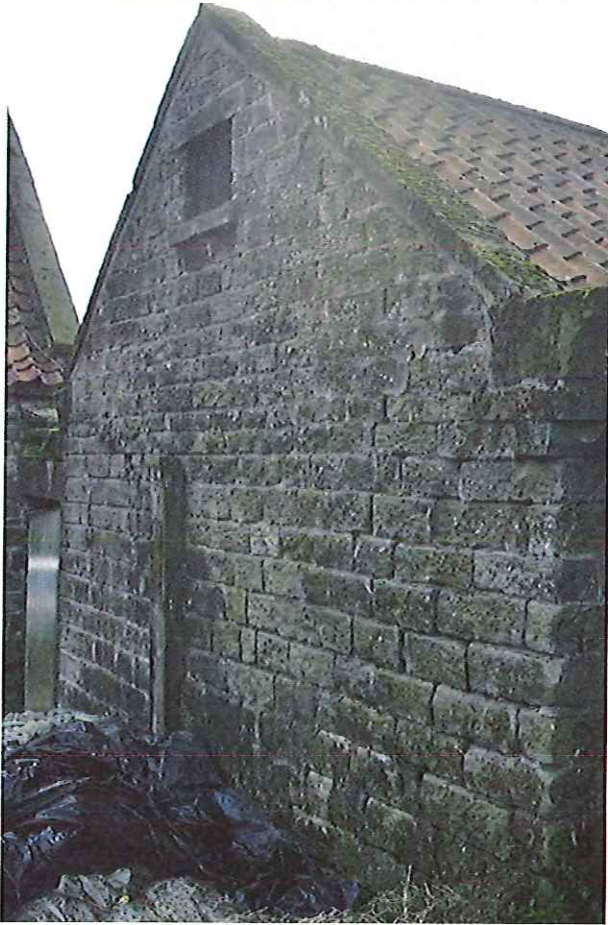
Photo 10: Poor condition of gable end wall

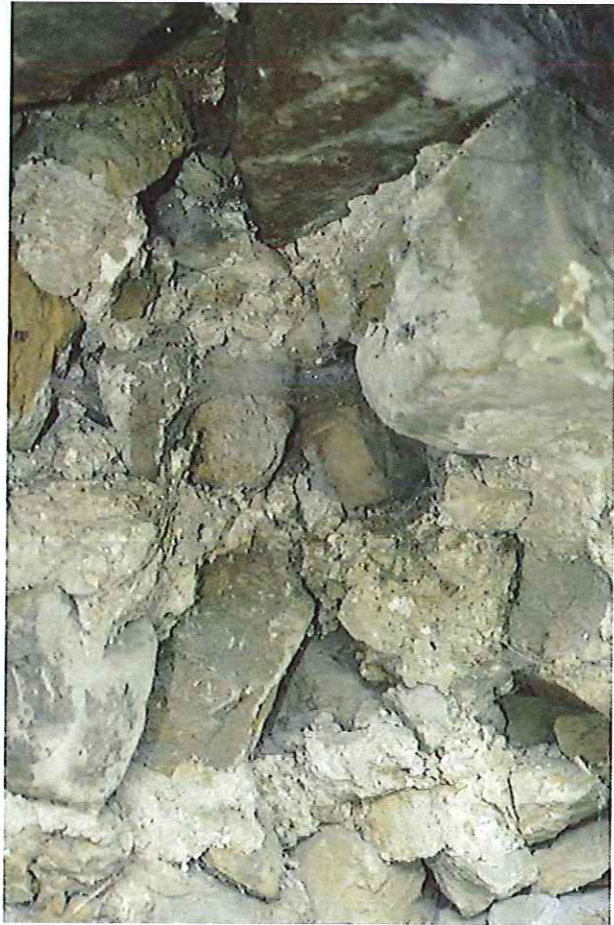
Photo 11: Collapsed area of wall

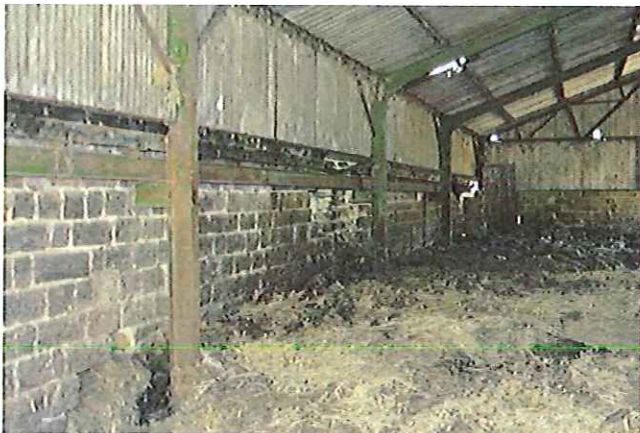
Photo 12: Rear wall of stable block.

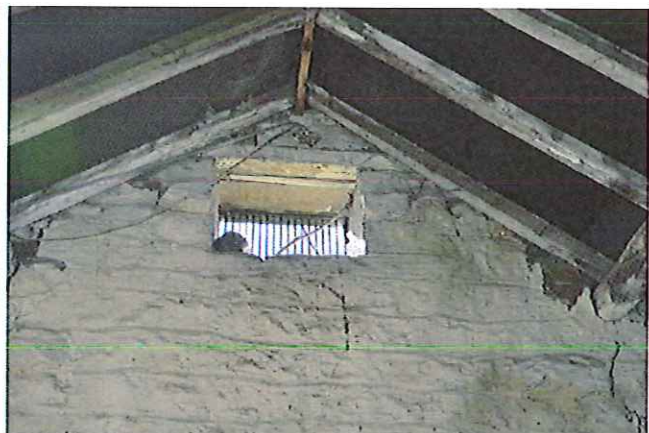
Photo 13: Aperture in gable end wall with close gapped grill.

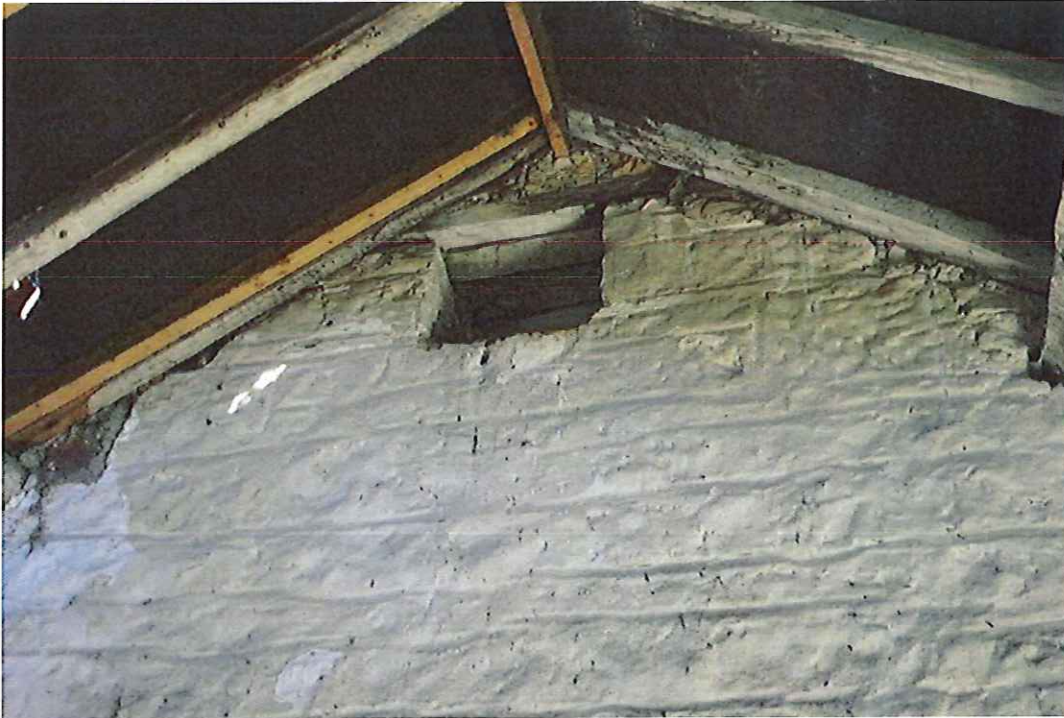
Photo 14: Opening through internal wall

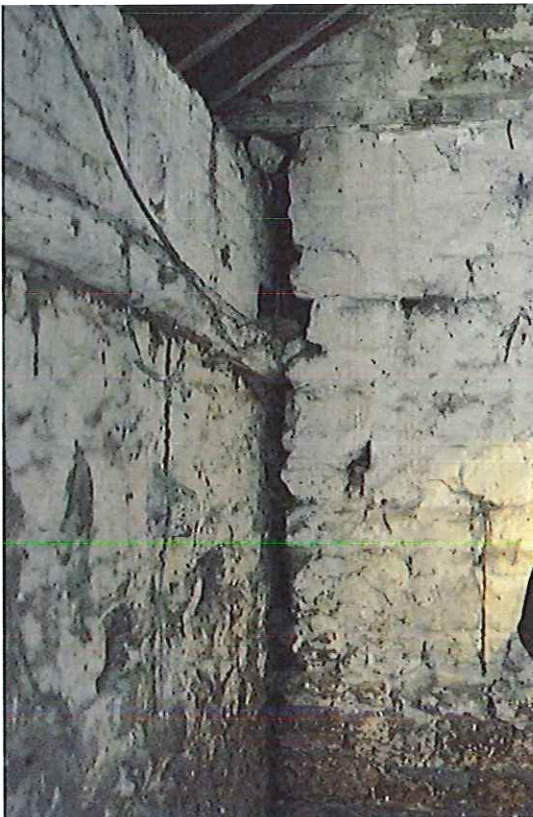
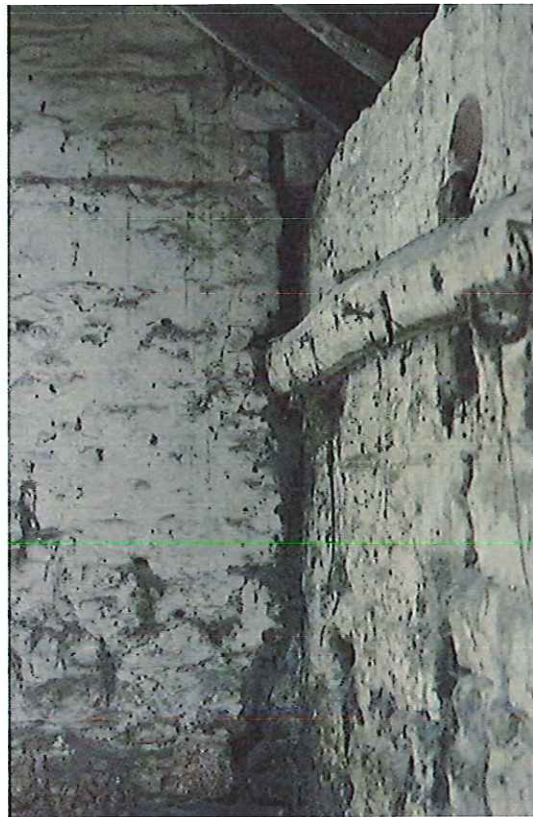
The 3 rooms within the stable block are connected by a series of open apertures allowing flying animals to use the whole space. A number of large cracks between the internal and external walls, as shown in photos 15 and 16, appendix 4, offer some potential for use by roosting bats. The cracks in the gable end also provide potential roosts. There is however a large amount of activity from nesting birds within the structure which could lead to conflict.

Photo 15 and 16: Cracks between internal and external walls.

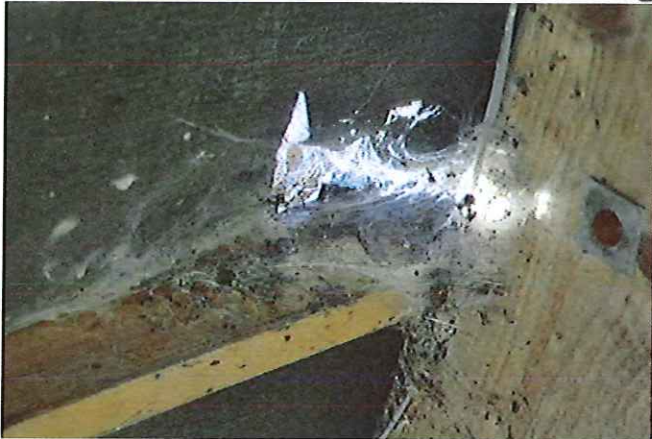
Photo 17: Hole in sarking

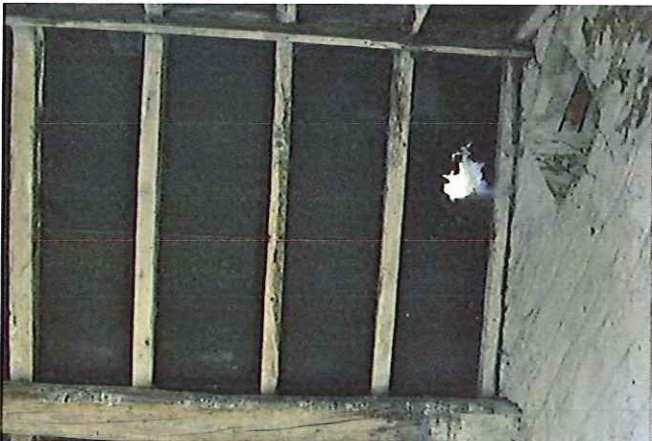
Photo 19: Hole in sarking and aperture through to adjacent room.

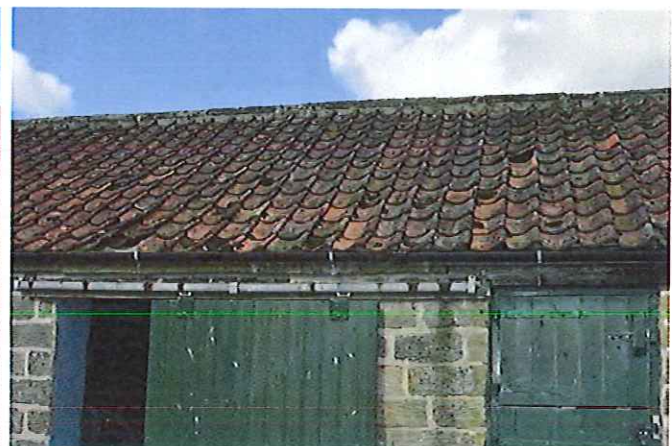
The roof is in generally good condition; however there are some occasional lifted and broken tiles (Appendix 4, Photo 22). The stone work is in good repair the pointing is all sound (Appendix 4, photo 23). The rear of the building is in slightly poorer condition, with some degradation to the mortar and the lower three rows of tiles on the roof being displaced (appendix 4, photo 24).

Photo 22: Roof of adjoining stores

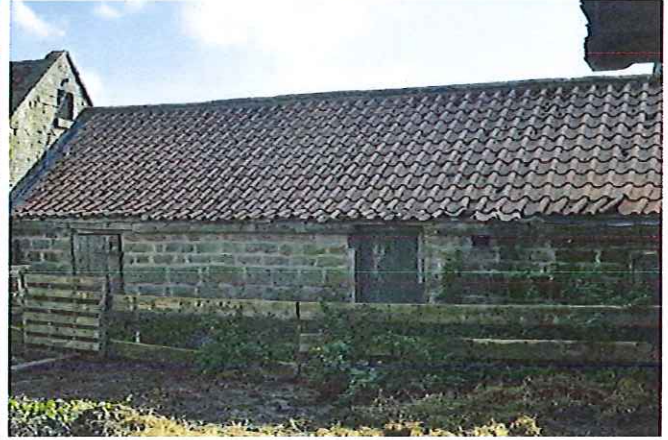
Photo 24: Rear Wall of adjoining stores.

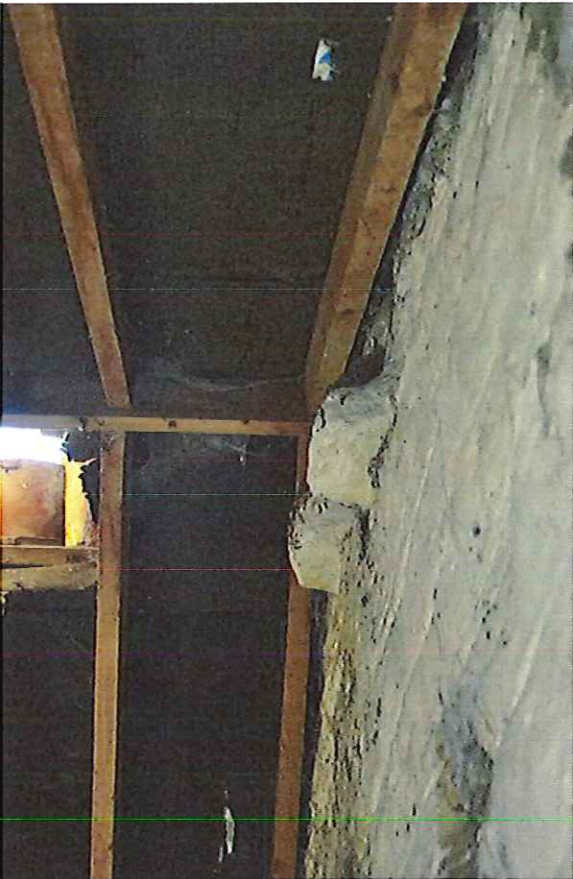
The first of the store rooms contains garden machinery and tools. The walls are whitewashed and in generally good repair. There are some close gaps formed by rafters and the gable end wall (Appendix 4, photo 25).

Photo 25: Gaps between rafter and gable end wall.

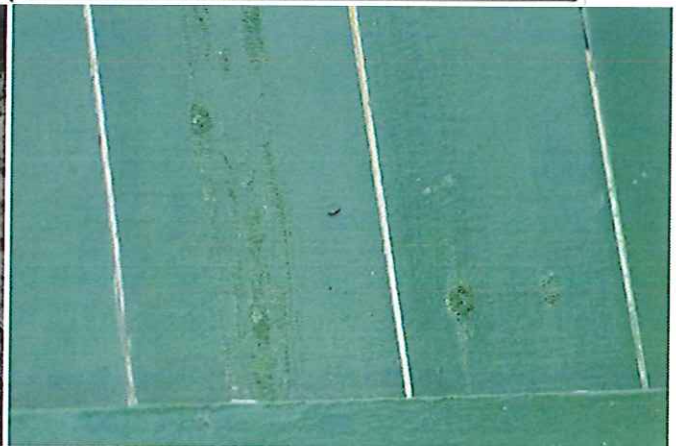
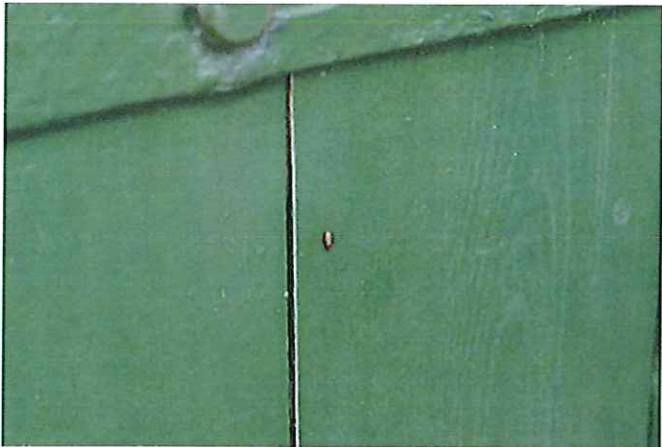
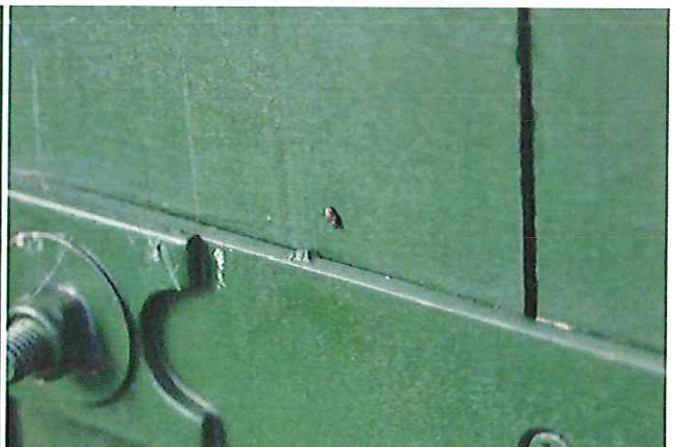
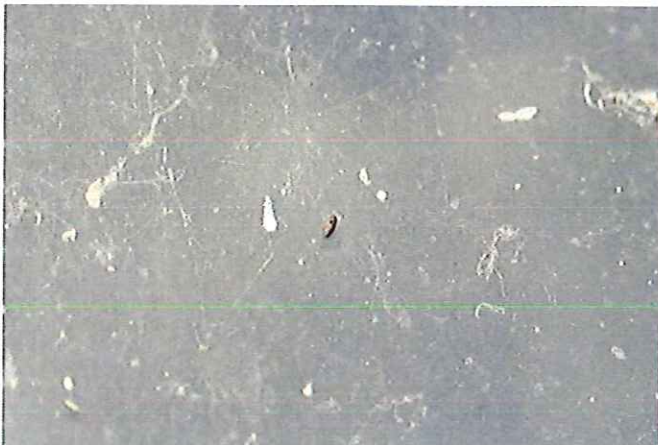
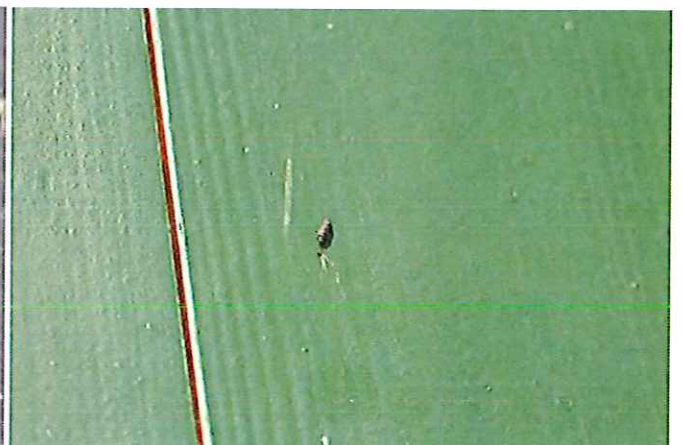
A single bat dropping was found adhering to the external surface of each door and also to one of the window panes (Appendix 4, photos 28 – 32). There was a large amount of evidence of use of the structure by birds, with Swallows nests being observed throughout and a number of feral pigeons.

Photo 28: Bat dropping on door 1

Photo 29: Bat Dropping on door 2

Photo 30: Bat dropping on door 3

Photo 31: Bat dropping on window

Photo 32: Bat dropping on door 4.

Due to the evidence of bat presence found on site, further surveys will be required to determine the likely roost status and the potential impacts. Dusk emergence surveys and/or dawn re-entry survey provide a valuable method to determine species and population sizes and should also identify the specific areas/features of the structure being used. This will then allow the production of an impact assessment for the development on bats, define necessary mitigation and assess' the requirement for a Protected Species Licence.
