Heritage Statement

Conversion of The Old Blacksmiths, Staithes, to Holiday Cottage

Bat, Breeding Bird and Barn Owl Scoping Survey

The Old Blacksmiths, Staithes

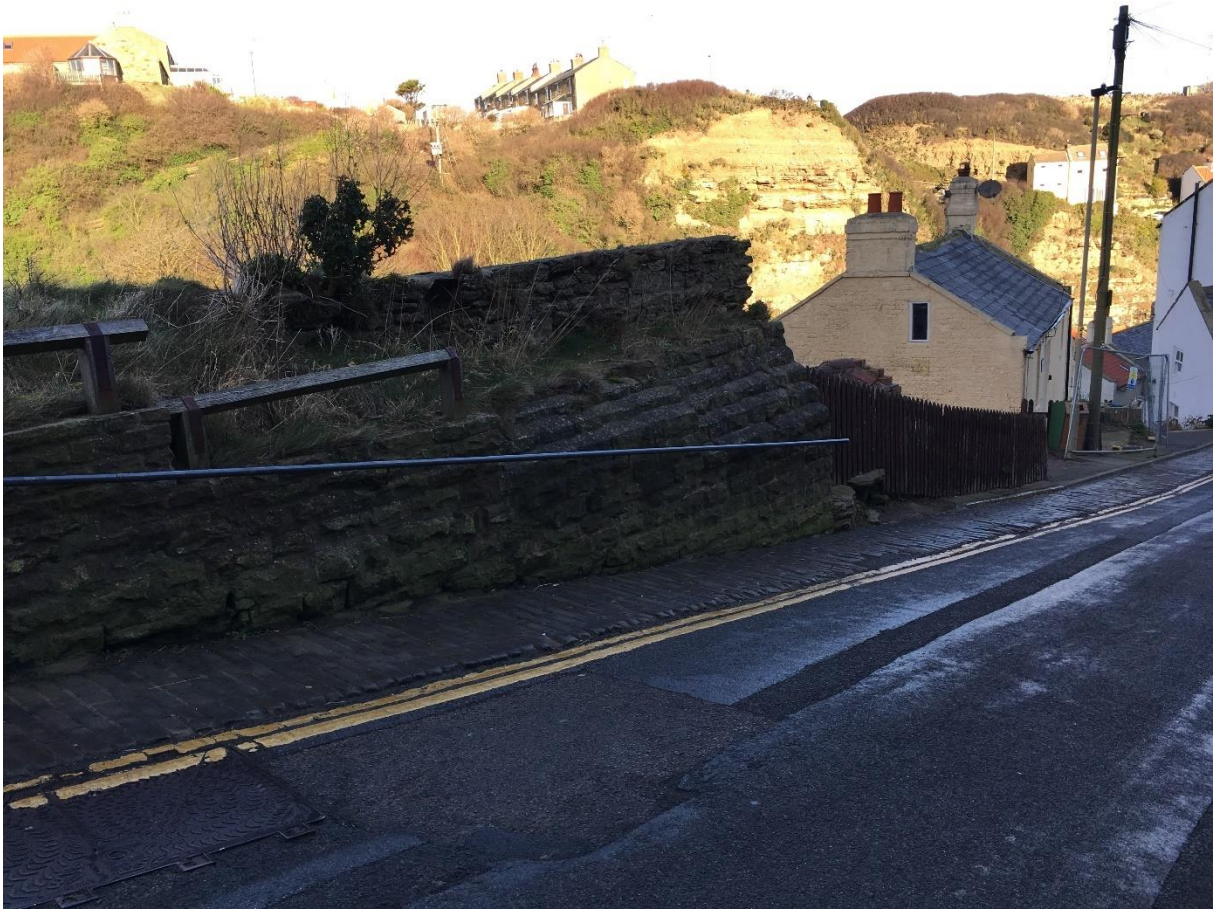
It sits in a unique position. Despite being immediately adjacent to the road, the building and land are very discreet. The steepness of the road hides the bulk of the east elevation.

Photograph 1
East elevation and road (Staithe Bank)

As previously mentioned, the east side of the building is mostly set below the road level and therefore any change will just involve renewal of the roof materials as specified.

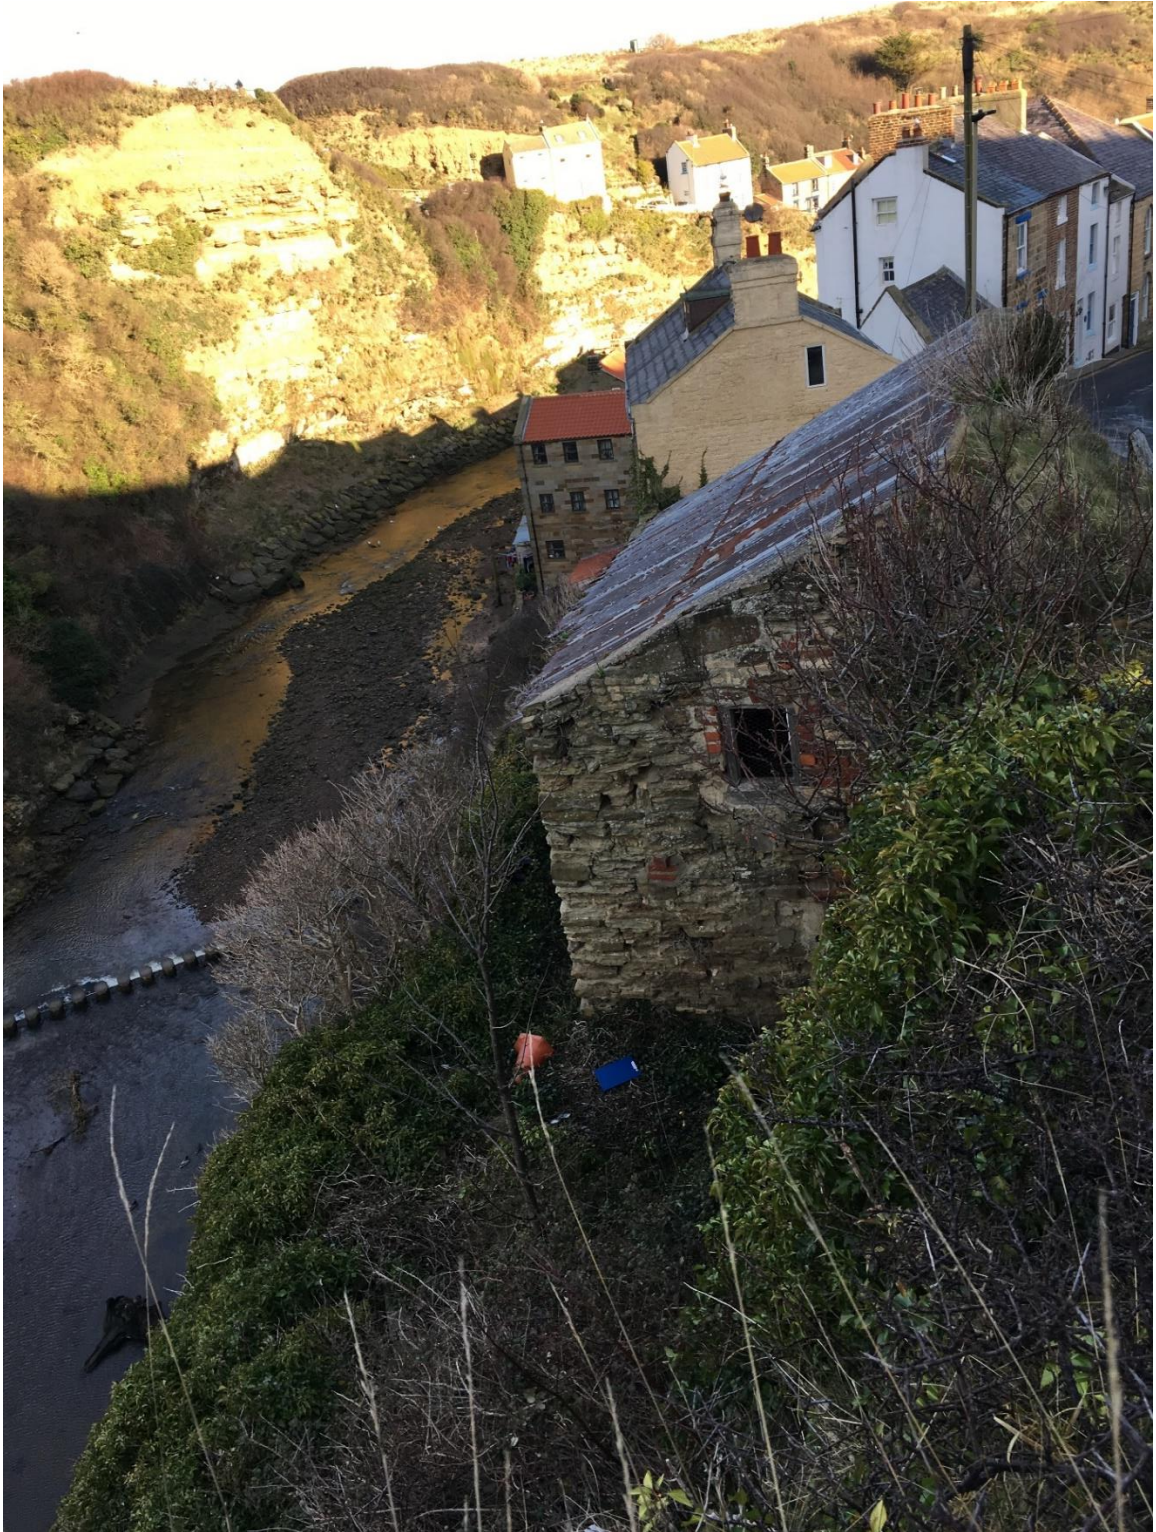
The south elevation lies at a low elevation and faces directly up the Staithes Beck Valley. It is not visible from the road and only very occasional views can be gained from the south and west.

Photograph 2
South elevation looking north along Staithes Beck

The larger south elevation will be kept in its current layout, with existing openings being retained to provide sufficient windows and a single personnel door. These will all be timber framed and simple in design to reflect the previous utility use of the building.

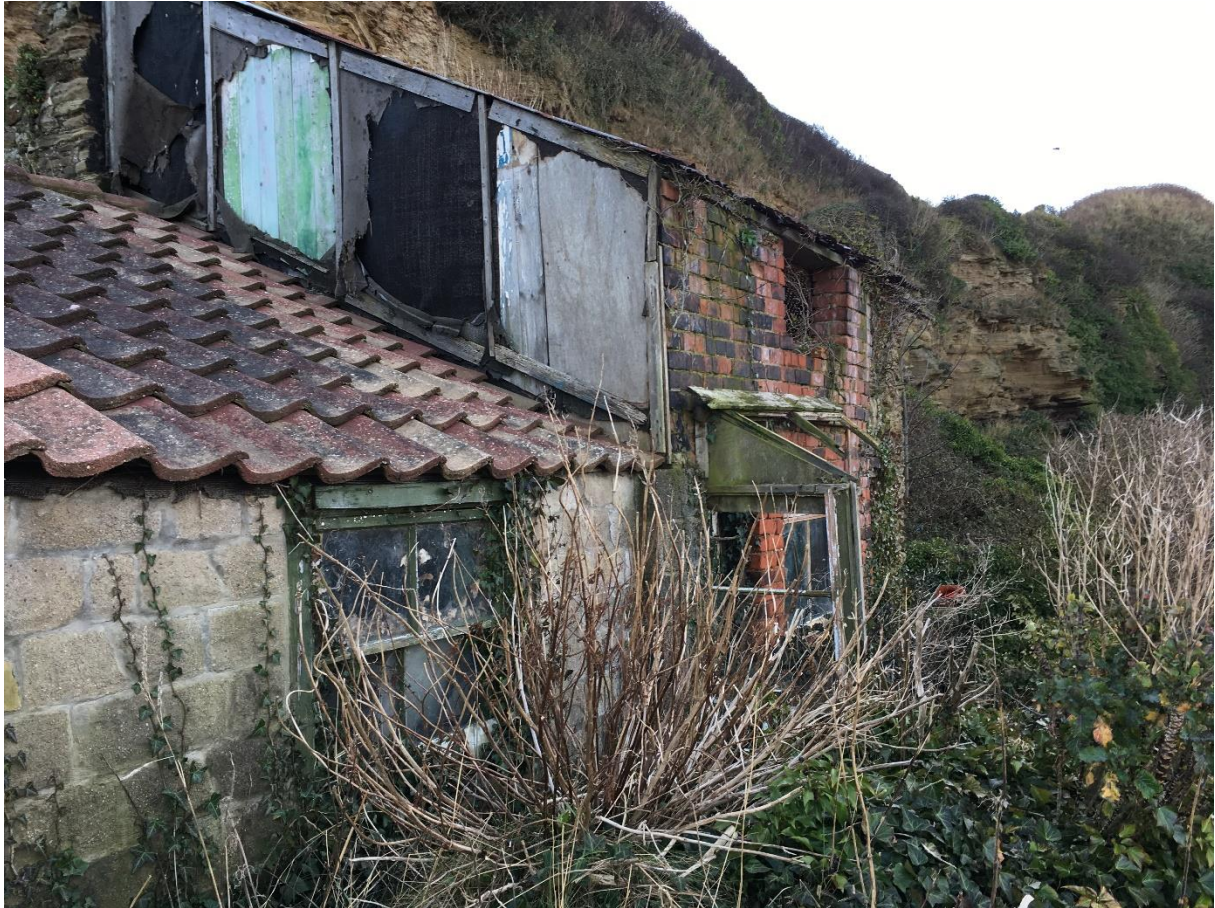
The west elevation runs parallel to the very sharp drop into Staithes Beck Valley. The random mix of walling materials can be seen on this elevation, although due to the proximity of the drop, it is difficult to photograph.

Photograph 3
West elevation, note remnants of timber porch

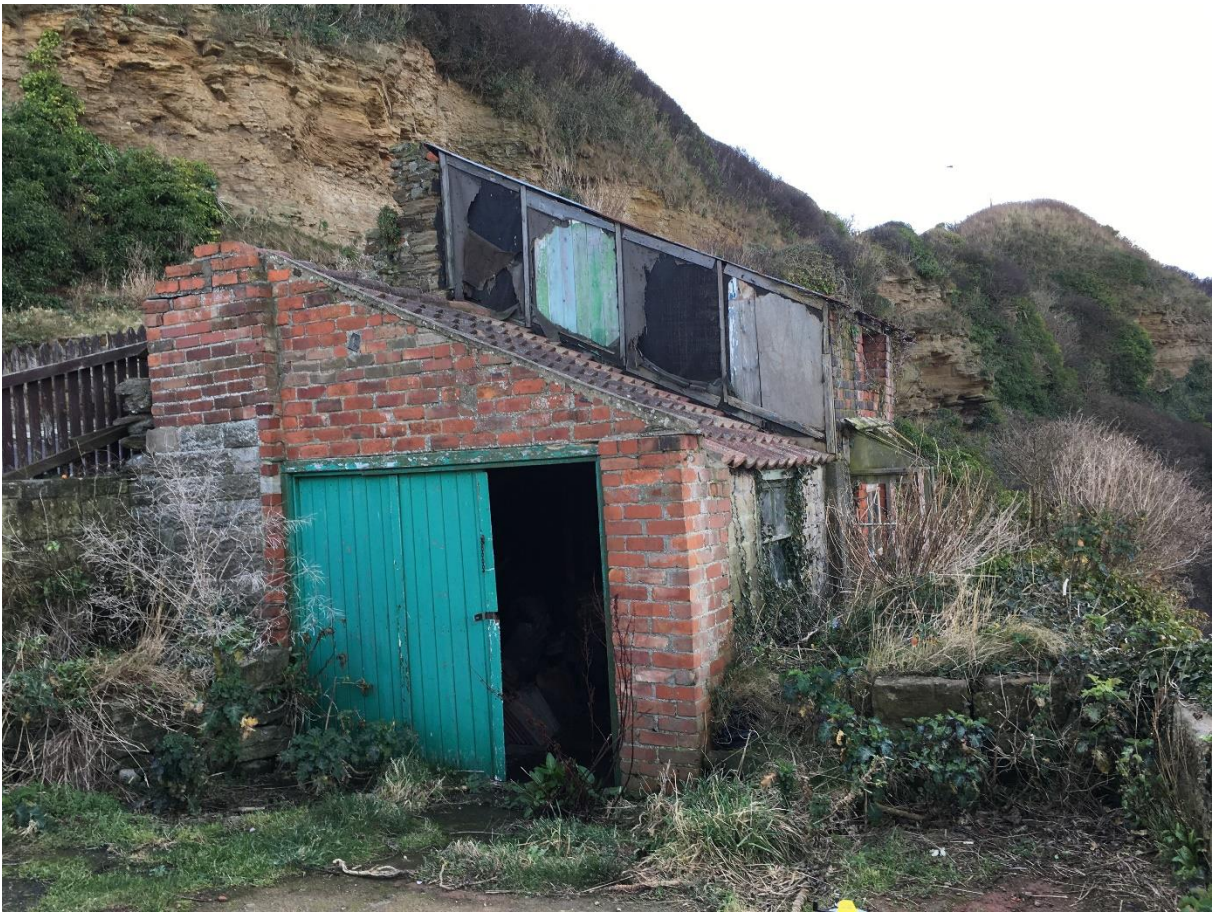
The north elevation, which provides access to the building via a concrete hardstanding, is modest in size and is formed by brick walling and timber doors. The higher level of building can be seen further back, with the timber frame and sheeted finish visible.

Photograph 4
North elevation

The north elevation will be retained as a brick and timber façade. The timber doors will be replaced with similar timber painted vertical boarding incorporating a simple glazed opening with no glazing bars.

At the higher-level wall will again be timber painted vertical boarding and plain glazing. The masonry will be repaired and repointed.

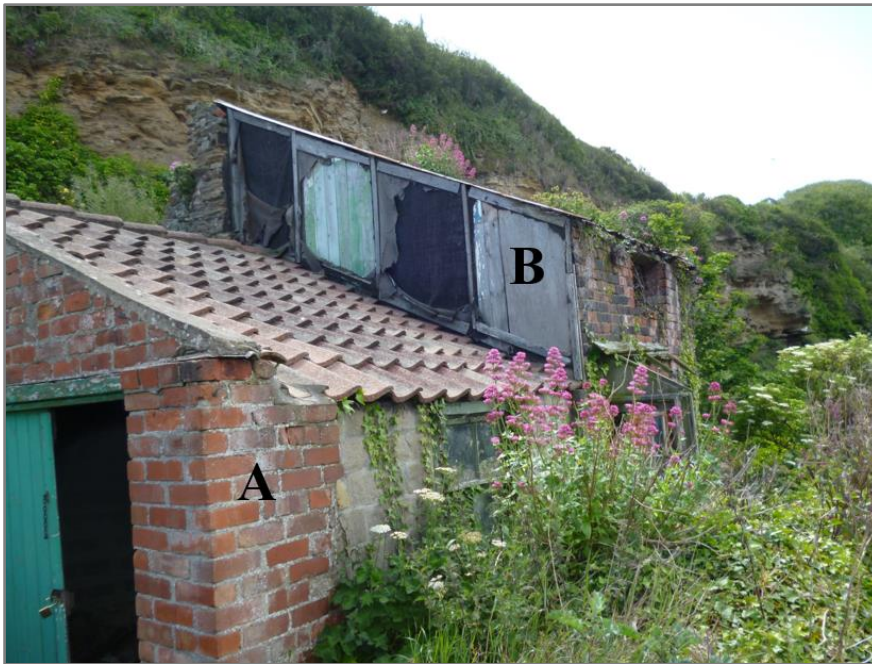
The former blacksmith's workshop is a brick-built outbuilding which is set into the cliff on the banks of Staithes Beck. Externally, there are two sections (see Photo 1); *Section A* is single-story and has a clay pantile roof, and *Section B*, which rises higher, has a corrugated iron roof and wooden side-panelling. Internally, the building consists of one room with a mezzanine floor in section B. Hollows are cut into the cliff rock within, which historically contained the blacksmith forge.

Photo 1. The Old Blacksmiths, southwest aspect.

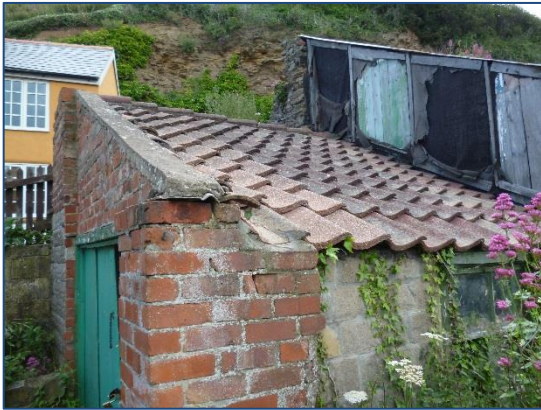
Photo 2: Section A northwest aspect.

Section A holds very low potential risk of supporting bats, due to a low number of access points between clay pan tiles and a wooden board liner, however the roof was low to the ground, and all crevices could be checked for any evidence of bat use. No evidence was identified in or around any crevice. It would not be proportionate to recommend an evening emergence survey due to the very low risk of use.

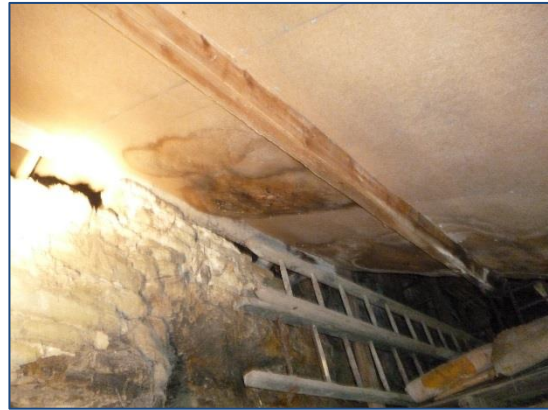
Photo 3: Section A roof boarding with damp.

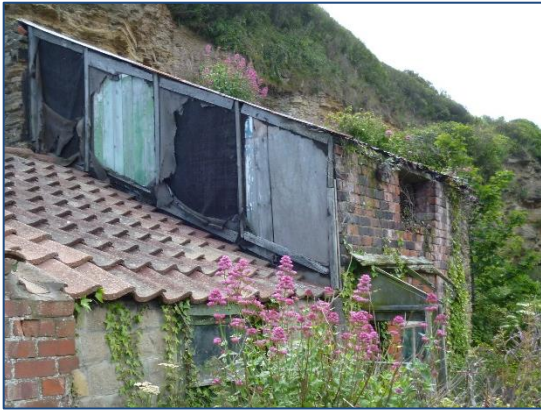
Photo 4: Section B northwest aspect.

Section B holds negligible risk of roosting bats, mostly due to the materials used in its construction, and very damp interior. In addition, no droppings or feeding remains were identified. No further survey effort or mitigation is considered necessary.

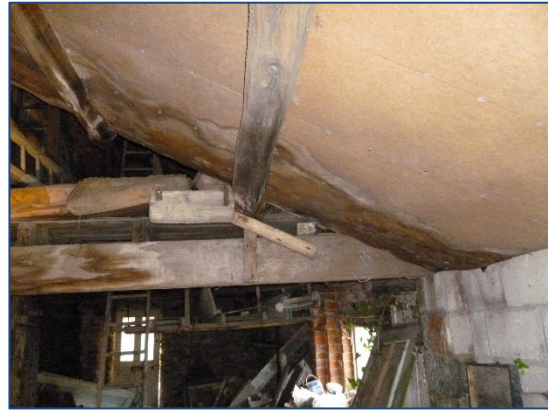
Photo 5: Section B mezzanine and lower floor, view from section A.

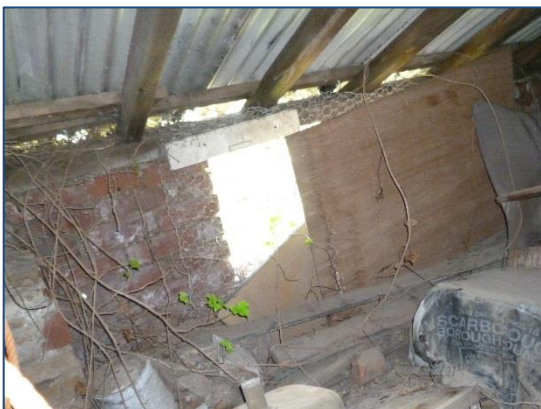
Photo 6: Section B gaps under corrugated roof and mesh over window.

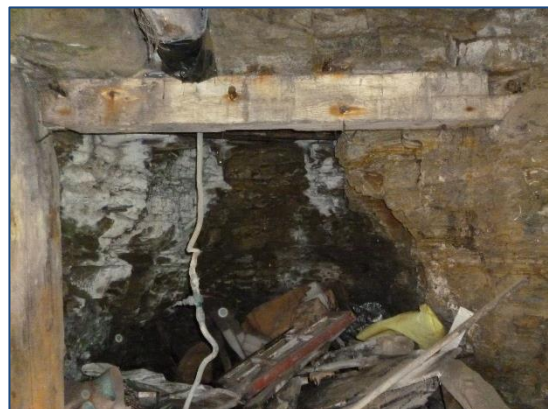
Photo 7: Section B cliff side wall.

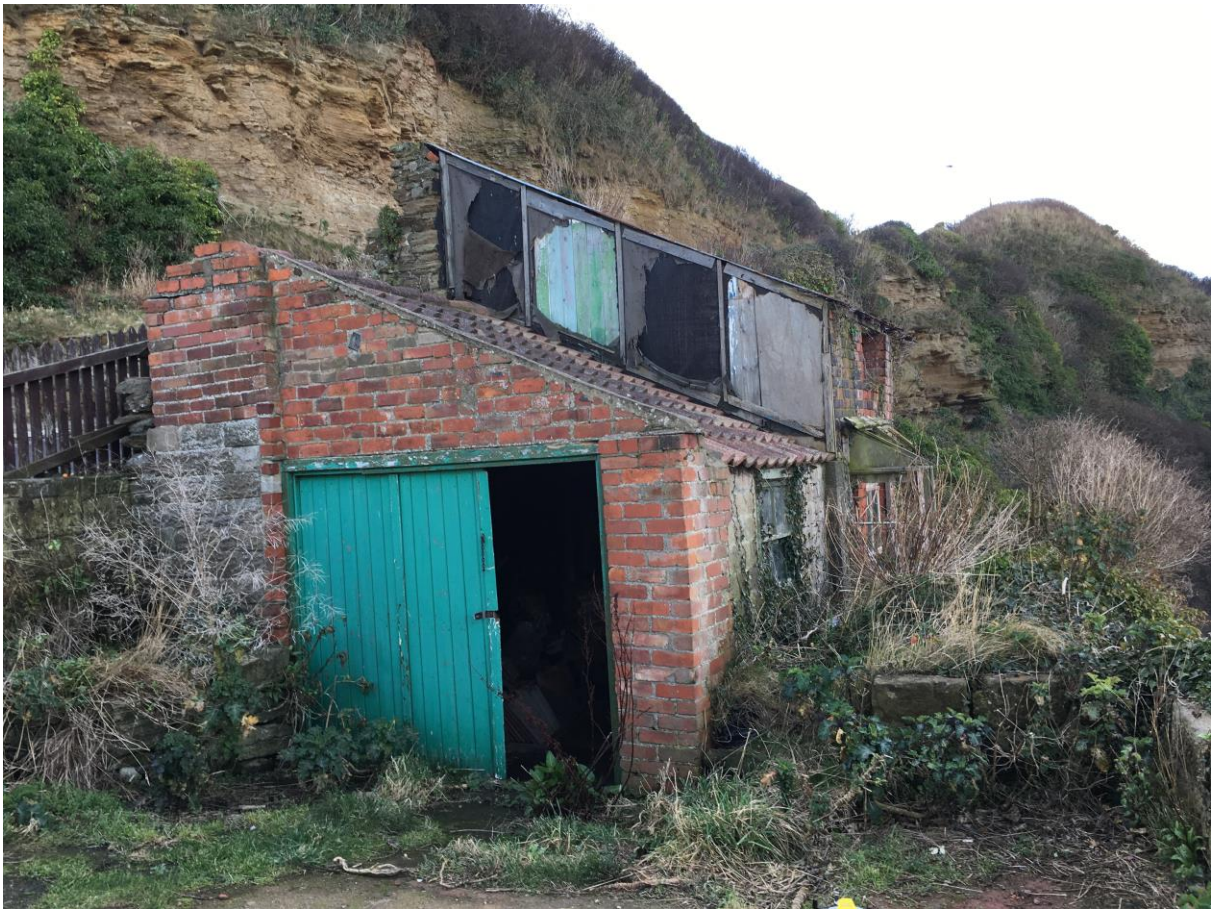
Photograph 1
The Olds Blacksmiths, Staithes Lane, Staithes

- 2.2 The northern elevation can be seen in photograph 1. The brickwork is in reasonable condition except for a void where the gable wall meets the rear wall, see photograph 5.
- 2.3 The southern elevation can be seen in photograph 6. This wall is mainly built of random stone approximately 500mm thick, although some brickwork exists towards the rear wall, see photograph 7. Most of the wall is in reasonable condition except above the doorway.
- 2.4 The rear wall consists of the original stone cliff.
- 2.5 The roof is in poor condition and will be completely re-built.
- 2.6 We have not inspected woodwork or other parts of the structure which are covered, unexposed or inaccessible and we are therefore unable to report that any such part of the property is free from defect.

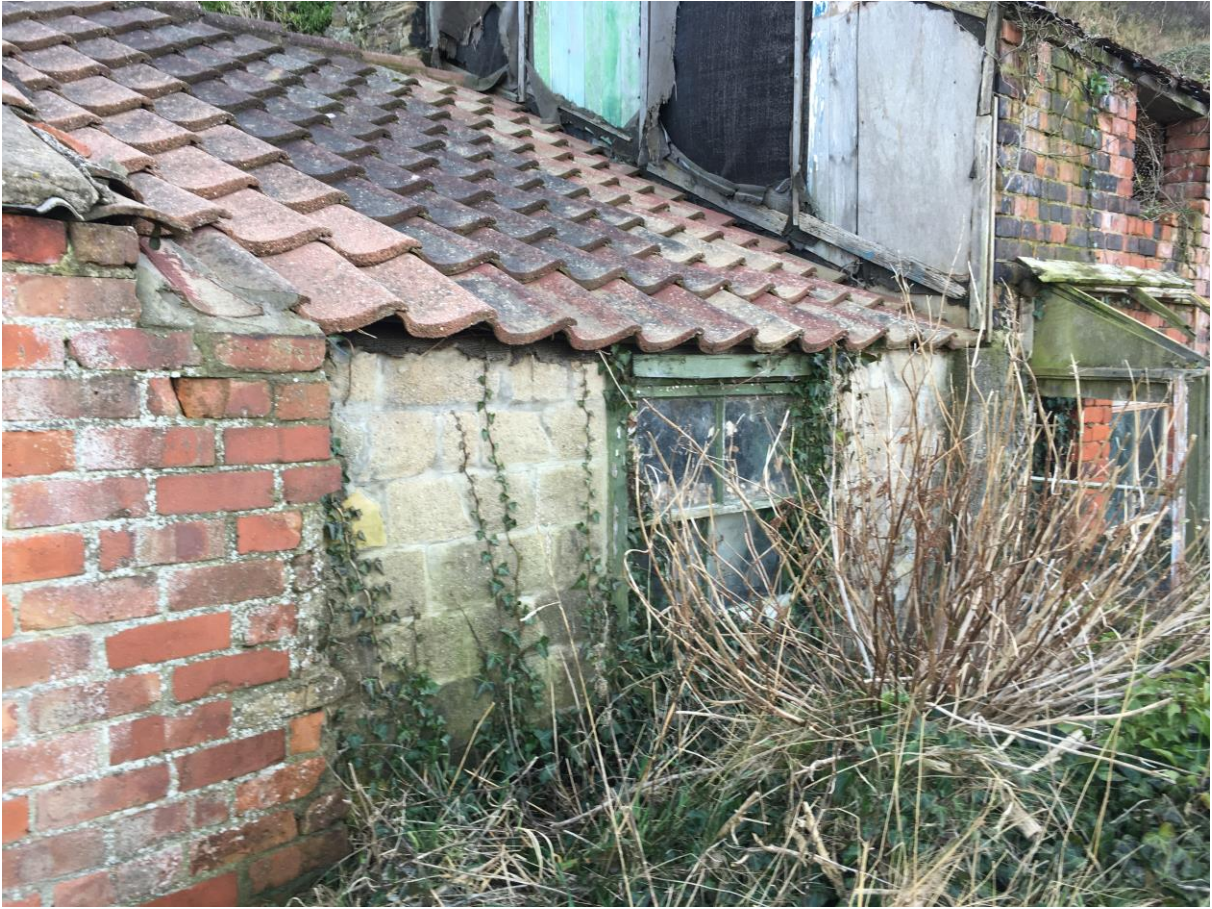
Photograph 2
The Olds Blacksmiths, Staithes Lane, Staithes

- 2.1 The front elevation can be seen in photographs 2, 3 and 4. At the northern corner there is a brick pillar 450mm thick and then towards the south there is a panel of blockwork approximately 200mm thick ending in a block pier, followed by brickwork 230mm thick ending in a brick pier.
