Bat Scoping Survey, May 2019.

Job Title: **Structural Condition Survey
Northfield Farm, Suffield**

**Heritage &
Design And Access Statement
For
Barn Conversion at Northfield Granary,
Suffield, Scarborough**

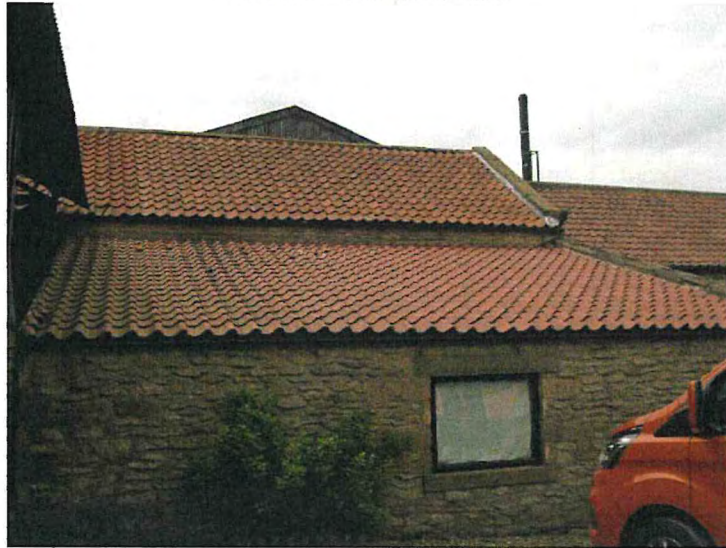
Plate 1 – east elevation.

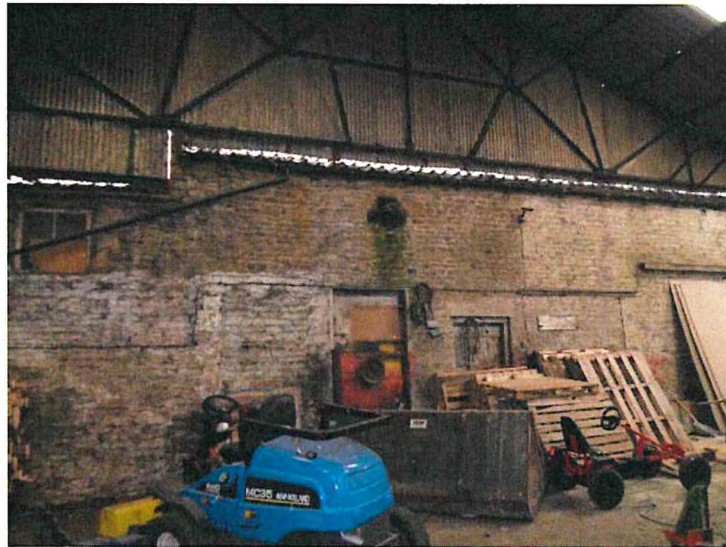
Plate 2 – west elevation.

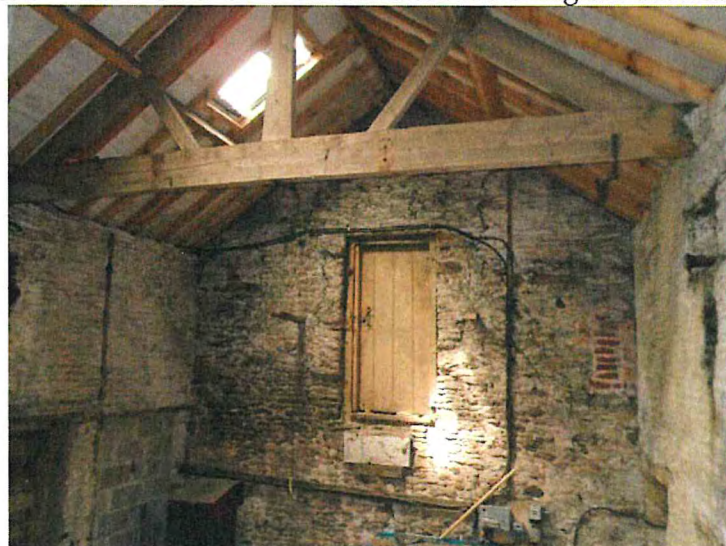
- No evidence of bats was observed.
 - The internal component of the building has been assessed as having a **NEGLIGIBLE SUITABILITY** to support bats.

Plate 3 – internal section to be converted into living accommodation.

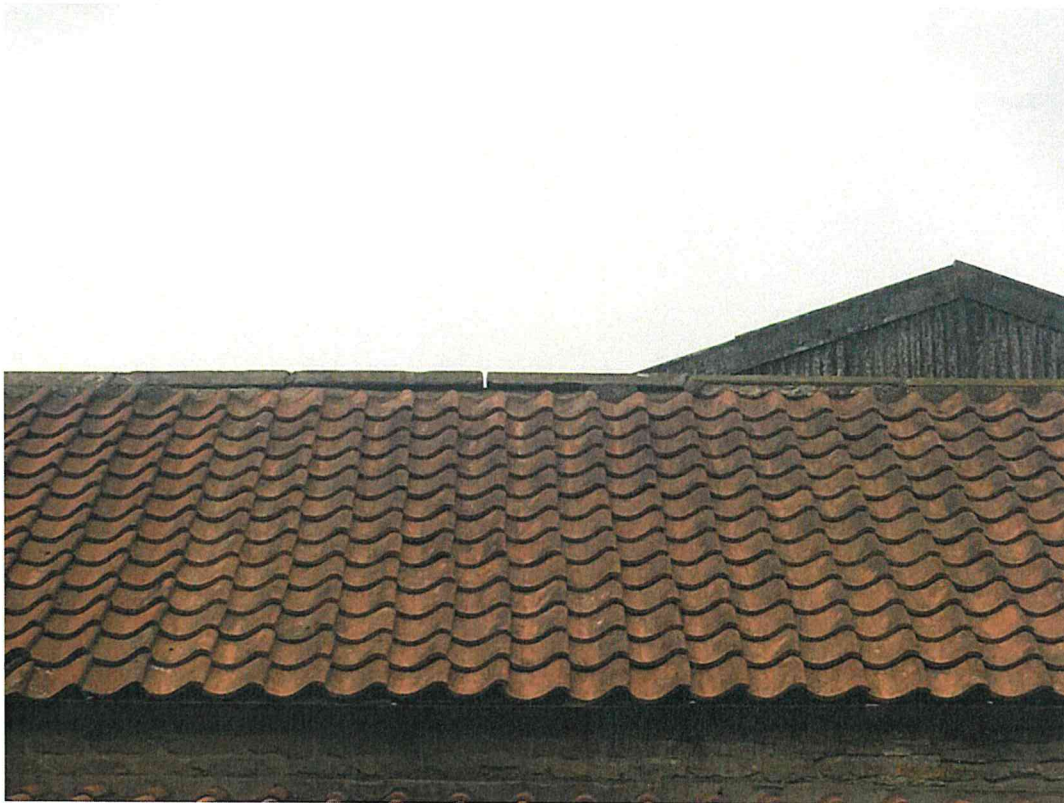
- 3.1 Externally, the buildings are generally in good condition, having been recently re-roofed and pointed.
- 3.2 Some mortar pointing has come away from some of the ridge tiles of the barn roof – see photograph 2.

Photograph 2 – ridge tiles mortar missing

- 5.1 The loose barn roof ridge tiles should be re-laid and re-pointed.
- 5.2 It would be prudent to provide concrete padstones to the seats of the timber purlins and trusses.

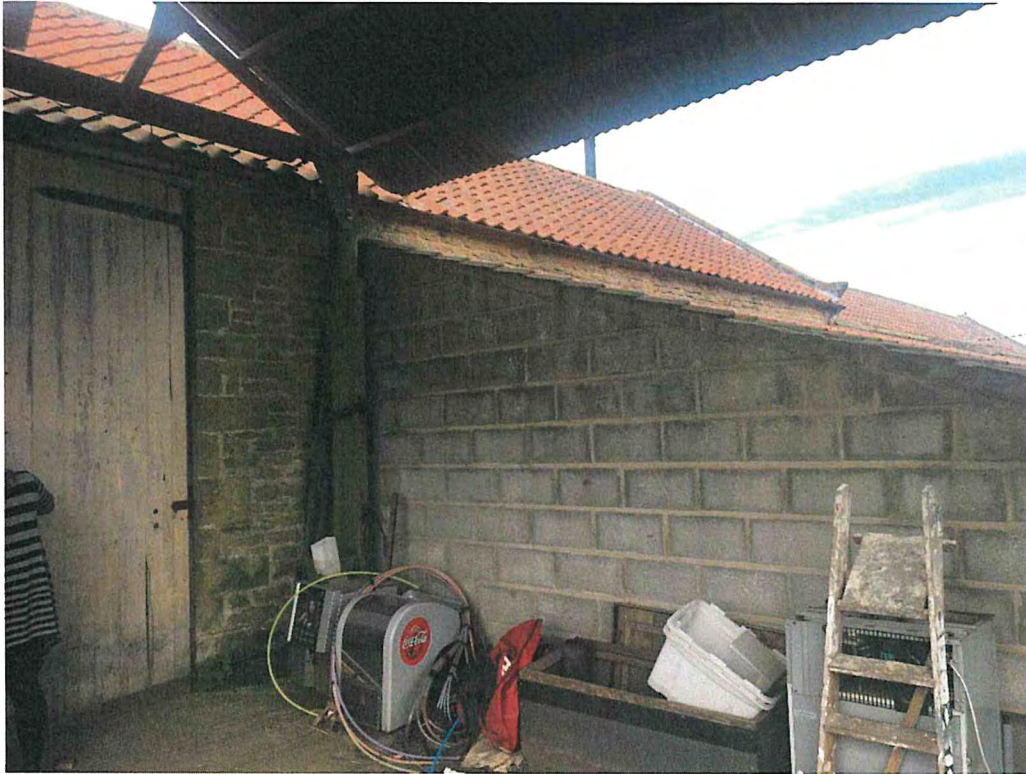
Photograph 3 – blockwork wall to garage under canopy

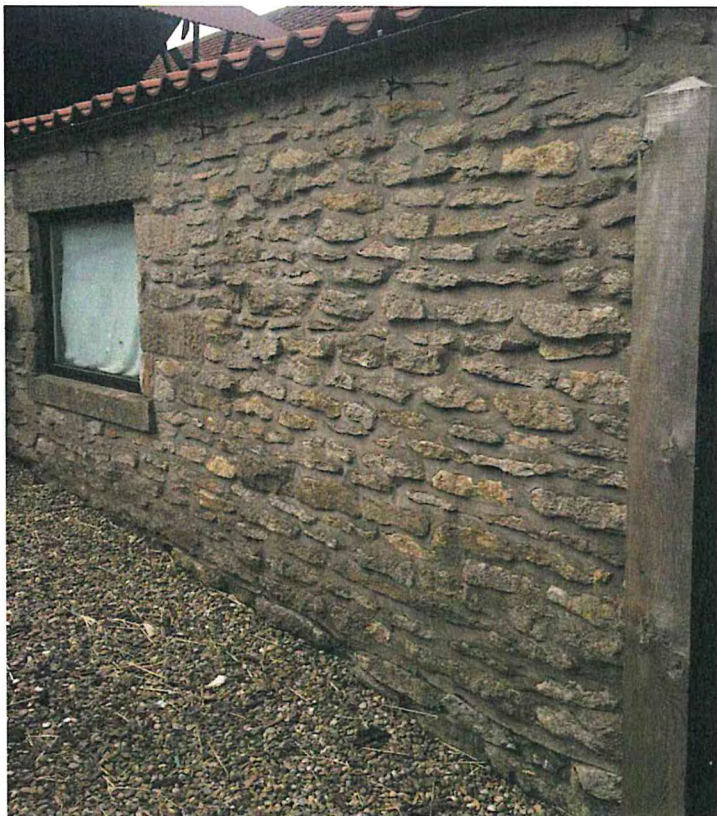
Photograph 4 – Garage DPC

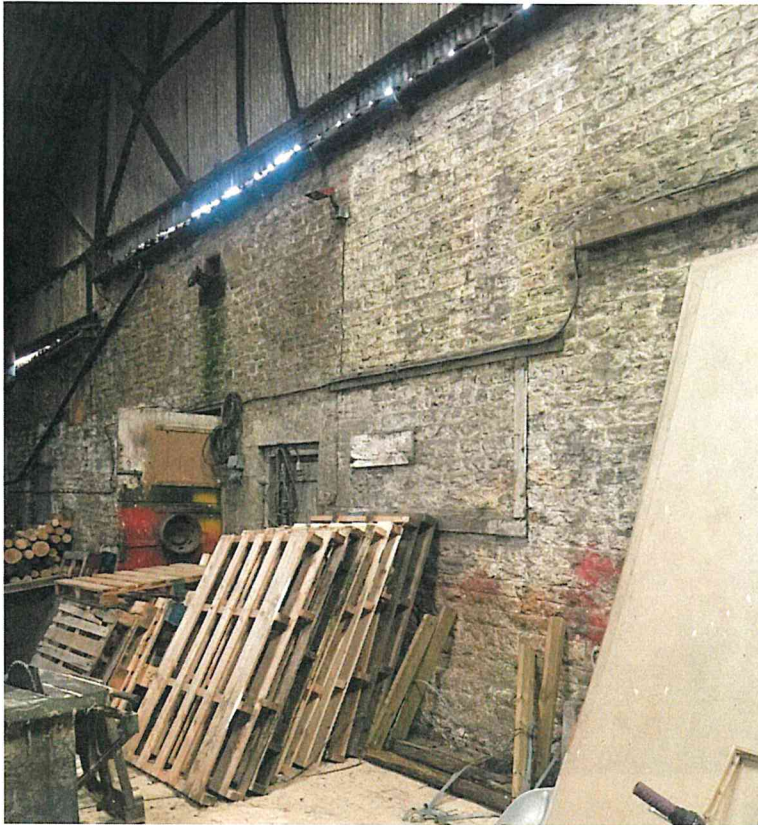
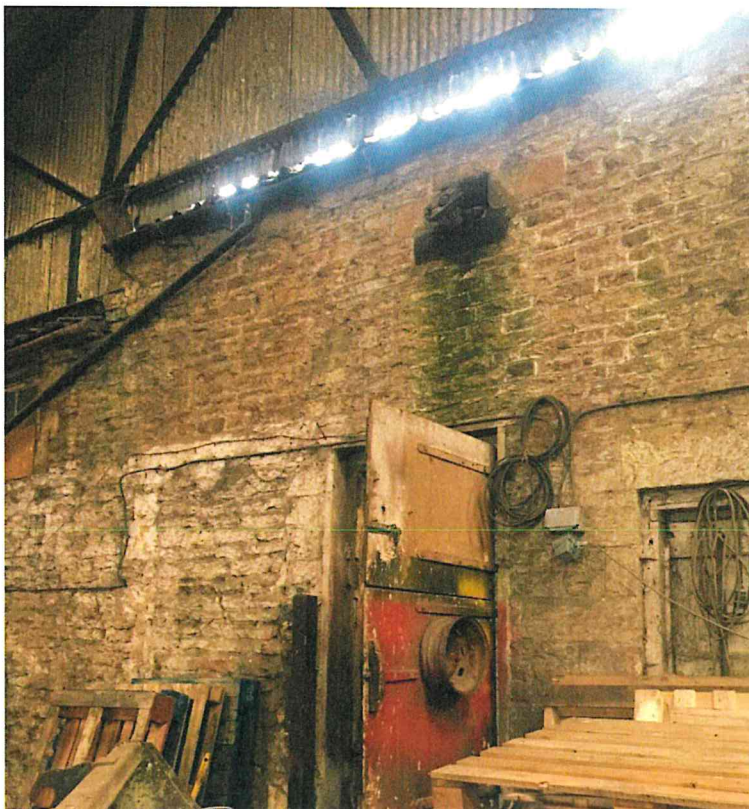
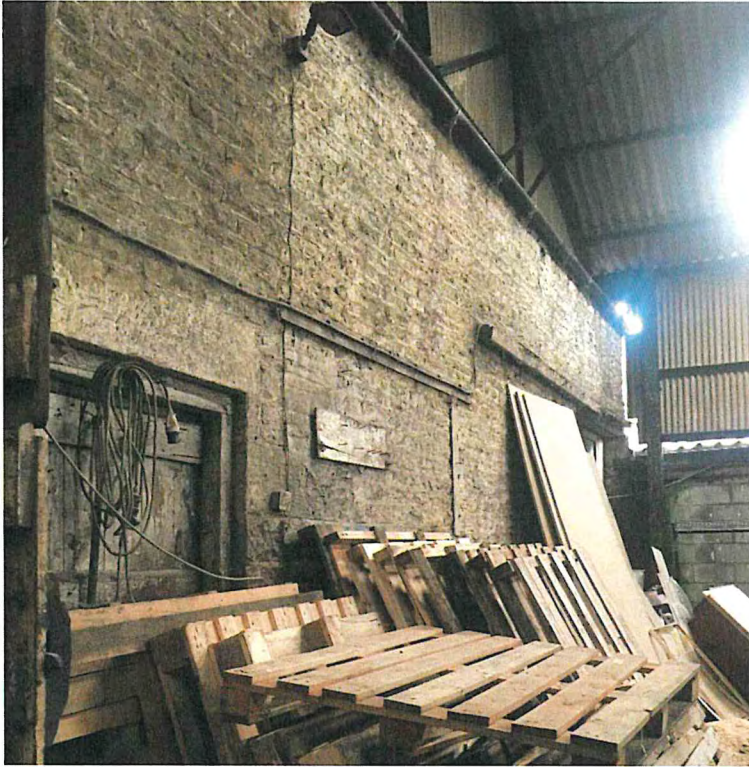
- 3.5 The rear wall of the barn is generally in good condition and is covered by the roof of the attached barn – see photographs 5, 6 & 7.
- 3.6 Internally the stonework has suffered some cracking.

Photograph 5 – rear wall of barn

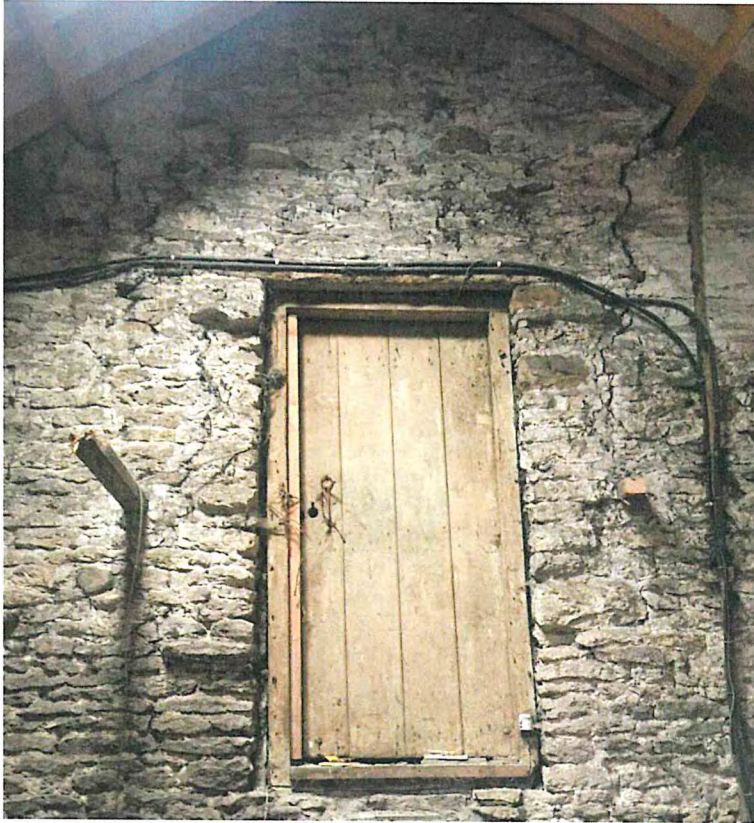
- 3.7 Stress cracks are present from the purlin seats moving towards the doorway – see photograph 9.
- 3.8 Cracking is also evident below doorway in wall adjoining existing dwelling – see photograph 10.

Photograph 9 – cracking to purlin seats in walls

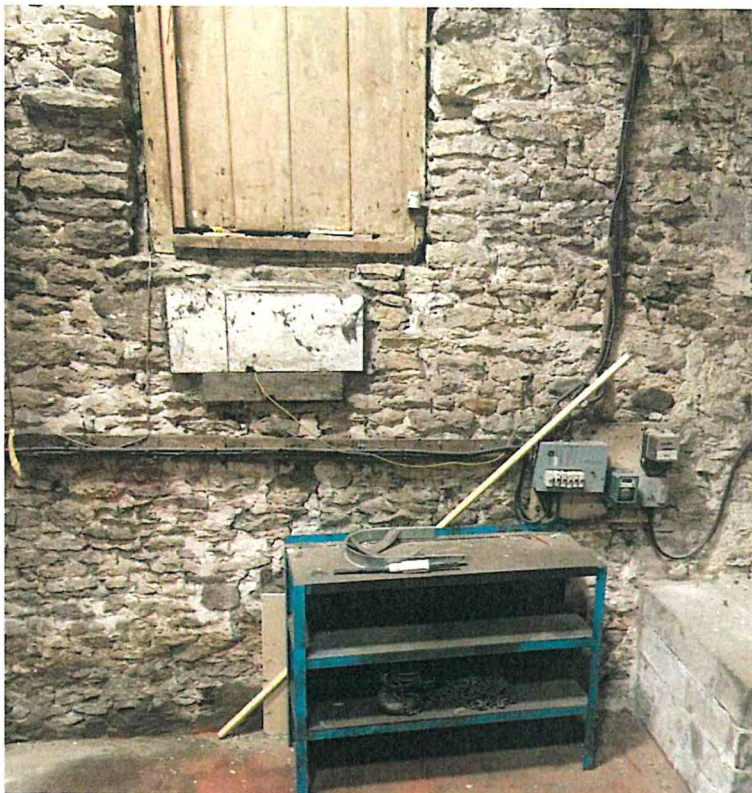
Photograph 10 – cracking under doorway

- 5.5 The vertical cracking to the internal barn walls should be stitch repaired using an appropriate Helifix crack stitch repairs.
- 5.6 The internal stone barn wall should be tied into the external walls via 5mm thick L-shaped steel restraint straps fixed at 450mm vertical centres, or an alternative Helifix repair solution.

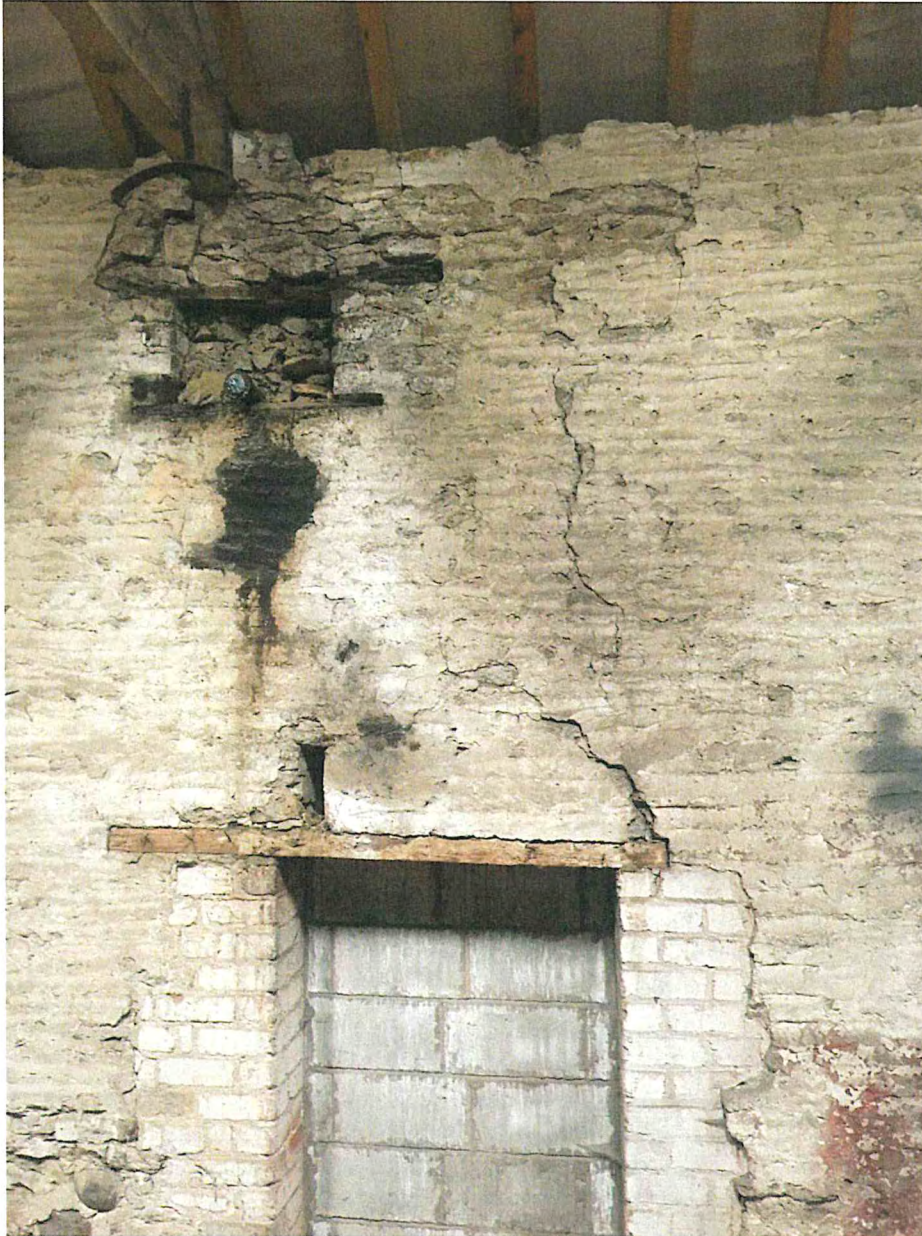
- 3.10 Cracking and vertical distortion has occurred to the front barn wall below the truss seat and over the blocked up doorway – see photograph 13.
- 3.11 The southern end of the barn floor is covered with a later addition of a concrete floor and steps up - see photograph 14.

Photograph 13 – cracking in wall below roof truss

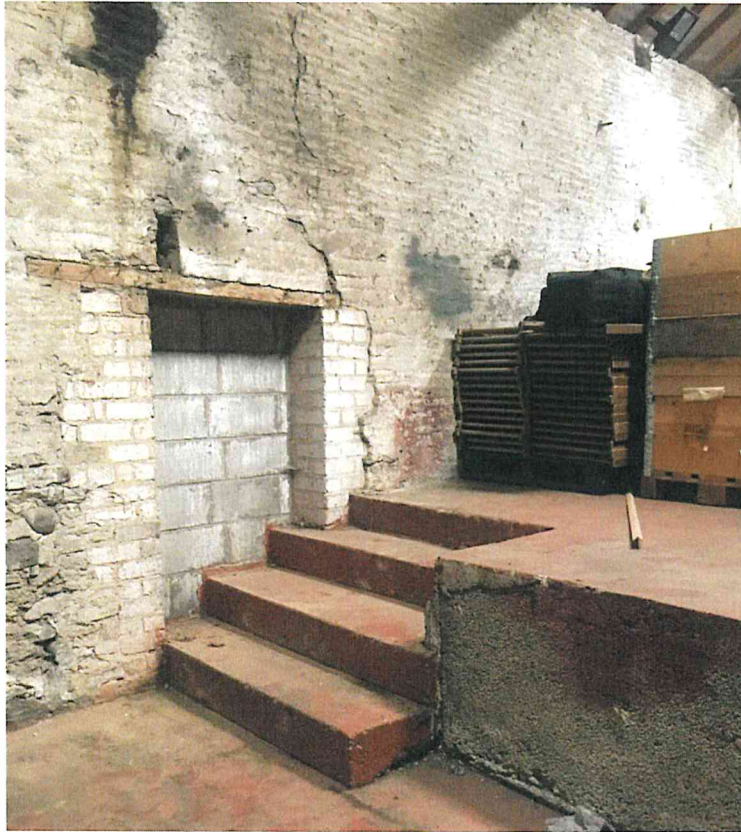
Photograph 14 – view on wall buried by later concrete floor

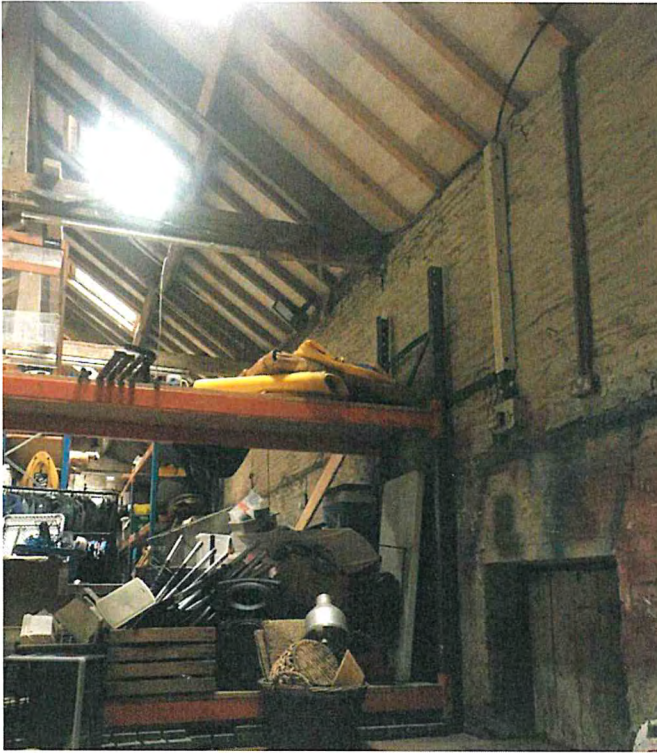
Photograph 17 – cracking over timber lintel below truss seat

- 3.12 Stress cracking is present below the seat of the truss to the rear barn wall and above the timber lintel over the doorway – see photograph 17.
- 3.13 The garage building is generally in good condition both internally and externally – see photographs 19 & 20.

- 4.1 Generally the barn and garage are in a good condition.
- 4.2 The majority of cracking to the internal barn walls appears to stem from rotten timber lintels, which are no longer fit for purpose.
- 4.3 Stress cracking around the timber purlins is likely to have been cause during installation and due to a lack of a spreader padstone.
- 4.4 The mould patches to the walls are as a result of previous leaking of water and / or oil and are likely to have worsened through lack of treatment.
- 4.5 The internal corner of the front garage wall was not readily accessible, however is likely to be damp due to the covering of the DPC externally.

- 5.3 Any remaining timber lintels should be removed and replaced with concrete lintels or tied in and bricked up where possible.
- 5.4 All redundant openings should be tied in and bricked up.

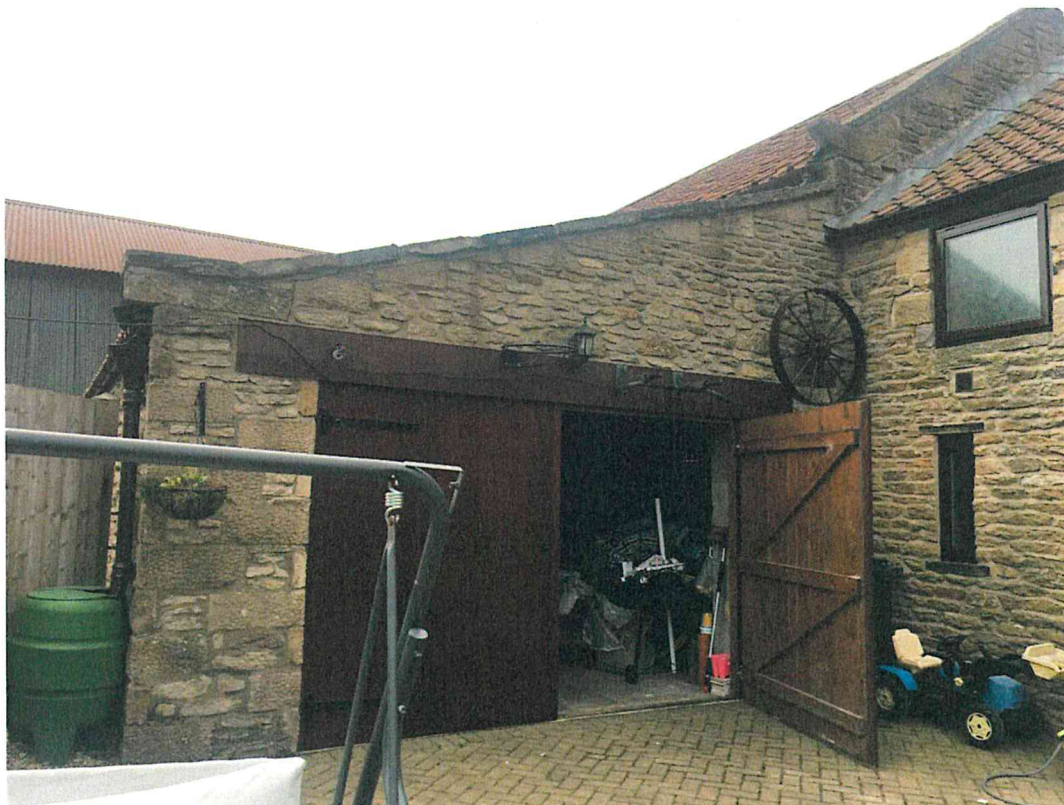
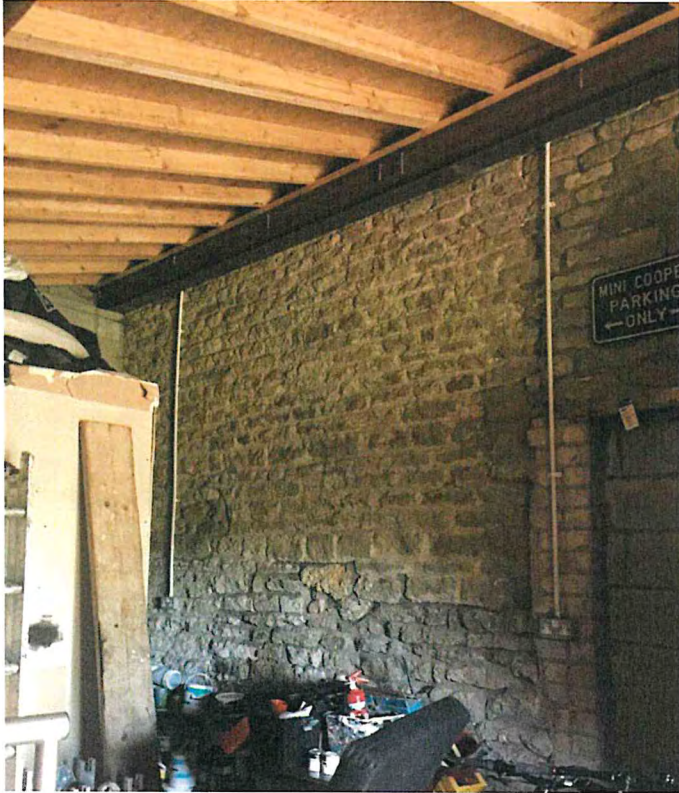
Photograph 19 – view on garage door elevation

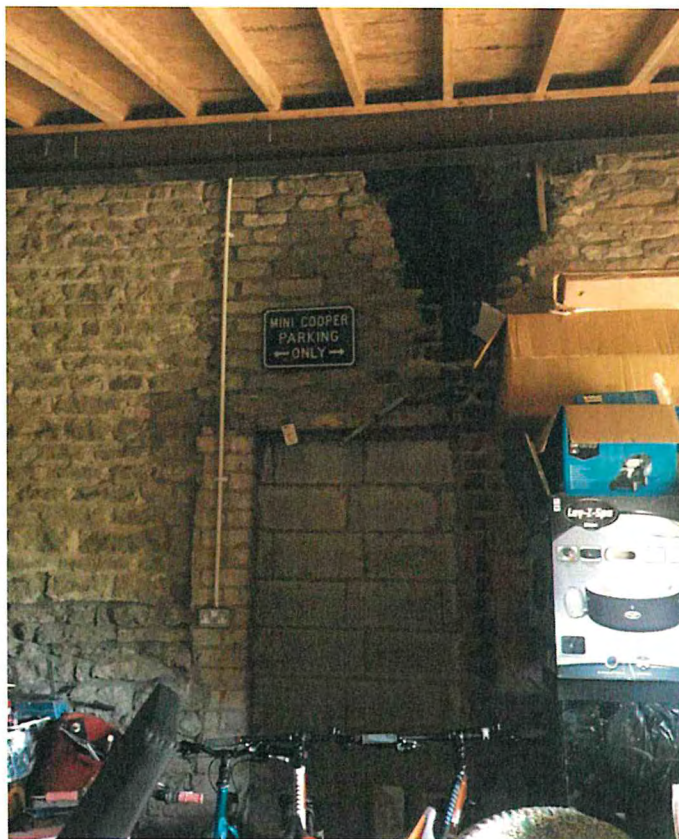
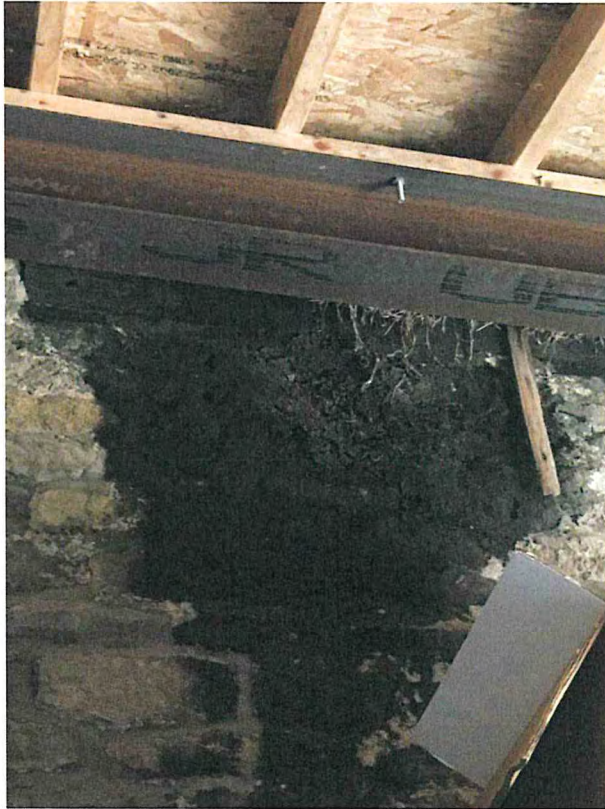
3.15 There is some local mould staining to the wall – see photographs 21 & 22.

Photograph 21 – mould patch on garage internal rear wall

- 5.9 The areas of mould patches should be investigated to establish that the leaks are not current / ongoing.
- 5.10 The black mould patches to the walls should be treated with an appropriate mould remover.
- 5.11 The steel purlins to the garage roof should be cleaned back free from rust and re-painted with red iron-oxide paint prior to plasterboarding.
- 5.12 It would be prudent to treat the timber trusses, purlins and rafter prior to plasterboarding.
- 5.13 The lower section of internal garage wall should be pointed prior to plasterboarding.
- 5.14 Care should be taken when lowering the internal concrete floors not to undermine the foot of the existing walls.
