Design and Access Statement

The-Cranny

HERITAGE STATEMENT
APPLICATION FOR MINOR WORKS

Like for Like replacement of partially rotten staircase window to gable - 1st floor

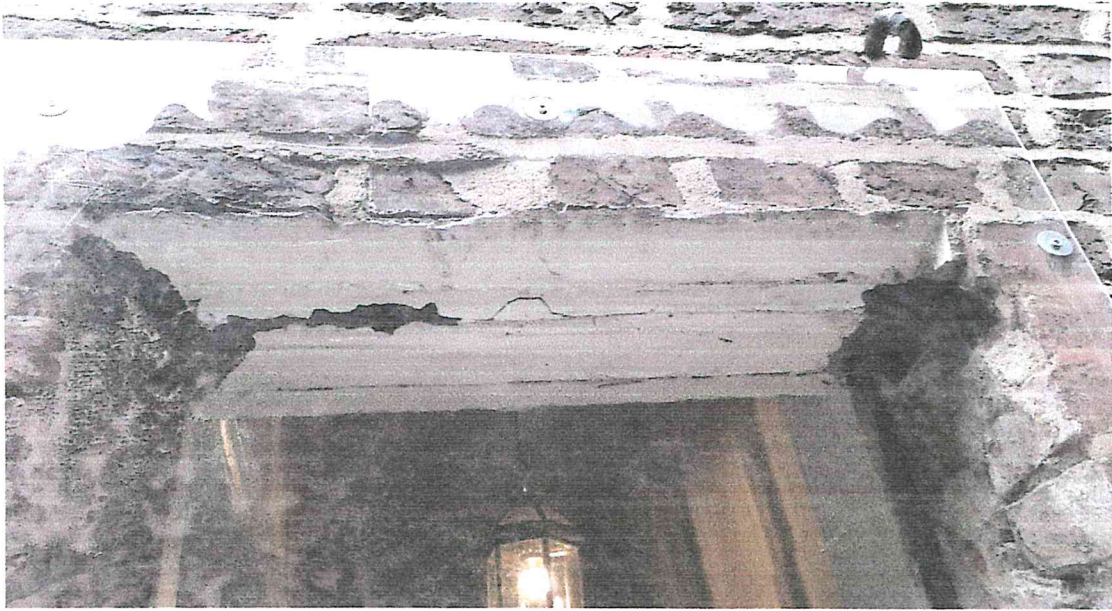
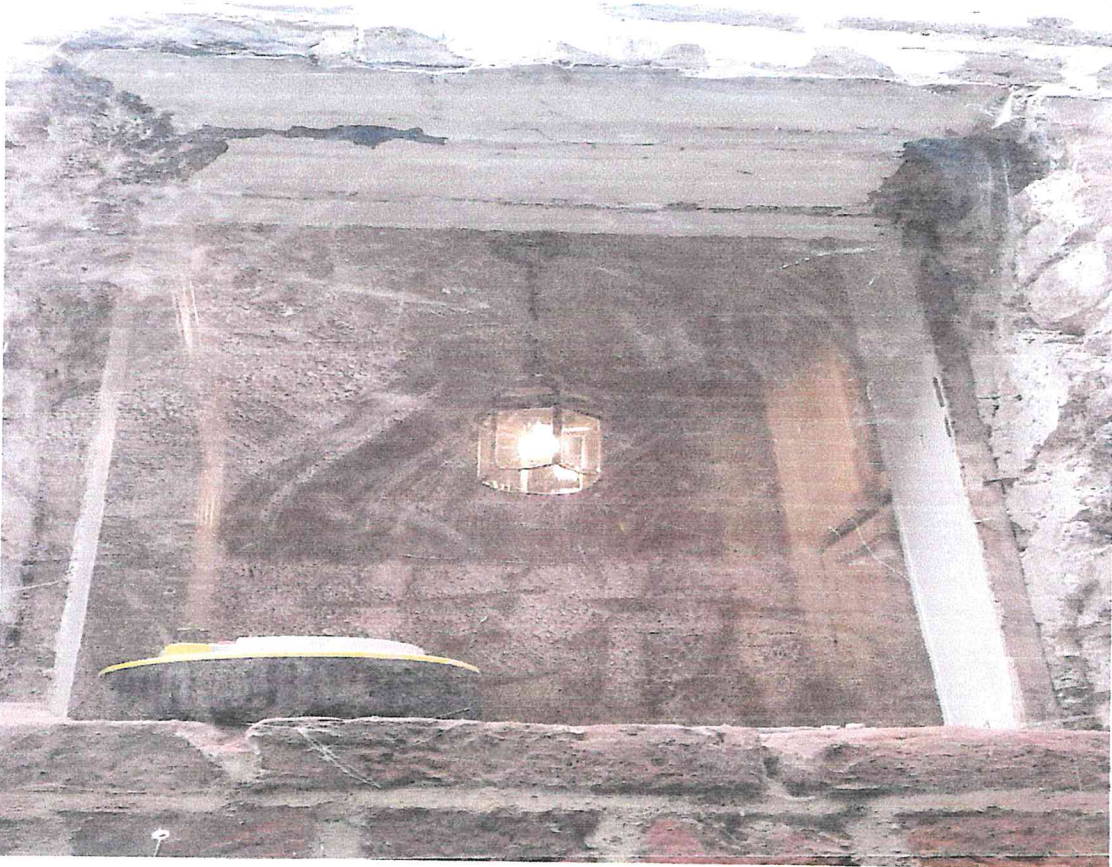
PHOTOGRAPHS A(1)

Photographs A (1) & A (2)

A temporary piece of perspex has been fitted to protect from the weather.

The narrow passage way to the side of the Cranny makes it impossible to show the whole side of the property.

The Perspex covering the existing opening will be removed after installation.

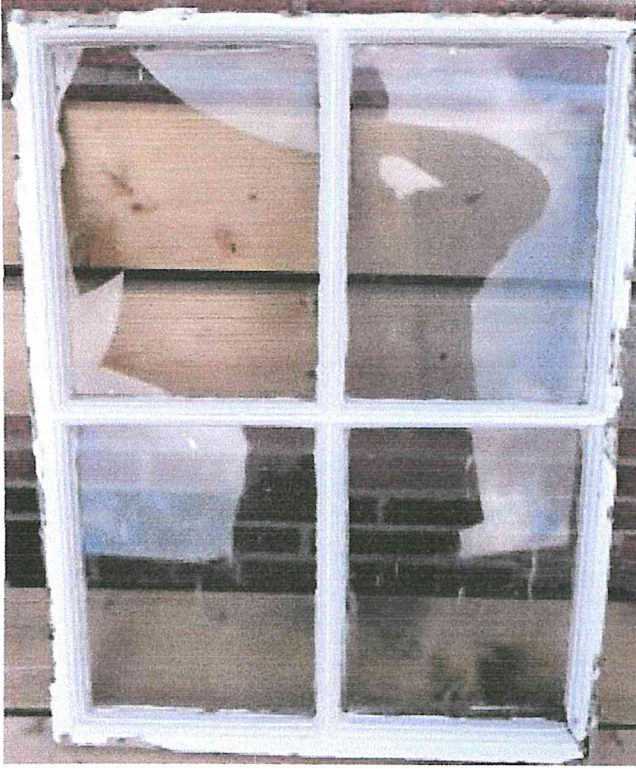
PHOTOGRAPH B

Photograph B

Window Frame which is being renovated and re-installed.

Full replacement of the frame is to be carried out as per the drawings attached to the application. The opening window will be restored, repainted and reused in the new frame.

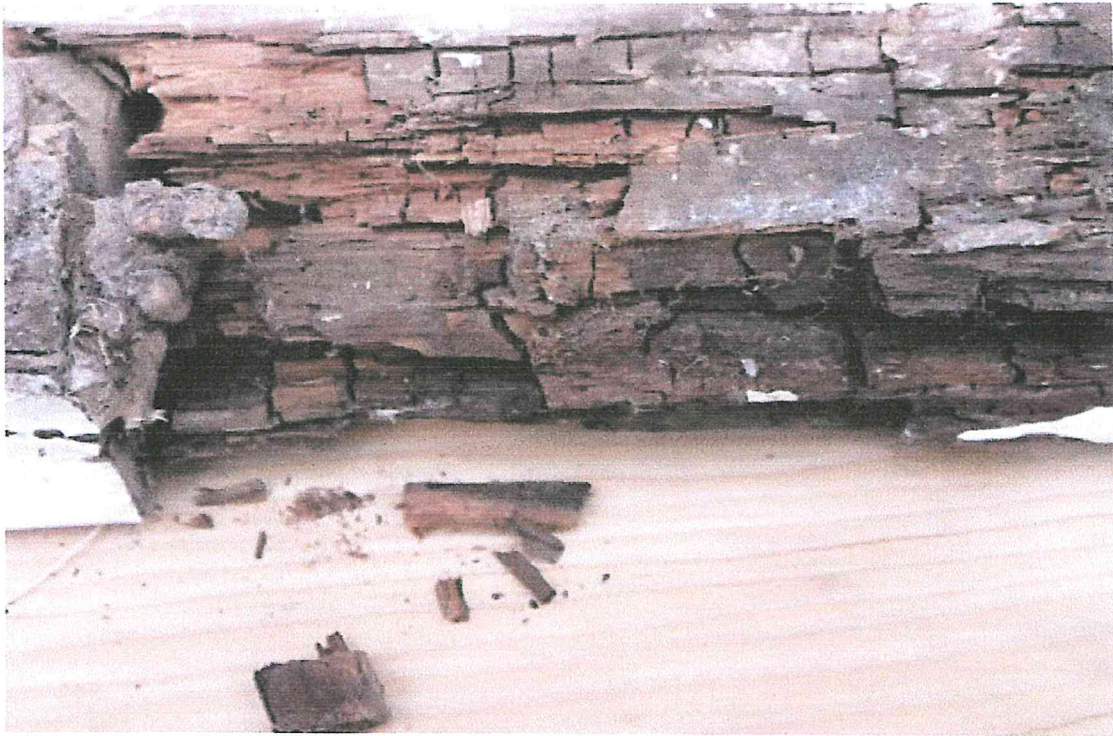
PHOTOGRAPH C

Photograph C & D

You can see from these photographs the rotten frame and the other attempts made by previous owners/builders to extend the life of the window framework.

The existing rotten solid frame is to be replaced with new in a like for like fashion, as detailed in this drawing (see provided photos to match)

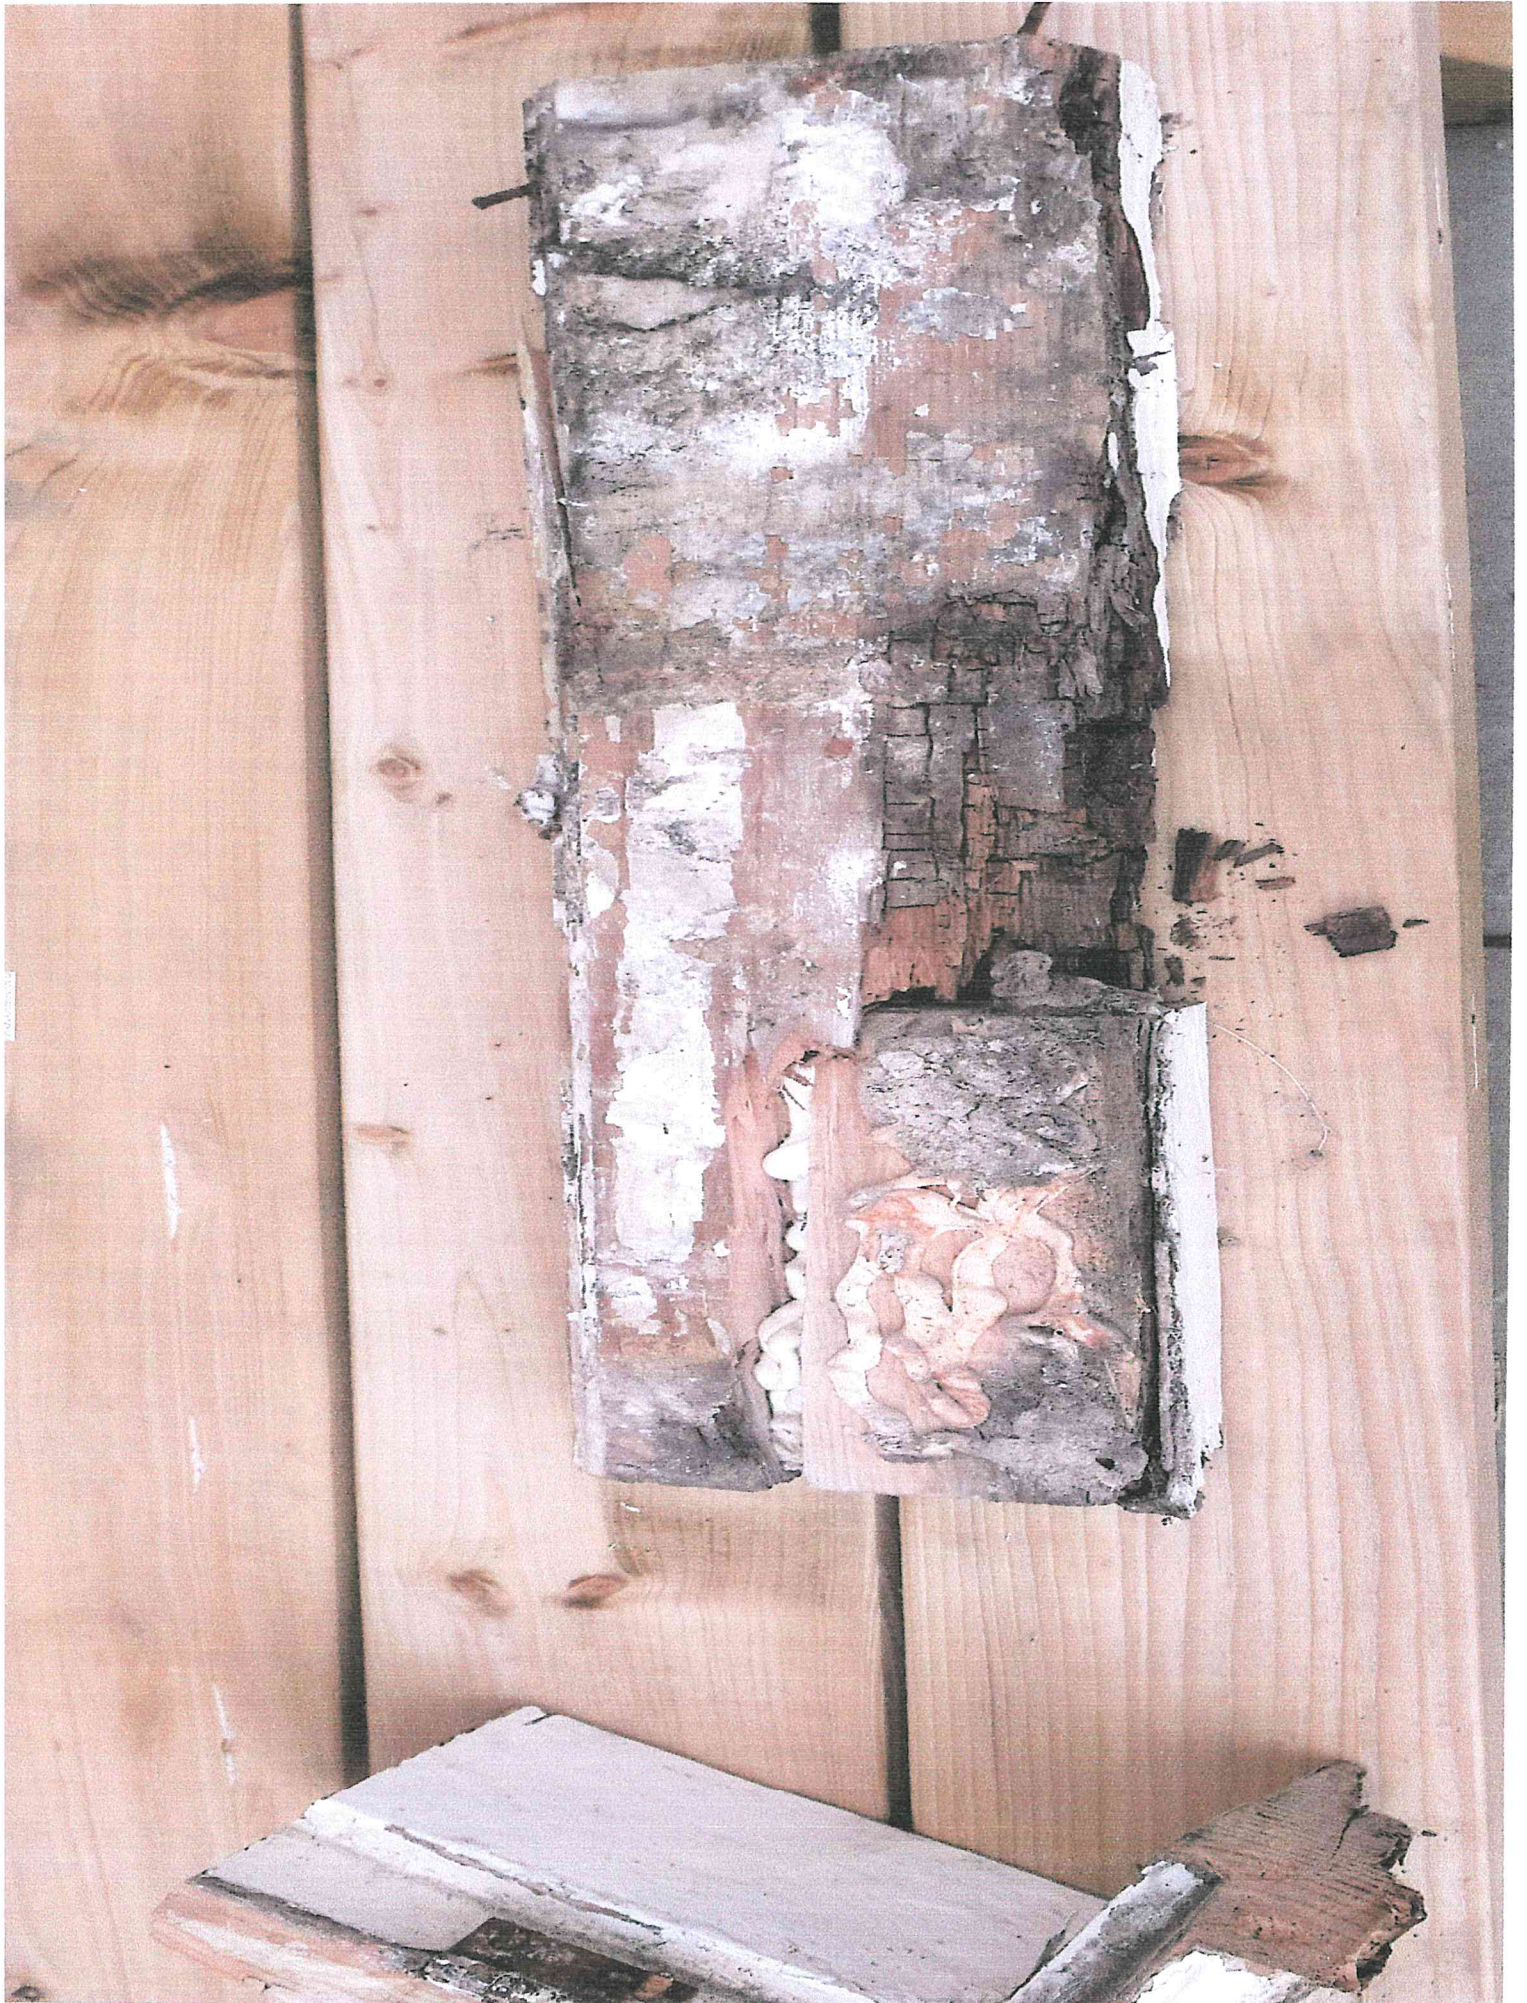
PHOTOGRAPH E

Photograph E

A further example of the rotting framework

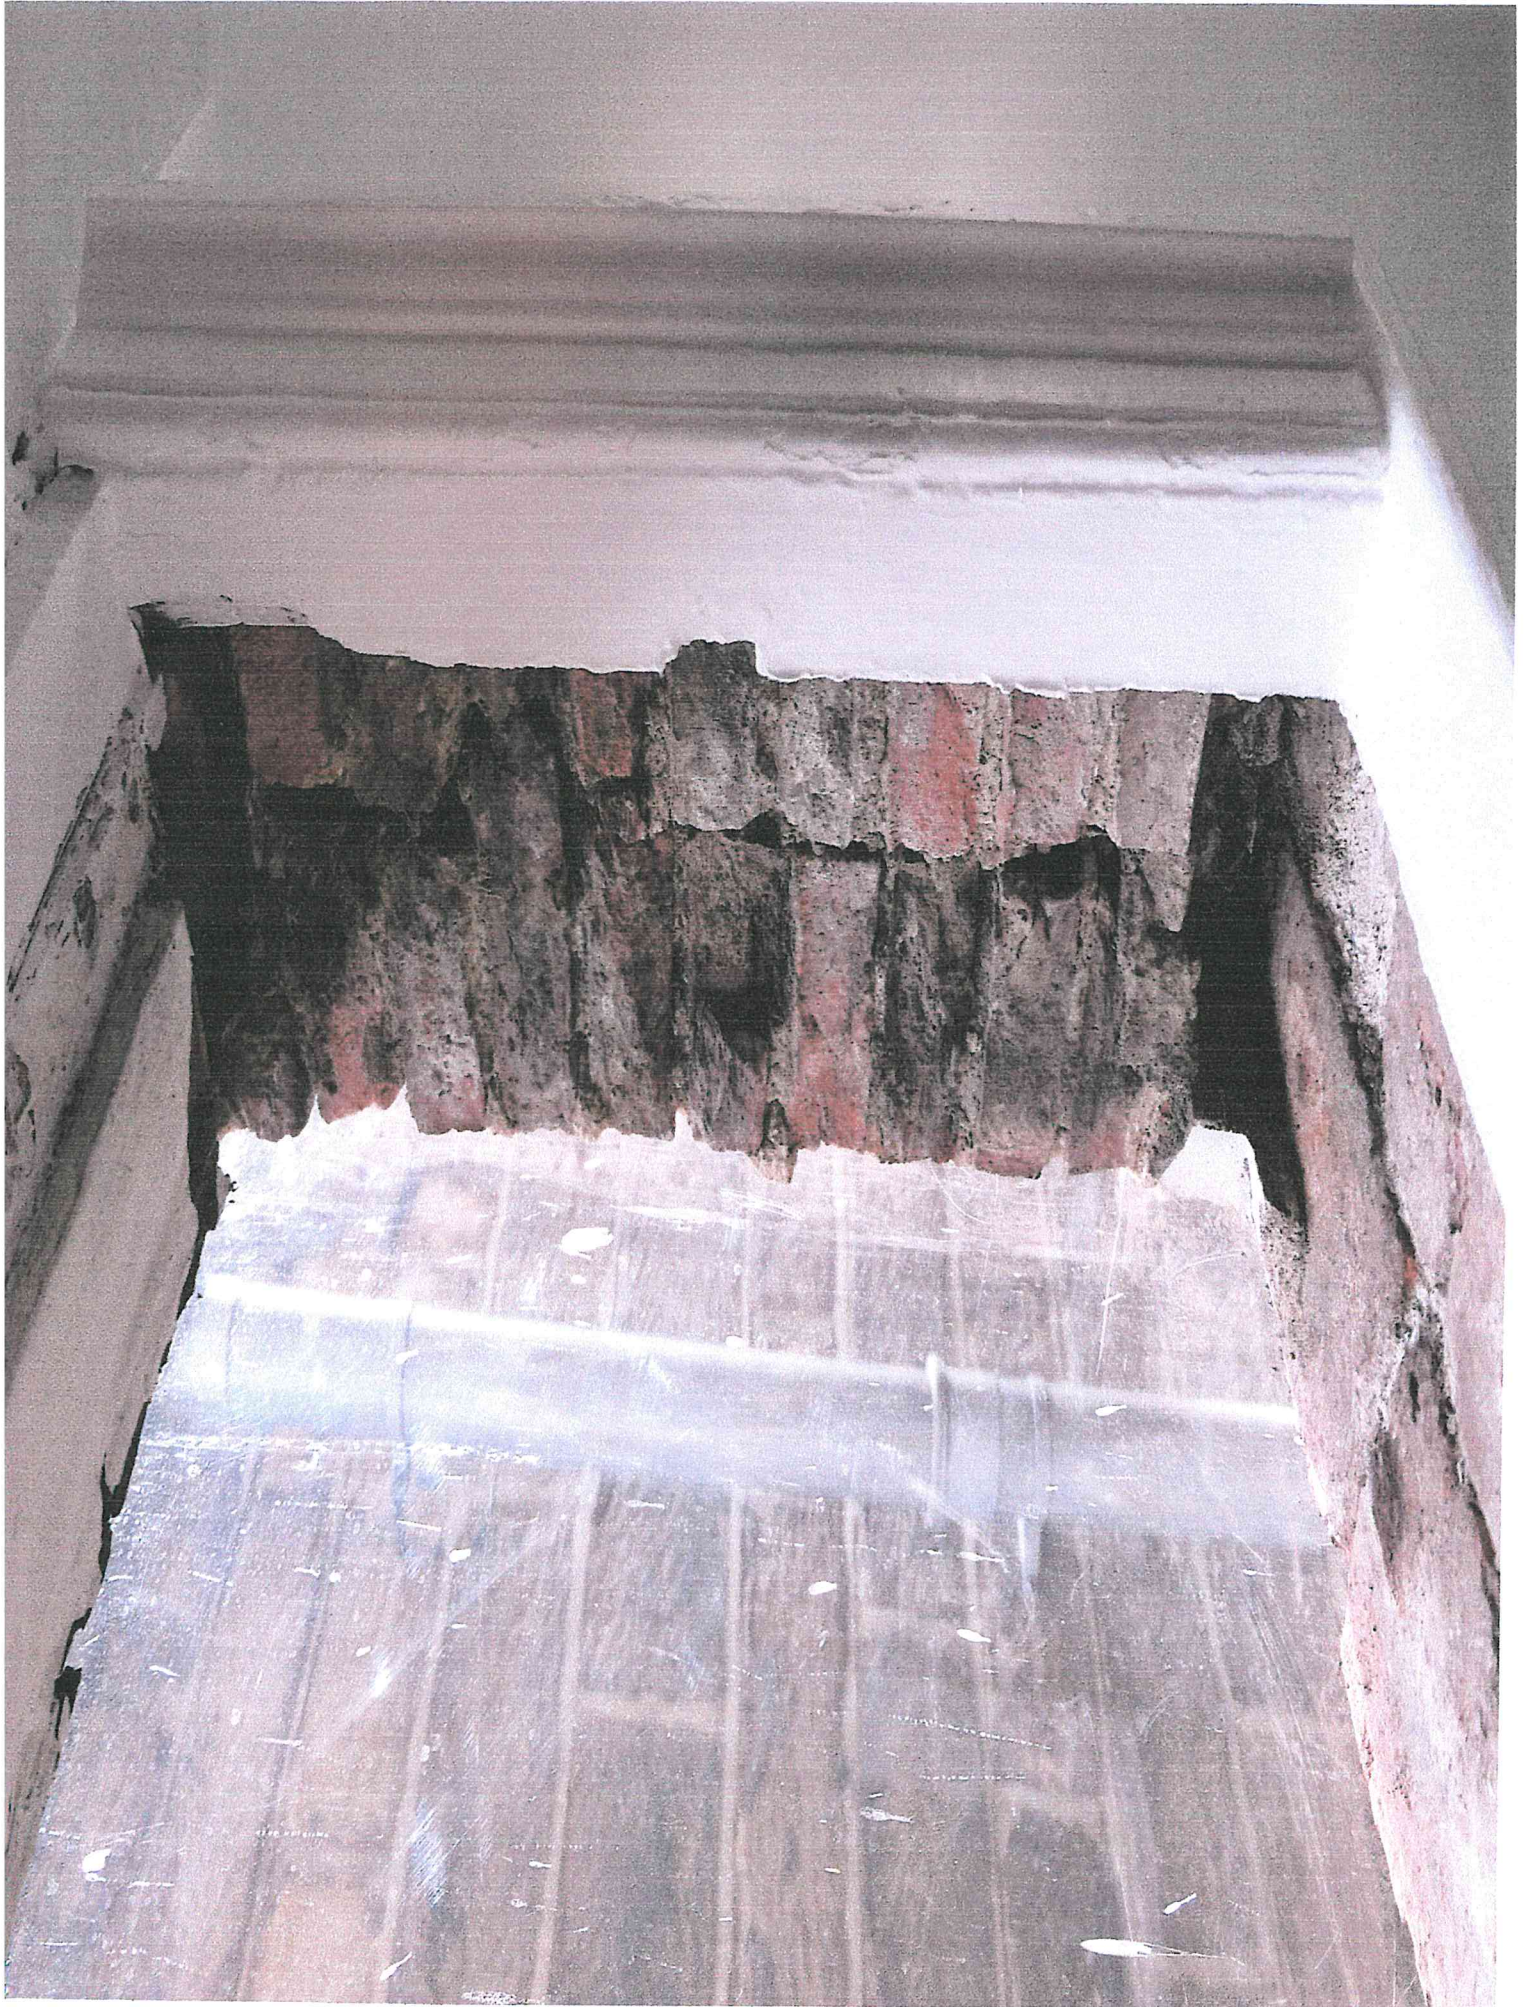
PHOTOGRAPH F

Photograph F

You can see by we have removed the window without damaging internal woodwork.
