# Forge Valley, Scarborough

## Construction Method Statement

D/I/D/128858/04 Issue 1  
September 2019

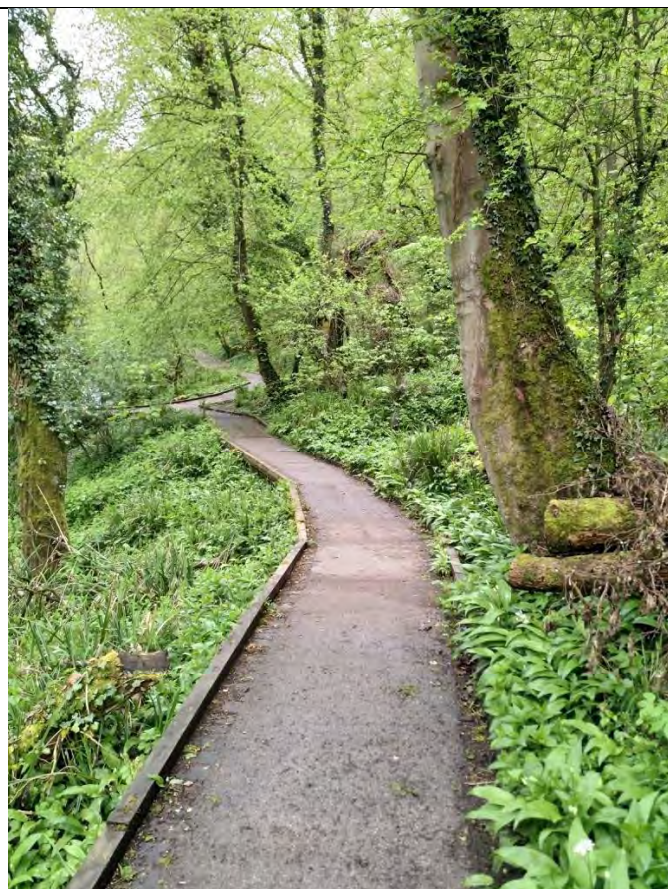
Location B7. Note the large, mature Sycamore restricting any widening of the path at that point.
