Conversion of barn to holiday letting cottage at Field House Farm, Newholm.

ECOLOGICAL IMPACT ASSESSMENT

**FIELDHOUSE FARM
NEWHOLM
WHITBY**

**FIELDHOUSE FARM
NEWHOLM, WHITBY
NORTH YORKSHIRE
YO21 3QY**

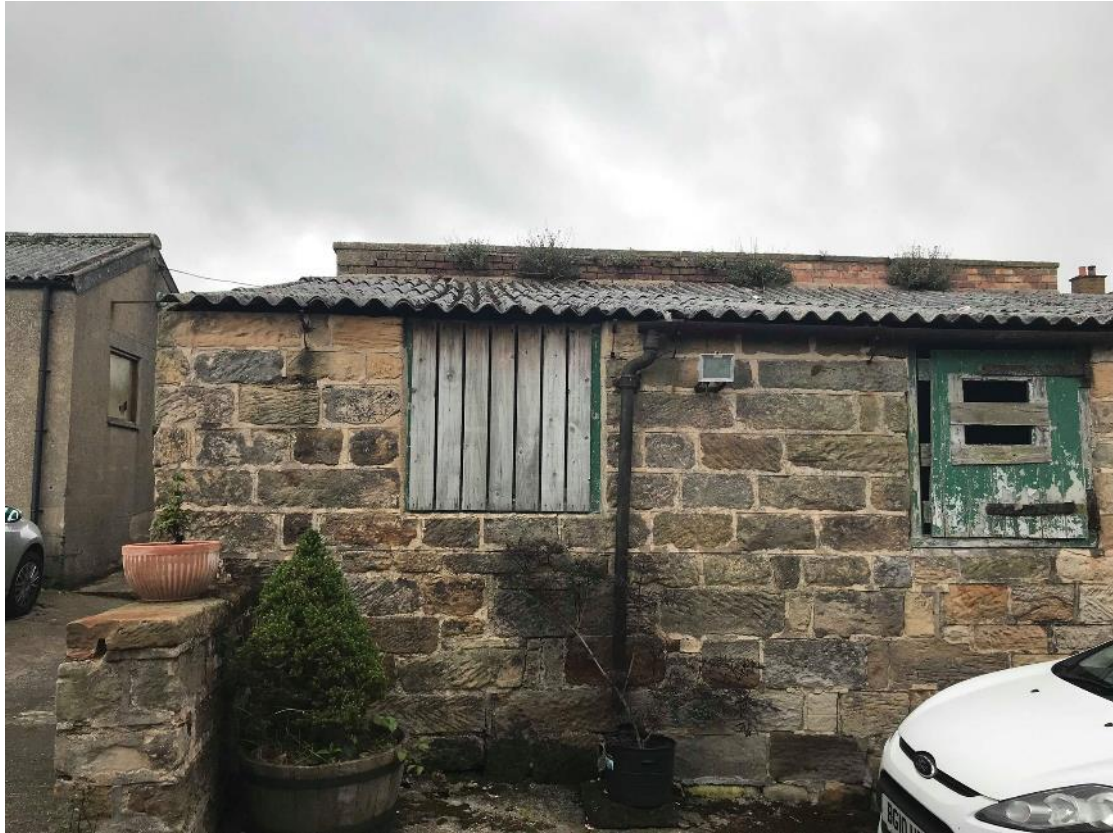
Image 1. North elevation of building

The building was constructed with stone with a pitched roof; the northern elevation made of corrugated asbestos and the southern elevation from clay pan tiles which had several gaps under tiles. On the northern elevation there were two boarded-up windows with gaps round the boards allowing for some ingress of light into the building. The eastern elevation had two access points which lead into two internal rooms and the southern elevation had an entrance which led into one internal storage room. The most northerly entrance was a large, open, garage doorway which remains open at all times. The other two entrances lead into small storage rooms which had locked wooden doors closed at all times. The building was attached to a small storage building on the western elevation. The garage building and storage building do not share any internal voids or roofing and the storage building will not be impacted on by the proposed works. There was no external evidence of bats on, or near to, the building.

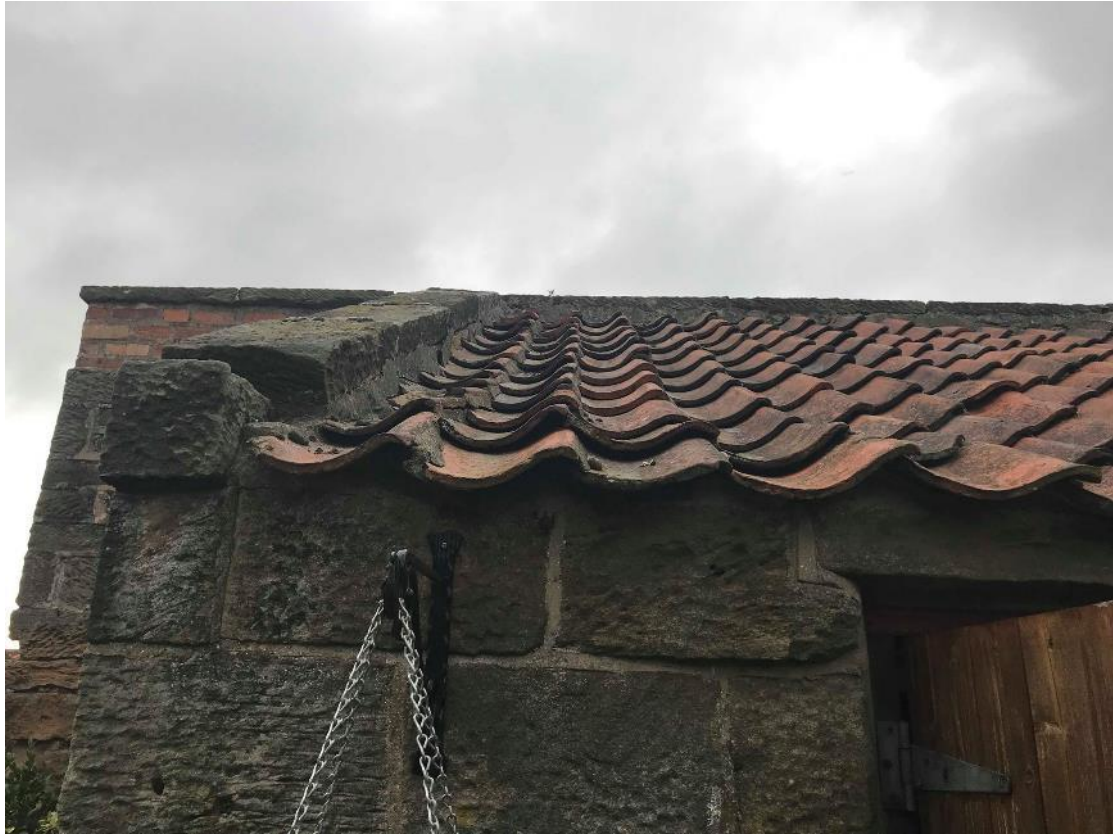
Image 2. South elevation of roof showing gaps under tiles

Bats: Due to there being several gaps under roof tiles it is considered that the site is of low value to roosting bats, though suitability was considered to be extremely limited due to the ingress of light and, potentially, external weather conditions resulting in likely disturbance to bats, and the abundance of cobwebs indicating a lack of bat usage and reducing suitability for future use. A single, old and desiccated bat dropping was found in the centre of an exposed internal room of the building not located under potential feeding perches or PRFs. This dropping is deemed to be from a bat which is likely to have briefly entered the building to forage on a single occasion but is unlikely to use the building as a roost or feeding perch.

- Tiles on the southern elevation of roofing, made from clay pan tiles, should be removed by hand in a soft strip style demolition. This is as a precautionary in the highly unlikely event that bats are found to be roosting here.

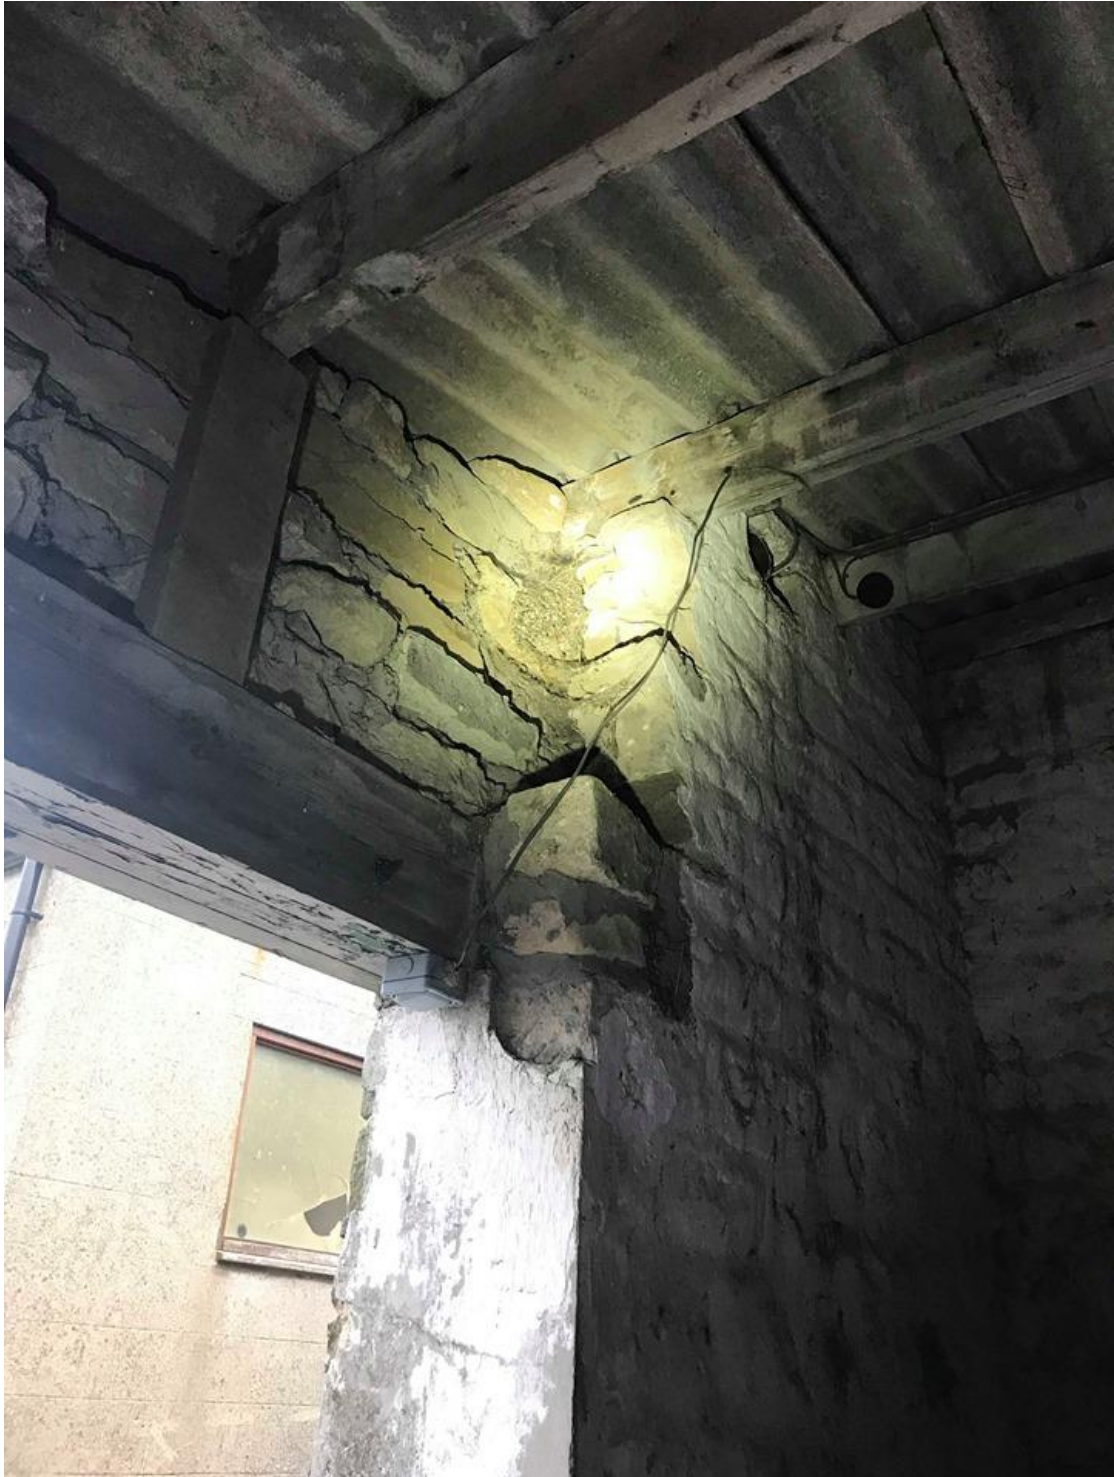
Image 6. Internal of open garage showing recently used bird nest

Nesting Birds: There was a low level of recent bird nesting activity on site within the building. It is considered that there is a low value to nesting birds on site. If the building was to be demolished then a small number of bird nest would be destroyed and has the potential to kill or injure a small number of birds and chicks.

- At least two sparrow terraces must be installed on the near-by buildings on the farm to compensate for the loss of potential nesting habitat within the building.

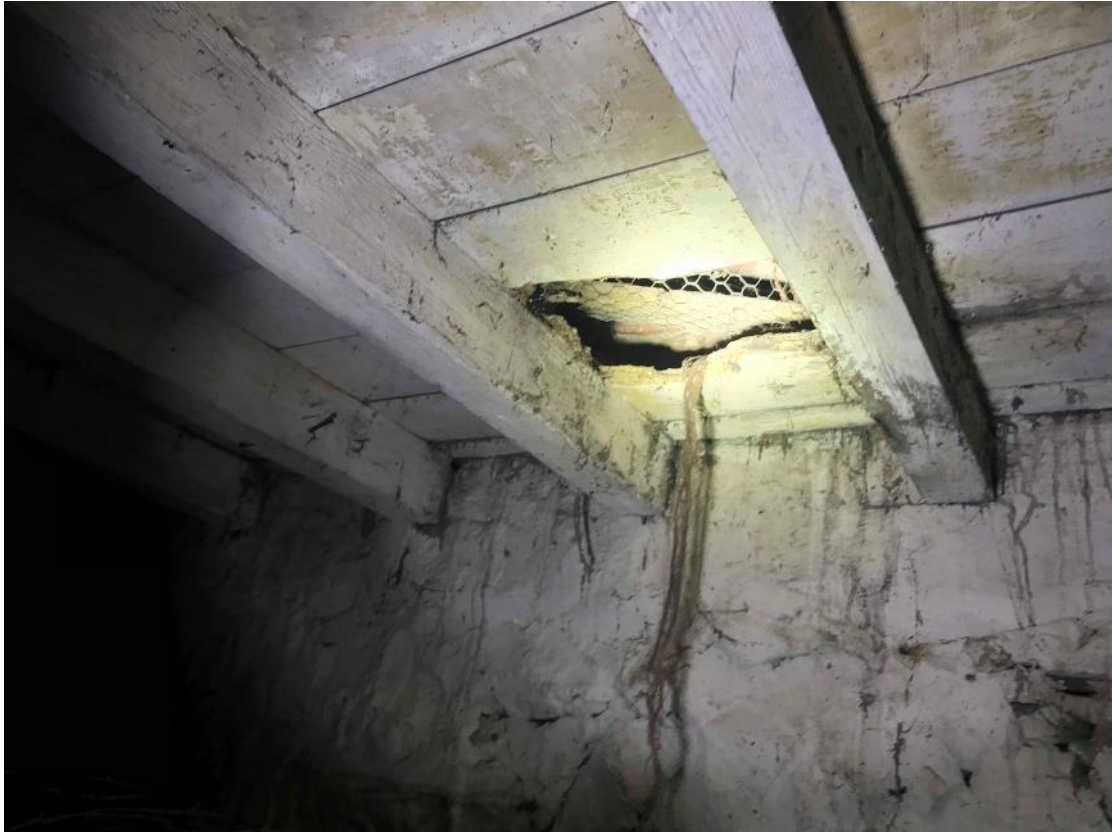
Image 7. Hole in ceiling of storage room.

A very small, and heavily cobwebbed, loft void within the southern section of the building could not be fully accessed as there was no access hatch; however, the majority of the void could be observed from the ground floor through a large gap in the ceiling and was evident that the loft had a large ingress of light from a skylight. Furthermore, additional survey effort to confirm bat presence or likely absence was undertaken following the initial assessment. It is therefore considered that this minor constraint has not significantly impacted the survey findings.

Internally, there was a small loft void within the most southern section of the building. From inspecting the loft void through a large hole in the ceiling, it was found that there was a large ingress of light into it from a skylight and a large abundance of cobwebs with no evidence of bats observed. The central and southern internal rooms were being used for storage and contained an abundance of cobwebs and had evidence of previously nesting birds in the form of old nests and droppings. The large internal room, the garage, was also being used for storage on the date of survey and was open sided on the eastern elevation. The room had a large ingress of light, had a noticeable draught and was somewhat exposed to the elements. Within this room, several recently used bird nests were observed within large gaps in the stonework. A single, very old and desiccated, bat dropping was found within the centre of this room and not located under any potential PRFs or potential feeding perches for bats. Due to the open nature of this room and its exposure to the elements, it is thought that the dropping would have likely been from a foraging bat which entered the building to briefly forage on a single occasion. No further evidence of bats was observed within or external of the building. The building was considered to be of low value to nesting birds and low value to roosting bats, though it is highly unlikely that there is a bat roost within this building.
