Bat, Breeding Bird and Barn Owl Survey

Centre Farm, Battersby

June 2019

MAB Environment & Ecology Ltd

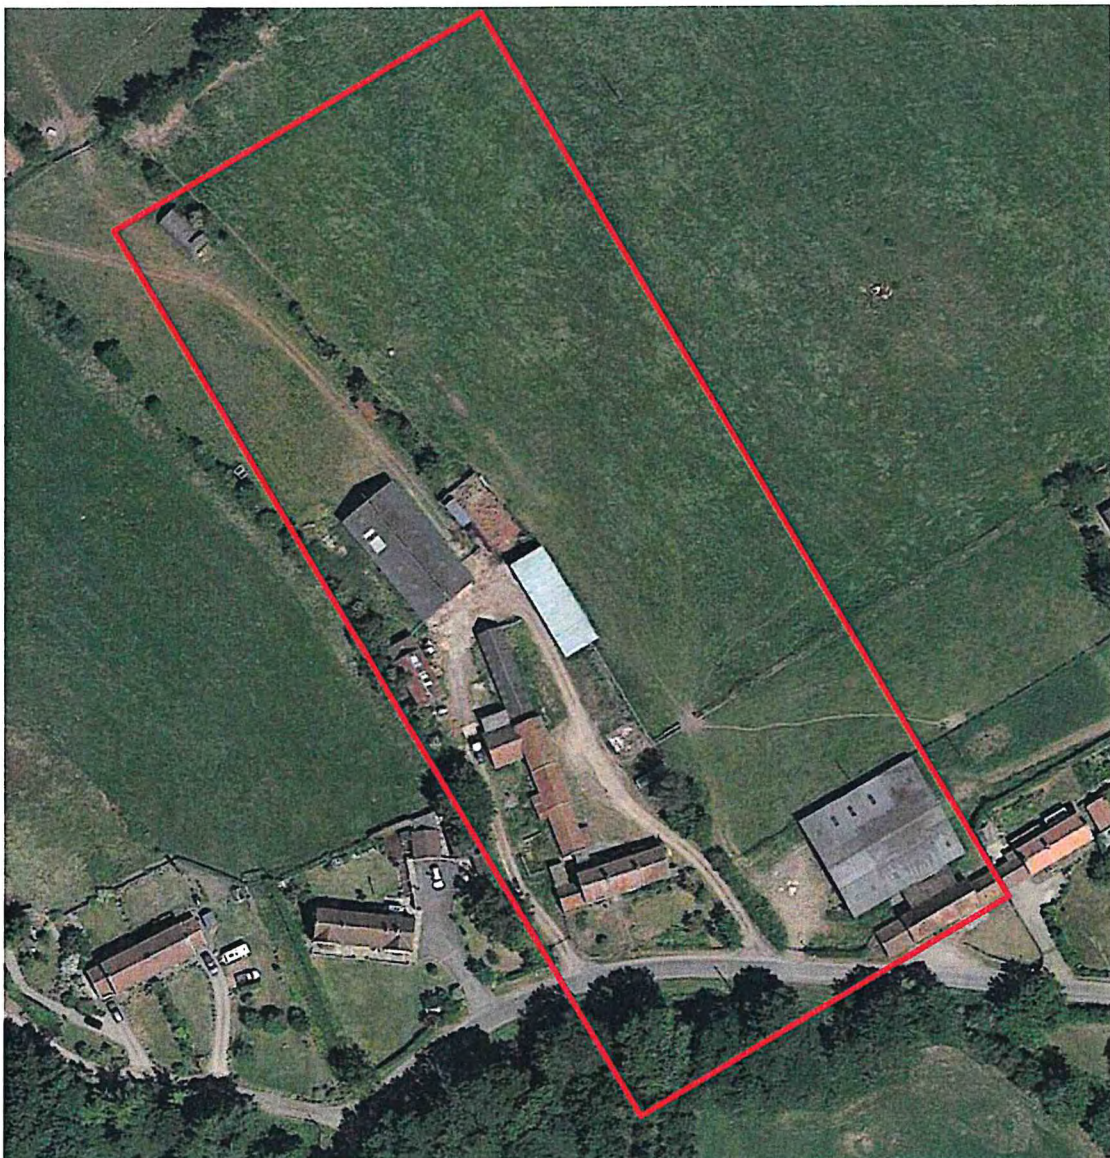
Figure 2: Buildings included within the scope of the survey.

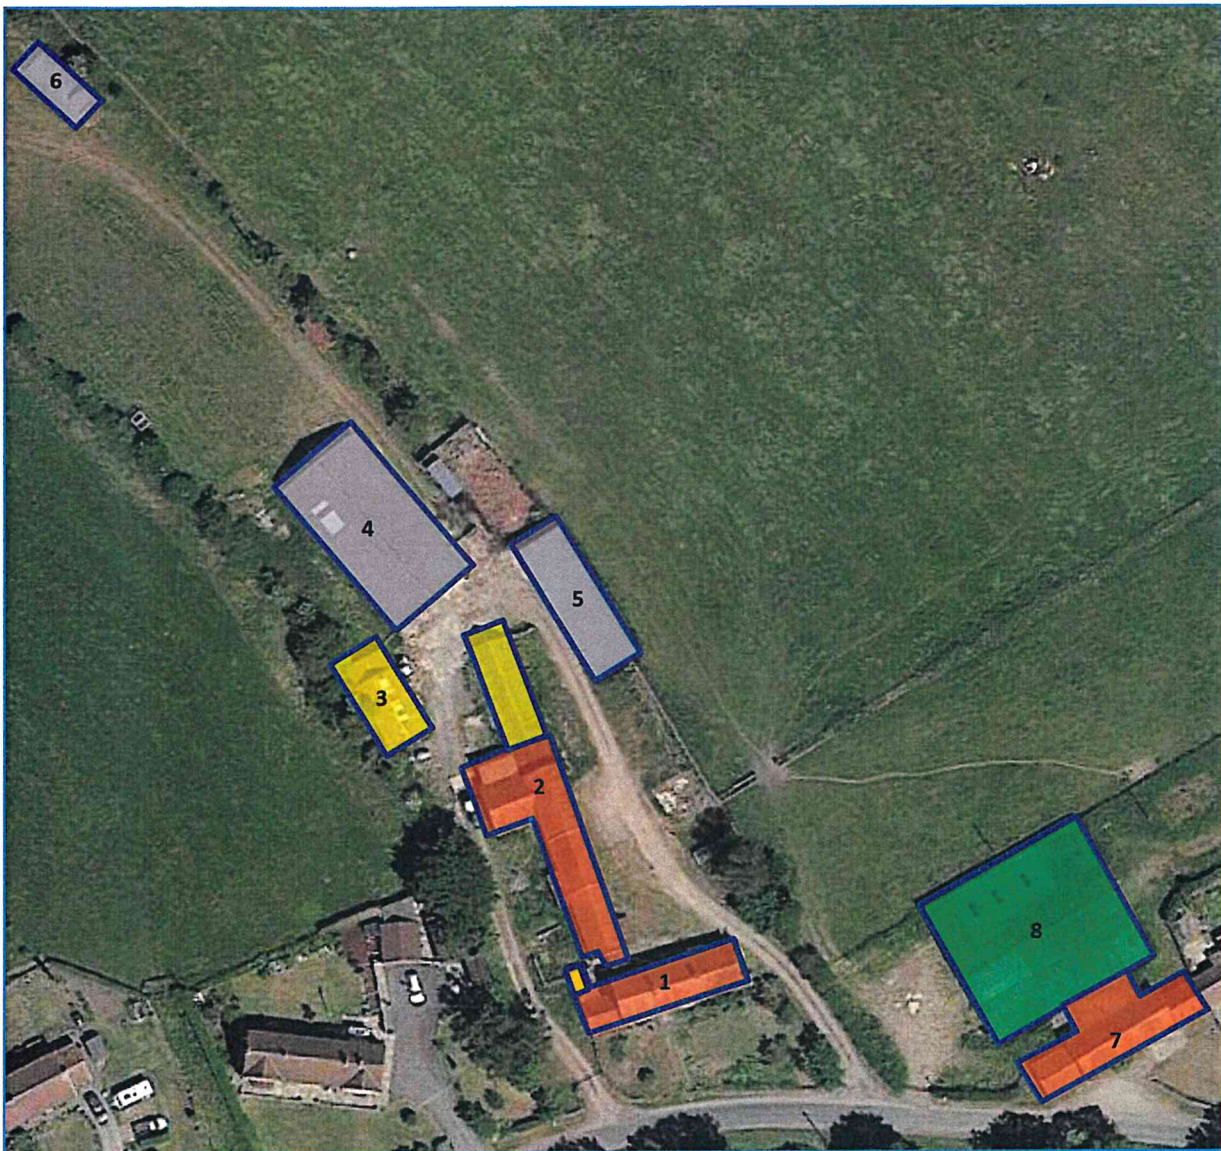
Figure 4: Scoping survey results and building reference numbers (see also detailed Figure 5: Building 1 and 2 and Figure 6: Building 7 and 8).

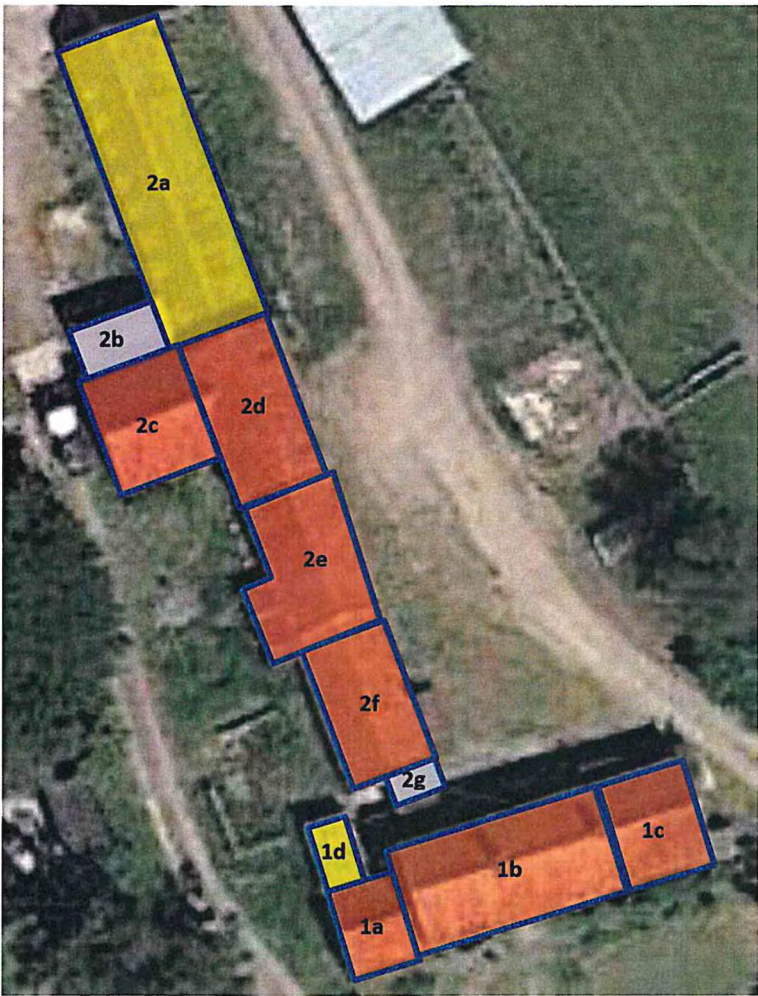
Figure 5: Building 1 and 2 detailed scoping survey results and building reference numbers.

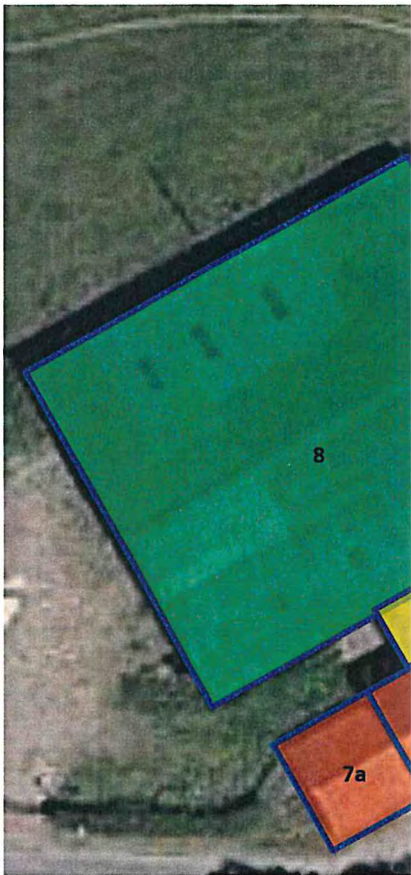
Figure 6: Building 7 and 8 detailed scoping survey results and building reference numbers.

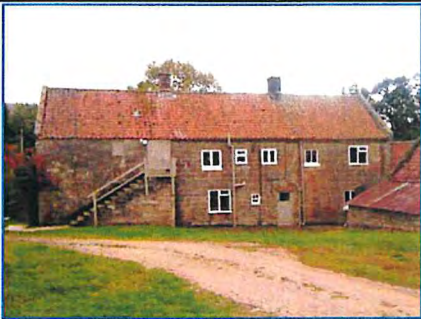
<p>Photo 1: Building 1 from north</p>		See below for details.
1a Moderate potential risk of bat roosts.	  <p>Photo 2: Exterior - 1a</p>

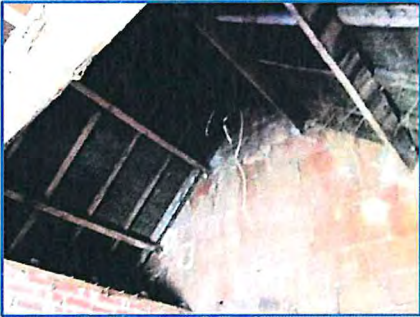
<p>Photo 3: Internal roof – 1a</p>	<p>One storey stone barn attached to far roof under a stone ridge. Some gaps between tiles and visible crevices below/between courses of external and internal stonework.</p> <p>Internal void is open to roof. A bitumen membrane beneath roof tiles. The floor is damp timber. Roof is supported by traditional timber beams. Some beam crevices were visible. Internal roof beams are densely cobwebbed.</p>
1b Moderate potential risk of bat roosts.

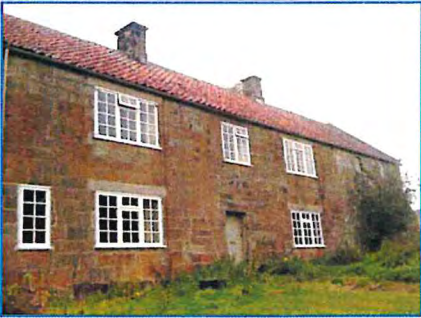
<p>Photo 4: Building 1b – south</p>	  <p>Photo 6: Building 1b north.</p>	<p>Two storey stone farmhouse. External walls are made of stone. Internal void inspected via a hatch. Fil has been laid across the floor joists. Timber is undisturbed. A bitumastic felt liner is beneath roof tiles. The roof is supported by traditional timber beams. Only minor beam crevices were visible. Internal roof beams are densely cobwebbed.</p>

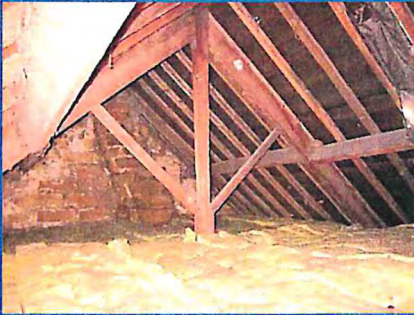
<p>Photo 5: Building 1b – roof void.</p>

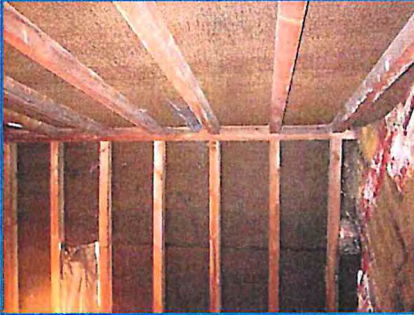
<p>Photo 7: Building 1b – internal roof.</p>	
<p>1c Moderate potential risk of bat roosts.</p>

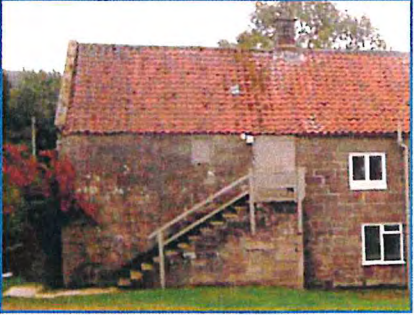
<p>Photo 8: Building 1c – south</p>

<p>Photo 11: Internal crevices in wall - 1c</p>	<p>Two storey stone barn attached to far</p> <p>External condition as 1a. Ground floor west elevation.</p> <p>Upper floor is open to the roof. The rc timber sarking beneath tiles. The spac undisturbed. The roof is supported by beams. Crevices visible at wall tops of droppings beneath. Internal ridge and cobwebbed.</p>

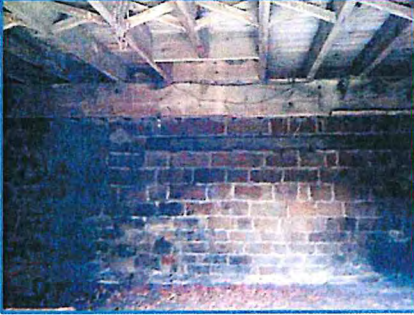
<p>Photo 10: Interior ground floor – 1c</p>

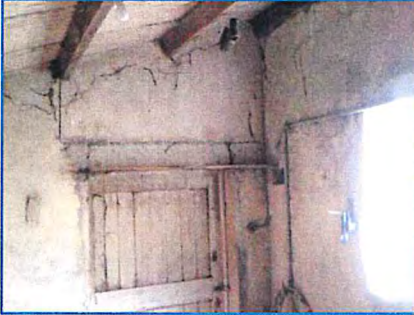
<p>Photo 17: Inside 2b</p>		<p>One storey lean-to with corrugated fit which are tight fitting. Walls are rendered. Minor crevices were found which are potential roosting sites. The roof is unlined, and the interior is undisturbed.</p>
<p>2c Moderate potential risk of bat roosts.</p>

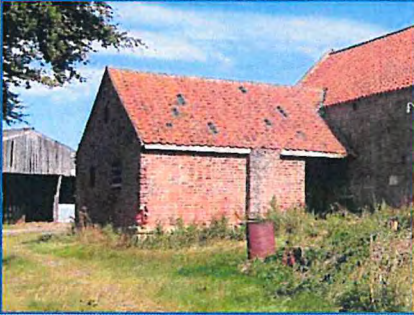
<p>Photo 18: 2c External</p>

<p>Photo 20: 2c Internal platform.</p>	<p>Brick and pantile barn. Part of the north wall has been replaced with fibre cement sheeting. Some roof tiles are missing and crevices in external masonry are potential roosting sites.</p> <p>A bitumen felt is fitted beneath the roof tiles to reach to the ridge. Beam crevices present as potential roosting sites.</p> <p>The floor is covered in deep straw.</p>

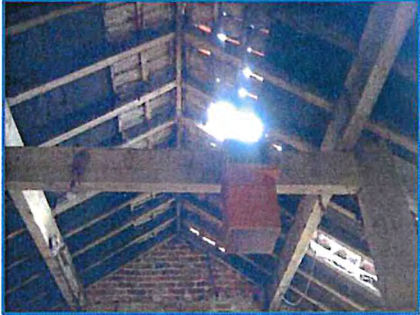
<p>Photo 19: 2c Internal roof and barn owl box.</p>

There is evidence of use of Building 2 by barn owl and a barn owl was observed within the open barn 8 during the emergence survey. The number of barn owl pellets found during the visual inspection (2 in total) indicates very occasional use only. No signs of nesting were found; however, this building provides suitable barn owl nesting habitat in the form of a barn owl box and a large timber platform.

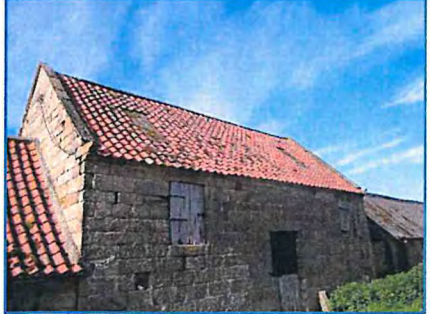
<p>Photo 21: 2d External.</p>	  <p>Photo 22: 2d Internal.</p>	<p>Stone and pantile barn, 2-storey – open to 2c at ground level.</p> <p>Some gaps below lifted roof tiles and below/between copings. Crevices in the masonry. Internal access available via gaps around window and door frames</p> <p>Roof is underlined with bitumen felt or Roof is supported by traditional timber crevices present but cobwebby.</p>
<p>2e Moderate potential risk of bat roosts.</p>

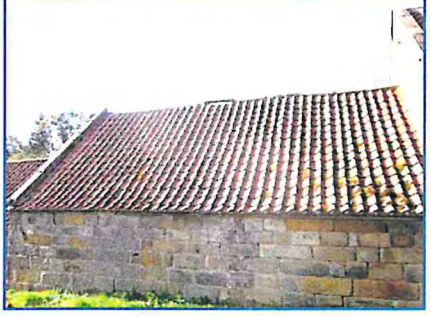
<p>Photo 23: 2e External.</p>	  <p>Photo 24: 2e Internal.</p>	<p>One-storey, internal and external as 2c beneath roof tiles.</p>
<p>2f Moderate potential risk of bat roosts.</p>	  <p>Photo 25: 2f External.</p>

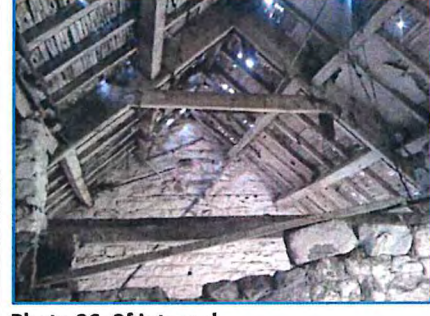
<p>Photo 26: 2f Internal.</p>	<p>One-storey, external as 2c and 2d.</p> <p>Roof is underlined with lath, which is in and gappy. Roof is supported by traditional timber Beam crevices present but cobwebby.</p>

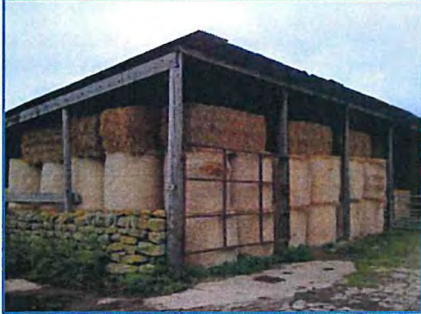
<p>Photo 32: Building 5.</p>		<p>Large open pole barn. The mono pitch corrugated tin sheets, supported by timber crevices suitable for bats were identified.</p>
<p>6 Negligible potential risk of bat roosts</p>

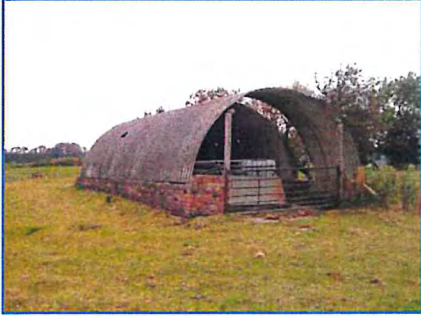
<p>Photo 33: Building 6.</p>

<p>Photo 34: Interior.</p>	<p>Nissen hut. Steel sheet roof and low brick walls. Open on south elevation. No suitable features for bats.</p>
<p>7a Moderate potential risk of bat roosts</p>

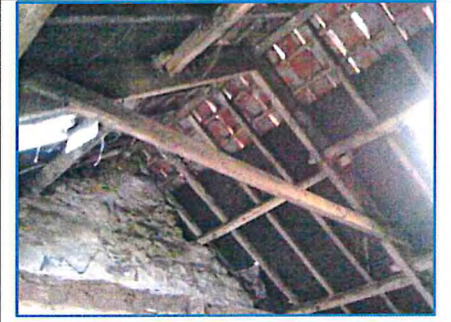
<p>Photo 36 internal roof.</p>	<p>Pantile roof under a stone ridge. Part of the roof is accessible via the eaves and also large vents to the ridge masonry, around coping stones, door etc.</p> <p>Open to the roof internally. A bitumen membrane beneath the roof, this is in very poor condition and does not reach to the ridge. The ridge beam is exposed. Internal roof and beams are damp.</p>

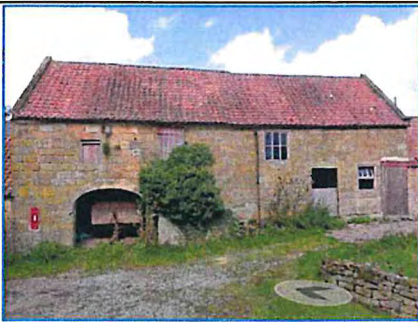
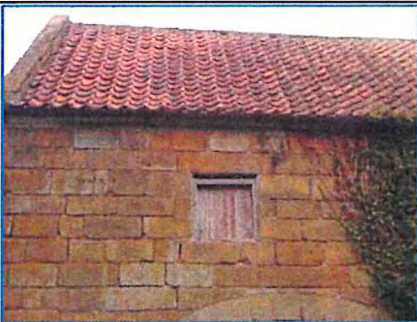
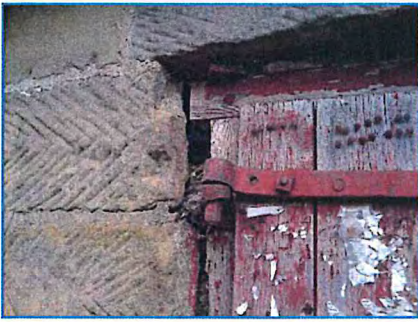
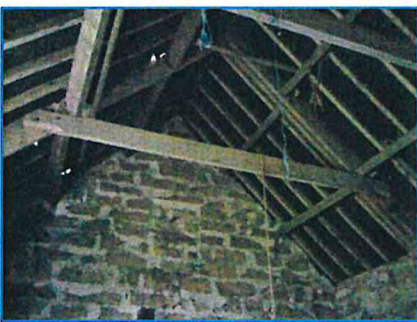
<p>7b Moderate potential risk of bat roosts</p>

<p>Pantile roof under a stone ridge. Tile missing at the ridge. Crevices in masonry stones, door frames and hatches.</p> <p>Has a large open doorway to the south also available via open windows/door</p> <p>Has a bitumastic liner beneath the roof, open and exposed. Beam crevices visible and undisturbed.</p>

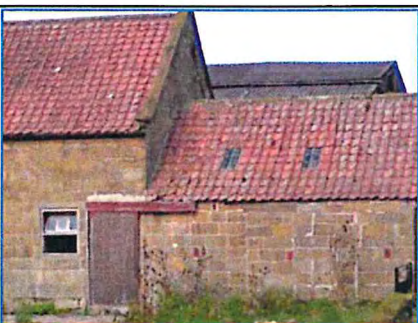
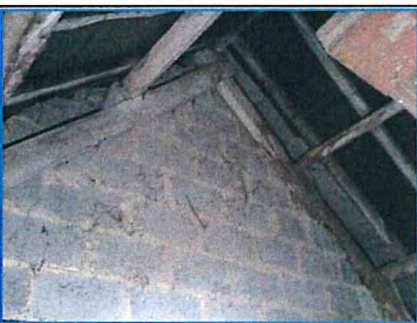
<p>7c Moderate potential risk of bat roosts</p>

<p>Pantile roof under a stone ridge. One condition as 7b.</p> <p>Has a bitumastic liner beneath the roof, cobwebby. Timber crevices present. It is dry and undisturbed.</p>

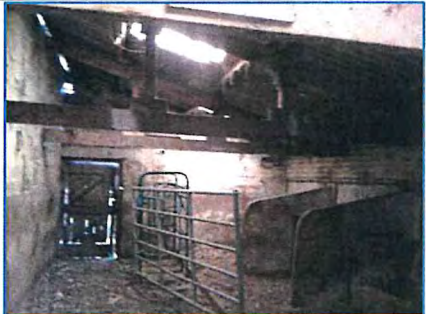
<p>Photo 43: Building 7d Interior.</p>		<p>Mono pitch lean to on north of 7b. Fib roof is supported by rough sawn timber only and the space is dry and bright.</p>
<p>8 Very low potential risk of bat roosts</p>

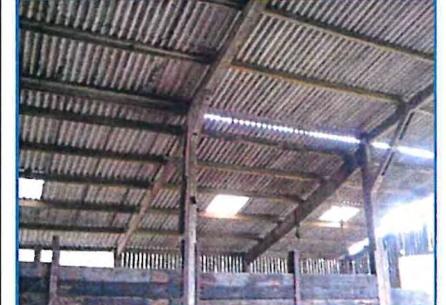
<p>Photo 45: Interior.</p>	<p>Large open barn. Upper sections are Y and lower sections of wall are stone. It is made from timber sleepers. The roof is made of corrugated fibre cement sheets, supported by concrete and steel beams.</p> <p>Some minor timber crevices visible. They are not disturbed.</p>

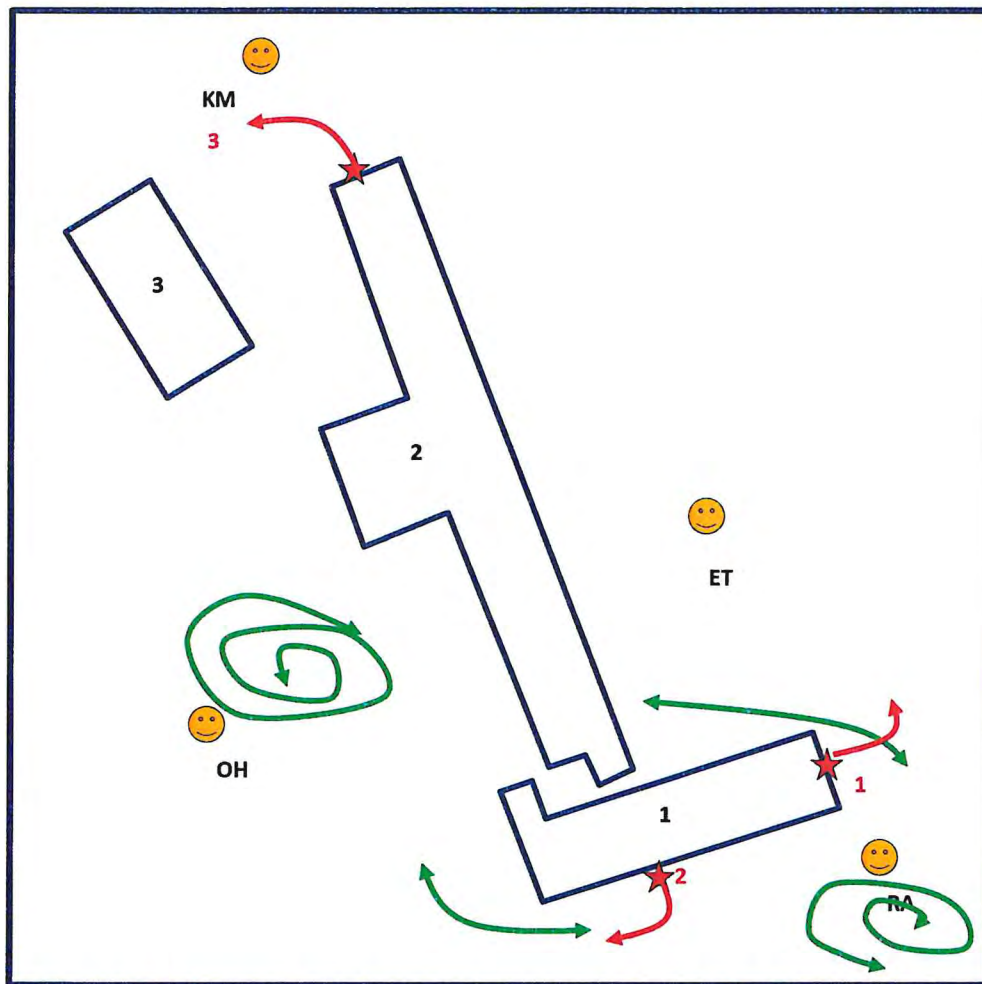
Figure 7 – Surveyor locations and bat activity recorded during survey 1 (10/06/2019).

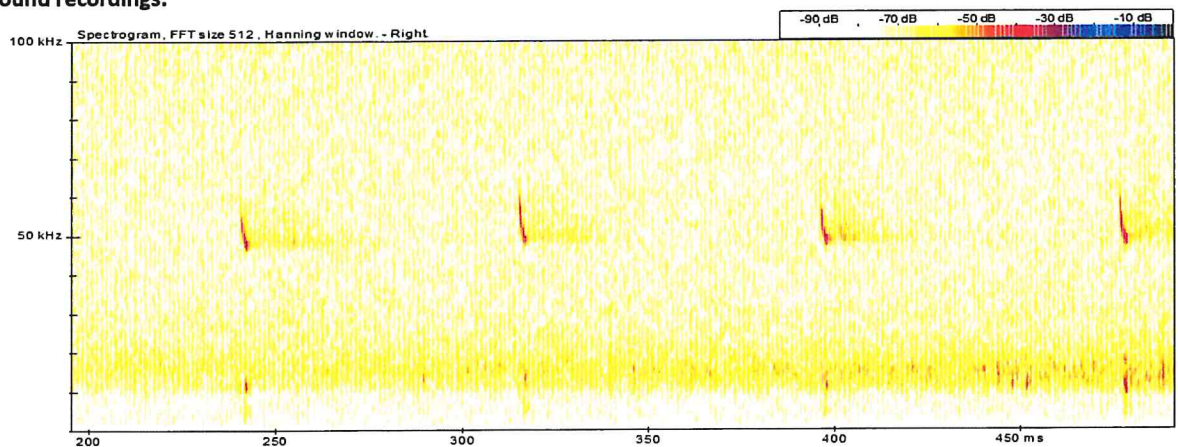
Figure 8: common pipistrelle emergence from location 2.

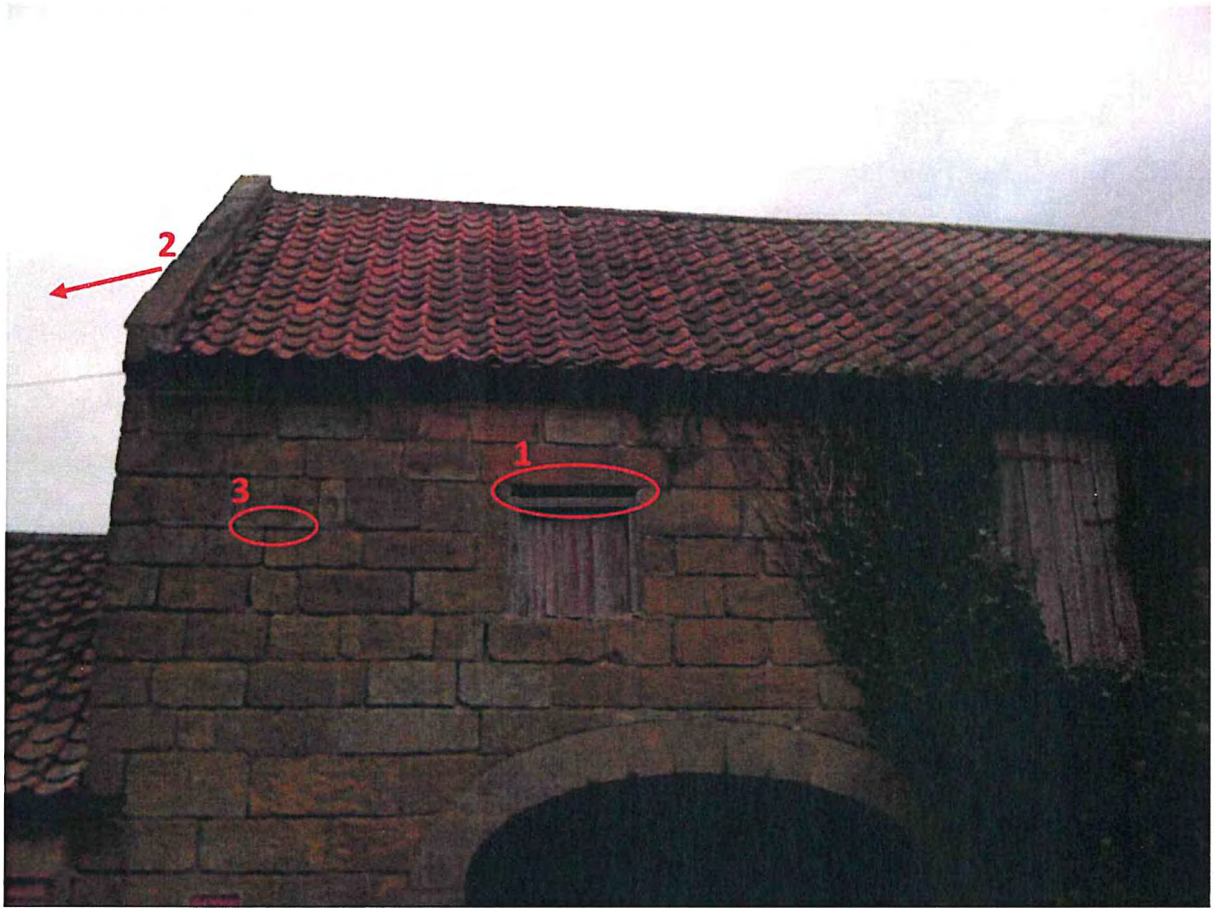
Photo 48 emergence locations 1,2 and 3 on building 7b

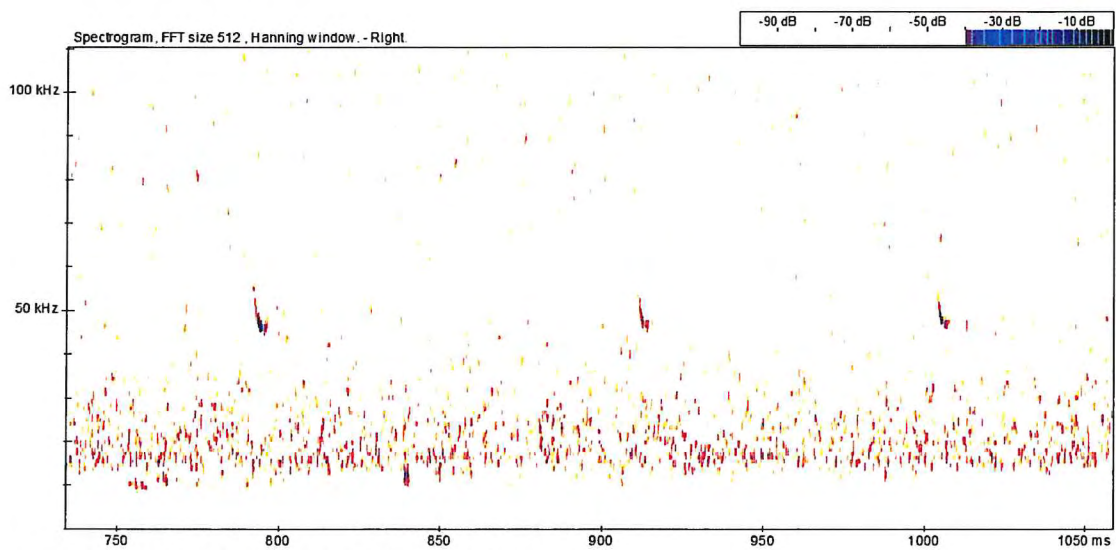
Figure 10 Common pipistrelle emerging from location 2

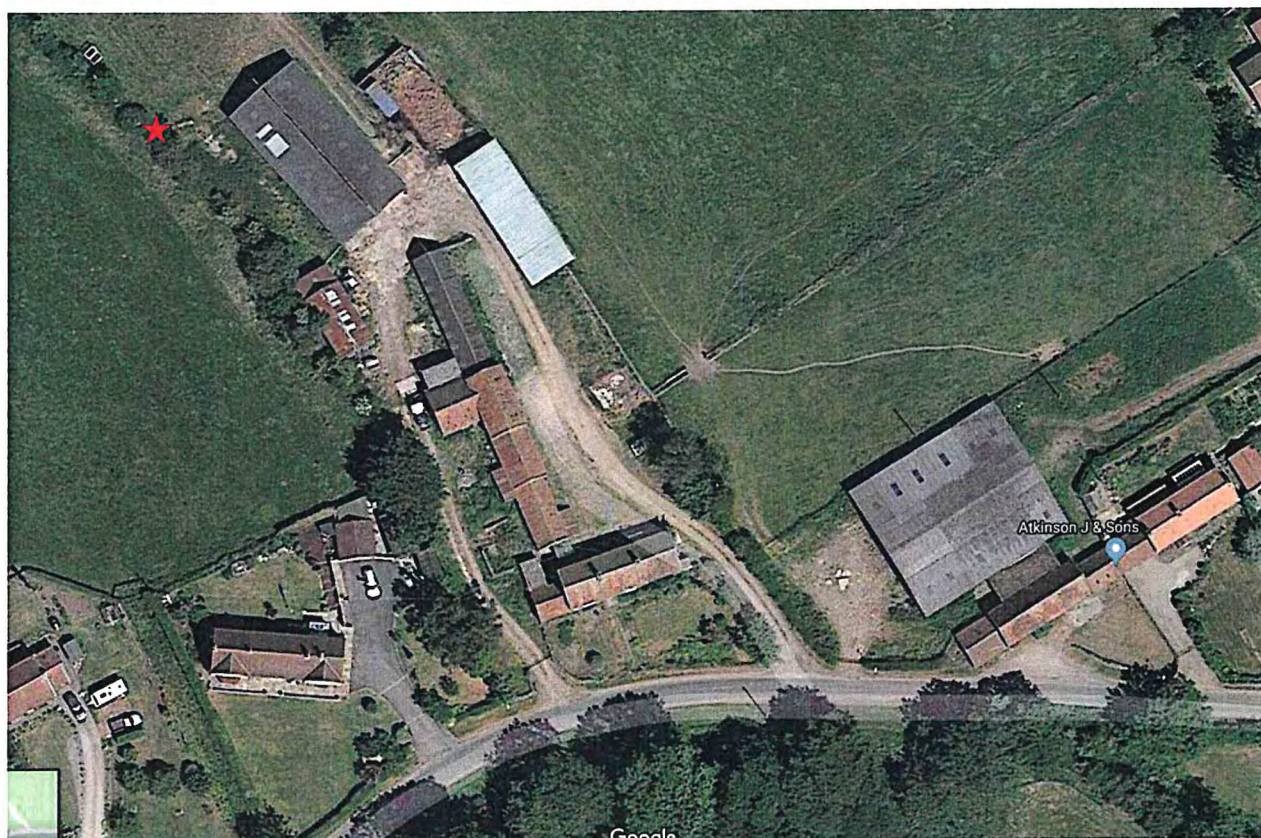
Figure 13 Aerial photograph of site with location of barn owl pole box highlighted by red arrow

To help safeguard the long-term use of the site and surrounding area by barn owls, at least 30 days prior to work, a pole mounted barn owl box will be provided within the location shown on Figure 12 and Figure 13. This will ensure that alternative habitat, including opportunities for nesting are made available. Once suitable alternative

1. A pre-works check of the site should be undertaken not more than 2 months before work commences to ensure that usage by barn owls has not changed.
2. At least thirty days before work commences on site an external barn owl box on a pole will be located on site (see Figure 12 and Figure 13Figure 12). Construction of the box will follow the guidelines provided by the barn owl trust. (see appendix 3).
3. Once suitable alternative provision is made available, the existing nest box within Building 2 will be removed, ensuring that no owls are present.
4. If work to any building takes place during the bird breeding season, then a check should be made prior to work for any active bird nests within buildings to be worked on. If nests are found, then no work to these immediate areas will take place until any chicks have fledged.
