Design and Access Statement**Demolition of Existing Dwelling & Erection of Replacement House****Honey Bee Nest, Glaisdale****Guy Bentley Ltd****Appraisal/ Physical**

BAT RISK ASSESSMENT

HONEY BEE NEST GLAISDALE

HONEY BEE NEST GLAISDALE WHITBY NORTH YORKSHIRE YO21 2QL

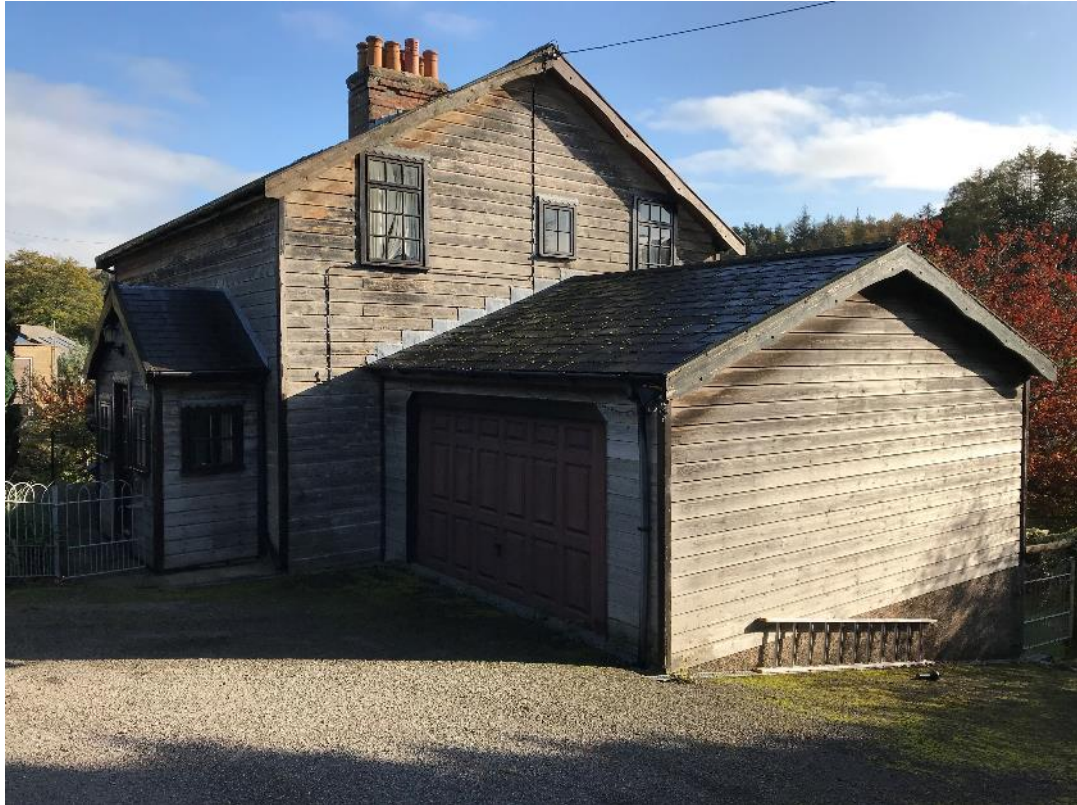
The existing property was found to be two-storey, clad with timber externally and had a pitched, slate-tiled roof, around which timber soffits and fascias were present (Images 1 and 2 in section 6). Porch areas of the same construction type were present on the north-eastern and north-western elevations, which had sections of lead flashing present where they connect to the main property. Further sections of lead flashing were present around the chimney and some of the windows. An attached garage was present on the south-western elevation, which was again of the same construction type as the main property.

Image 1. Existing property, looking north-east.

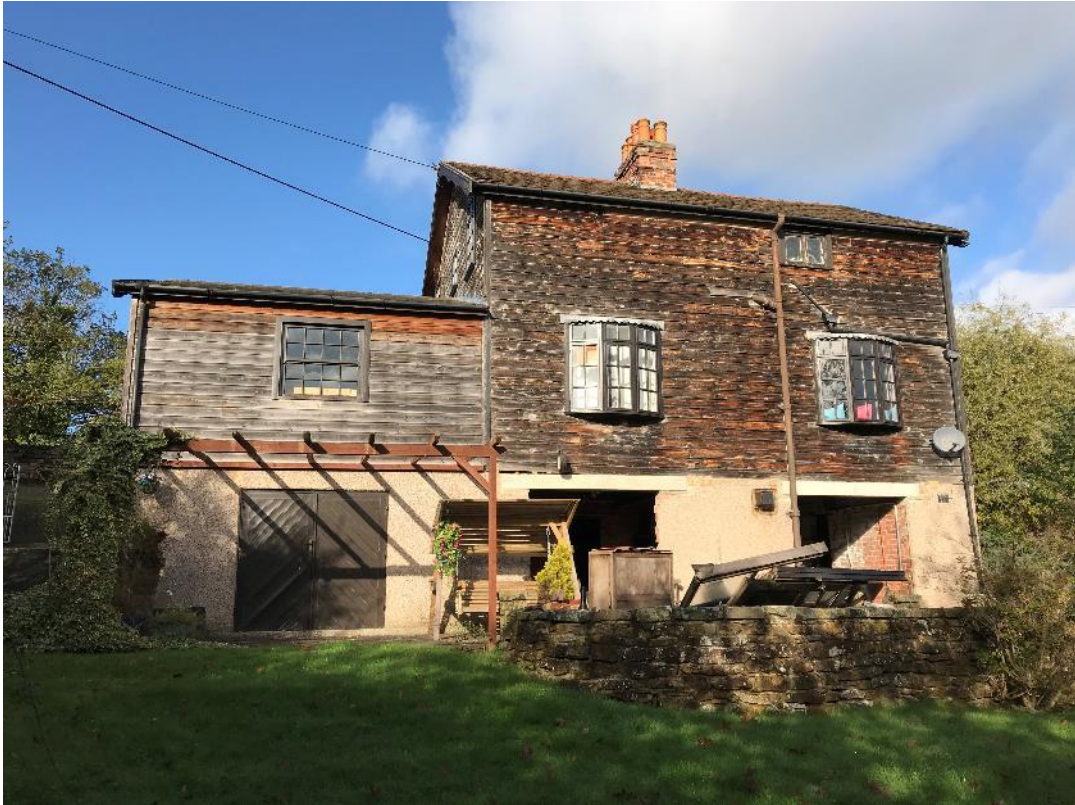
Image 2. Rear of the property.

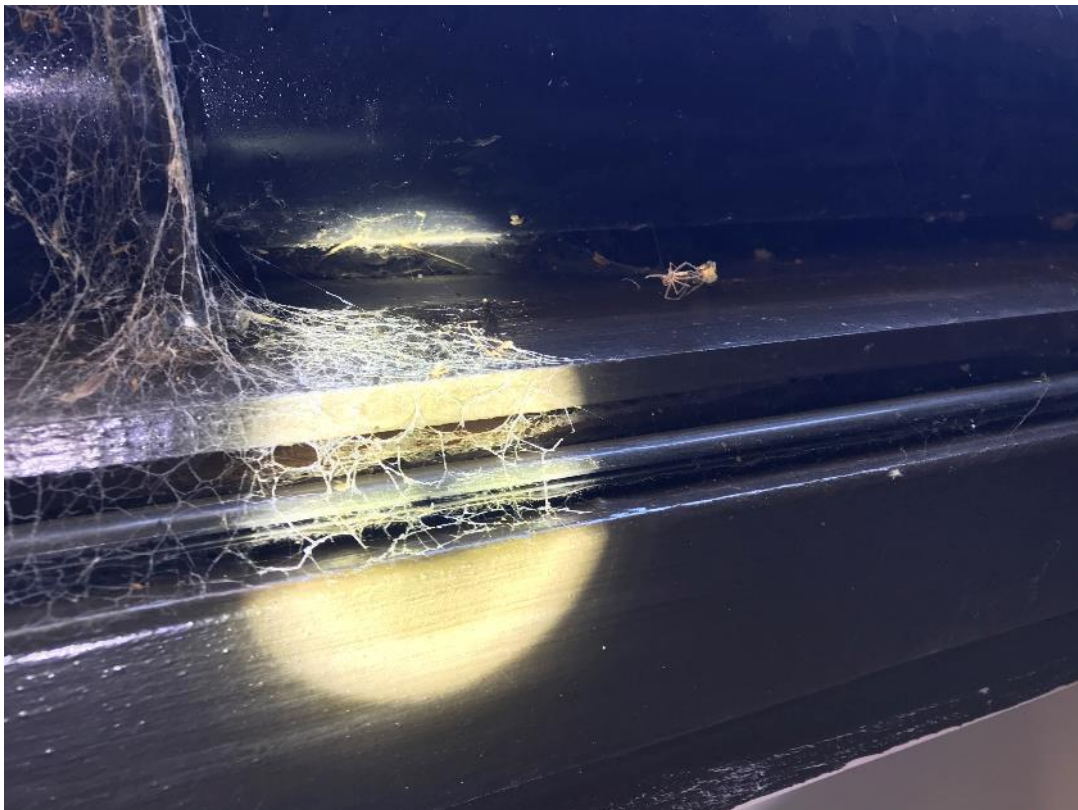
During the external inspection, building features were generally found to be tightly fitted and in a good state of repair, with negligible access opportunities for bats. Gaps were noted behind the fascia boards on the porch on the north-eastern elevation; however, they were found to be entirely filled with detritus and/or covered with cobwebs (Image 3), indicating a lack of bat use and reducing suitability for any potential future use. A gap was also noted in the fascia board on the north-eastern corner of the property, but this appeared to be filled with old bird nesting material.

Image 3. Gap behind fascia on porch, with cobwebs and detritus.

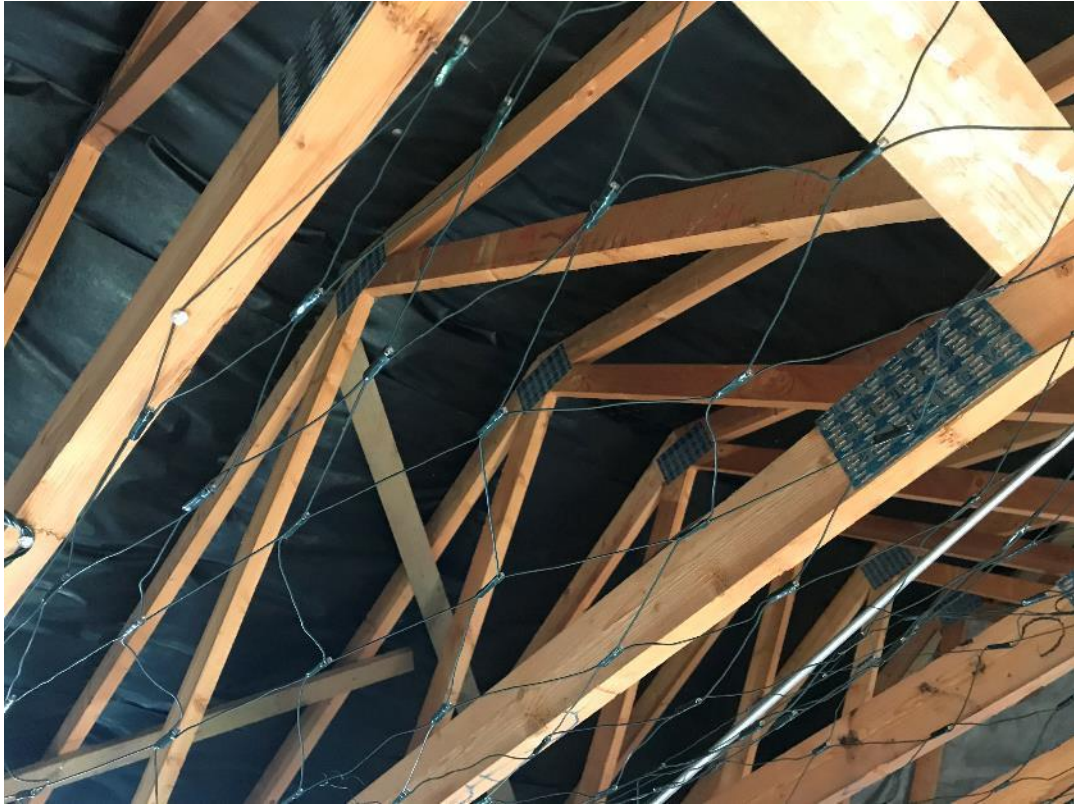
During the internal inspection of the garage, the roof lining and timber beams were all found to be in good condition, resulting in a lack of access opportunities or PRFs. It was found to be well-lit due to the presence of a window and lack of an enclosed roof space, and the garage appears to undergo regular human disturbance, being directly attached to the main property and used for storage. Alone and in combination, these factors result in sub-optimal roosting conditions for bats, and no evidence of bat presence was found in the garage.

Image 4. Roof space of garage.

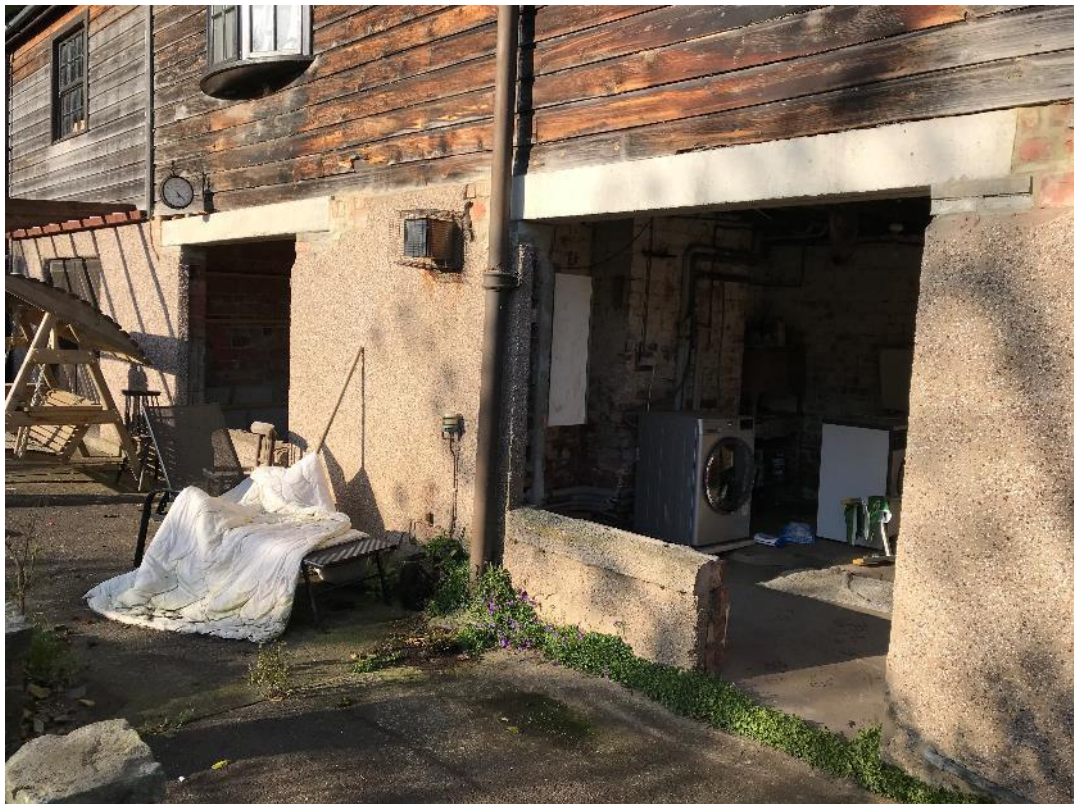
Two of the utility/storage areas were found to be well-lit during the daytime due to the absence of doors, allowing the ingress of natural light, and would also be largely exposed to external weather conditions and changing temperatures, all of which would create unstable roosting conditions for bats. They also appeared to experience regular disturbance by human activity. Further inside, more stable internal conditions were available, and a few gaps in the brickwork were noted; however, these were all found to be heavily cobwebbed (Image 8) and no evidence of bats was found. The third area was found to have negligible access opportunities for bats.

Image 5. Storage/utility areas.

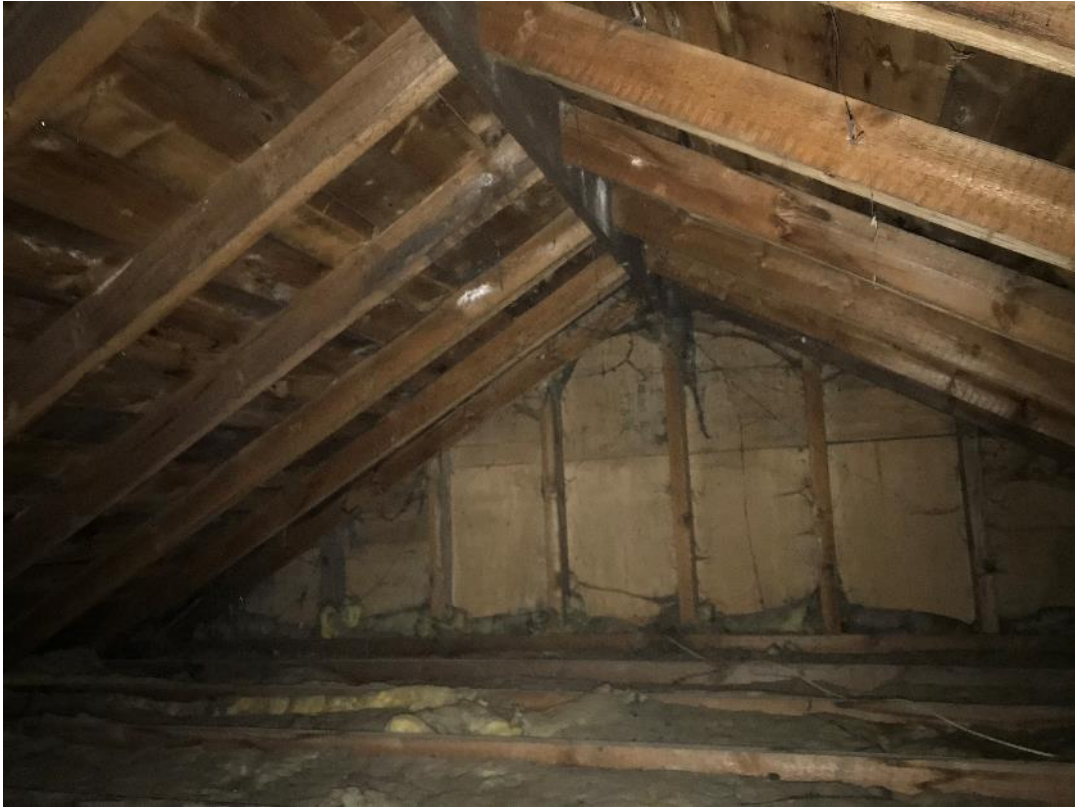
During the internal inspection of the main property, the timber beams and sarking were found to be tightly fitted, with negligible access opportunities for bats. Both loft spaces were also found to be heavily cobwebbed (Images 6 and 7), again indicating a lack of bat use and reducing suitability for future use. No evidence of bats was found in either loft space.

Image 6. One of the roof spaces of the main property, with heavy cobwebbing.

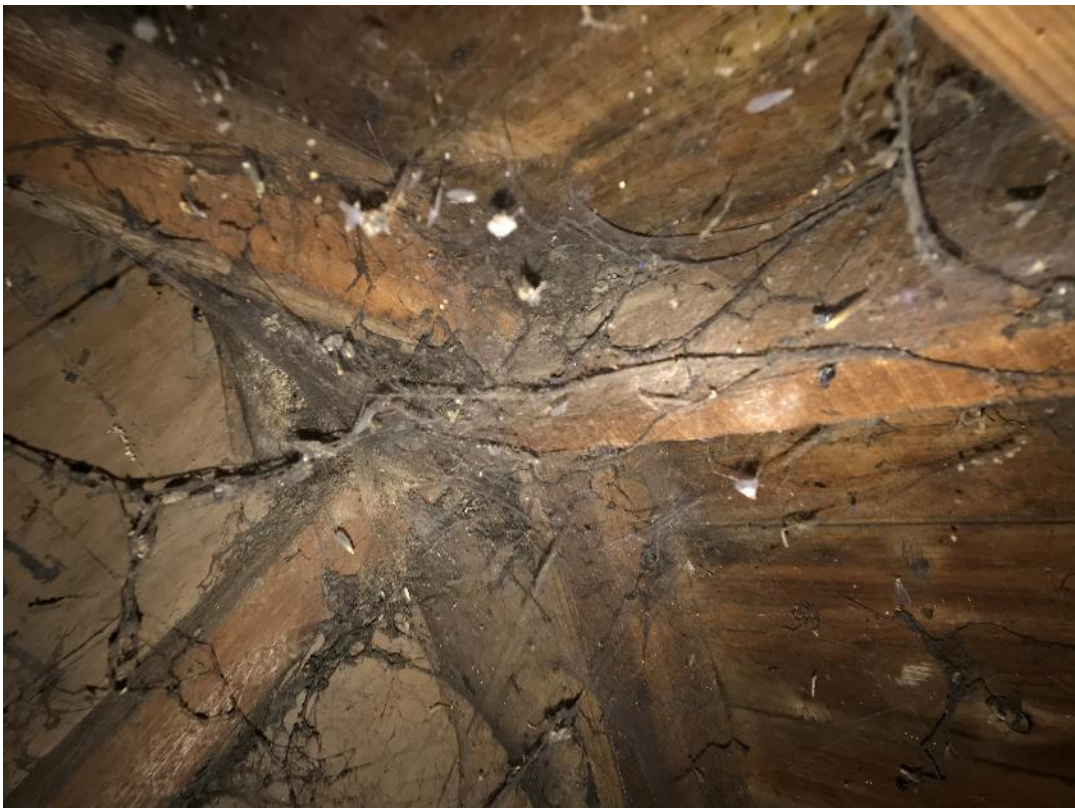
Image 7. Closer view of cobwebbing.

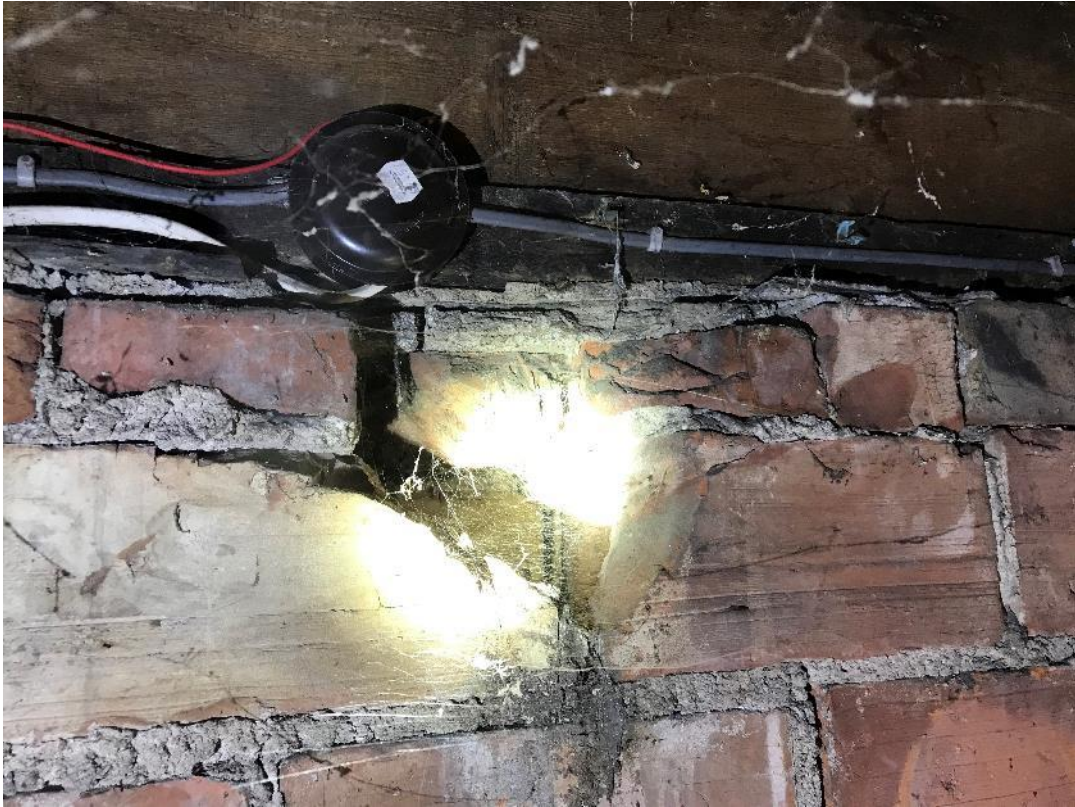
Image 8. Example of heavy cobwebbing in utility area.

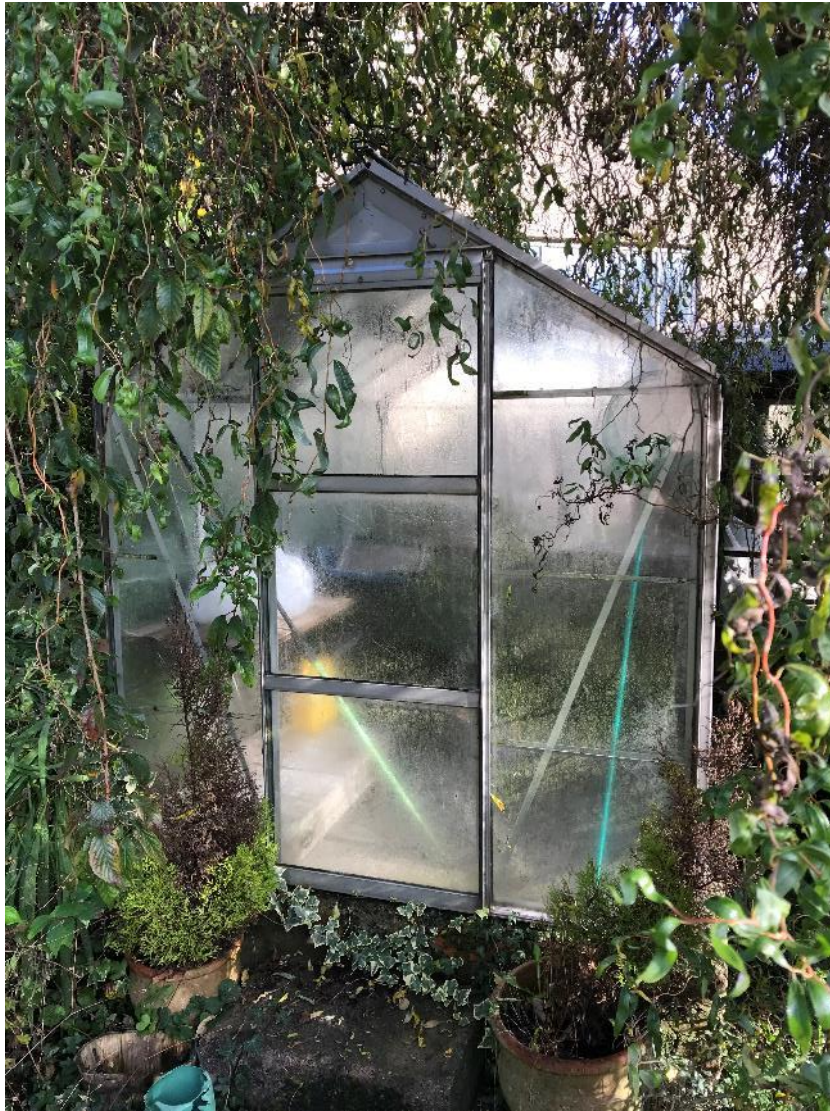
Two further buildings were present in the rear garden – a greenhouse and a summer house. The greenhouse was of metal frame and glass panel construction (Image 9). The summer house was timber-built and clad, with window panels in the walls and doors (Image 10). It had a pitched roof, which was covered with felt lining.

The greenhouse offered negligible access or roosting opportunities for bats due to its construction type and the significant ingress of artificial light during the daytime. As such, it was assessed to be of negligible roosting value. The summer house was also considered to be of negligible roosting value due to it being in good condition, with tightly fitted features, resulting in a lack of access for bats, as well as the presence of windows resulting in significant ingress of artificial light internally and consequent disturbance to bats in the event that they were ever able to gain access.

Image 9. Greenhouse.

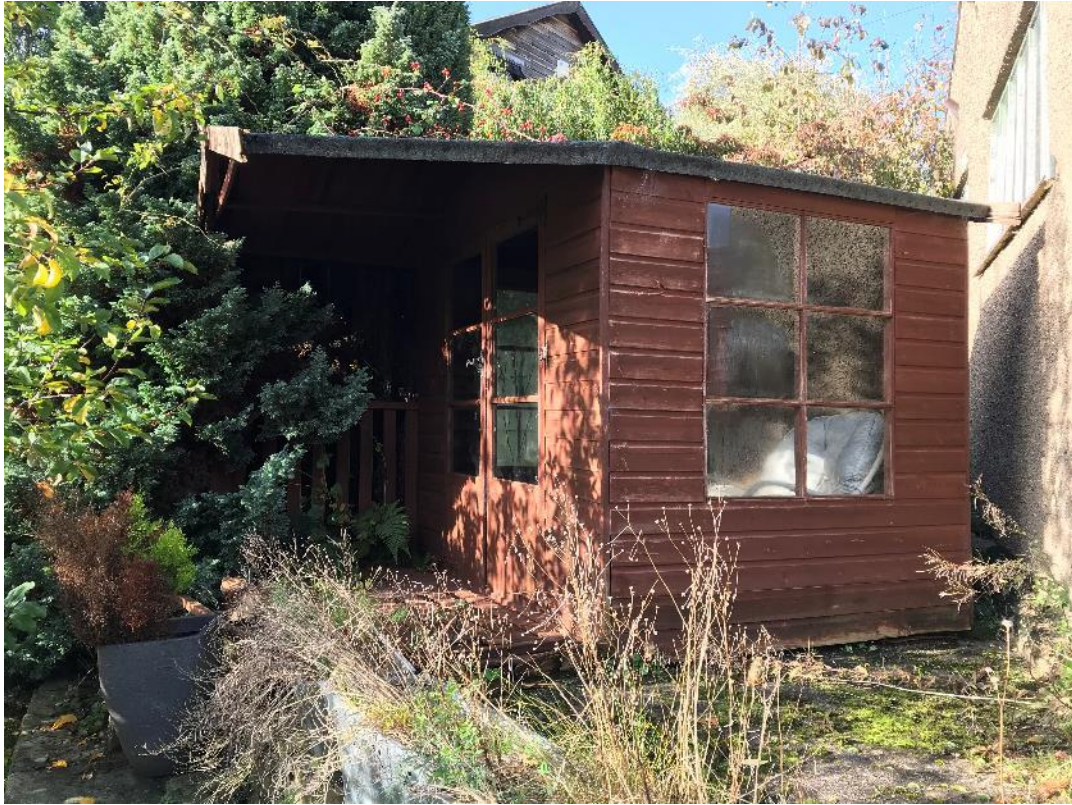
Image 10. Summer house.

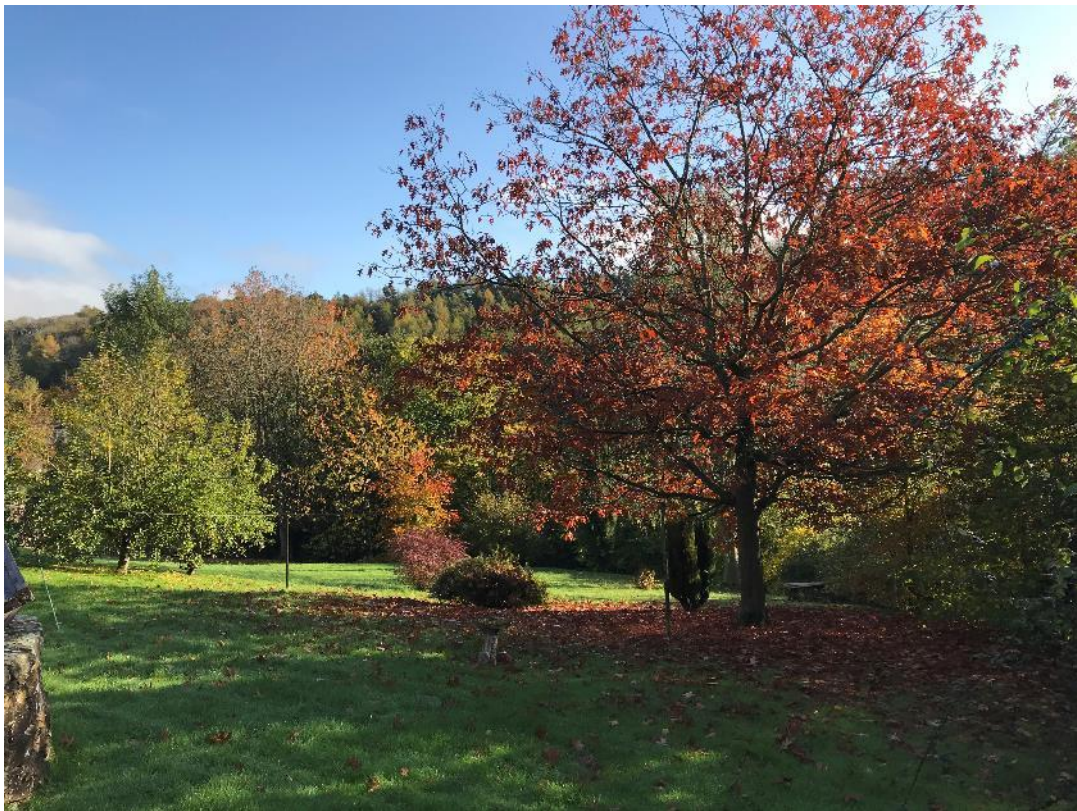
The garden area was dominated by a lawn which had a short sward of vegetation present at the time of the survey. Ornamental tree and shrub planting was dispersed across the garden and adjacent to the property. The southern and eastern boundaries were lined with native trees and shrubs, including hazel (*Corylus avellana*), field maple (*Acer campestre*) and blackthorn (*Prunus spinosa*), with some bramble (*Rubus fruticosus* agg.) also present. Two mature trees were also present – one scarlet oak (*Quercus coccinea*) and one ash (*Fraxinus excelsior*) (Image 11).

Neither of the mature trees had any PRFs, such as split bark or rot holes, and were therefore considered to be of negligible roosting suitability. The garden and adjacent areas do provide suitable habitat for commuting and foraging bats, though it is expected that the vast majority of garden habitat will be retained as part of the re-development.

Image 11. Garden.

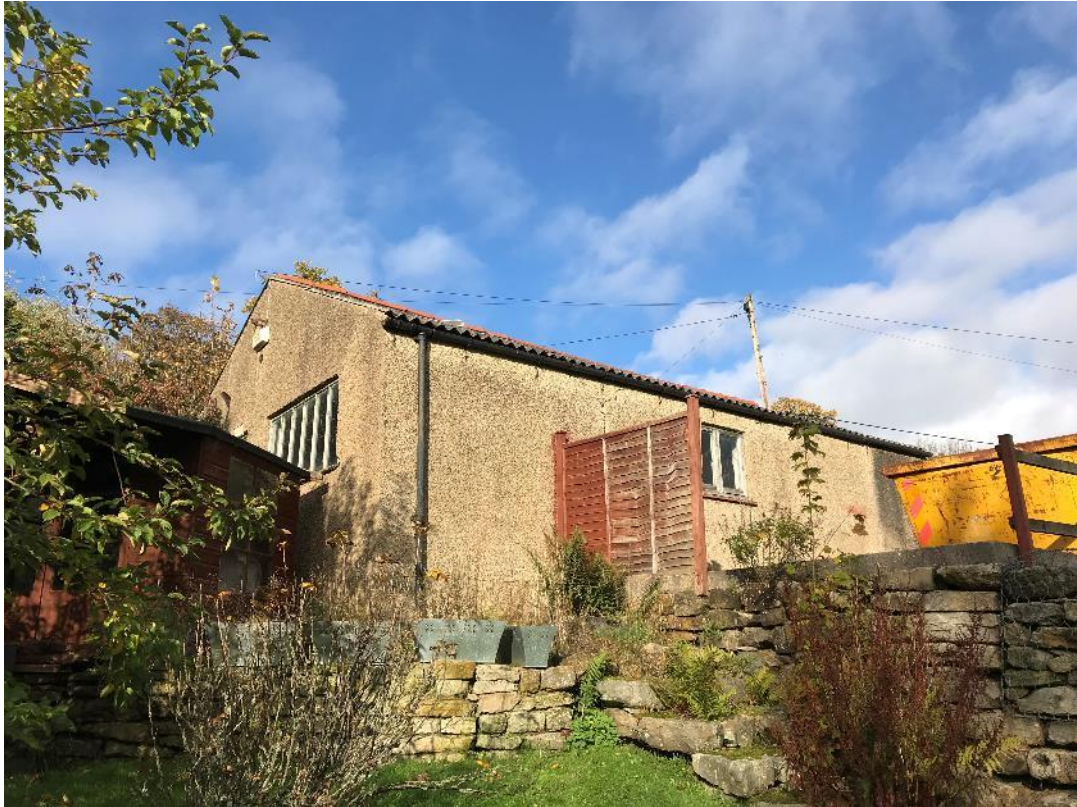
Detailed inspections of Honey Bee Nest Garage and the Arncliffe Arms were not undertaken. An external inspection of the garage was carried out and, based on its construction type and lack of any obvious evidence of bats, it was considered to be of low to negligible roosting suitability. Notwithstanding this, neither building is due to be directly impacted by the proposed works. The footpath (which was lined with the same vegetation composition as that present along the southern boundary of the garden), Glaisdale Beck and the adjacent woodland would offer moderate to high value foraging and commuting habitat for bats; however, again, these habitats will not be directly impacted by the works and, providing appropriate mitigation measures are in place, it is expected that any significant impacts can be avoided.

Image 12. Honey Bee Nest Garage.
