Faceby Lodge Farm,
Faceby, North Yorkshire

Ecology Report (Inc. bats and birds)

August 2019

Report reference	1270
Revision	1
Prepared by	Thomas McQuillan
Approved by	Andrew Westgarth
Issue date	23 rd August 2019

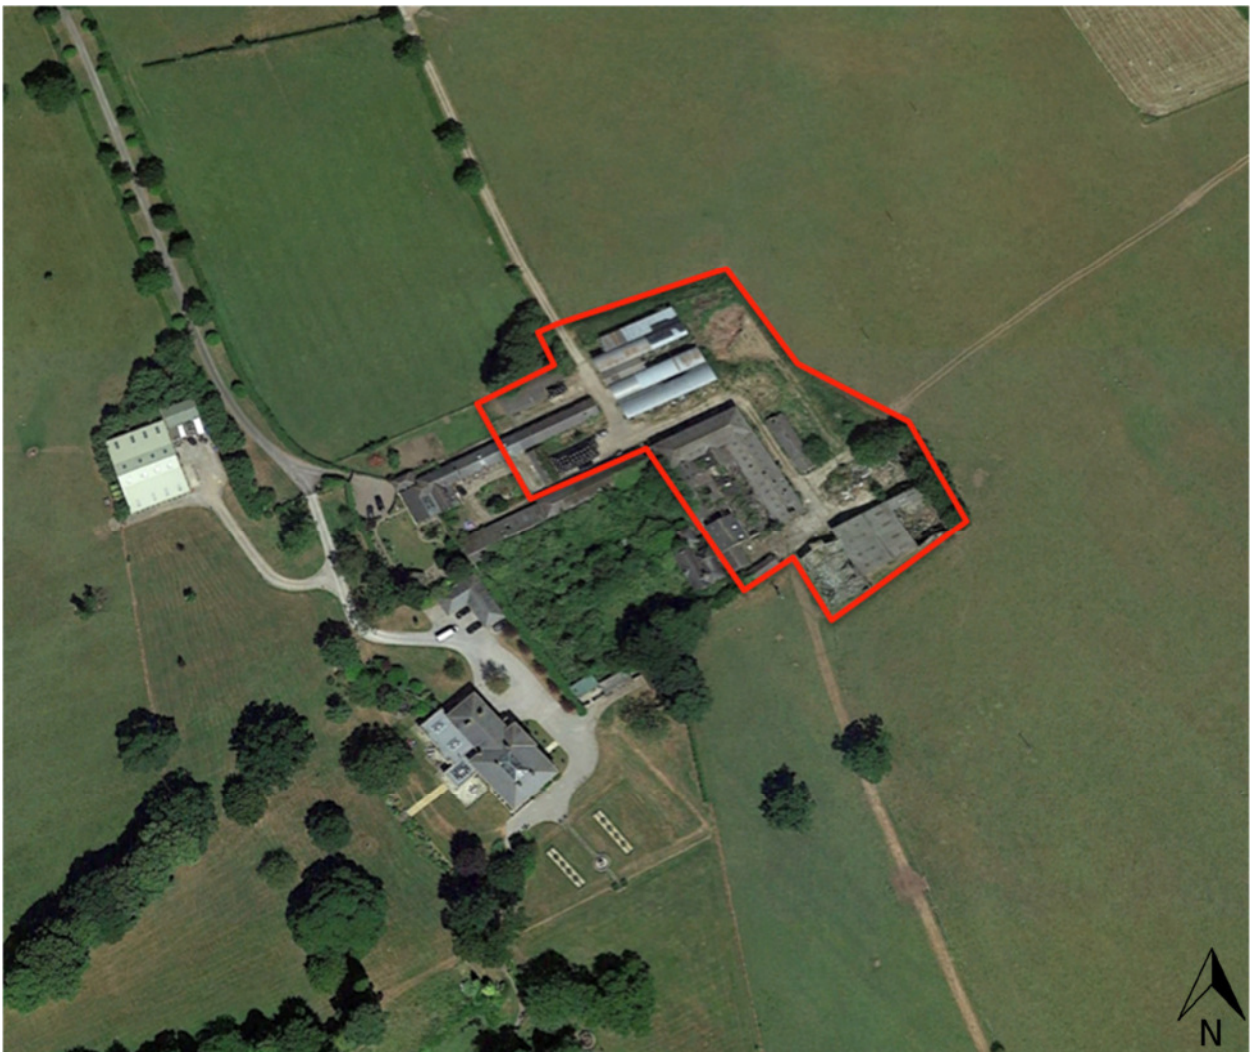
Figure 1. Approximate site location shown by red line red (aerial imagery dated 2018)²

- 1.1.1.2 The site is located at OS grid reference NZ49880432 at an altitude of ~90 m above sea level and comprises several agricultural buildings in various states of use on the Faceby Lodge farmstead. The site is located 3.1 km to the south-west of the village of Great Busby; 15.9 km south of Middlesbrough (see Figure 1).

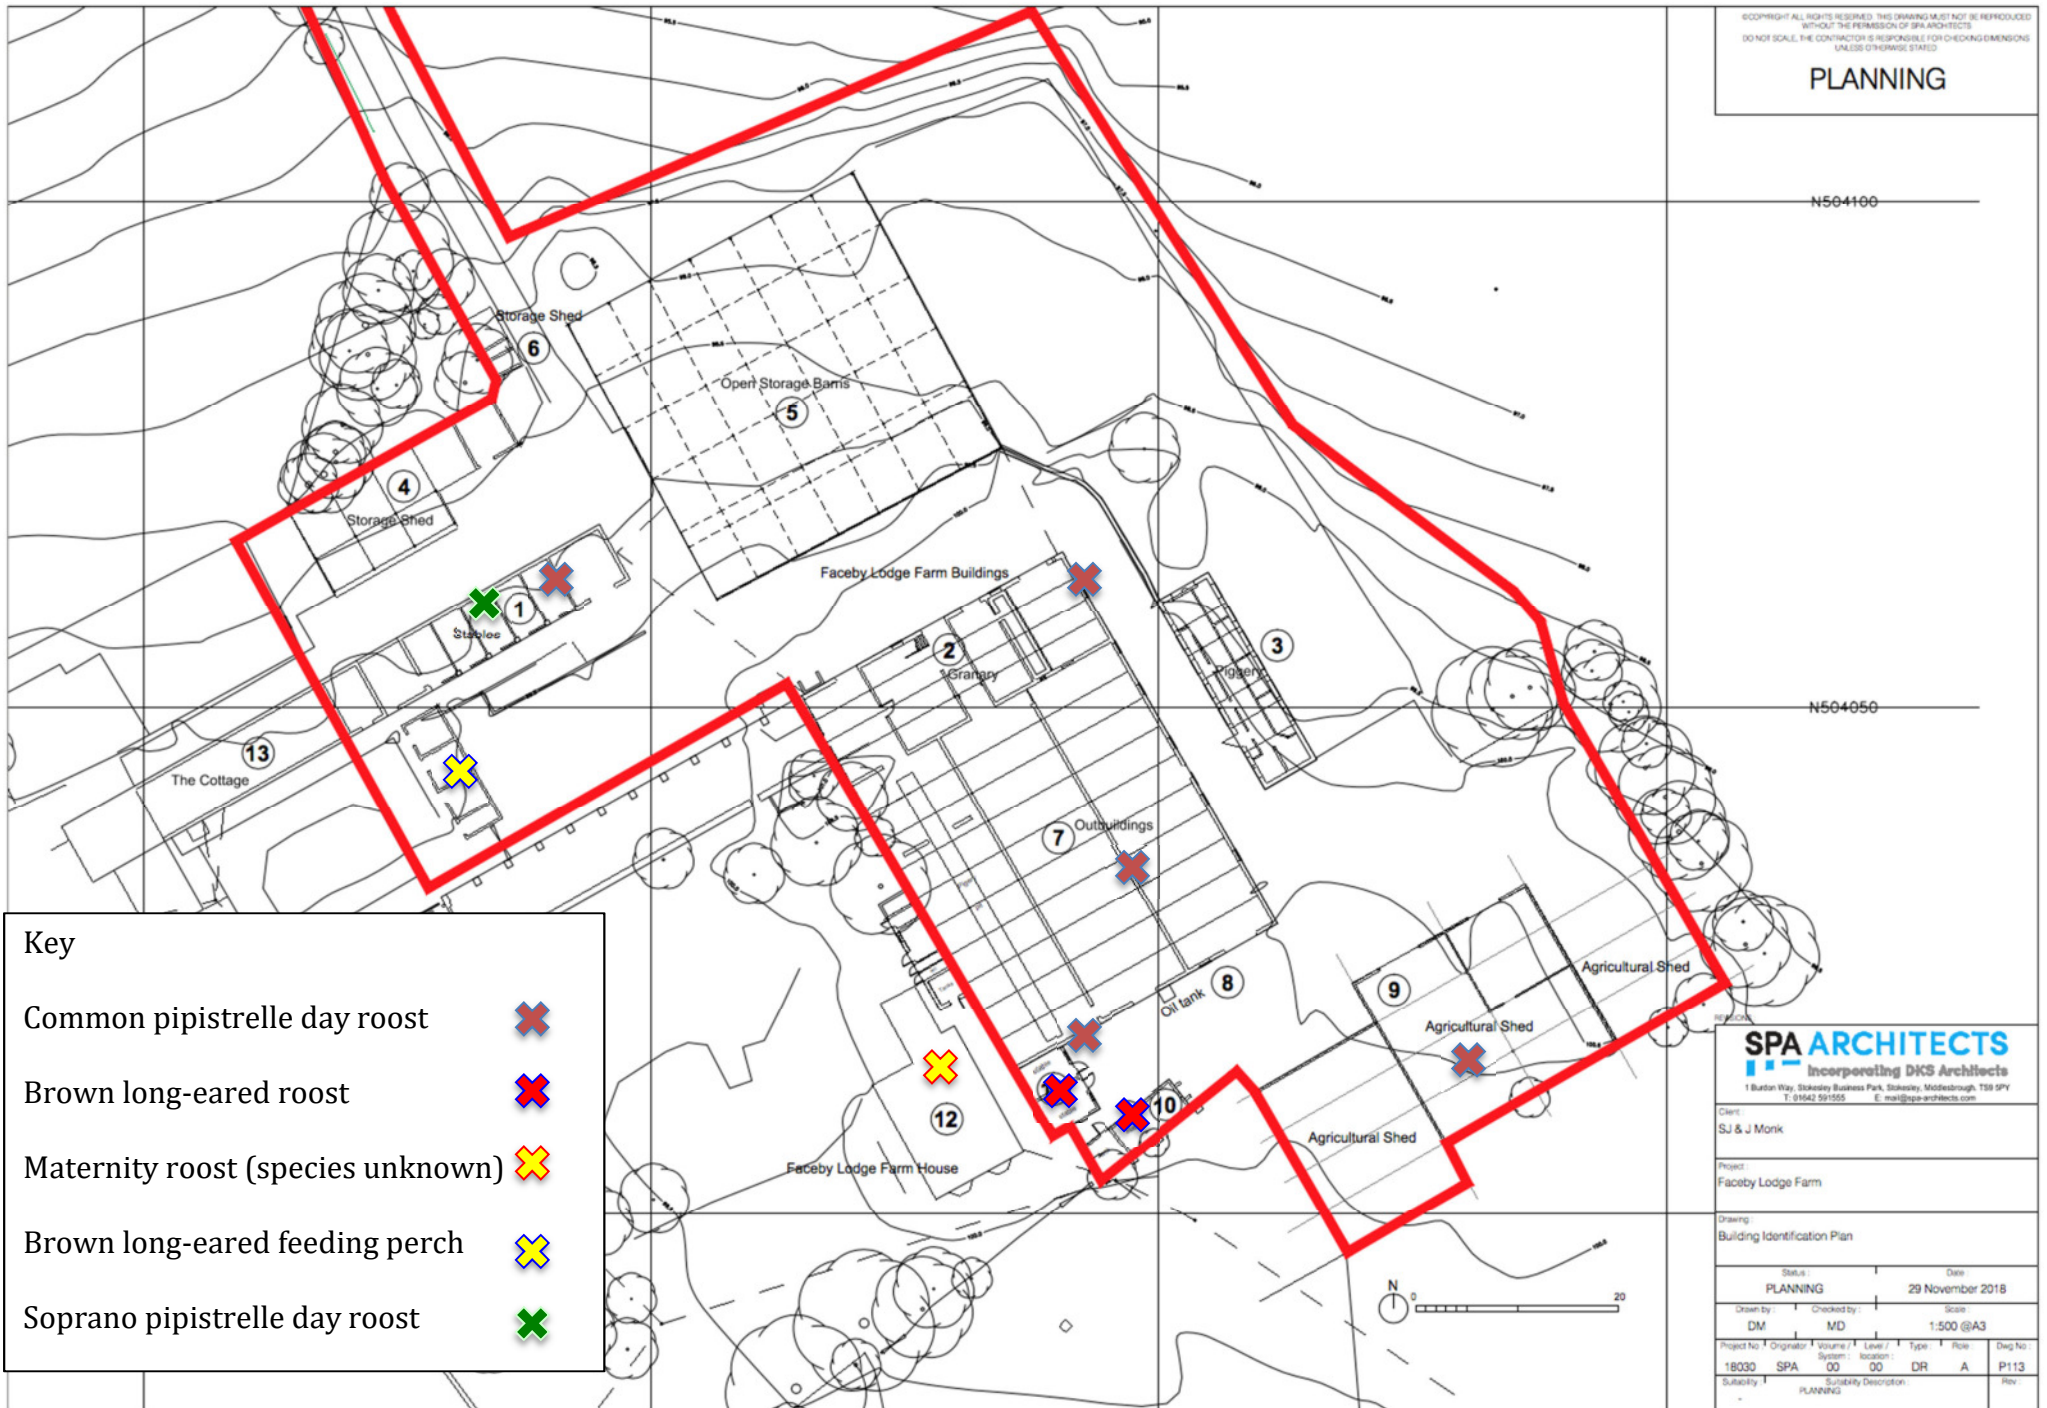
Figure 2 – Locations of Bat Roosts

- Building 2 – common pipistrelle day roost (max. 1 individual bat). Roost located within a crack around the first floor doorway on the eastern elevation of the barn.

- Building 7 – previous surveys on the site recorded the presence of a common pipistrelle roost (5 bats) within an interior wall of this building. No evidence of this roost was recorded during the 2019 surveys and given that the condition of this building has deteriorate significantly (roof collapsed on much of the barn) this roost is unlikely to still be active.

- Building 11 – brown long-eared day roost recorded during the 2014 surveys. The building was considered to remain suitable for roosting bats and it is considered that this roost is still active although used on an occasional basis. Roost likely to be located along the timber ridge board / under the ridge tiles.

4.2.2.5 Appendix 4 provides an overview of the Mitigation and Compensation strategy recommended for the project. This information will form the basis of the NE EPSM licence application. Roost provision should include permanent features suitable for soprano pipistrelle, common pipistrelle and brown long-eared bats.

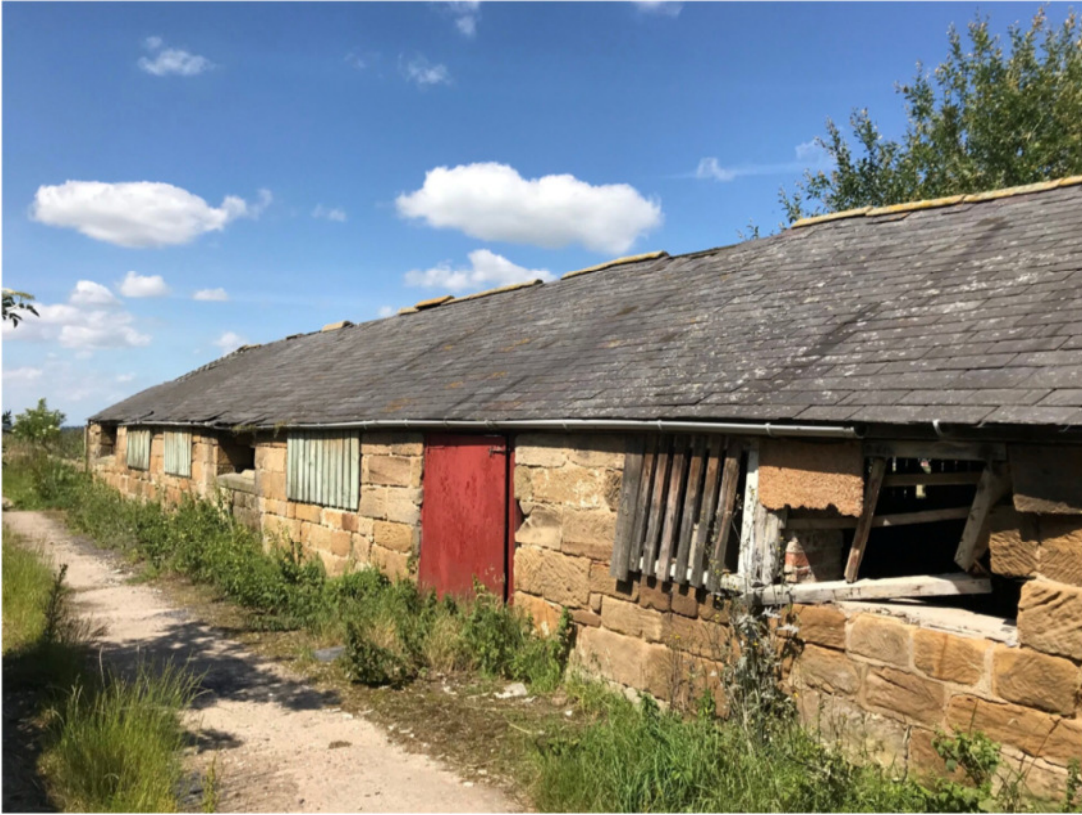
Photo 1. Building 3

- 3.2.4.4 Building 3: a single-story building on the eastern region of the site. The building measures 21 m (L) x 6 m (W), and was in poor condition and not in-use. The building is of sandstone construction with

a timber roof frame. The roof is pitched with east and west elevations; roof tiles are slate with timber sheeting below. Defunct plastic guttering is present on the building. Yorkshire boarding clads the western elevation of the building.

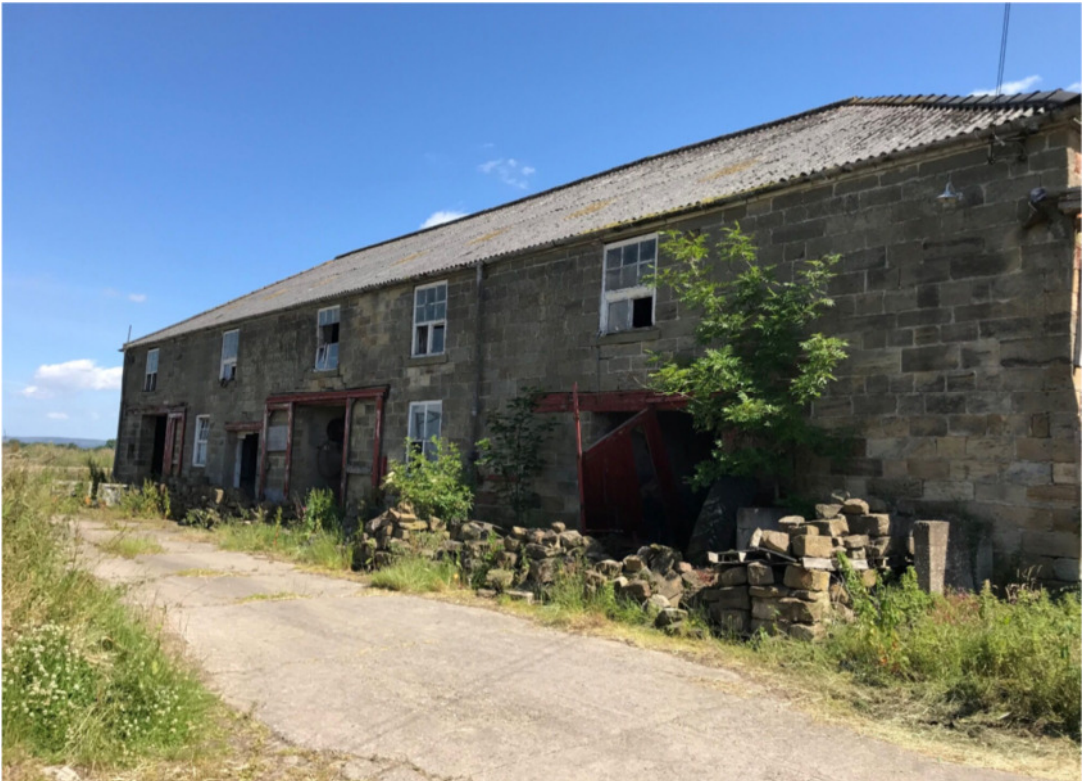
Photo 2. Building 2

- 3.2.4.3 Building 2: the two-storey former granary is located in the centre of the site. The building measures 32 m (L) x 9.5 m (W). The building is in poor condition and not in use. There are five ground floor rooms. The first floor was inaccessible due to a damaged staircase and unsafe floor. The building is of sandstone and redbrick construction with a steel reinforced timber frame. The roof is pitched, and is clad with asbestos sheeting (with some translucent tiles), and has north and south elevations. Guttering is also asbestos. There is no enclosed loft void with the first floor rooms open to the underside of the roof sheets.

- 3.3.1.2 Building 2: Evidence (bat droppings) to indicate bat roosting activity was recorded within building 2, with a low-moderate density of droppings noted within the ground floor rooms. Building 2 was considered to hold Bat Roost Features of moderate potential to support roosting bats. Typical roost features included gaps and crevices in the internal and external walls, and gaps under roof sheets.

- 3.4.1.3 At 20:14 the second floor granary (building 2) was viewed from the top of the stairs. A barn owl, most probably a male, was flushed from a beam and flew out to the west via a broken window. The granary floor is not sound so the search for splash and pellets was limited, though aided by torch light. There was insufficient evidence to suggest that breeding was taking place in the granary and it is likely that it is used as a roost site.

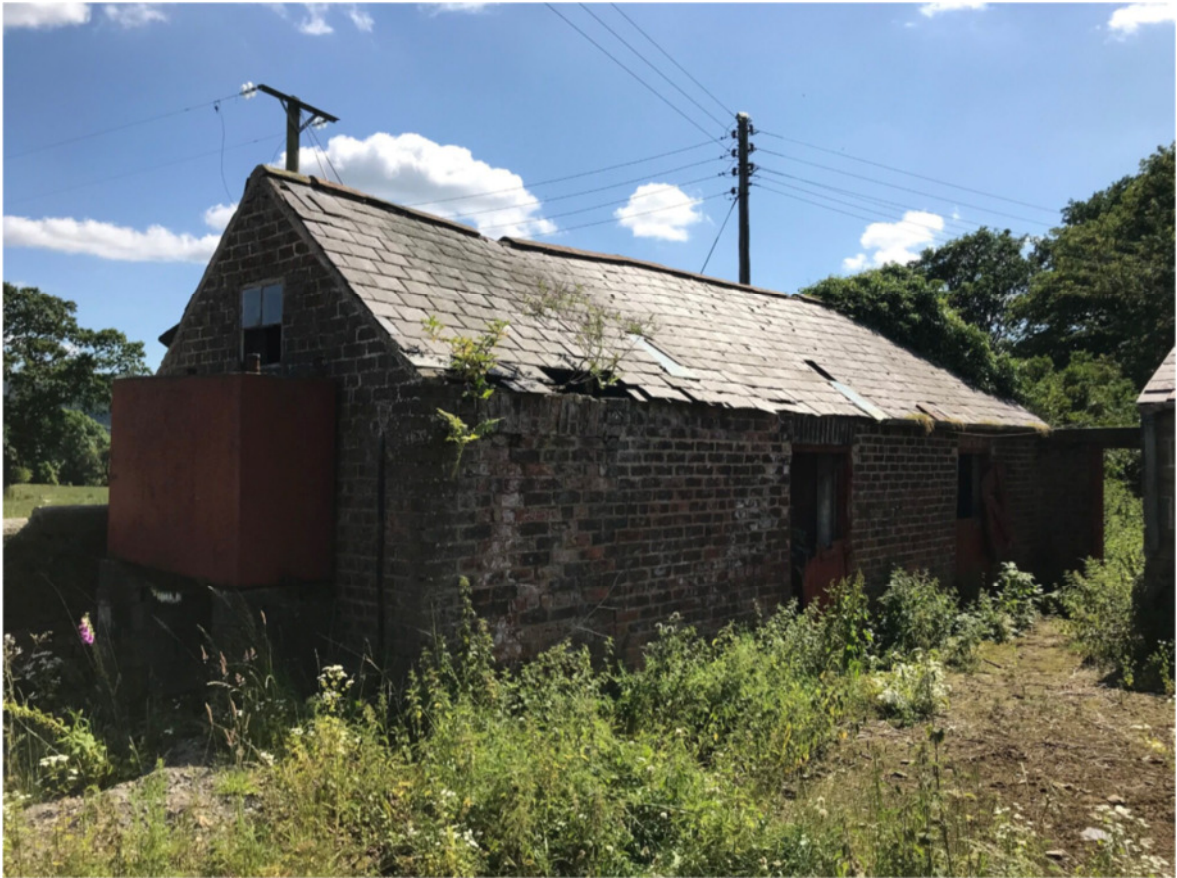
Photo 3. Building 10

2.7.1.1 One bat dropping sample was collected on 3rd July 2019 from inside building 10; this was sent to the University of Warwick for DNA species analysis and genotyping confirmation.

- 3.2.4.11 Building 10: a single storey stable containing two rooms in the south-west of the site. This building is of red brick construction with a pitched, slate tiled roof, with north and south elevations. The roof has a timber frame. There are timber framed windows on the north and south elevations.

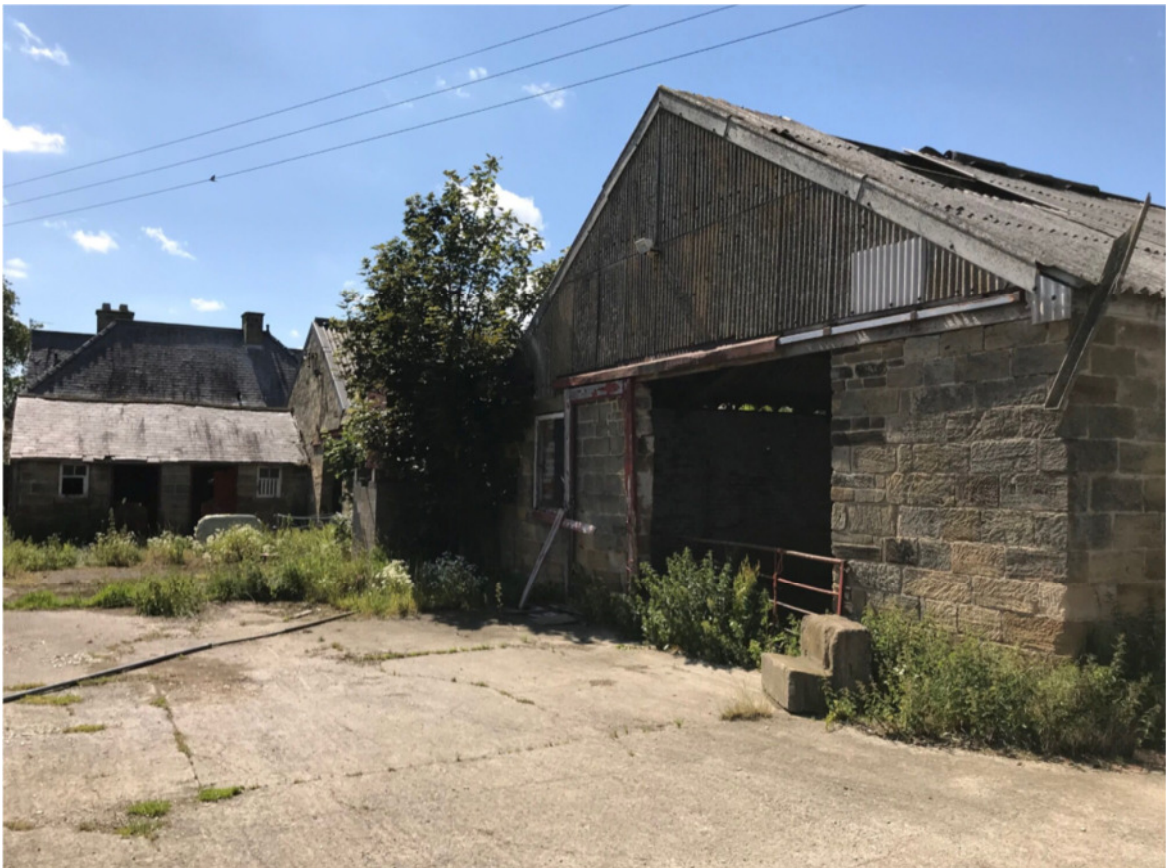
Photo 4. Building 8

- 3.2.4.9 Building 8: a large agricultural building at the centre of the site. The building measures 32 (w) x 10 (L). This barn is of sandstone construction and is in-use for livestock storage. The roof is pitched with a covering of asbestos sheeting. The barn has a steel and timber roof structure. The barn contains a single room with no enclosed loft void. Windows are located on the eastern elevation with a doorway on the southern elevation.

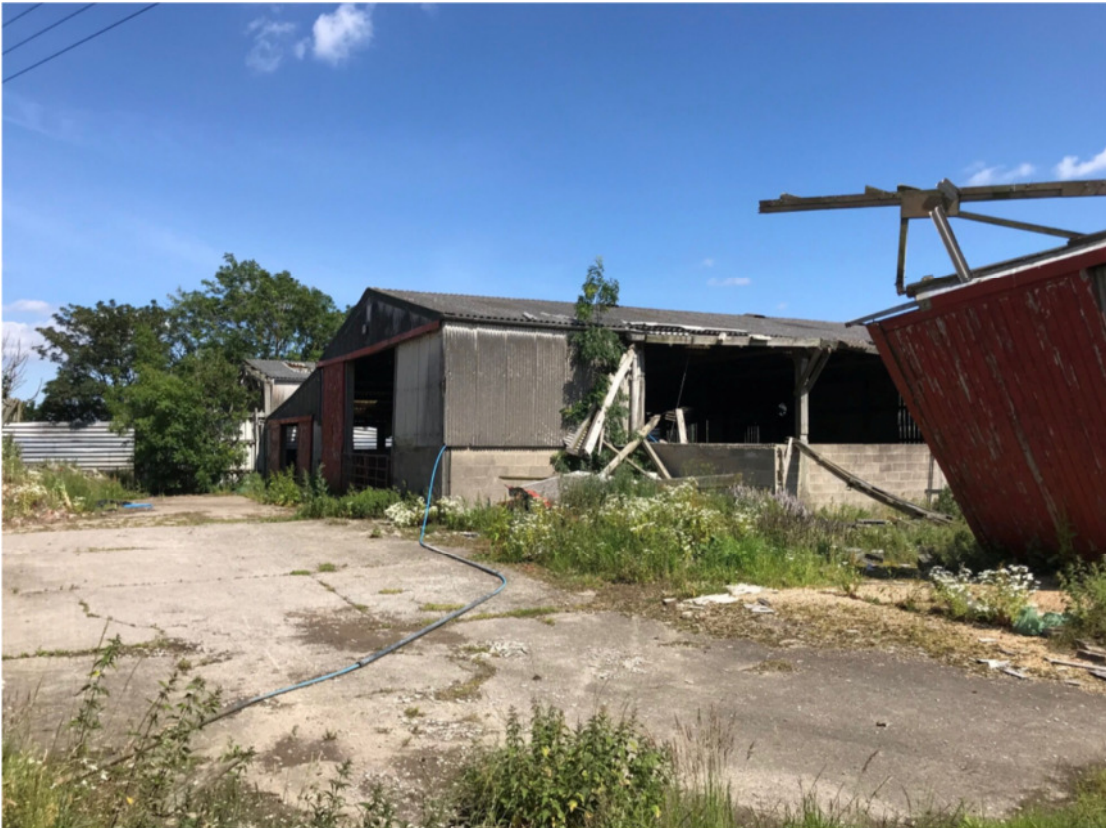
Photo 5. Building 9

- 3.2.4.10 Building 9: a series of agricultural sheds in the south-east region of the site. These buildings are of 'modern' design with breeze block walls, steel and/or timber frames and corrugated sheeting on the roofs. The eastern shed has partially collapsed with the remainder of the structure is in-use for livestock storage. The roof is pitched with east and west elevations and is composed of corrugated tin sheeting.

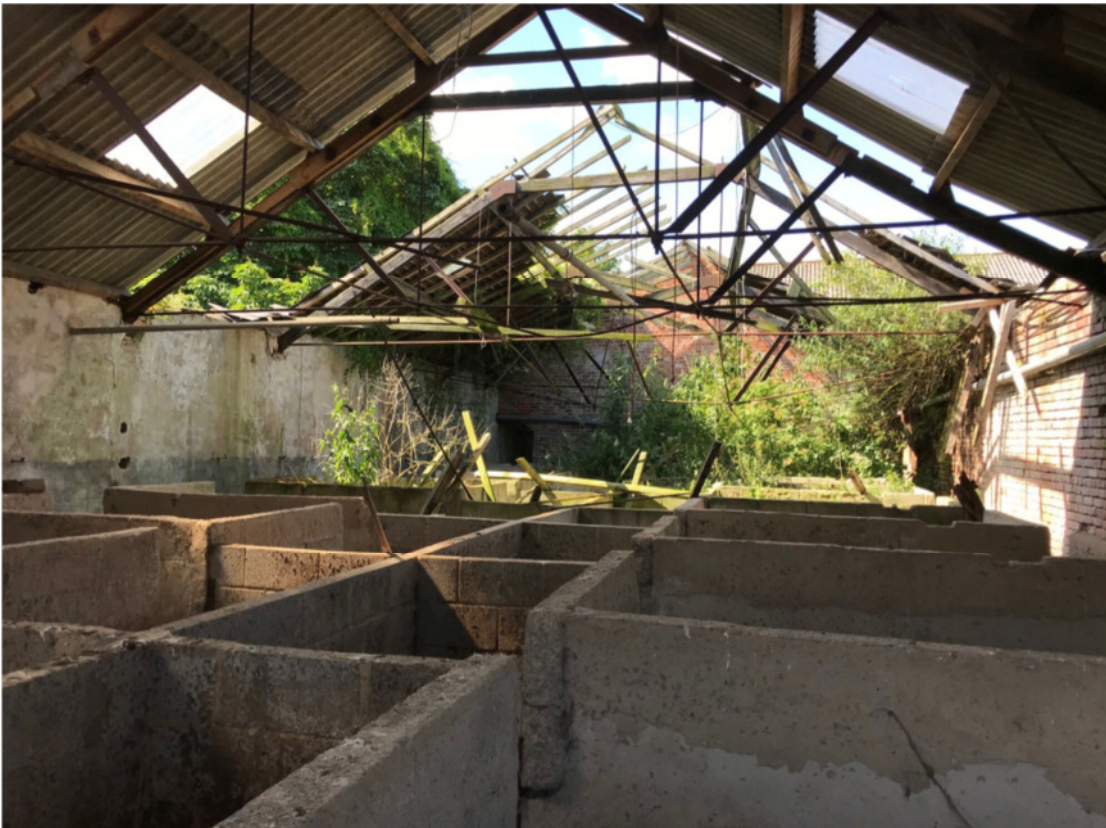
Photo 6. Building 7

- 3.2.4.7 Building 6: while present on plans this building is no longer standing.
- 3.2.4.8 Building 7: a large agricultural building at the centre of the site. The building measures 32 (w) x 20 (L). This barn is of sandstone construction is divided into two large linear barns. The roof on the eastern room has collapsed and the barn composed totally of rubble and loose material. The western room is vacant with significant damage and includes disused livestock pens. The roof on the western room is pitched with a covering of asbestos sheeting, although much of the roof has collapsed. The barns have a steel and timber roof structure.

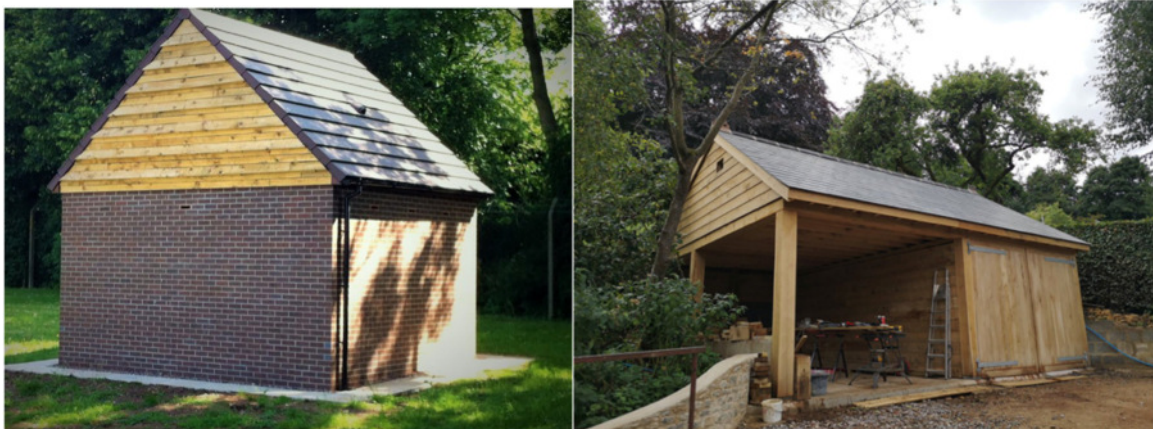
Bat bricks: are of concrete construction with a single access point. Dimensions: height 47.5cm, width 20cm and depth 12.5cm. Access entrance width 15cm and height 2cm. Weight ca.9.8kg. Bat bricks will be incorporated at a height of >4m. No artificial light should be directed on the bat bricks. The bat bricks are self-maintaining. Bat bricks are suitable for soprano pipistrelle, common pipistrelle and brown long-eared bats. Confirmation on bat bricks would be provided in the Natural England Licence Application. In total 8 bat bricks will be included in the new and renovated buildings. The roosting provision will include permanent features that will be incorporated within the buildings on site.
