Design Access/ Heritage Statement  
Mount Misery Farm  
Hackness

This design and access statement is produced to show the intention to sympathetically maintenance of farm cottage and associated buildings.

Mount Misery Proposed Schedule of Works  
Page 1 of 2

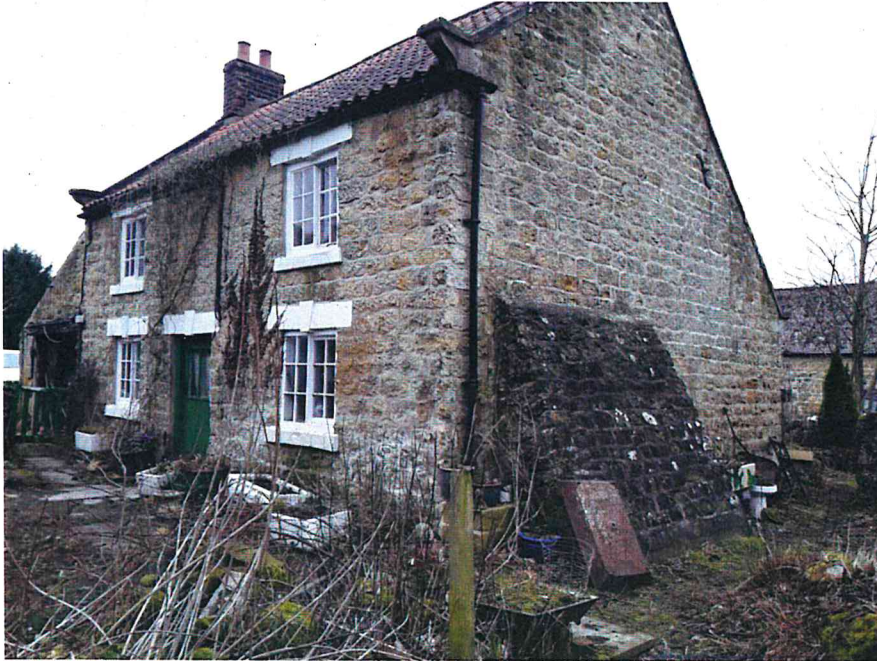
Item 1 Cottage Guttering

1. The Replacement of Existing Plastic Rainwater Goods.  
This work is intended to separate the surface water and the foul water and to divert the surface water from the back to the front and into a soakaway to the front of the building. The intention is to maintain the current location of the rainwater goods with the exception of including a fall pipe and a gully to the front of the garage. It was decided to install cast iron guttering as this would be in keeping with the age of the building cosmetically and would provide a longer lasting solution.

Front Elevation

| Item Number | Photo | Description of Proposed Work | |
|---|---|--|---|
| 1 | | <p><u>Cottage</u><br/>Replace existing plastic rainwater goods with cast iron and divert rear flow to the front by discharging on to the garage roof<br/>Install new gullies and drains to soak away</p> | |

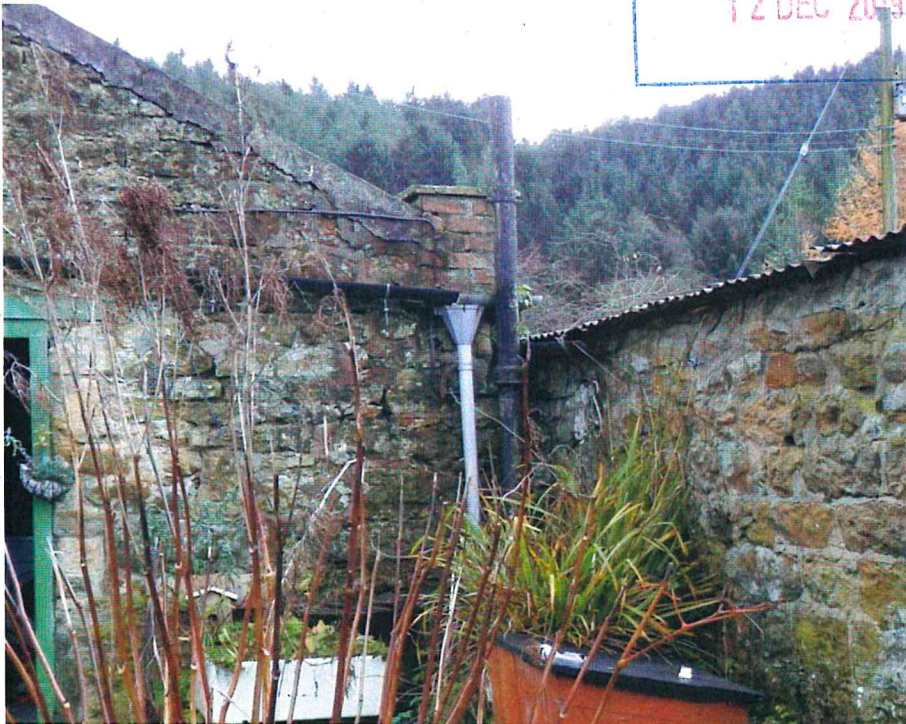
Current Gutter Layout To Rear

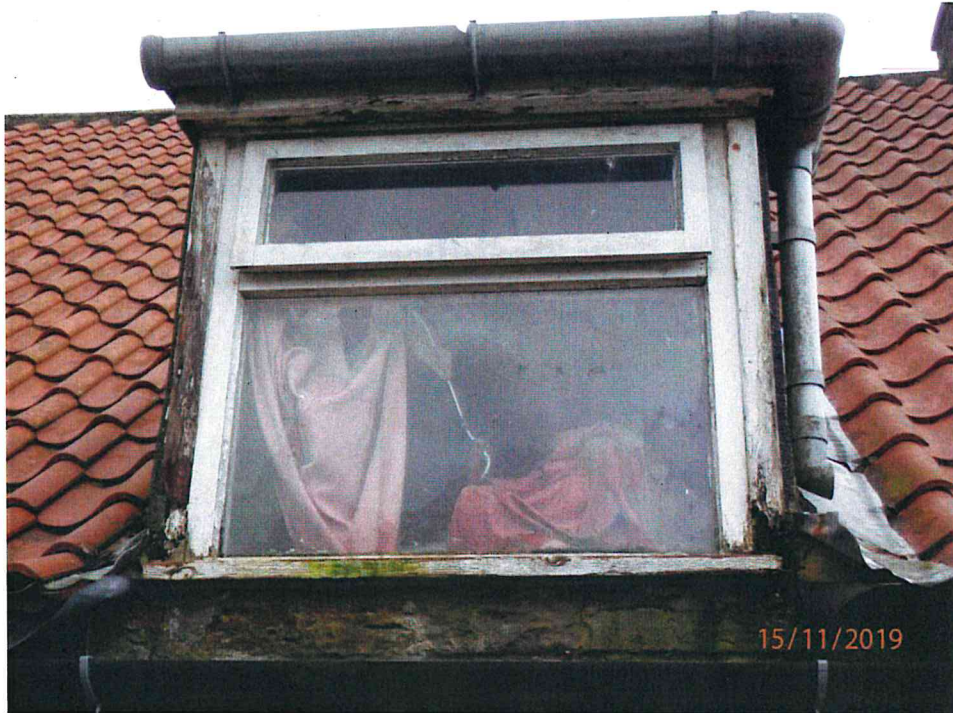
Item 2 Dormer Replacement

2. Replace Existing Rear Dormer.  
The existing Dormer has failed and is allowing water ingress causing further damage to the building. The intention is to replace the dormer like for like. The window is to be replaced to the same design but with double glazed units to help increase the thermal comfort for the occupant.

Dormer Window

| Item Number | Photo | Description of Proposed Work | |
|---|---|--|---|
| 2 | | <p><u>Rear of Cottage 1<sup>st</sup> Floor</u><br/>Replace existing Dormer to the rear of the cottage. Replacement to be like for like including window roof and internal finishing's.<br/>Window to be double glazed</p> | <p style="border: 1px solid blue; padding: 5px; color: blue;">NYMNP<br/>12 DEC 2019</p> |

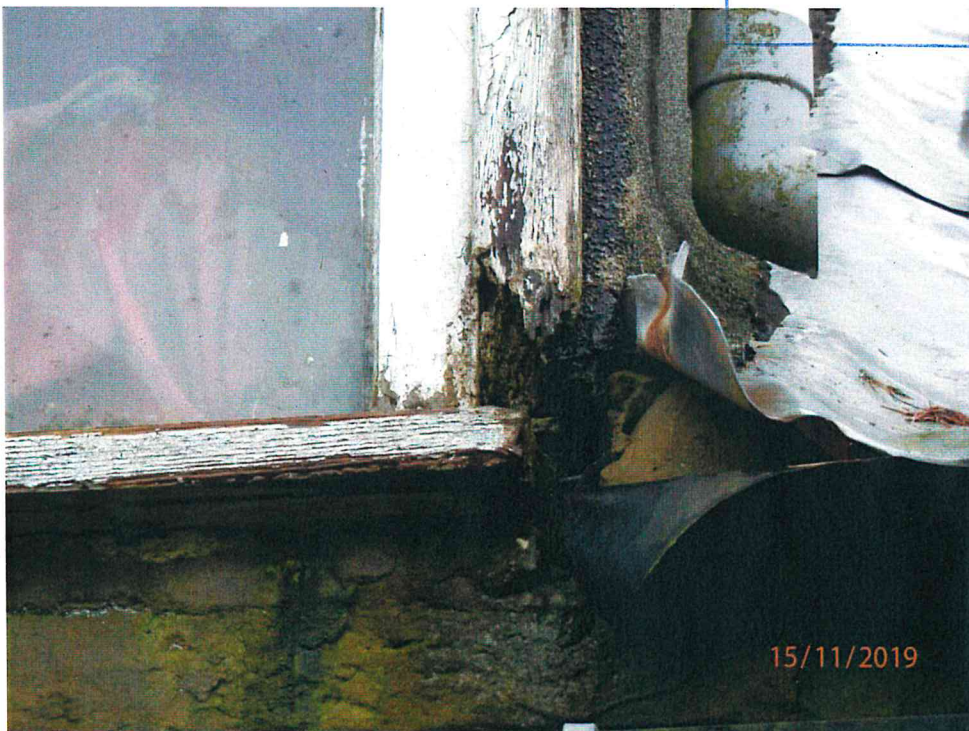
Bottom Right Hand Detail

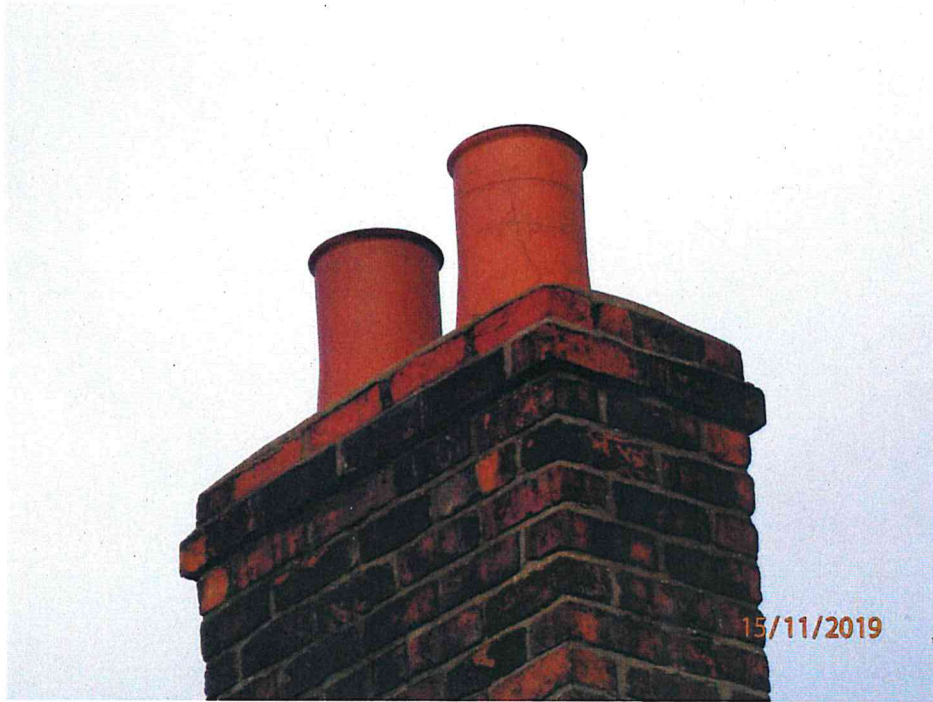
Item 3 Cracked and Missing Chimneypots

3. Replace Damaged and Missing Chimney Pot.  
One chimney pot to the left hand stack is cracking and requires replacement and there appears to be a chimney pot missing to the right hand stack. The intention is to replace the chimney pot to the left hand stack with a role topped pot in keeping with the building. Once the scaffold has been erected we will investigate the right hand stack with the intention of installing a role topped pot as the left hand stack if required.

Left Hand side Stack

| Item Number | Photo | Description of Proposed Work | |
|---|---|--|---|
| 3 | | <p><u>Cottage Roof</u><br/>Replace damaged and missing chimney pot with new red clay role top</p> | |

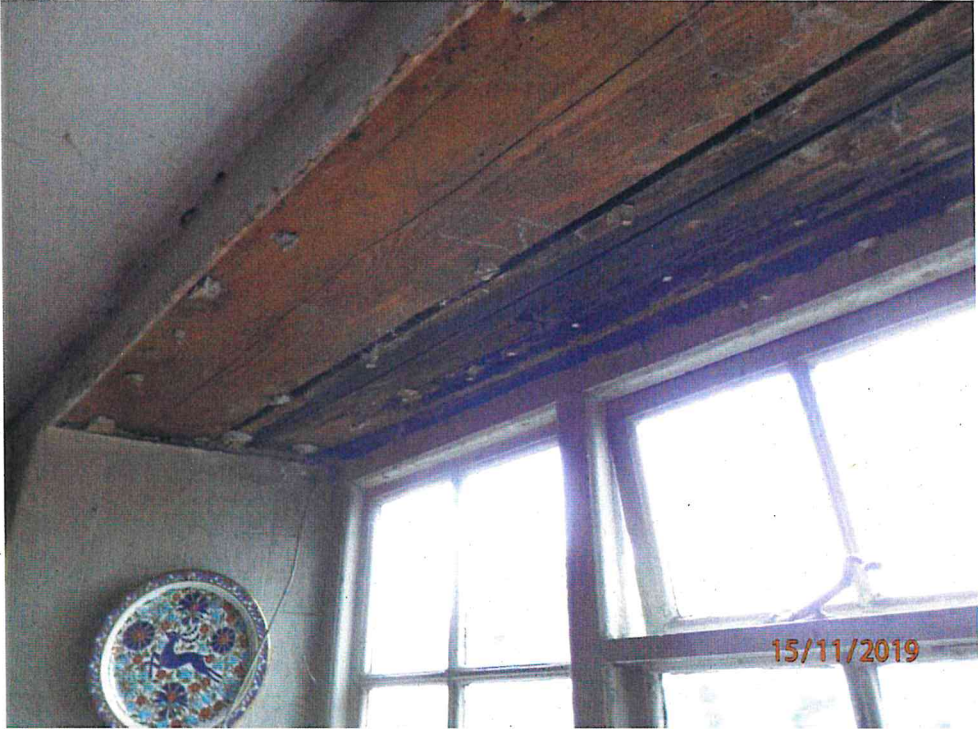
Item 4 kitchen Window

4. Replace existing Kitchen Window  
The existing kitchen window has detreated due to rot and is beyond economic repair. The intention is to replace the existing window with a matching the current style but with double glazed units to improve the thermal comfort for the occupant.

Internal finish to be repaired

| Item Number | Photo | Description of Proposed Work | |
|---|---|--|---|
| 4 | | <p><u>Rear of Cottage Kitchen</u><br/>Replace existing window with new timber window to match in appearance. To have double glazed units. Paint White. Repair finish internally.</p> | |

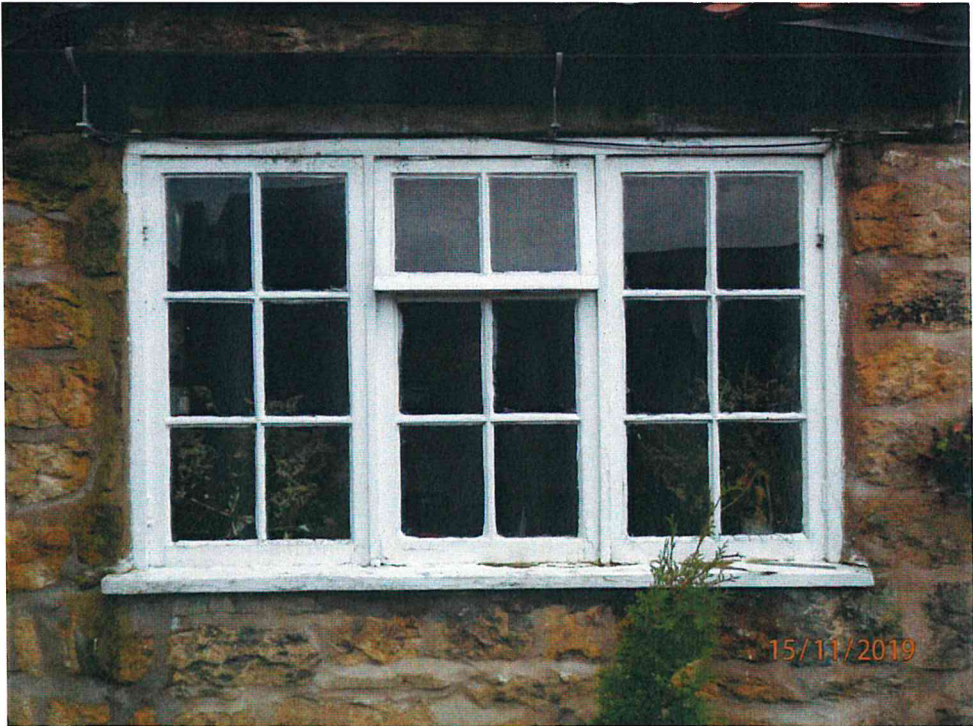
Kitchen Window

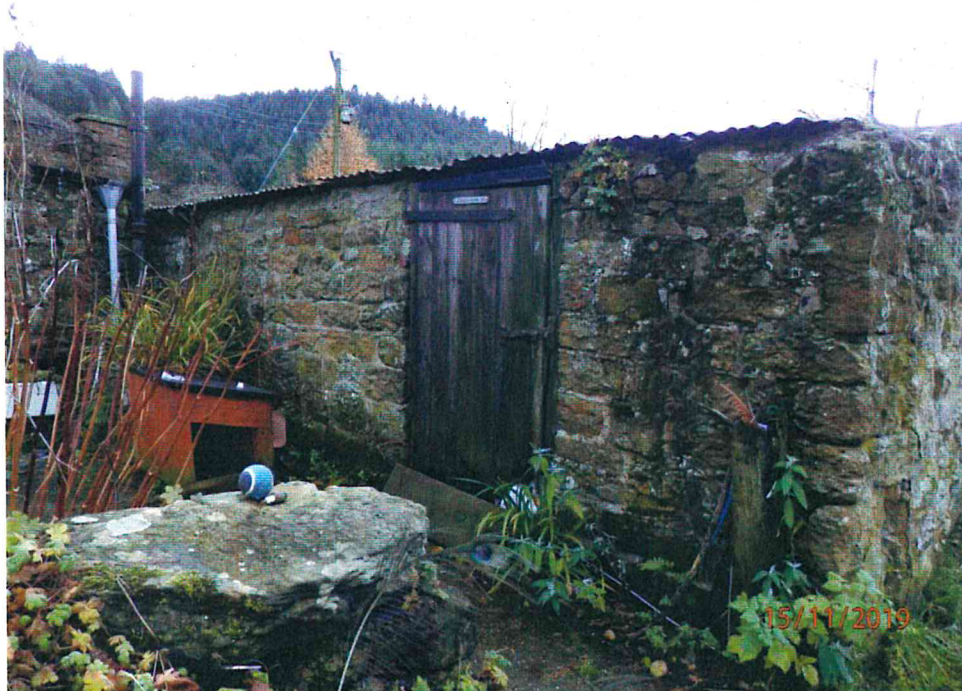
6. Renew Roof to Small Tractor Shed Roof  
The roof shows deflection and requires repair before further damage results due to neglect. The intention is to replace defective or damaged timbers to the roof and install new corrugated steel sheet. Also the batten door to the shed has deteriorated to the point it requires complete replacement. The intention is to replace like for like.

Batten Door

| Item Number | Photo | Description of Proposed Work | |
|---|---|--|---|
| 6 | | <p><u>Small Tractor Shed</u><br/>Remove existing steel roof covering, replace defective timbers to the roof, and repair any defective stonework. Install new steel roof covering and rainwater goods<br/>Replace batten door as existing</p> | |

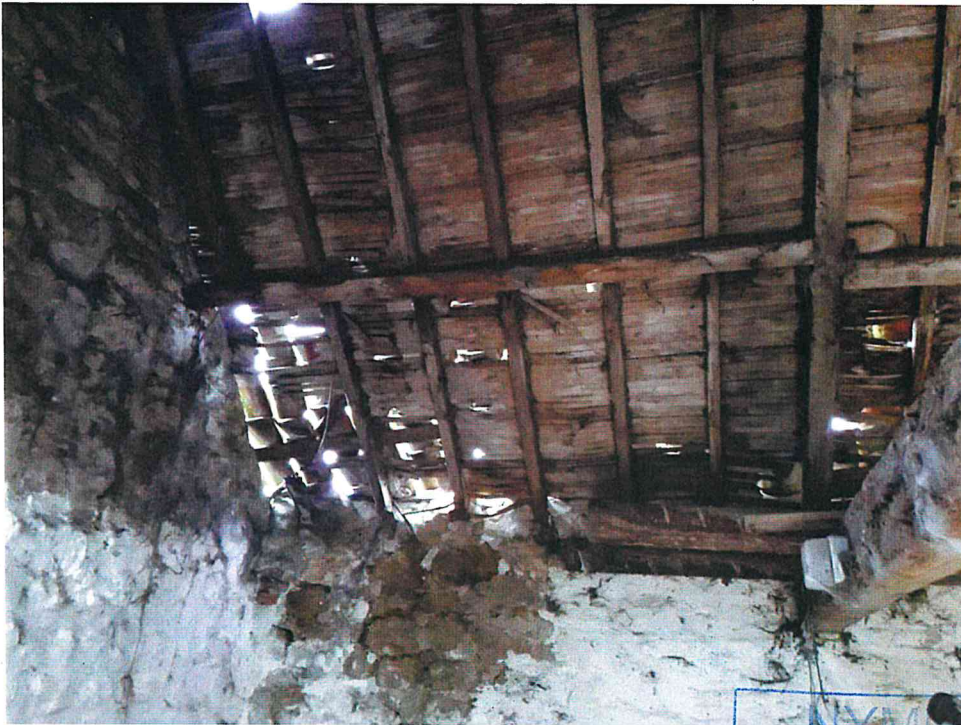
Item 7 Stable

The stable roof has a number of defective timbers and damaged roof tiles. The intention is to replace any damaged timbers to the roof structure, repair damaged stonework and to reinstall existing tiles where possible and to renew as necessary with matching tiles.

Internal

| Ref Number | Photo | Description of Proposed Work | |
|---|---|--|--|
| 7 | | <u>Stable</u><br>Remove existing pantiles, replace defective timbers and repair stonework. Refit existing and replace any damaged tiles as necessary. | |

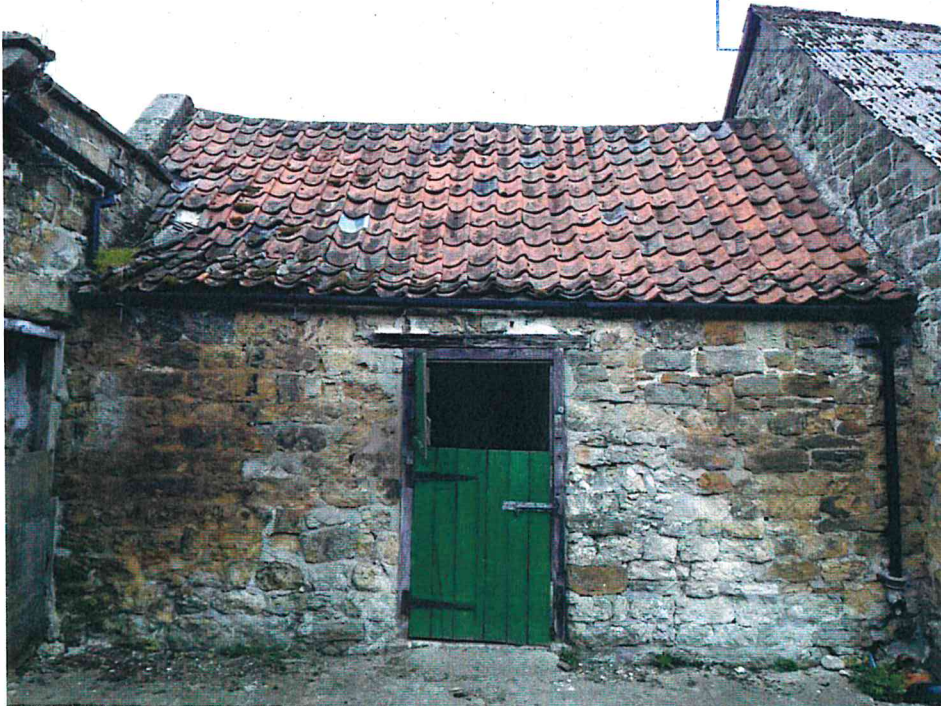
Front Elevation

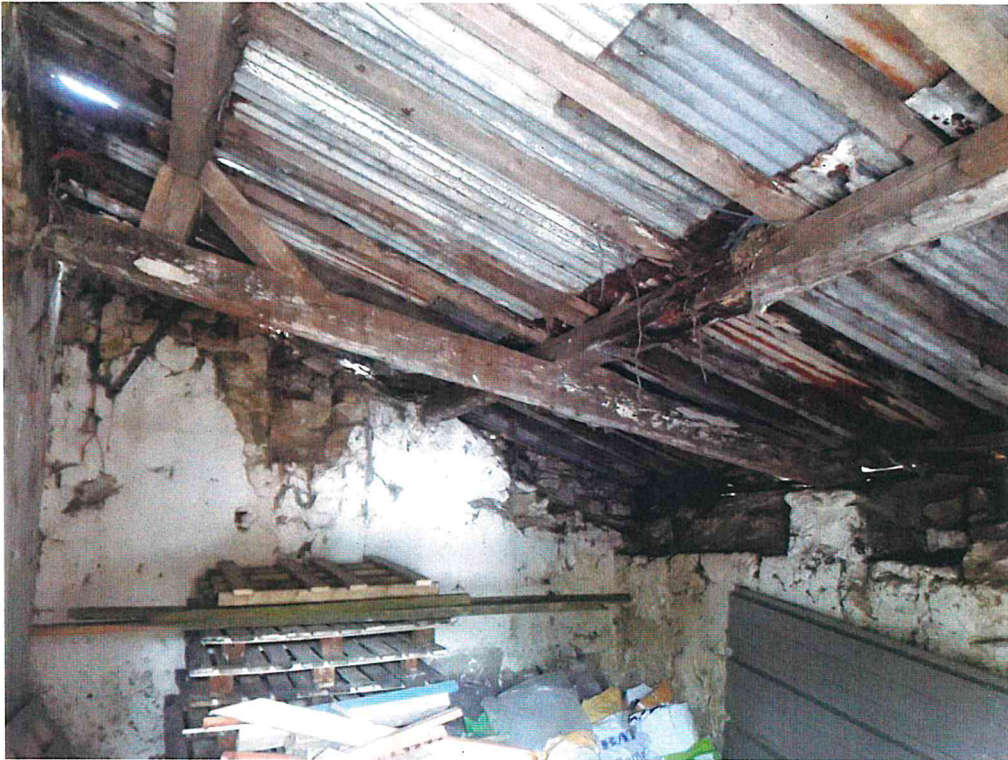
Item 8 Wood Store

The roof structure is showing signs of decay and has a corrugated steel roof covering. The intention is to repair and replace any defective timbers and install a pan tile roof covering with rainwater goods to prolong the life of the building.

Internal

| Ref Number | Photo | Description of Proposed Work | |
|---|---|--|--|
| 8 | | <u>Wood Store</u><br>Remove existing steel roof covering, replace defective timbers to the roof, and repair any defective stonework. Install new pantile roof covering and rainwater goods | |

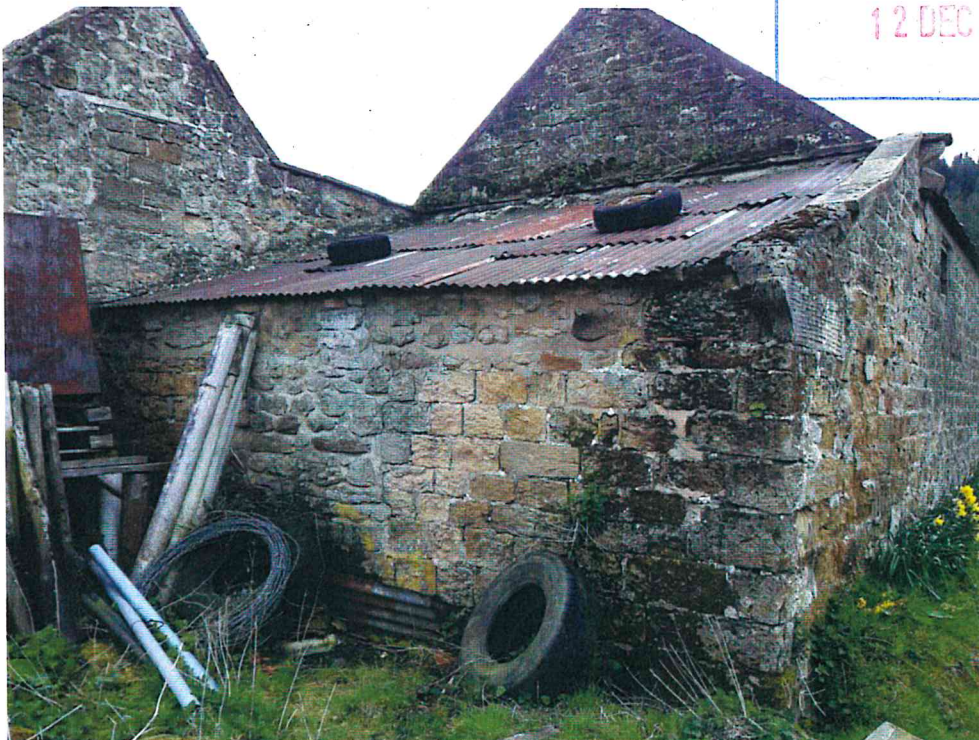
Rear Elevation/Roof
