High Dalby House
Dalby Forest Tracks
Pickering
YO18 7LP

NYM/2019/0452/FL

Emergence survey results – High Dalby House (outbuilding)

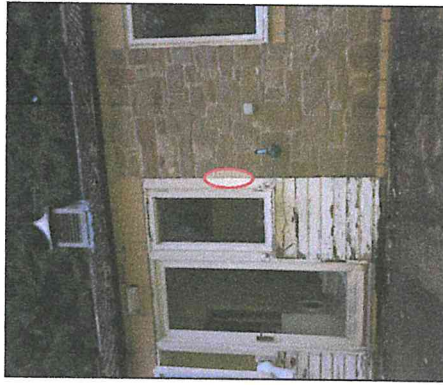
Following an Ecological Impact Assessment conducted in September 2018, an evening emergence survey was completed on 3rd September 2019 on Building 1 (small outbuilding) at High Dalby House, during which, a single common pipistrelle was recorded emerging from a crevice between the wall and doorframe.

Photo 2. Emergence location at side of window.

Once a licence has been obtained replacement crevice roosting habitat would be provided on site through the installation of one professional quality and long-lasting bat box on site (Schwegler 1FF or equivalent). Due to low numbers and non-breeding status, this mitigation is considered to be proportionate to the level of bat use and will ensure that ecological functionality is maintained post-development. Full emergence survey results can be found overleaf.

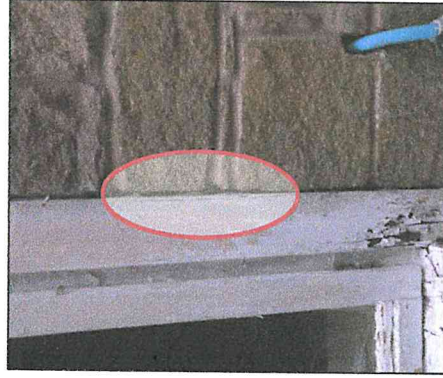
Photo 2. Emergence location at side of window.

Building Ref.	Species	Count	Roost type	Emergence location/access point
1	Common pipistrelle, <i>Pipistrellus pipistrellus</i>	1	Day roost	Gap between window frame and wall.

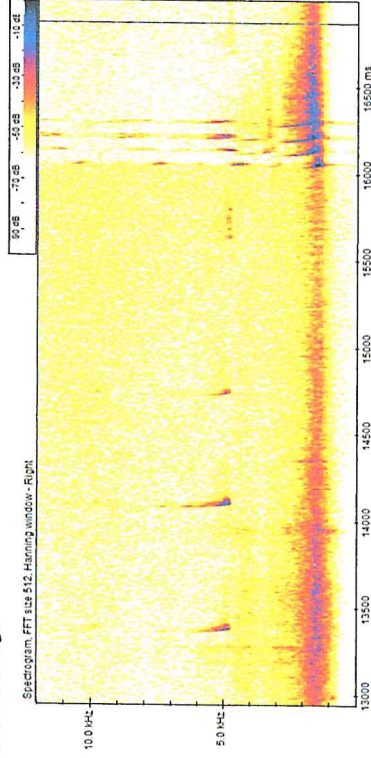
Figure 2. Emergence of common pipistrelle at 20:04, recorded on Pettersson D240x with Ediral R03.
