Foxhill Pasture

Throxenby
Scarborough
YO12 5TD

Heritage Statement and
Design & Access Statement

This document accompanies an application for Listed Building Consent for the installation of security cameras on the grade 2 listed building Foxhill Pasture

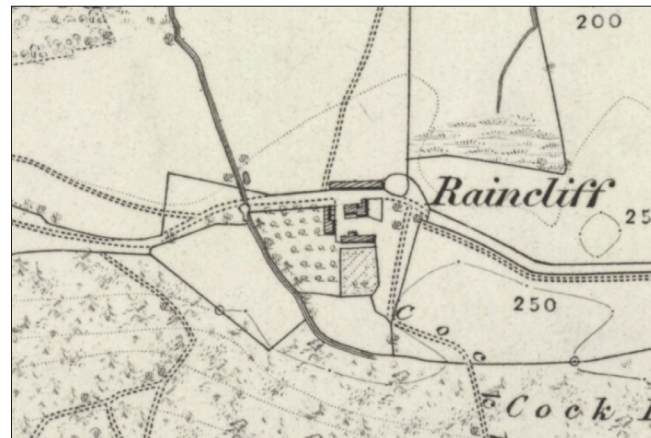
Extract from 1854 OS

Extracts from historic OS maps show that the buildings were all in evidence before the first edition Ordnance Survey of 1854. With the road running through the farm yard. There is significant development between 1850 and the second edition 18901 map where the fold yard is formed and a new wing extends to the north where the garde presently stands

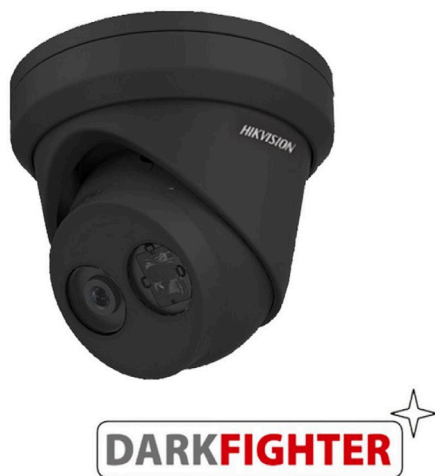
Detail of proposed cameras

The applicants have a young family and are concerned about security in a semi remote location. They need to spend long periods away from the house and security is essential. We have endeavoured to find discreet cameras and located them against black rainwater goods to limit any detrimental effect on the listed building.

Installation of the proposed security devices will have no harmful effect on the significance of this asset. Cameras however should be situated away from the period stonework detailing where possible and discreetly located such as close to rainwater goods to avoid obvious visual intrusion.

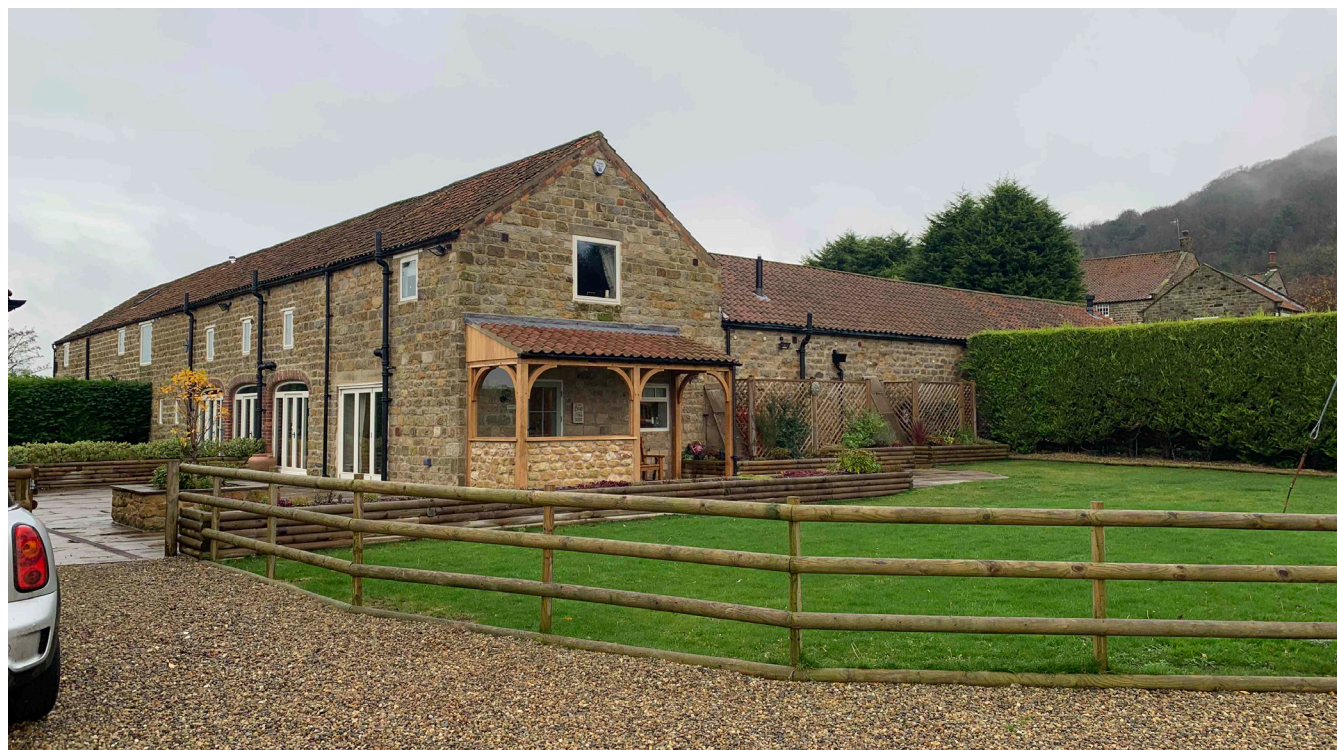
Arrival and north east side of barn
