# WOLD ECOLOGY LTD

## Highdales Farm, Hackness

Bat Survey, March 2020.

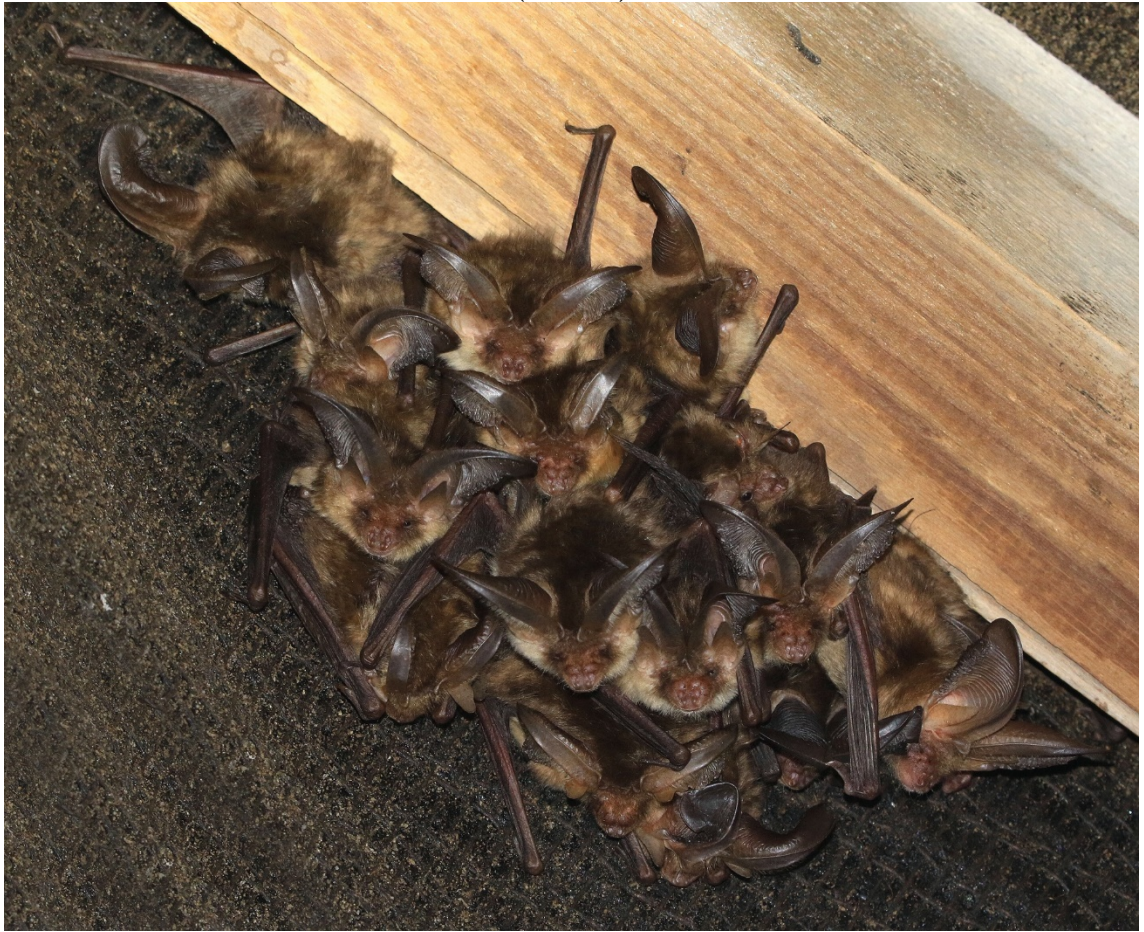
- **25<sup>th</sup> June 2019** – A cluster of brown long-eared bat was observed roosting adjacent to the ridge beam inside the roof void of the house, approximately 19 bats were observed (**Roost 1**).

- The following bat roosts were observed:
  - **Roost 1** – brown long-eared roost located inside the roof void of the house. The roost contains 19 bats (see 5.5 plates 1 and 3).

Plate 3 – brown long-eared (x19) maternity roost located in the roof void of the farm house (Roost 1)

7.2.2 The brown long-eared and common pipistrelle maternity/hibernation roost in the farm house (**Roosts 1, 5 and 6**) are of moderate conservation significance, however a maternity roost of a common and widespread specie requires ‘more or less like for like’ replacement with constraints on timing (Bat Mitigation Guidelines, 2004). Bat boxes are inappropriate substitutes for significant roosts in buildings and in the case of the brown long-eared maternity roost, do not constitute ‘like for like’ replacement.

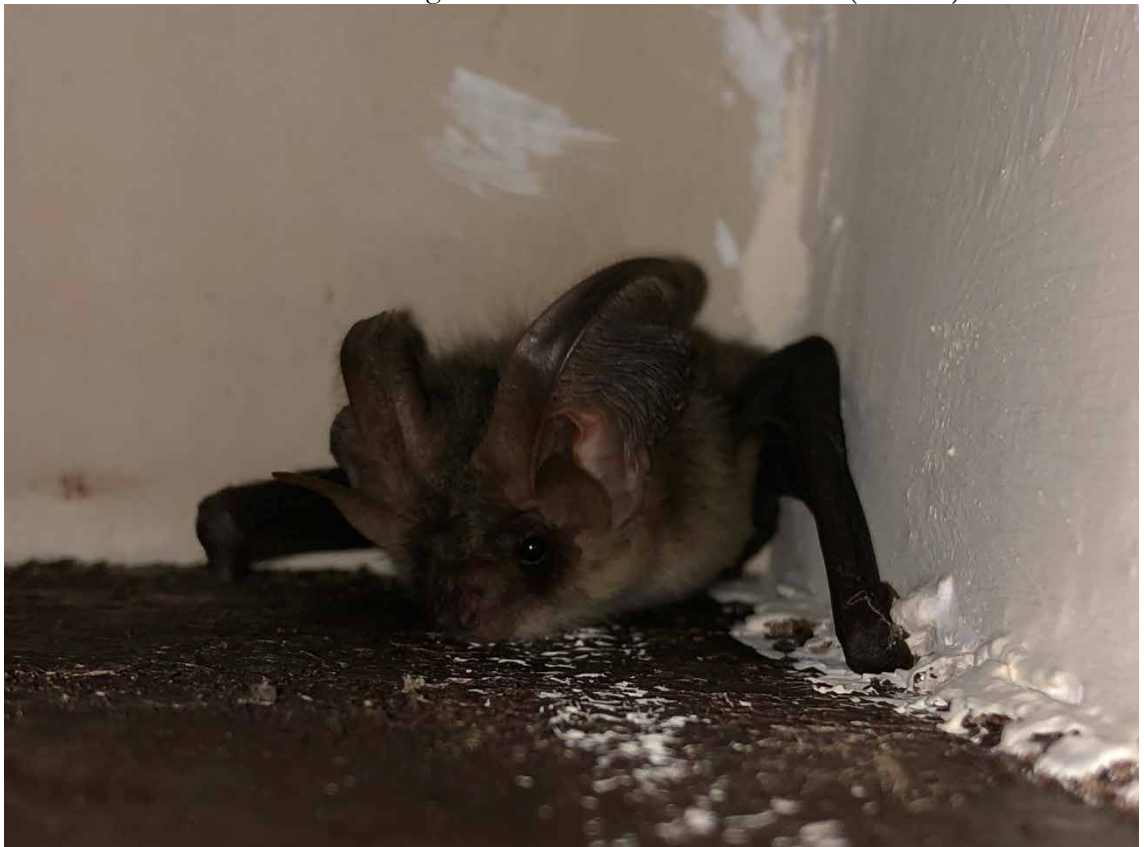
- **26<sup>th</sup> July 2019** - A brown long-eared bat was observed roosting against a ground floor ceiling beam in the farm house (**Roost 2**).
  - **13<sup>th</sup> March 2020** – two common pipistrelle bats were observed hibernating in a gap in the south elevation external wall during the endoscope survey (**Roost 5**).

Plate 4 – brown long-eared bat inside the farm house (Roost 2)

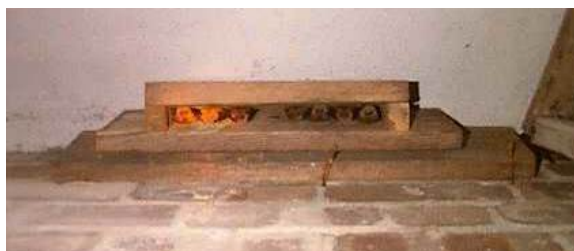
**Plate 7 - Example of an open bottomed slot box (Norfolk Bat Group)**

7.6.1.4 Eight open bottomed, rough sawn, slot boxes will be sited within the internal roof structure of each bat loft. These will be constructed from rough soft wood measuring 300mm deep by 450 – 600mm long leaving a narrow space about 30mm wide. This can be attached to the wall to create additional roosting opportunities in the bat loft (see plates 7 and 8).

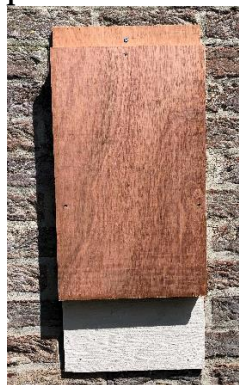
**Plate 8 - Example of an open bottomed slot box (Wold Ecology Ltd)**
