# Heritage Statement

# First floor Refurbishment and sauna Downhill Cottage, New Road, Robin Hoods Bay, YO22 4SF

11726-Downhill Cottage

12<sup>th</sup> June 2020

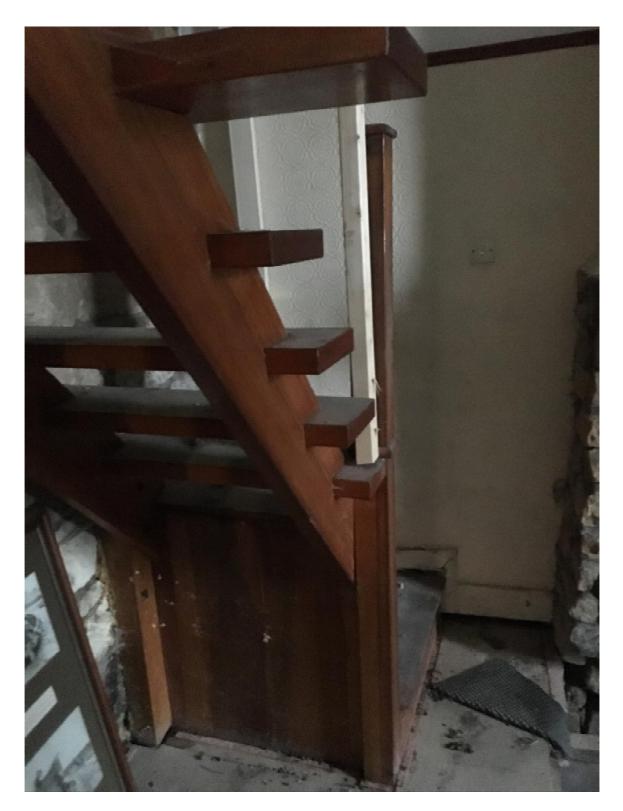
Photograph 1 Open plan stair to lounge

The ground floor is split into 2 rooms. A former kitchen and an adjacent living room. The living room has a modern (C20) open tread timber stair. The First floor is split into two bedrooms and a bathroom. Bedroom 2 and bathroom share window W4.

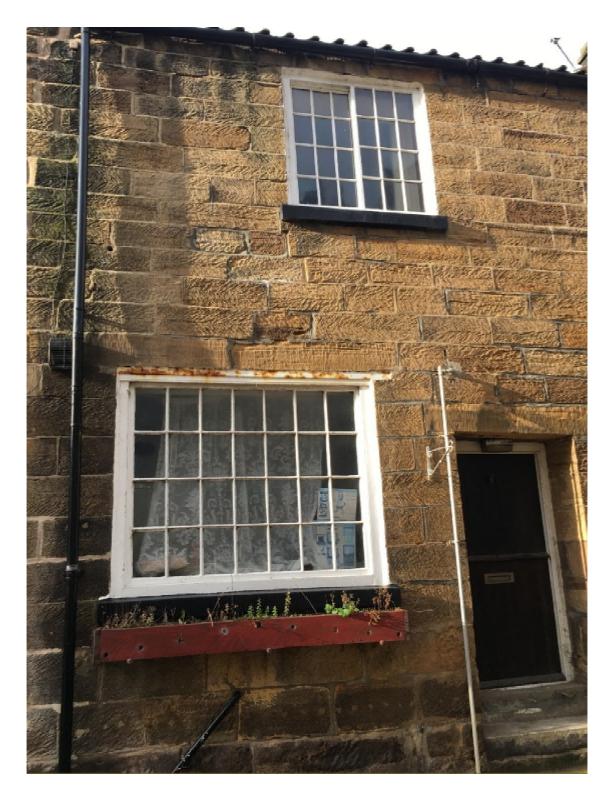
The kitchen window W1, has been amended at some point, although quite historic. It appears that due to a failure of the stone lintel above, a steel support was inserted below the stone lintel and cut into the coursed stone on either side. Possibly at the same point in time a fixed sash was inserted.

Photograph 5 Part Front Elevation, W1 and W3

The improvements to windows W1, W2, W3 and W5 have been approved under application NYM/2019/0794/FL.

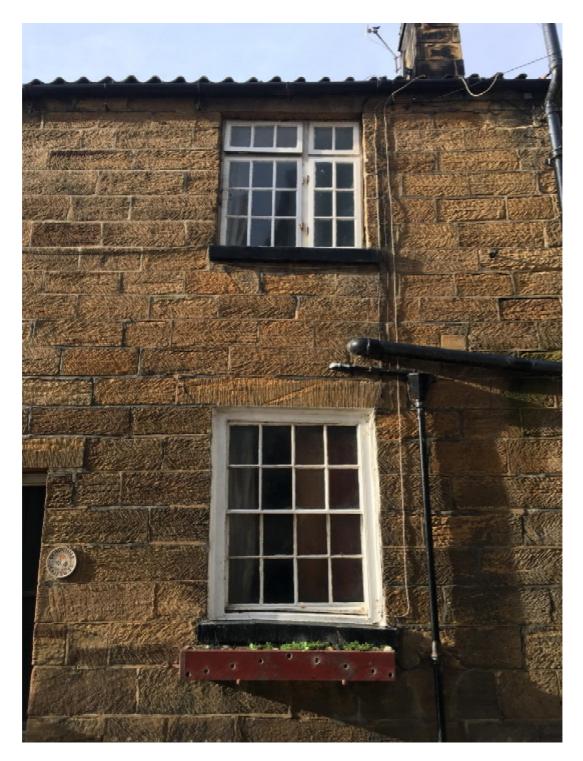
The front elevation contains 4 windows and the entrance door. The windows have undergone some alteration, in particular W4, which is a relatively modern casement window, presumably altered and replaced to allow the historic subdivision of a firstfloor bedroom to create a bathroom.

Photograph 6 Part Front Elevation, W2 and W4

W4; The side hung casements will be replaced by a vertical sliding sash window. To match the new window W3  $\,$

The window will all be timber painted construction and glazing is to be slimline doubleglazed units. Separate panes for each subdivision.

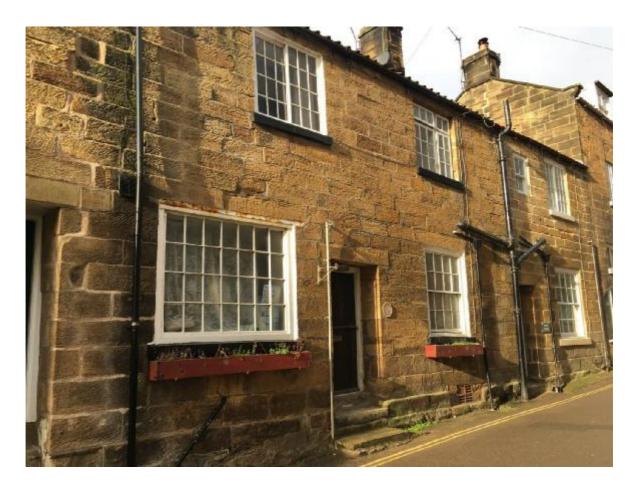
The Listing describes the front elevation, which closely matches the current appearance. The door and top right-hand window (W4) are noted as C20.

Photograph 7 Front elevation with Beadle Cottage beyond

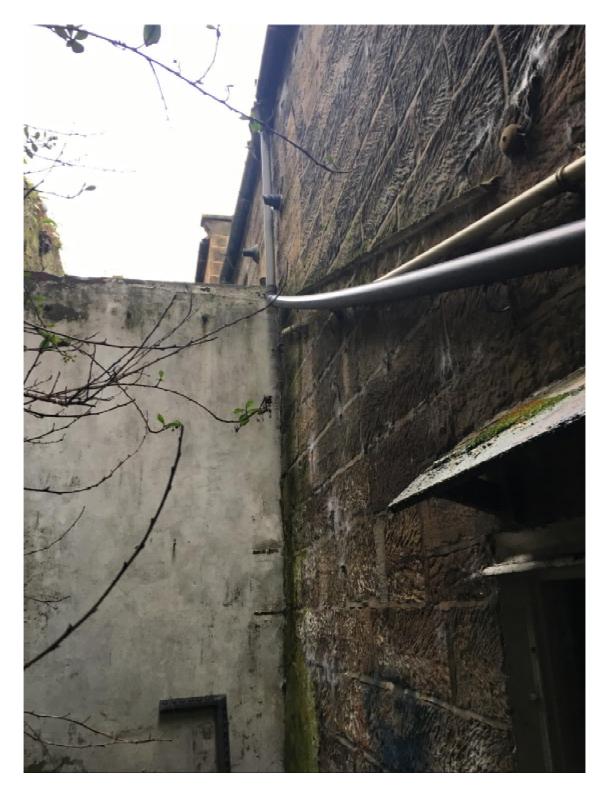
To the rear of the property is a small Yard area. It runs across the full extent of the rear of the property and varies in depth between 1500 and 1800mm.

The floor has at some point, been re-concreted to falls into a drain gully close to the rear door.

The Yard is bounded by 2/3 storey high Party Walls to either side and a very high (5m +) stone retaining wall to the rear. Due to its relative low position, the Yard will appear dark and damp for most of the time.

Photograph 8 Rear Yard looking at Party Wall of Beadle Cottage

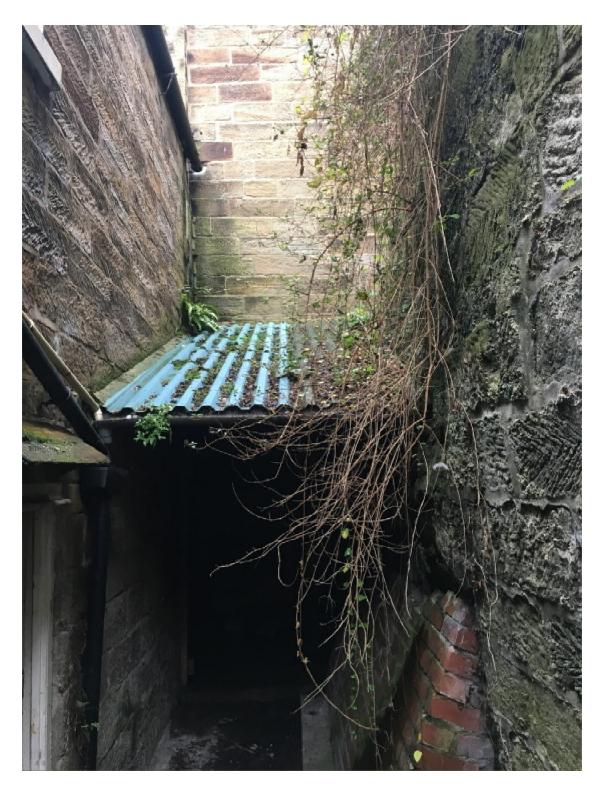
The rear retaining wall has a significant bulge in the centre and a relatively modern brick buttress has been constructed.

Part of the Yard has a modern steel sheet cover. Also apparent are the remnants of haunching, presumably from a previous roof attached to the rear house wall.

Photograph 9 Rear Yard looking at Party Wall to the south Note; covered area and brick buttress
