CONVERSION OF REDUNDANT FARM BUILDINGS TO FORM A LOCAL OCCUPANCY DWELLING AT BORROWBY BARN HINDERWELL

Borrowby Barn, Hinderwell Saltburn-by-the-Sea, North Yorkshire

Bat Survey

Report reference	1366
Revision	1
Prepared by	Thomas McQuillan
Approved by	Andrew Westgarth
Issue date	2 nd July 2020

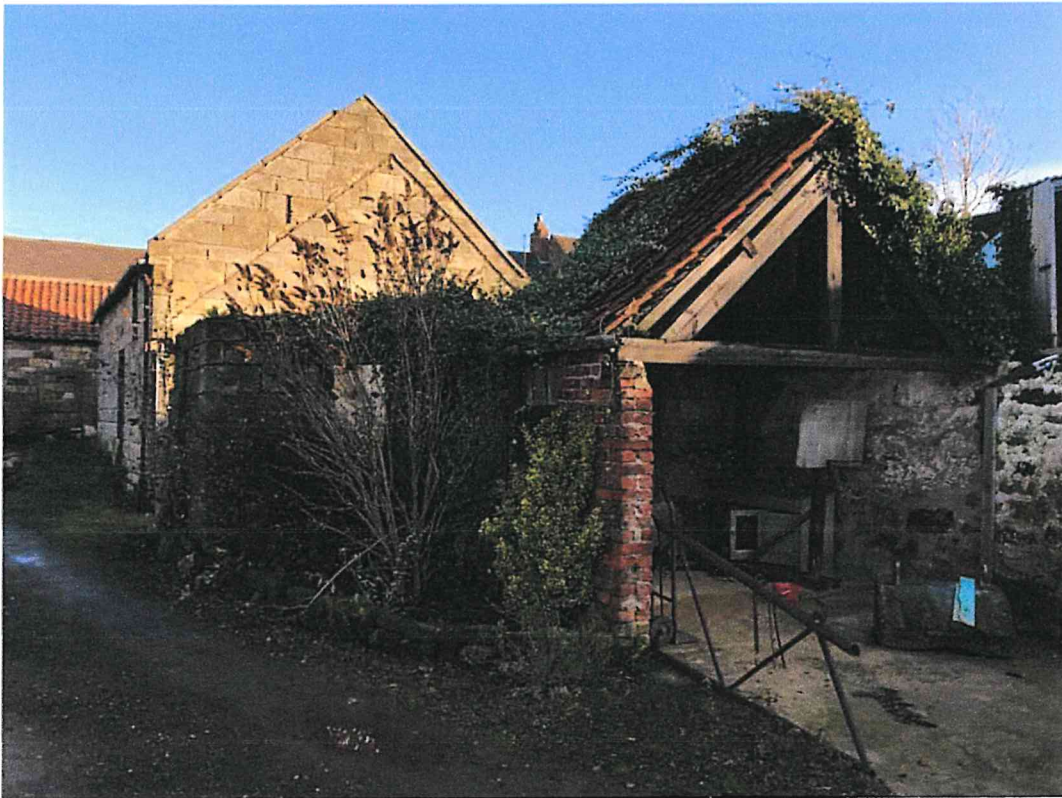
- 3.2.1.4 The southern part of the barn is of redbrick construction and includes a small lean-to measuring approximately 3 m (L) x 4 m (W). This part of the barn has a pitched roof with east and west elevations. A timber roof structure is located beneath a covering of clay pan tiles (majority of roof tiles are present). Dense ivy growth was present on the eastern elevation of the roof. The barn is open on the southern elevation. This part of the barn is not in use. Appendix 2: Photo 1.

Photo 1. Western and southern elevations of the surveyed barn.

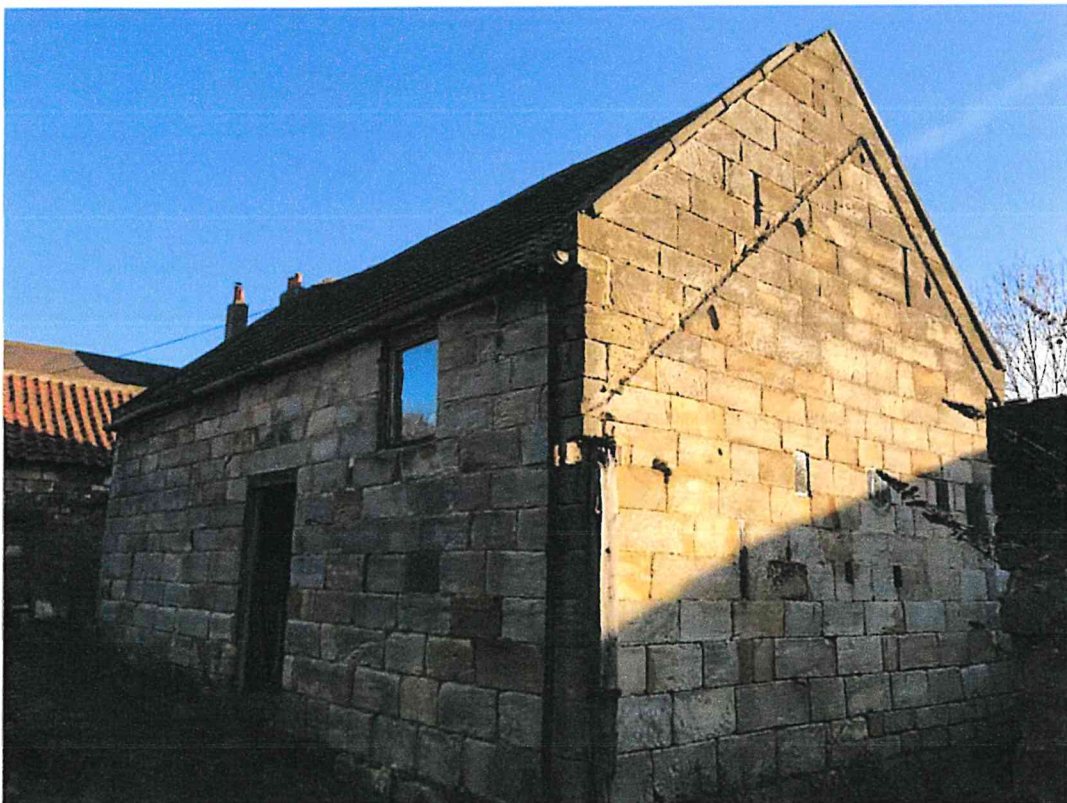
- 3.2.1.1 The agricultural barn is located centrally within the village of Hinderwell and includes three distinct sections as described below.
- 3.2.1.2 The northern part of the barn is of single skin sandstone construction and was considered to be in a moderate state of repair. The building measures approximately 11 m (L) by 6 m (W) and is used for general storage. The barn has a pitched roof with east and west elevations; the barn has a timber roof structure with a covering of concrete roof and ridge tiles (all present). Timber framed doors and windows are located on the north, east and west elevations; these have stone lintels. Sandstone coping stones are located on the northern and southern gable walls of the barn. There is no vegetation on the external elevations of the barn. Bitumastic felt is located beneath the roof tiles. Guttering is present on the east and west elevations. The arrow slit windows, notably on the southern elevation of the building, have Perspex sheeting within. Internally, the barn contains a single room with a small first floor hay loft on the northern part of the building. The first-floor area is accessed via the external stone steps on the northern elevation of the barn. There are numerous cracks and crevices within the internal and external walls where the mortar has failed and/or where timbers associated with adjacent barns removed. There is no enclosed loft void with the single room open to the underside of the roof. The barn has an internal concrete floor. Appendix 2: Photos 2, 3 and 5.

Photo 2. Western and southern elevations of the northern part of the surveyed barn.

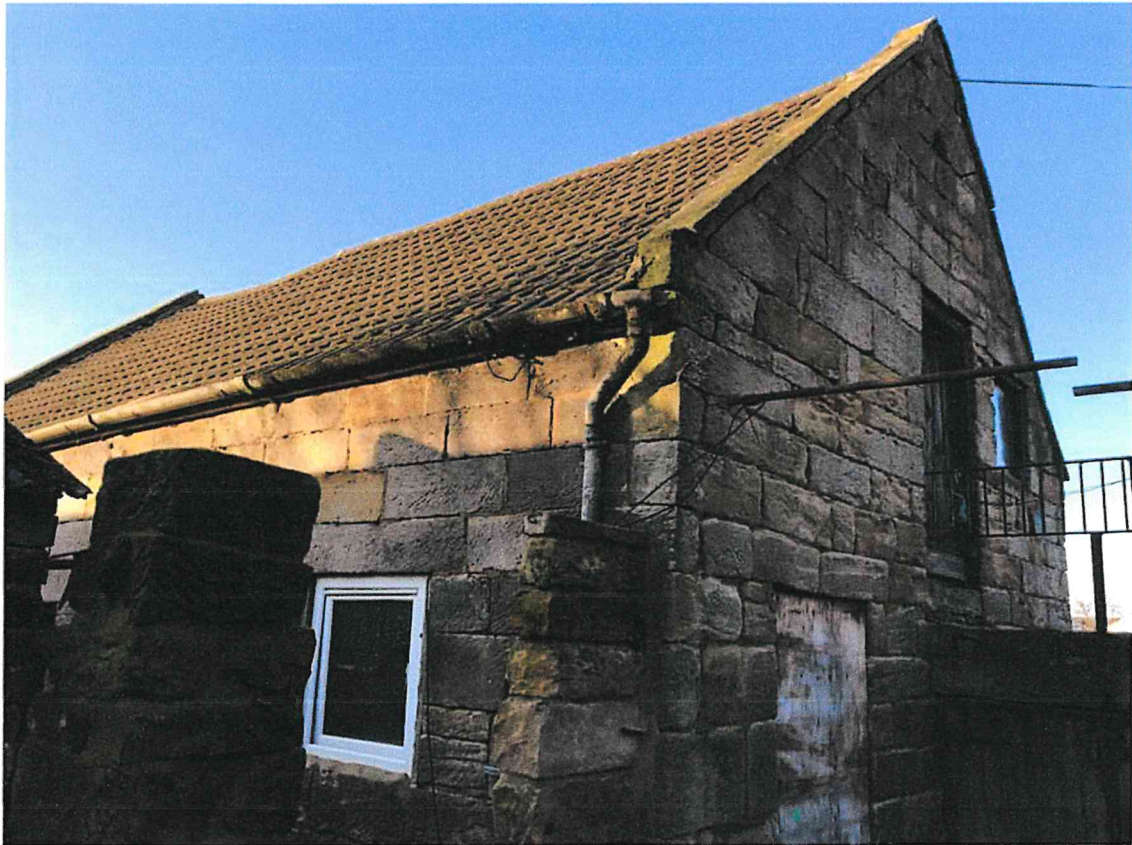
Photo 3. Eastern and northern elevations of the northern part of the surveyed barn.

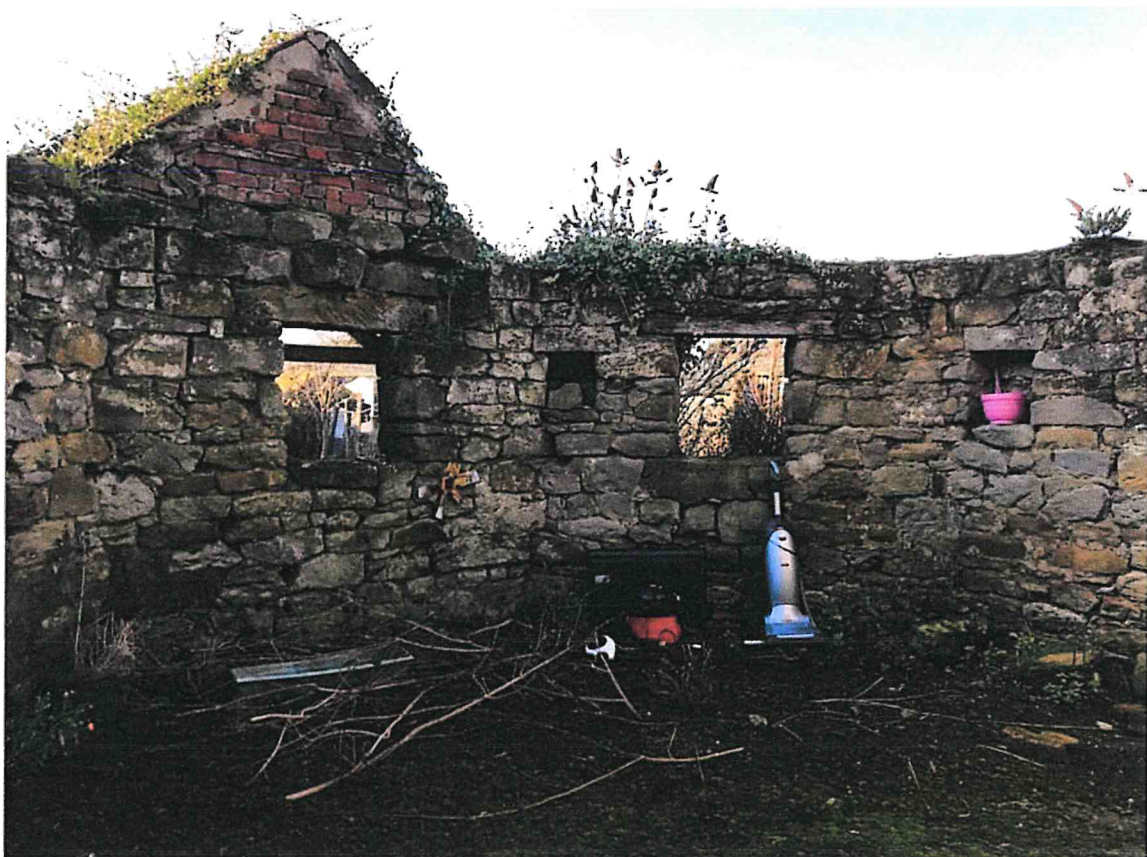
- 3.2.1.3 The central part of the barn measures approximately 7 m (W) x 8 m (L) and has sandstone external walls with no roof and was considered to be in a poor state of repair. This part of the barn is not in use and is empty. The walls and timber lintels above the windows are damp and exposed to the elements (rain and wind). There is an opening (former doorway) on the western elevation of the central part of the barn. Appendix 2: Photo 4.

- 3.2.2.3 The central part of the surveyed barn was considered to hold features of negligible potential to support roosting bats. With no roof on this part of the barn the exposure to the elements made this structure unsuitable for roosting bats.

Photo 4. Internal area of the central part of the barn.

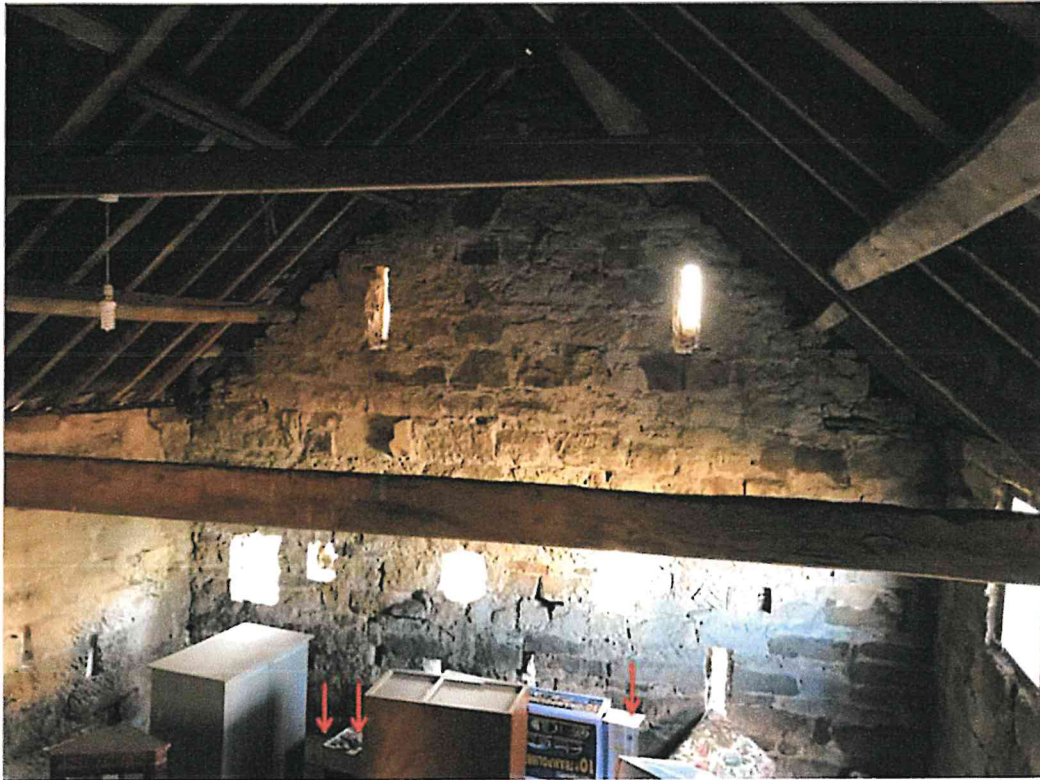
- 3.2.2.1 Evidence (bat droppings) to indicate bat roosting activity was recorded within the barn proposed for conversion; six bat droppings were recorded on stored items close to the southern internal wall on the northern part of the barn; see Photos 5 and 6 in Appendix 2.

- 3.2.2.2 The northern part of the barn was considered to hold features of moderate potential to support roosting bats. Typical roost features include crevices on the external and internal elevations of the barn and under the roof coping stones.

Photo 5. Internal area of the northern part of the surveyed barn. red arrows show locations of bat droppings.

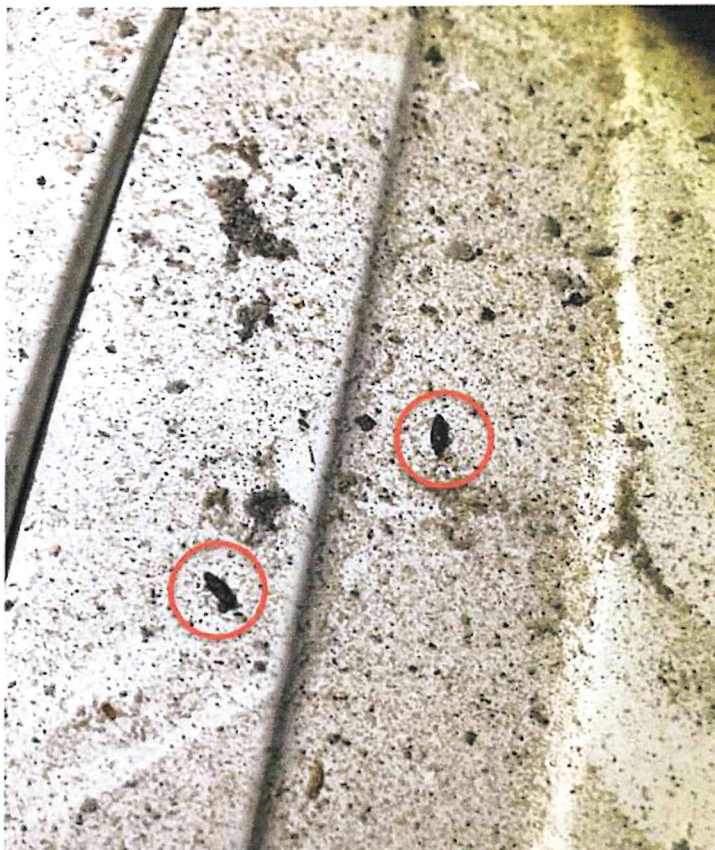
Photo 6. Bat droppings (red circles) recorded on stored items within the northern part of the barn

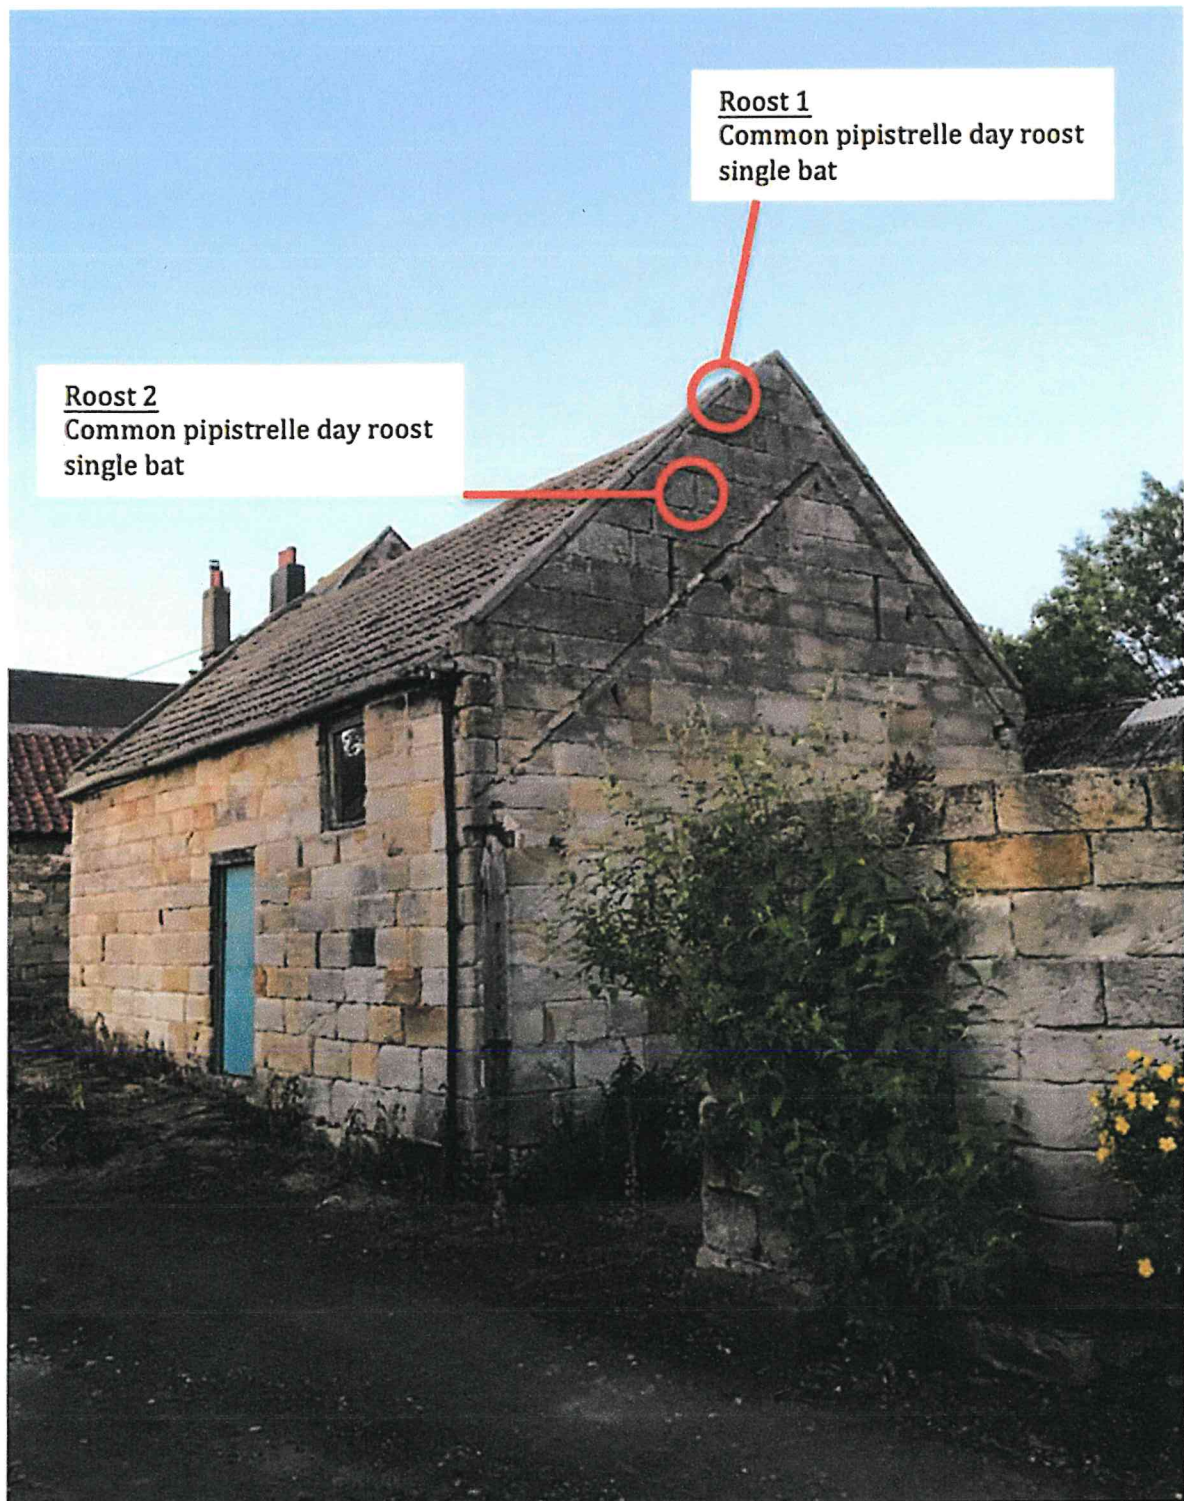
- 4.1.1.6 During the dusk emergence bat survey on 9th June 2020, one common pipistrelle bat was recorded to emerge from a roosting location (Roost 1) on the southern elevation of the barn; the roosting location is shown in Appendix 2; Photo 7, and is a crevice under a coping stone on the southwest elevation of the barn.

- 4.1.1.7 During the dusk emergence bat survey on 29th June 2020, one common pipistrelle bat was recorded to emerge from a roosting location (Roost 2) on the southern elevation of the barn; the roosting location is shown in Appendix 2; Photo 7.

- 4.1.1.8 The survey findings would indicate that the surveyed building contains two common pipistrelle daytime roosts (Roosts 1 and 2) used by low numbers of males or non-breeding females. A maximum of one common pipistrelle bat was recorded to emerge from each roost during the surveys.

Photo 7. Red circles show the two common pipistrelle day roosts recorded during the dusk emergence bat surveys in June 2020.

4.2.1.1 This report concludes that the building proposed for development is used by low numbers of common pipistrelle bats as a summer day roost. One of these roosts (Roost 1) will be impacted (lost) by the development and therefore suitable mitigation and compensation input will be required. It is possible to retain the roost (Roost 2) in the gap between the stones on the southern elevation.

4.2.1.7 The proposal would be to retain the common pipistrelle day roost (Roost 2) in the gap between the stones on the southern elevation; to retain this roost the crevice between the stones where the pointing has failed would be retained and not pointed. The ecologist would confirm the location of the roost access crevice as part of the toolbox talk to ensure it is retained.

- 4.2.1.13 Permanent compensation input would include replicating the existing roosting points that will be lost during development.
- 4.2.1.14 Roost 1: this roost will be lost during developments, therefore to compensate for the loss of the roost under the coping stones the following would be provided. Four small gaps would be created in the new mortar when the coping stones are re-laid. These would be located under the coping stones on the south-west elevation (same location as existing roost). The size and location of the small gaps would be guided by the ecologist to replicate the existing roost access point (the existing gap would be measured prior to removing the coping stone). The gaps would provide access into the hollow area under the coping stones creating an ideal roosting location for common pipistrelle bats.

- 4.2.1.15 Roost 2: based on retaining this roost no compensatory roosting features would be required.
- 4.2.1.16 The positioning of the bat box and permanent compensation features should be guided by an experienced ecologist to increase the chance of occupancy (avoiding overhanging vegetation, artificial light etc).
