DESIGN & ACCESS STATEMENT

Extension and Conversion of
HILLSIDE FARMHOUSE

Arboricultural Survey & Implication Study

Hillside Farm, Littlebeck, Whitby

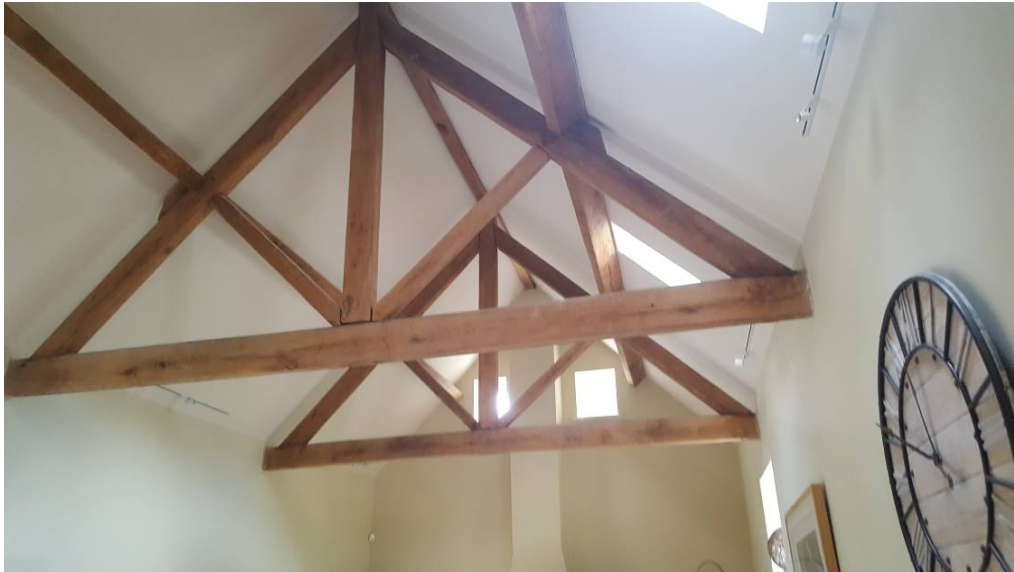
Exposed king post trusses and purlins to Sitting Room

The existing sitting room with the original king post trusses and exposed purlins to the vaulted roof will be retained, although the raised study area will now be incorporated into the adjacent bedroom and the access stair removed.

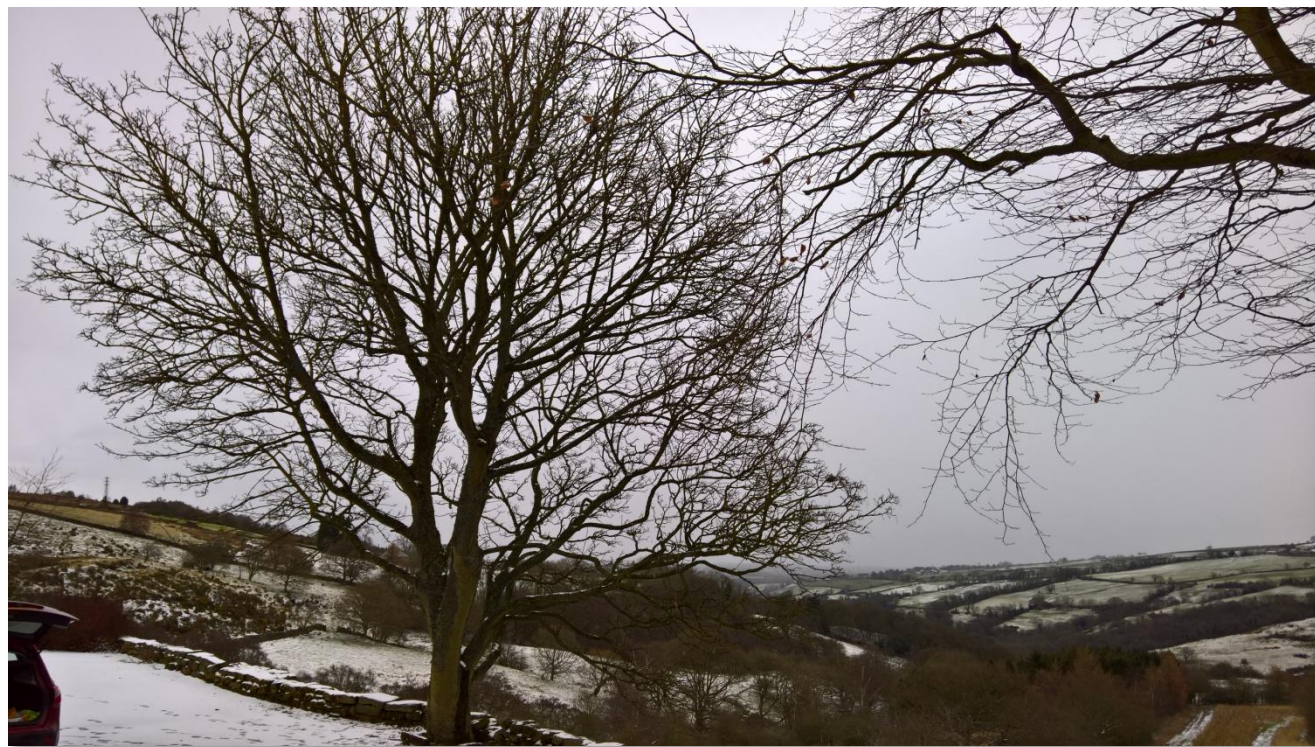
T1 Sycamore

A maturing fairly symmetrical tree in good condition somewhat stunted by its exposed location. Growing at the south eastern end of the forecourt almost adjacent to the low dry- stone wall.

The root protection areas of T1 T2 and T5 are totally under compacted stoned surfacing therefore to allow access to carry out the development it will only be necessary to fence off individual trees along the outer edge of crown spreads to ensure that the upper parts of the trees are not damaged by construction traffic. The alignment of protective fencing is annotated on the Tree Survey Plan at

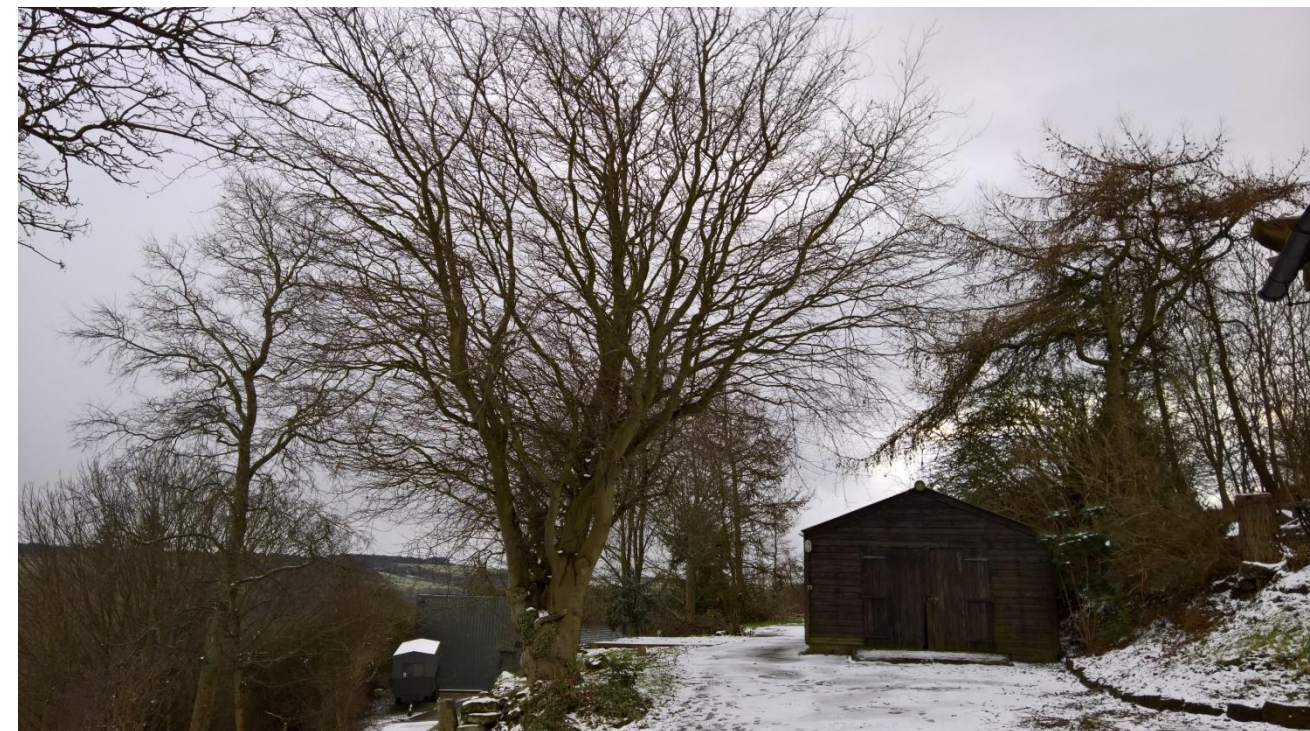
T2 Copper Beech

A maturing tree in fair condition having a multi-stemmed congested crown emerging from a short main trunk. Evidence of the removal of three main boughs several years ago where large wounds have partially healed. Growing on the edge of the elevated area adjacent to the access to the farm. May be the remnant of a former hedge on the site.

Piping for the new heating system from the converted shed to the south west of this tree could potentially run through the outer edge of the RPA for this tree.

Ensure that the alignment of the piping runs outside of the limit of the RPA.

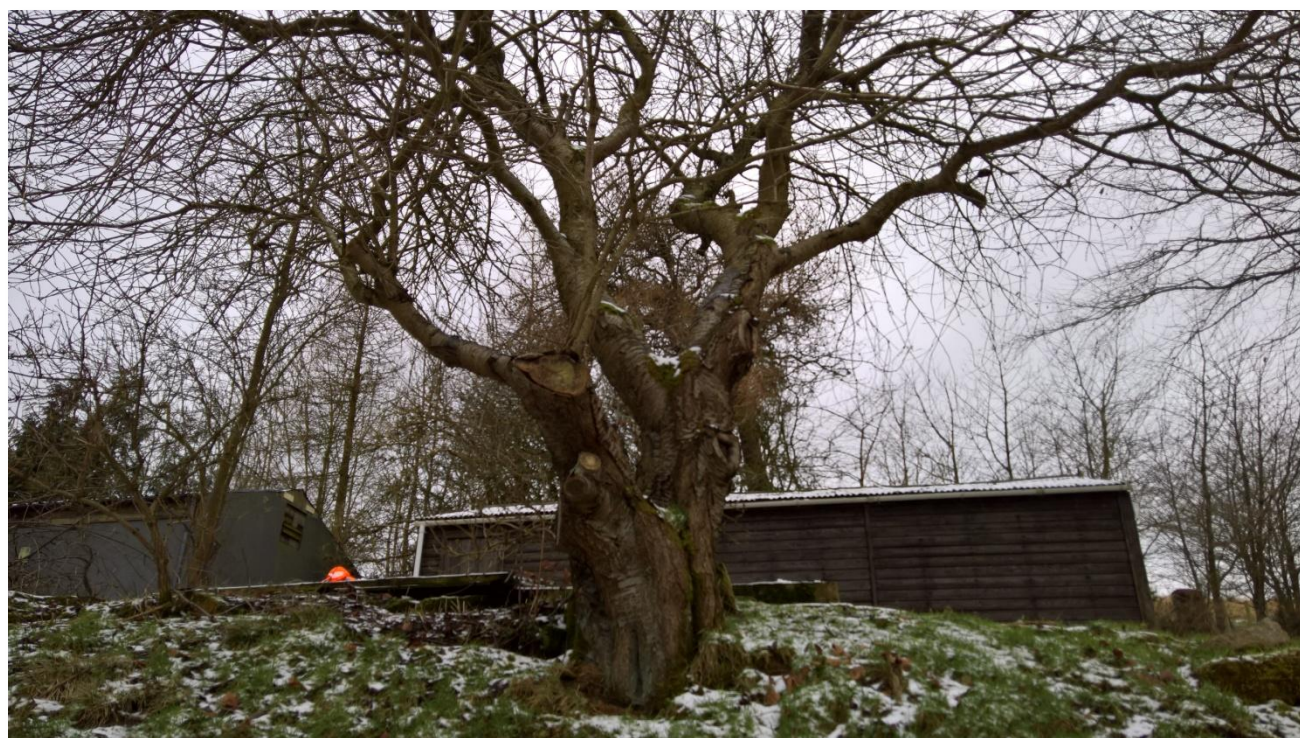
T3 Cherry

An over-mature tree in only fair structural condition growing on sloping land and to the south east of T2. The tree is formed by two main co-joined trunks. This tree has been heavily pruned in the past severing large limbs resulting in large scars where decay has set in.

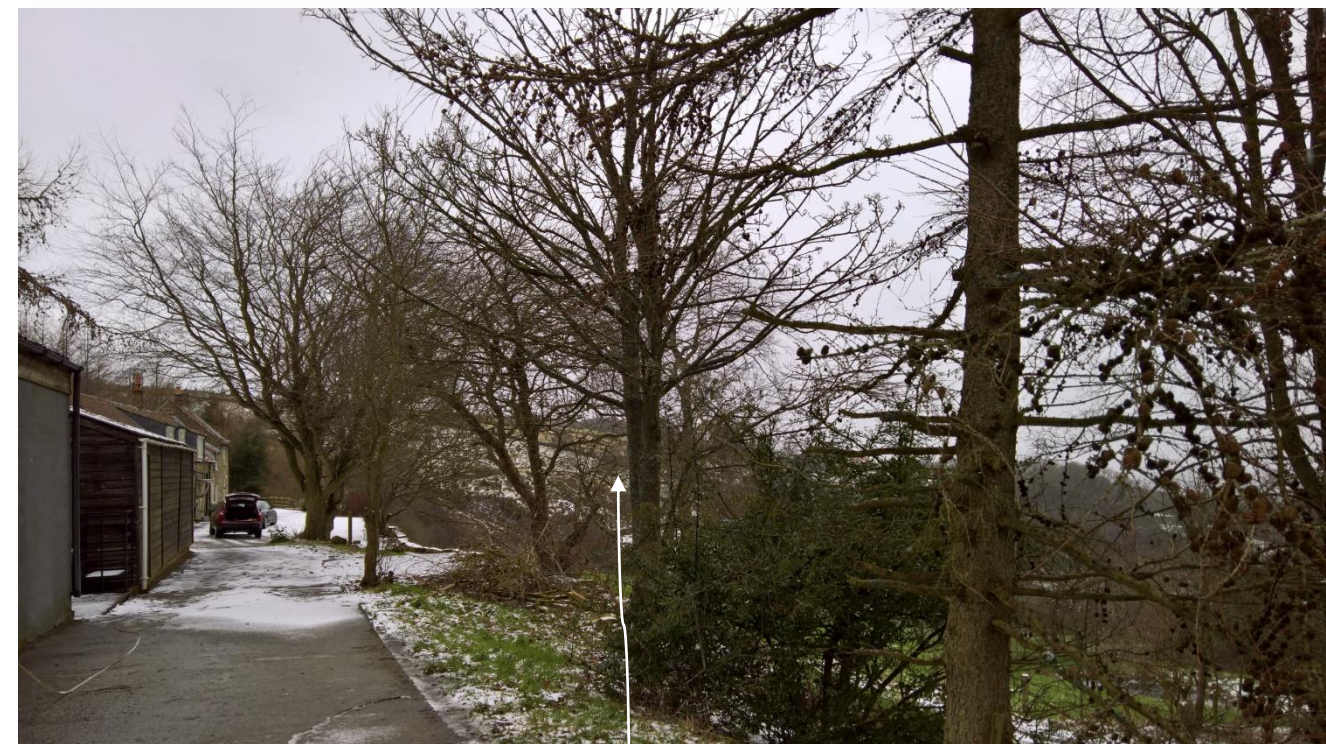
T4 Sycamore

A medium sized semi-mature tree growing along the same alignment and to the south east of T3 and formed by two co-dominant stems. A narrow crown in good condition.

T4 will only be required to be fenced along the alignment of grassed area as its RPA is within the grassed area it is growing in. The proposed alignment for protective fencing is annotated on the survey plan at Appendix 3

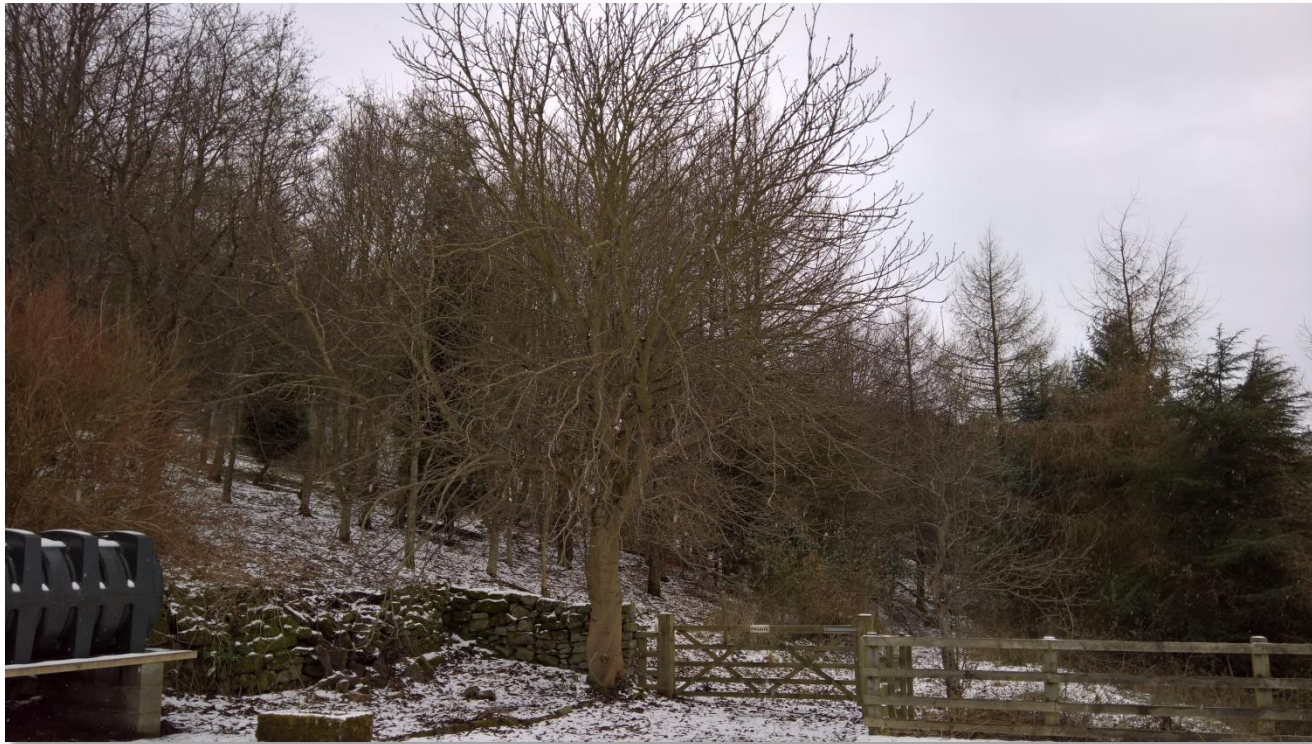
T5 Horse Chestnut and plantation beyond

A semi - mature tree growing at the north western end of the site. Congested crown but in a healthy condition. Some cracking of the bark at the base of the crown possibly due to twisting under wind stresses.

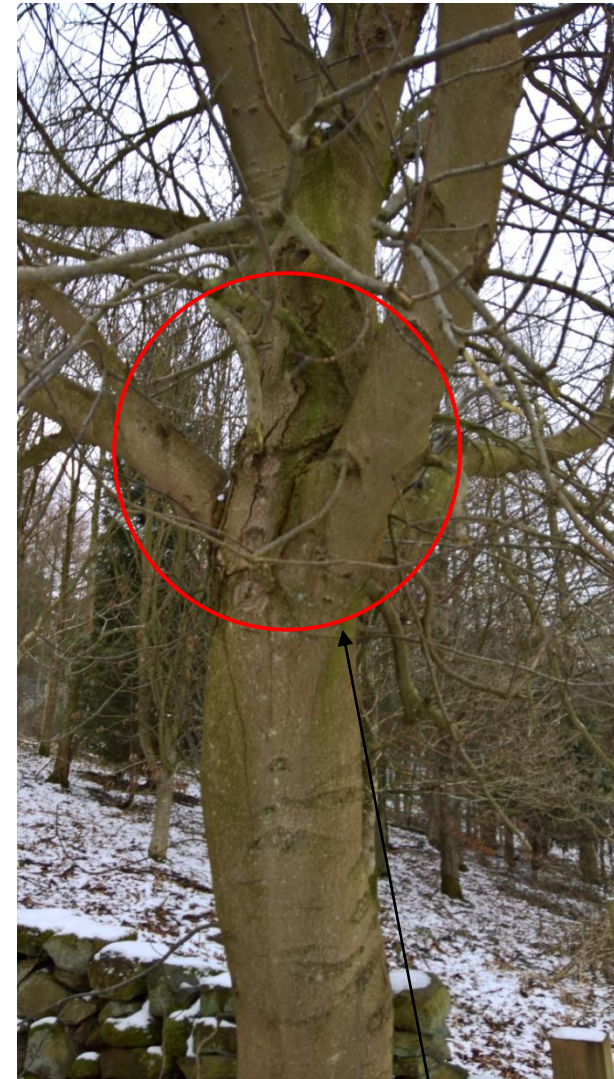
Minor cracking in bark at base of crown
