# Design and Access Statement

for proposed works at:  
Home Farm,  
Dunsley,  
Whitby,  
North Yorkshire,  
YO21 3TL

client:  
Mr & Mrs Hodgson

May 2020

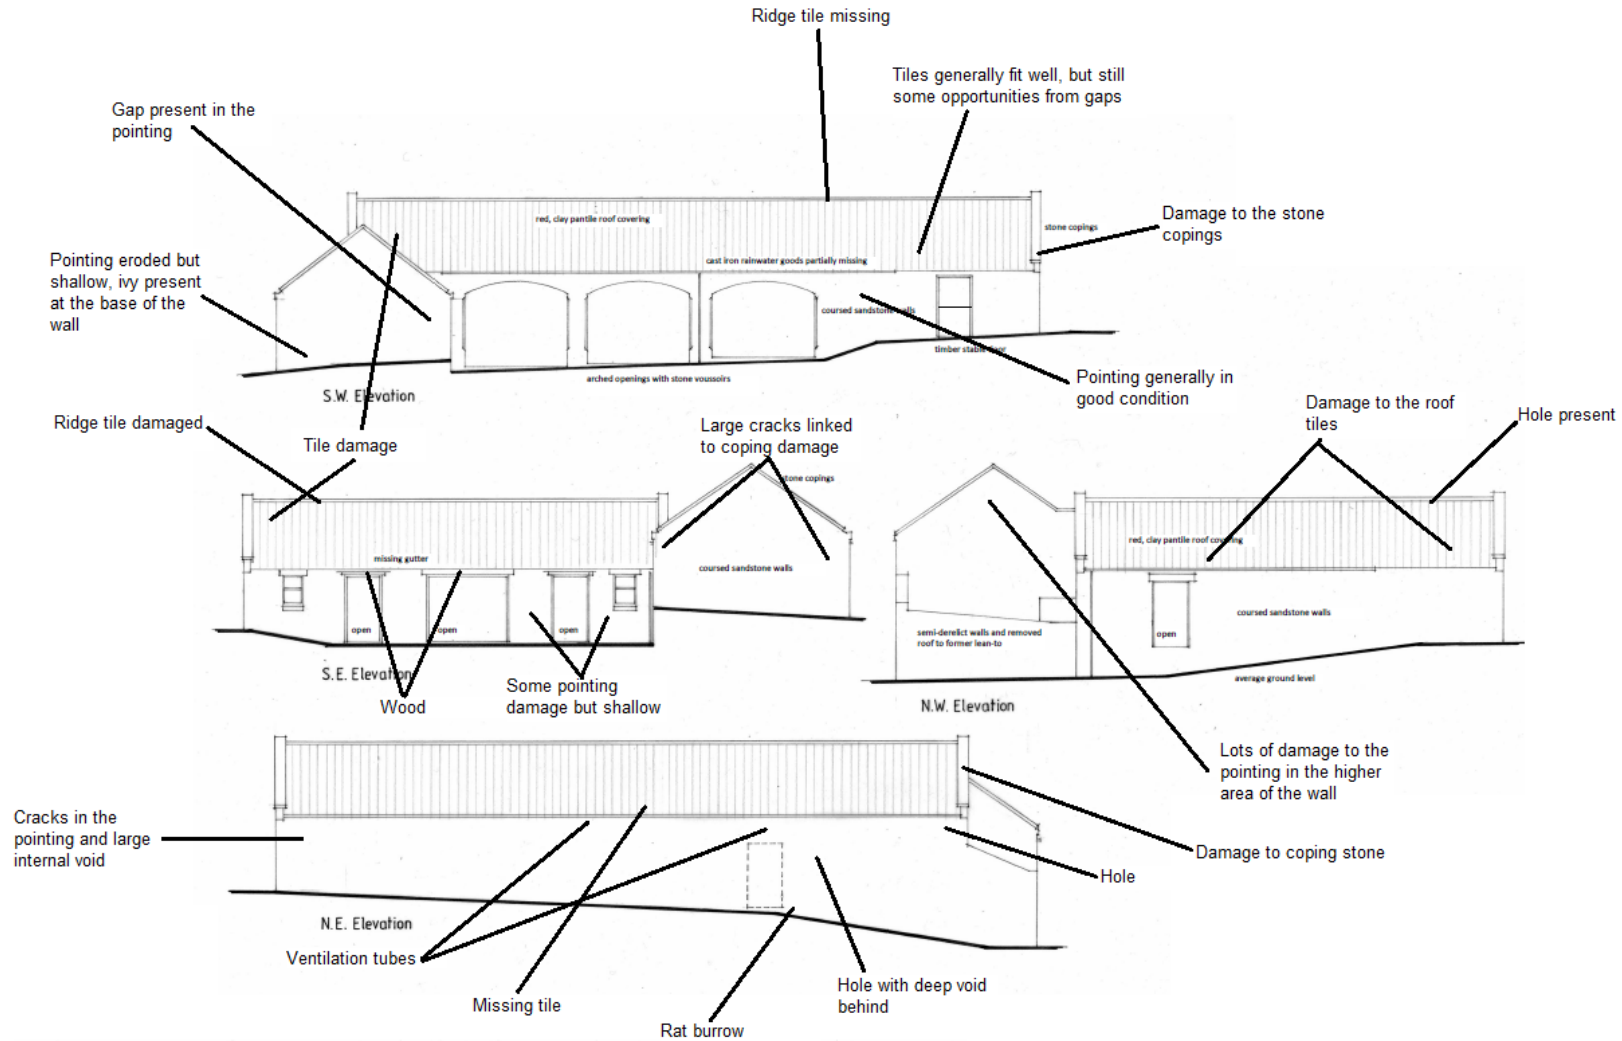
Diagram 4 showing the results of the survey for the external of the building

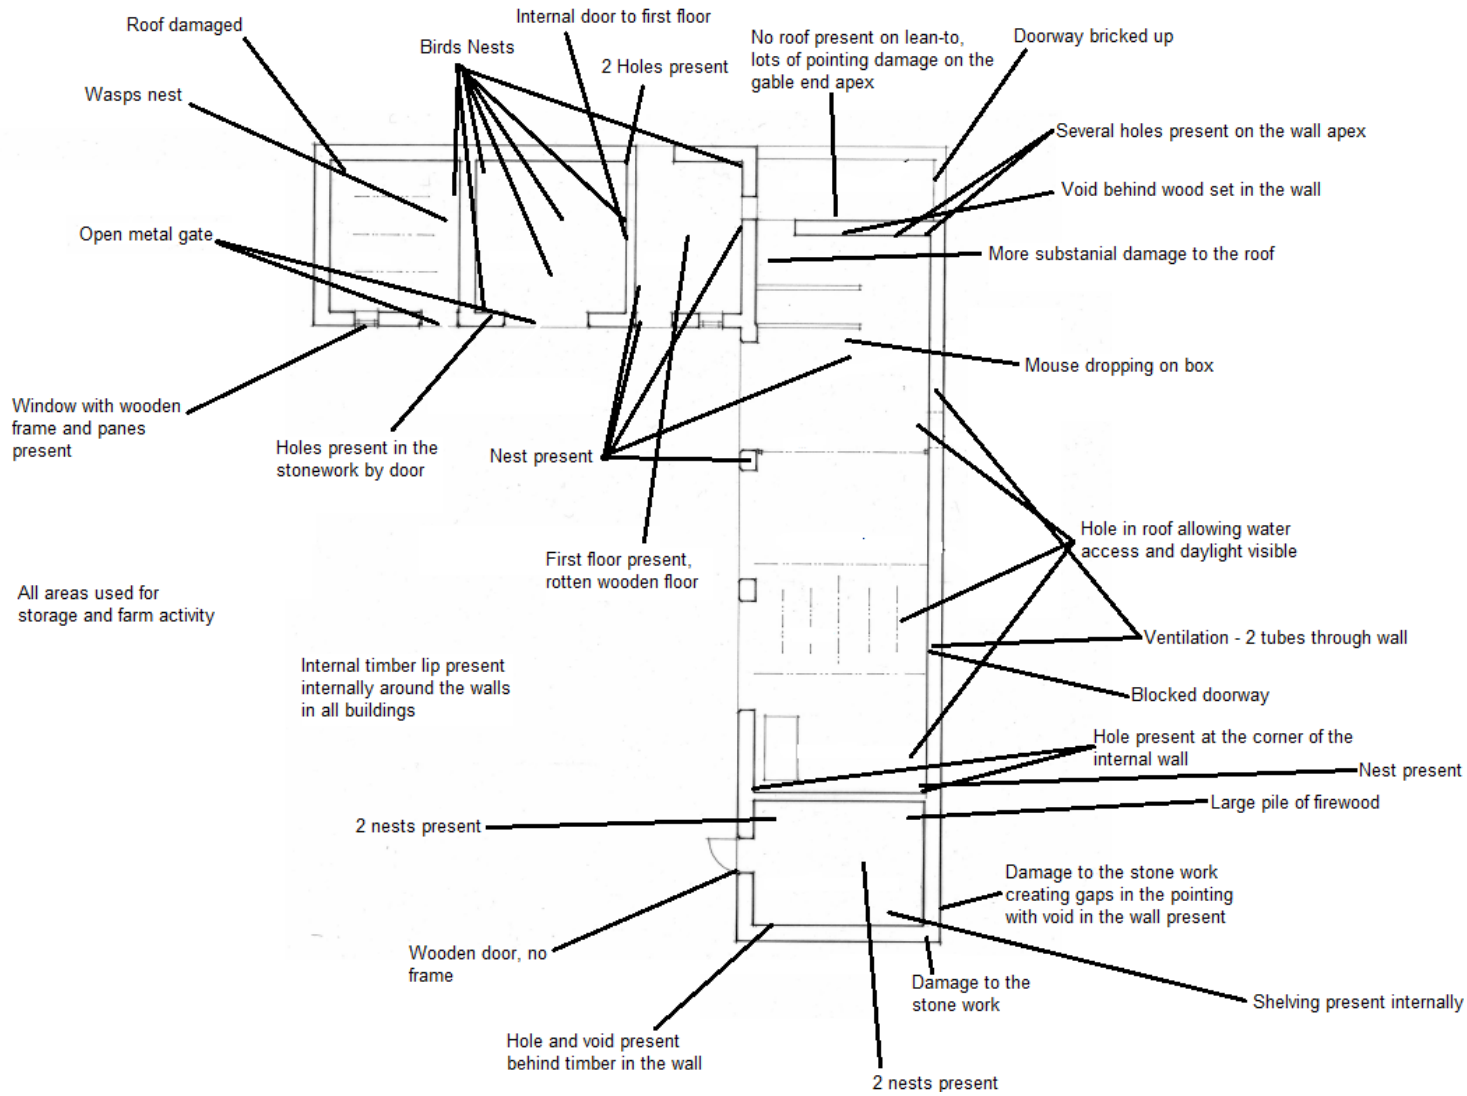
Diagram 5 showing the results of the survey for the internal of the building

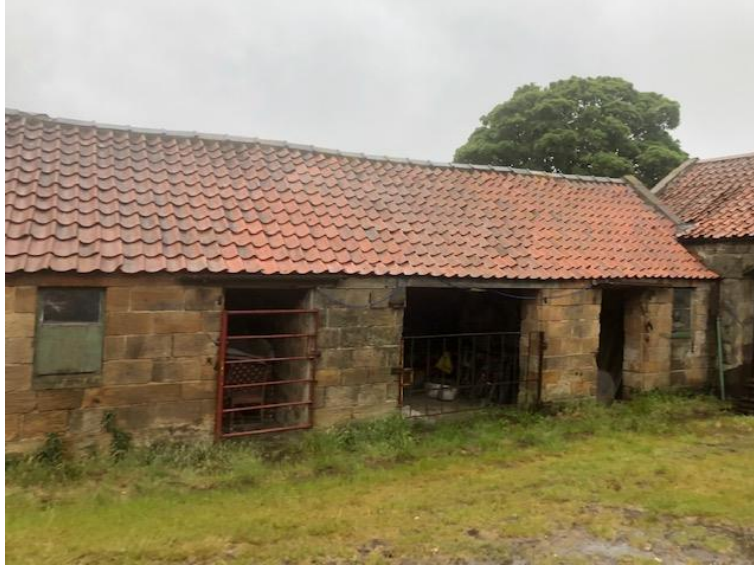
Photograph 1. Showing the external view of the south eastern elevation, including the metal gates, windows present and the damaged roof tiles on the adjoining elevation (on the far right of the picture).

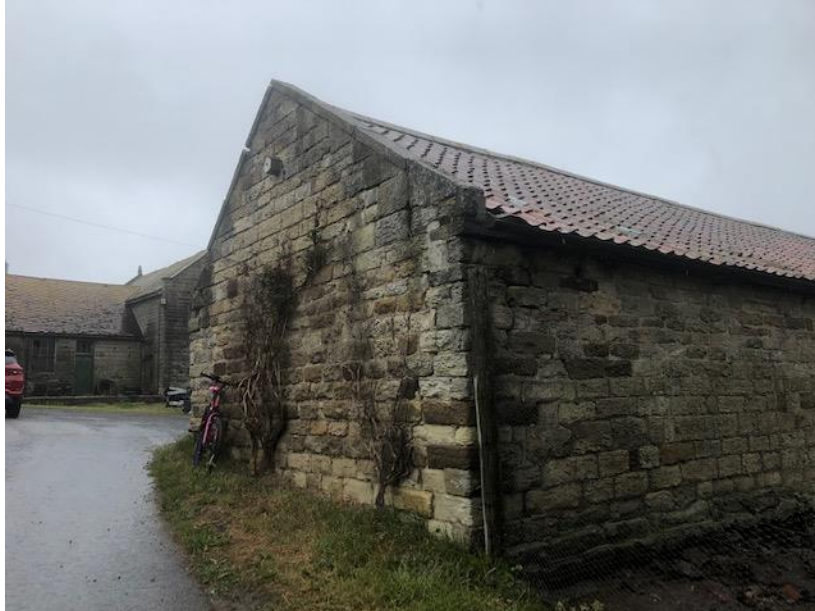
Photograph 4. Showing the external view of the south eastern elevation adjacent to the entrance road, with damage to both sides and coping stones

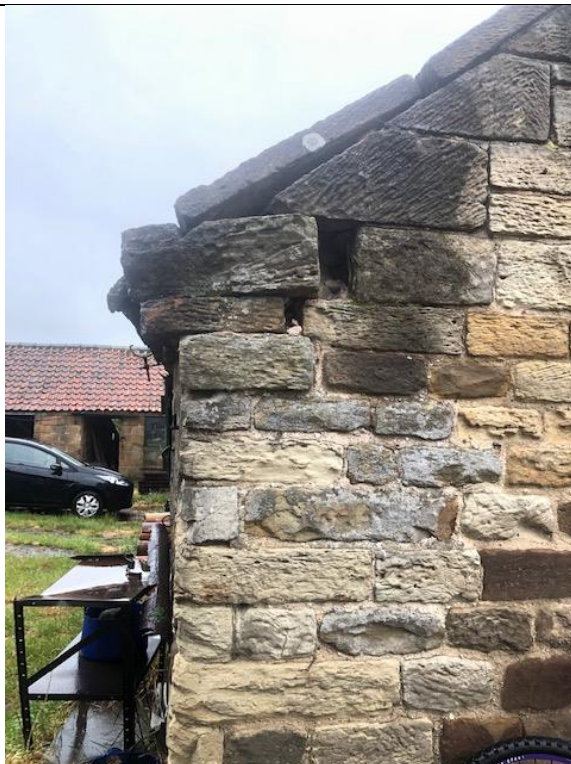
Photograph 5. Showing the coping damage on the south eastern elevation, left hand side.

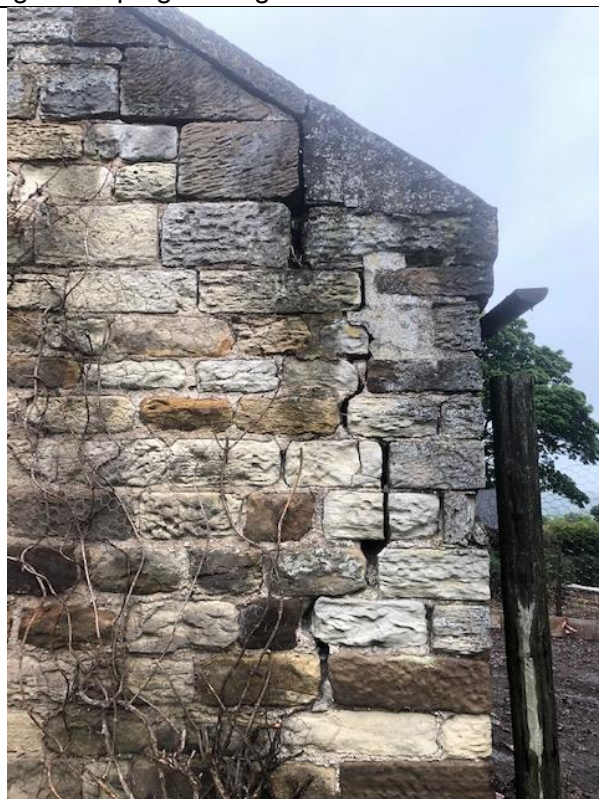
Photograph 6. Showing the coping damage on the south eastern elevation, right hand side with the large running split in the pointing and stone work.

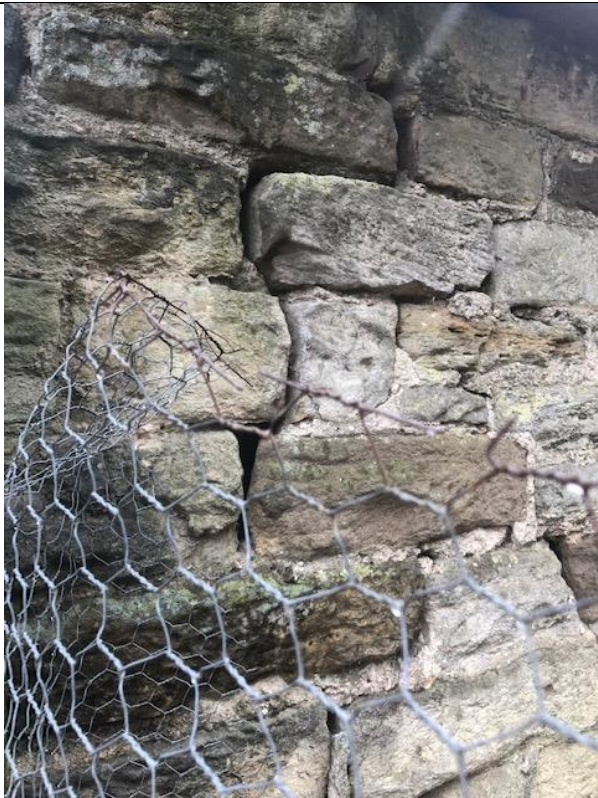
Photograph 7. Showing the damage on the other corner and north eastern elevation, leading into a large void behind.

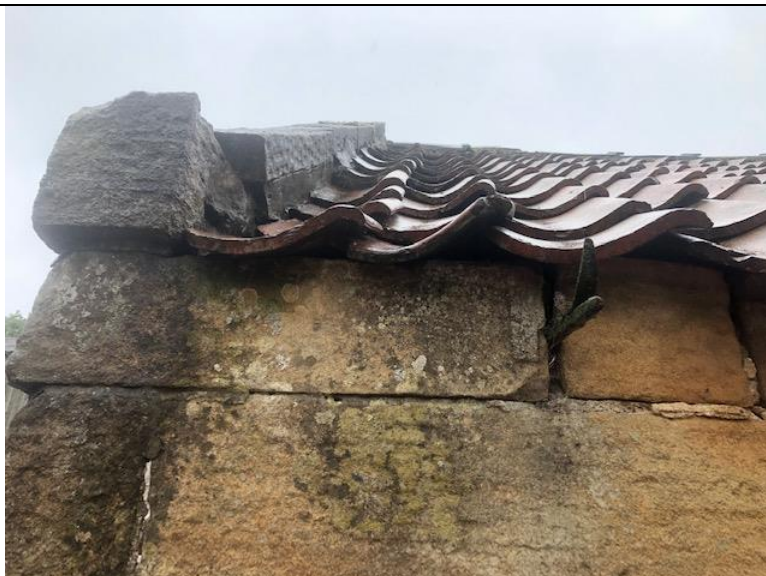
Photograph 9. Showing the tiles on the north eastern elevation with gaps under the tiles present.

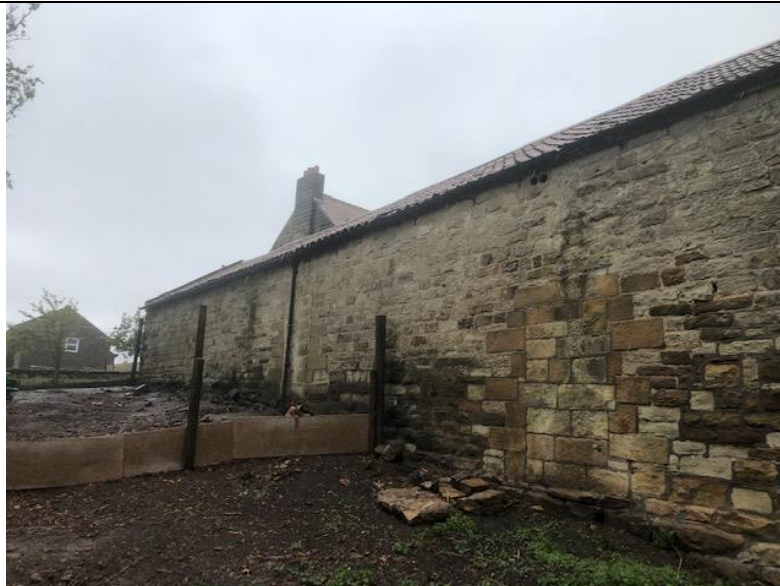
Photograph 10. Showing the other side of the north eastern elevation with the blocked up door and the hole with the deep void visible centre right edge of the picture.

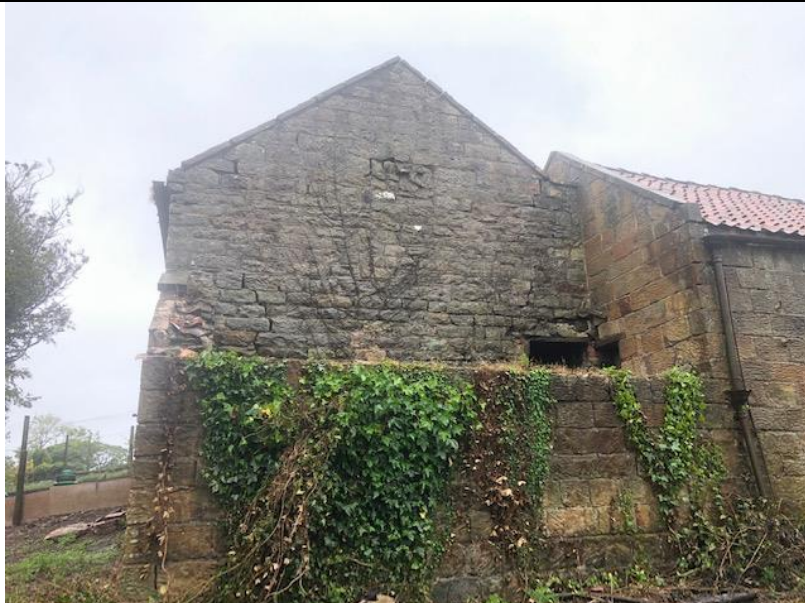
Photograph 11. Showing the north western elevation with the lean too that has been partly demolished. Note the damage to the stone work and pointing at high levels.

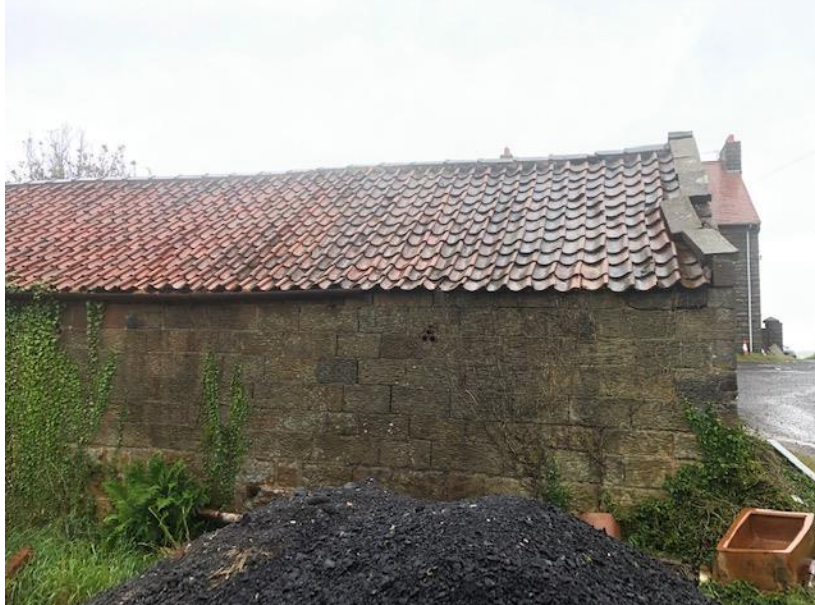
Photograph 13. Showing the end of the north western elevation with damage to the coping stones and roof tiles to the right of the picture.

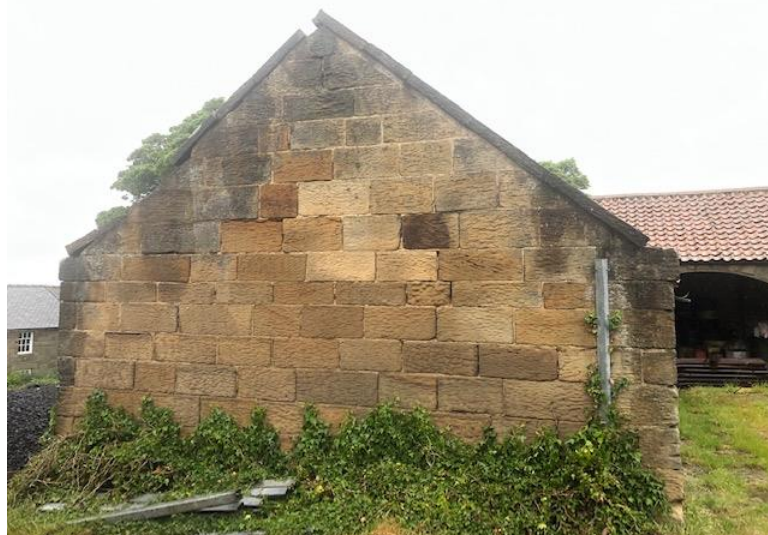
Photograph 14. Showing the gable end of the south western elevation with other side of the damage to the coping stones with shallow erosion to the stone work and ivy creeping up (possibly cut back at an earlier point in time).

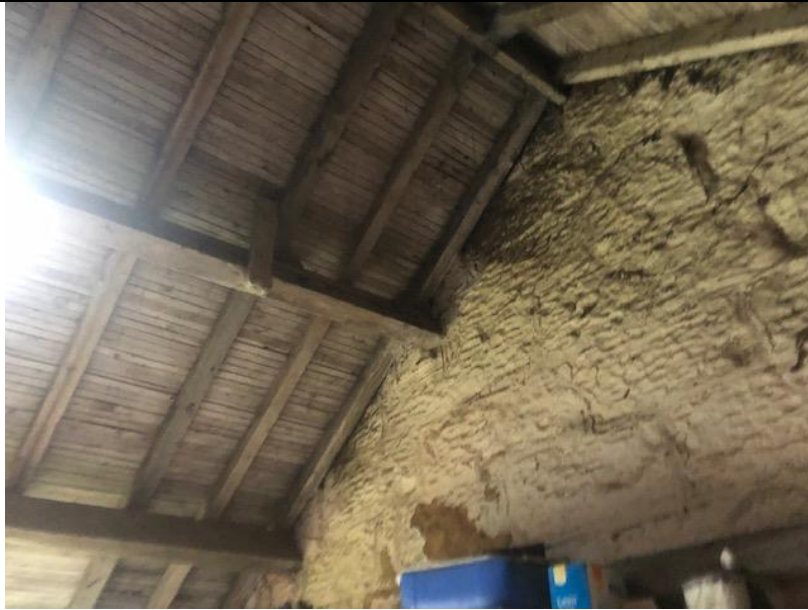
Photograph 17. Showing the roof inside the former stable with the white washed walls, timber framework and backing to the tiles.

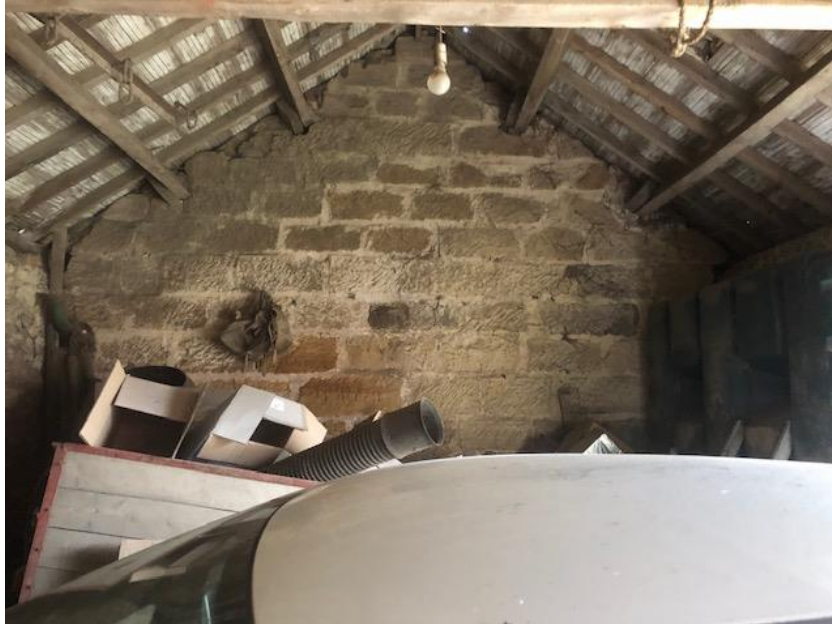
Photograph 18. Showing the gable end of the storage area (which joins to the stables) with the timber framework and wooden backing to the tiles. Gaps present where the timbers join the wall and in each corner of the bottom of the apex.

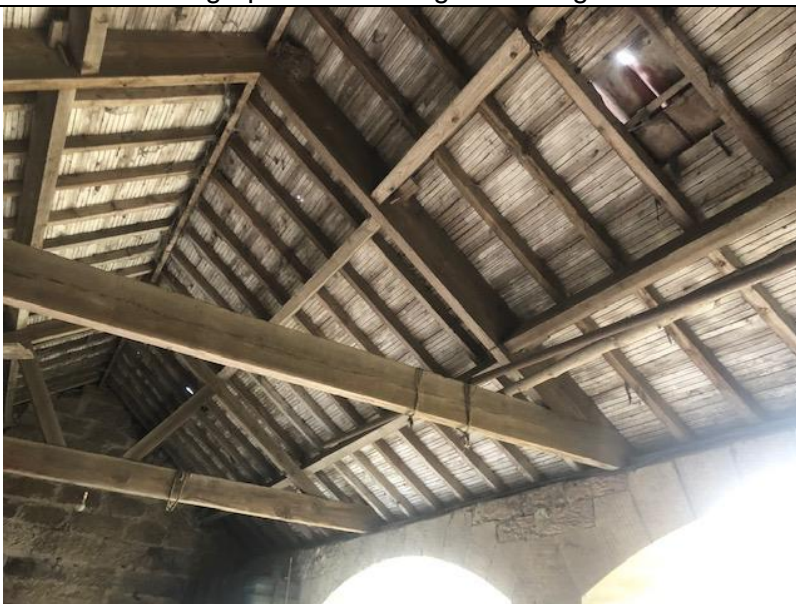
Photograph 20. Showing a view of the timber framework and tile backing of the storage area.  
Some daylight visible through the roof indicating the damage present

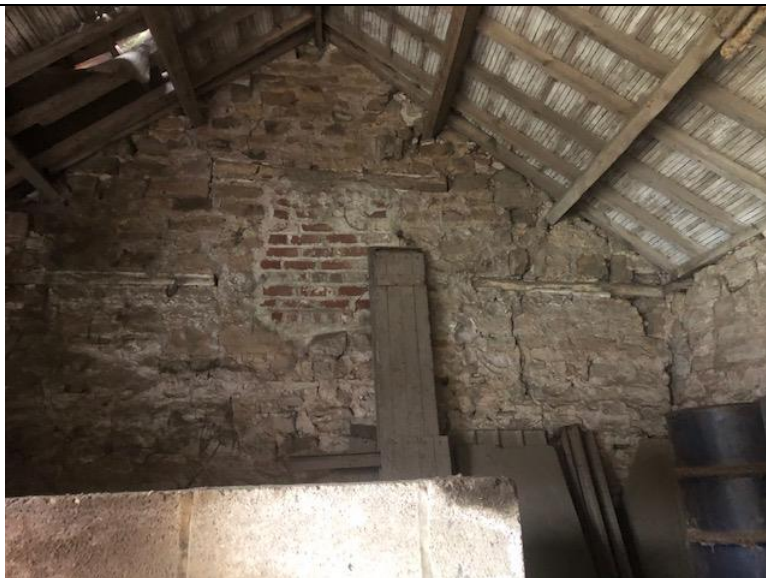
Photograph 21. Showing the gable wall at the other end of the storage area with some holes with bat potential to the left of the bricked up wall.

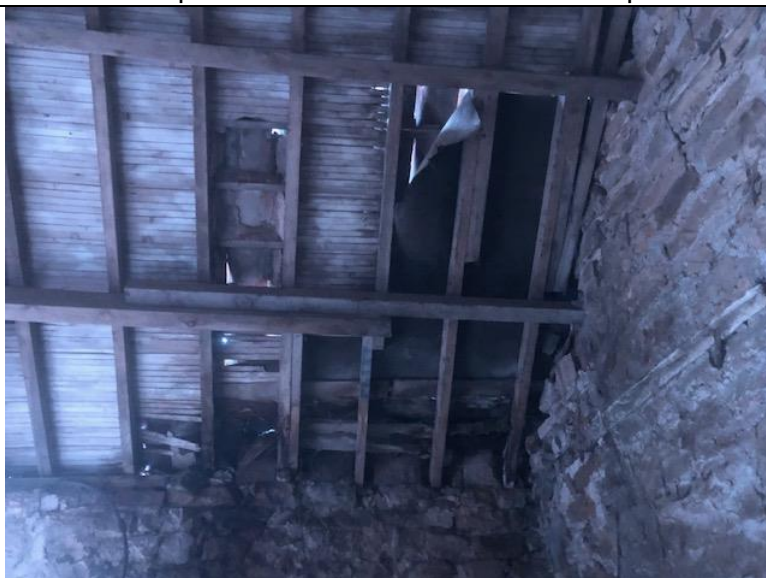
Photograph 22. Showing the roof damage at the gable wall and some more detail of the roof structure (felt present).

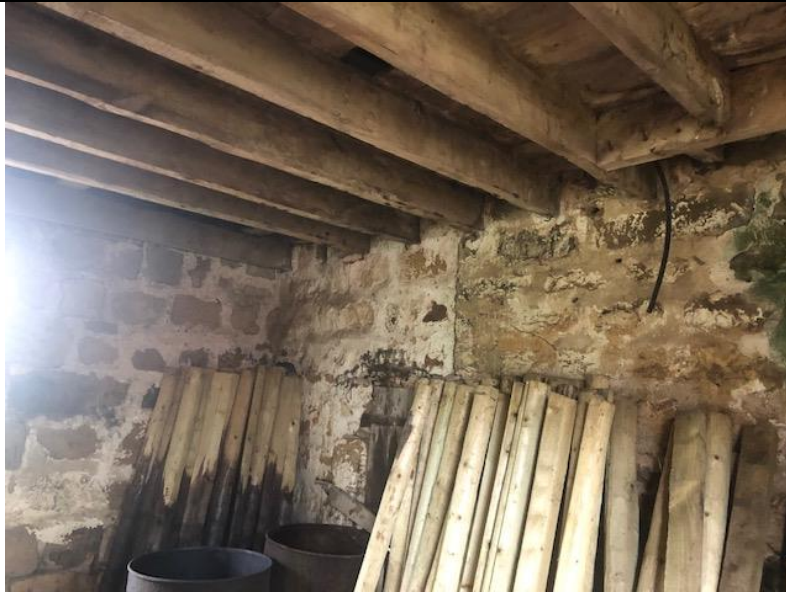
Photograph 23. Showing the small room used to store fencing materials, with a timber ceiling leading to the floor above.

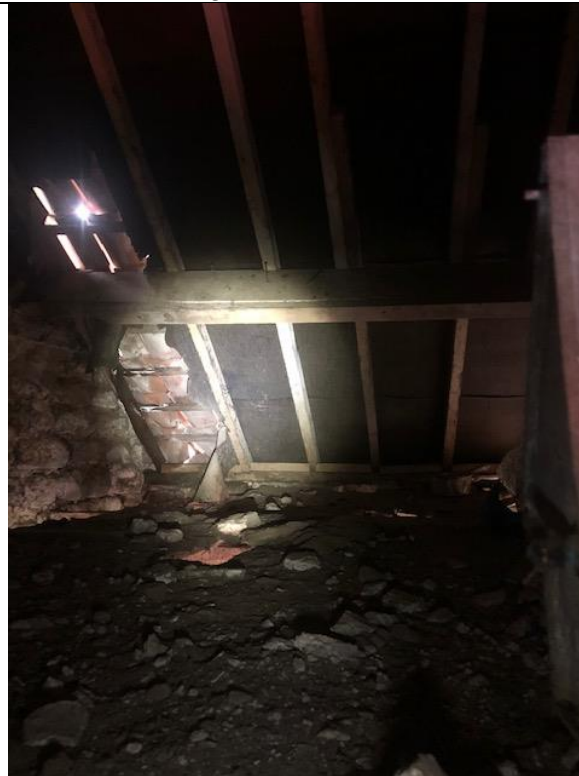
Photograph 24. Showing the first floor room with lots of debris and damage to the roof (daylight visible). Floor boards are rotten, door access from the adjacent room.

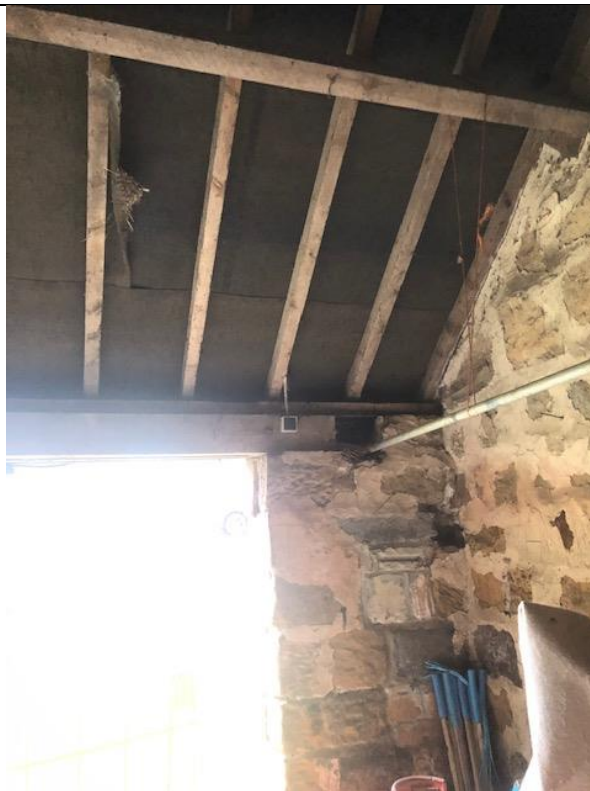
Photograph 25. Showing the felted roof and timber framework of the middle store room.

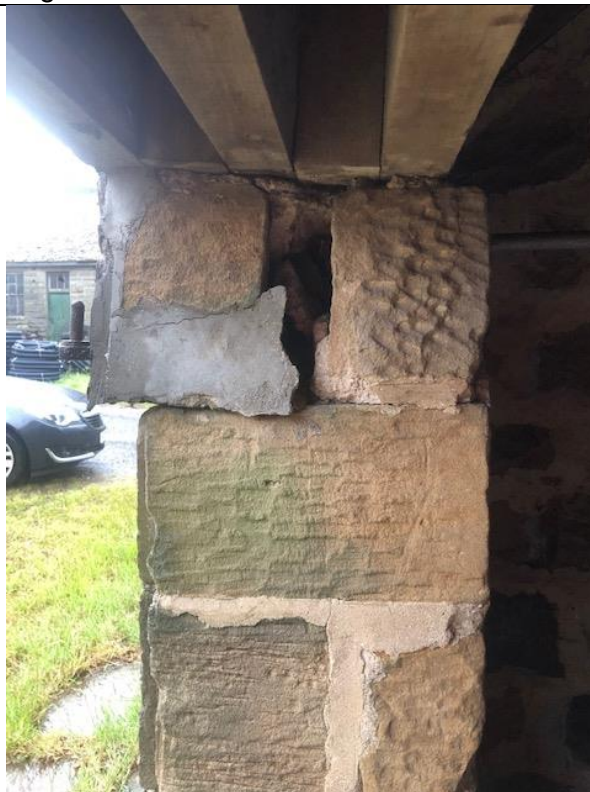
Photograph 26. Showing the gap present in the doorway below the wooden lintel.

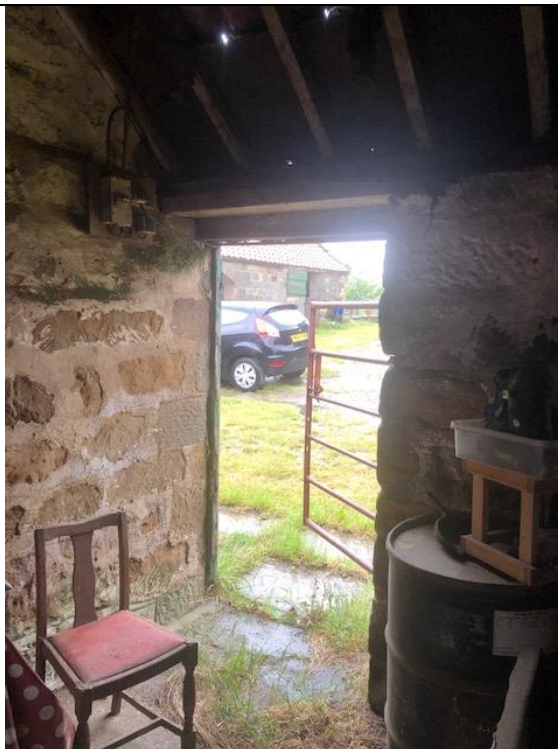
Photograph 27. Showing the doorway of the storage room/ office, with the gap in the corner of the wooden lintel and damage to the roof.

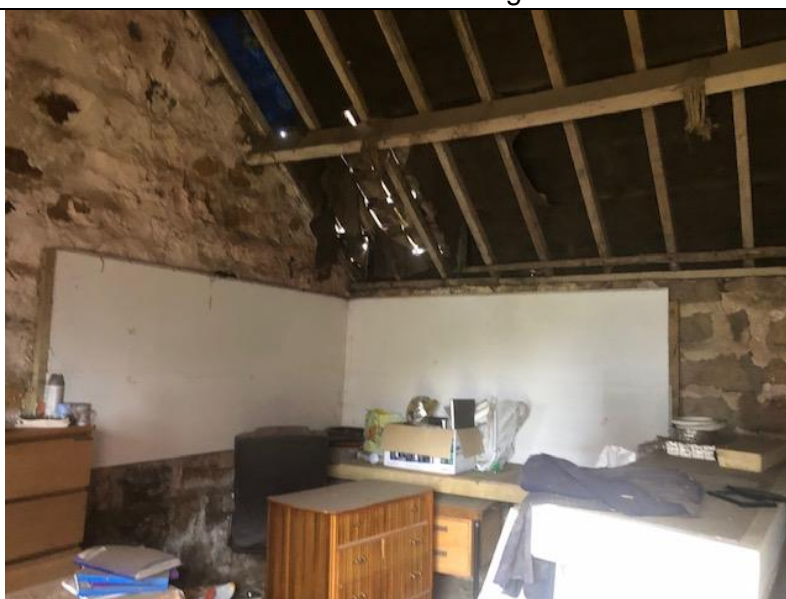
Photograph 28. Showing the storage room/ office with roof damage. Materials in this room provided excellent surfaces to detect droppings, but none were found

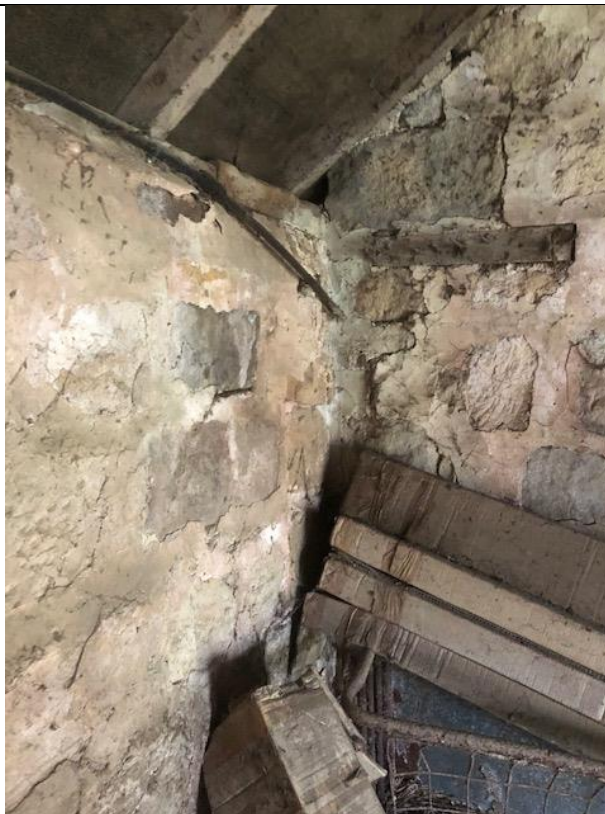
Photograph 29. Showing the voids in the corner of the room.

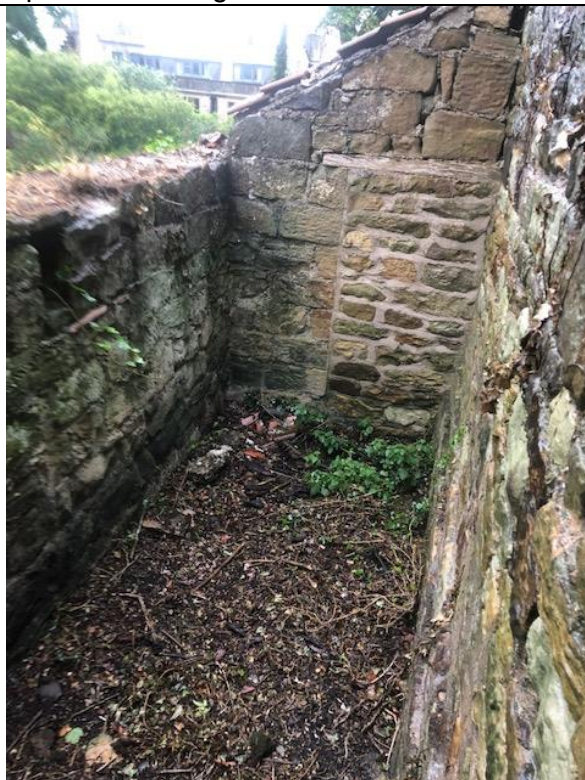
Photograph 30. Showing the internal view of the lean too with no roof

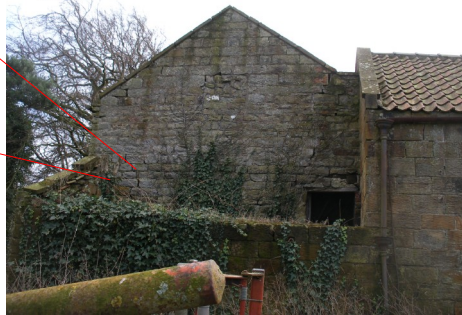
**Photograph A**  
north-east gable to eastern leg.

subsidence cracks

remains of tree

The tree was removed several years ago, except for the base of the trunk which is now dead and can be safely removed. Any further movement is not anticipated. Repairs and re-pointing can be successfully carried out in this area.

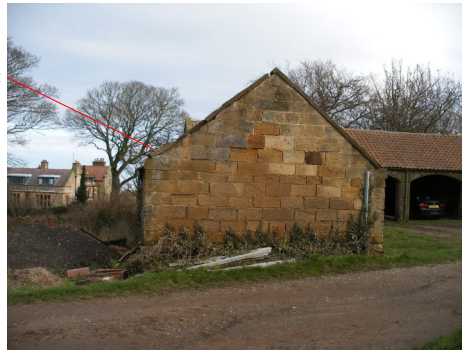
**Photograph B**  
impact damage

loose stones and coping

The north-west corner of the northern leg shows displacement of the stone coping and top section of wall where low impact from a vehicle has occurred. This can be successfully repaired.

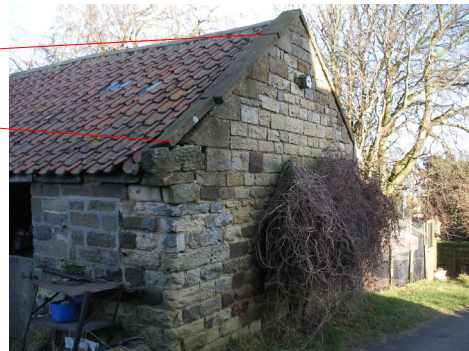
**Photograph C**  
loose copings and impact damage

Photograph C in Appendix 1 illustrates loose copings to the southern wall of the eastern leg with the bottom coping having been pushed off by vehicle impact.

loose copings

impact damage

There is a general loosening of the stone copings in several places as a result of general wear and tear but the coping stones themselves are intact and can be successfully taken off and re-bedded incorporating new leadwork.

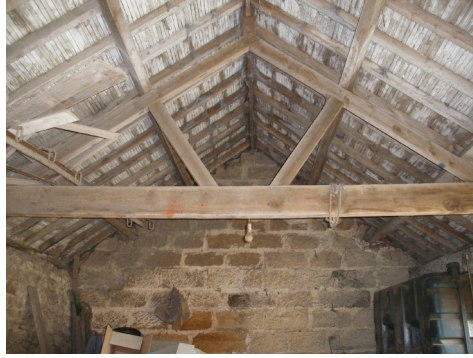
**Photograph D**  
roof truss and purlins arrangement

Internally, the roof timbers are exposed and appear to be generally in good condition. Joints in the trusses are good showing no indication of spread or deflection. Inspection from floor level did not reveal widespread insect infestation but most of the timbers are covered in dust and dirt and require cleaning prior to further, closer inspection. In any case it recommended that all timbers be cleaned, exposed and treated with preservative prior to the insulation and roof build up taking place.
