From: Graham Forster
Sent: 29 July 2020 17:11
To: Hilary Saunders
Cc: Planning; 'Gill Forster'
Subject: NYM/2019/0628/FL - Land to rear of Brookfield, Maltongate, Thornton Dale

THE PINFOLD MALTONGATE THORNTON DALE

REPORT ON THE PINFOLD BROOKFIELD THORNTON DALE YO18 7SD

THE PINFOLD BROOKFIELD THORNTON DALE YO18 7SD

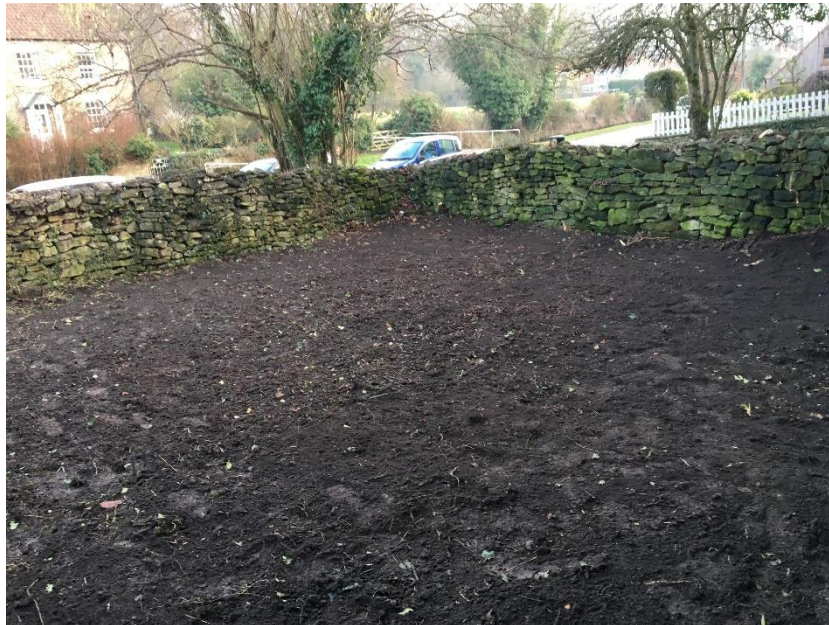
The Pinfold Immediately following clearance (Photograph by Contractor)

Note the hazel Tree (subsequently removed) to the left of the corner.

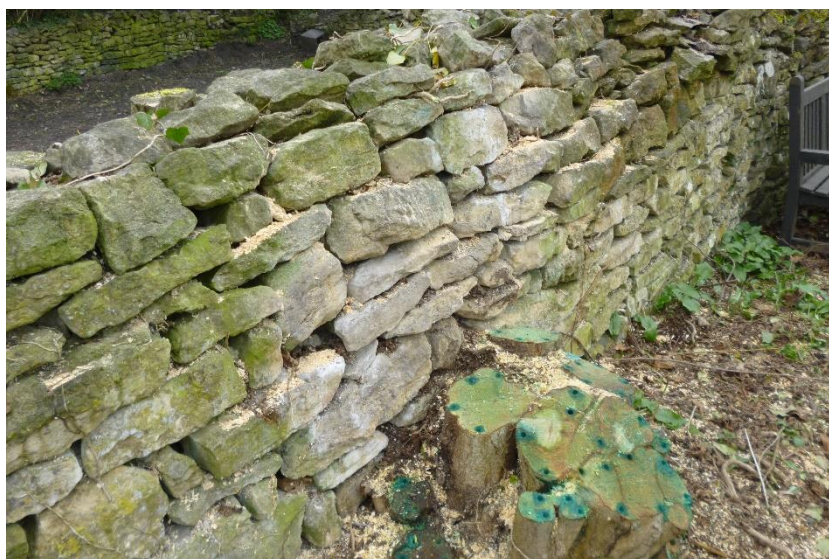
On 23rd March 2017 the hazel tree was removed leaving the base of the trunk and the root, removal of which would have caused the wall to collapse. The remains were treated to prevent further growth.

The treated stump of the Hazel Tree immediately following removal (Photograph by Contractor)

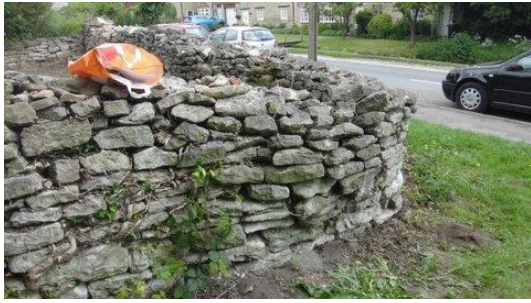
Photograph 1. Position A (External Wall)

- A & F The south-east corner shown in Photographs 1,2 ,11 and 12 where bulging of the wall over a length of approximately 4.0 metres has taken place over many years. This is due in part to the hazel tree (photograph 11) which was removed by NYMNP. As part of the proposed works, the stump and roots should be removed.

- c) All limestone rubble brought to site to match existing and be approved by NYMNPA.
- d) Use large flat coping stones to finish pinfold wall tops.
- e) Take down and rebuild using the recovered stone all of the areas identified above. Remove tree root stump.

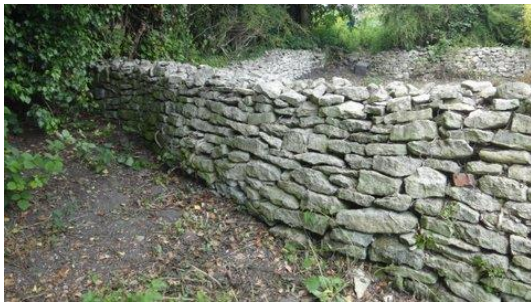
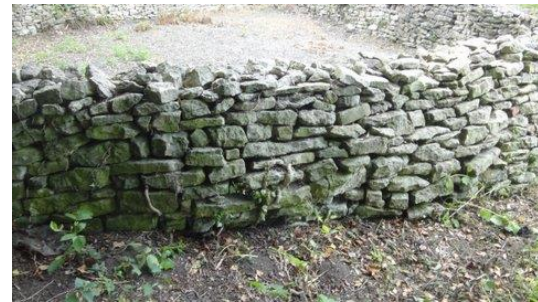
Photograph 3. Position B (External Wall)

- B The southern wall shown in Photographs 3 and 4 where bulging of the wall over a length of approximately 3.2 metres has taken place over many years.

Photograph 4. Position B (External Wall)

- f) Using the wall height along the eastern (front) boundary to level off the top of the eastern and southern walls forming the Pinfold at approximately 1.450 metres above external ground level.

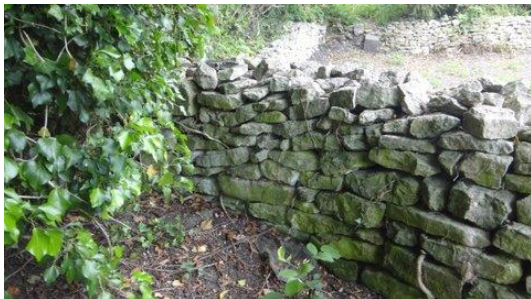
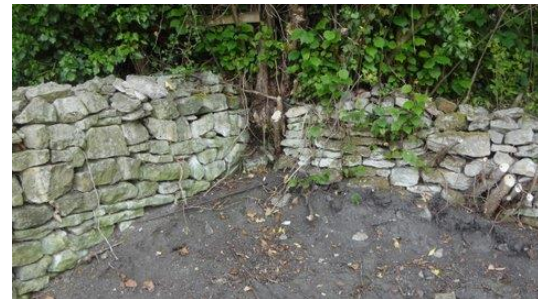
Photograph 5. Position C (External Rebuilt Wall – Former Gate Position)

There is no definitive evidence of the position of an entrance gate which must have existed at one time in the past. Mrs Forster has a clear recollection of there being in the mid 1970's an opening in the southern wall which was blocked up by boarding. She believes that a wall was built to completely block the entrance at about this time. There is evidence of part of the southern wall approximately 7.2 metres back from the line of the eastern (front) wall having been rebuilt and it is reasonable to assume that this is the position of the original entrance.

Photograph 6. Position C (Internal Rebuilt Wall – Former Gate Position)

- k) A gate opening to be constructed in position "c" shown on the plan. New 3ft tantalised softwood picket gate with a pair of substantial tantalised softwood gateposts to be of a style and size to be agreed with NYMNPA.

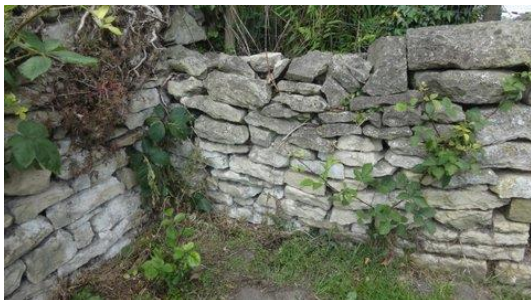
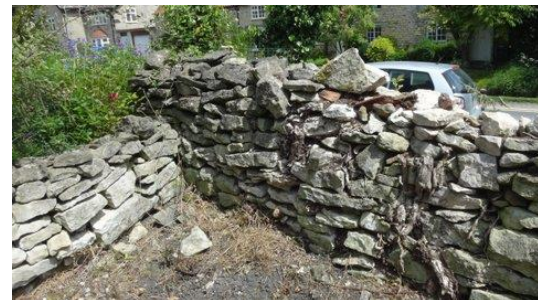
Photograph 7. Position D (External Wall)

- D The eastern wall shown in Photographs 7 and 8 where bulging of the wall over a length of approximately 2.9 metres has taken place over many years. Photograph 8 clearly shows the difference in wall heights between the eastern and northern walls which should be addressed as part of the restoration.

Photograph 8. Position D (Internal Wall)

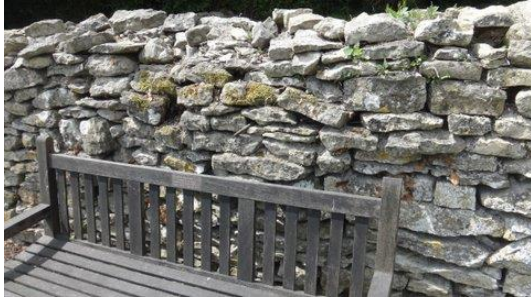
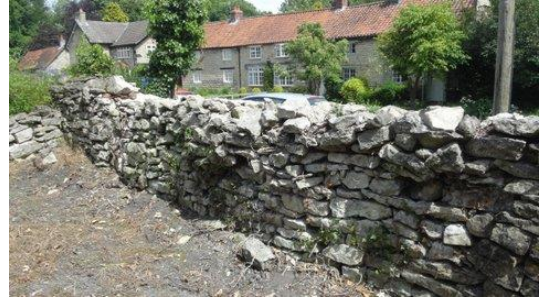
Photograph 9. Position E (External Wall)

- E The eastern wall behind the seat shown in Photographs 9 and 10 where bulging of the wall over a length of approximately 1.7 metres has taken place over many years.

Photograph 10. Position E (Internal Wall)

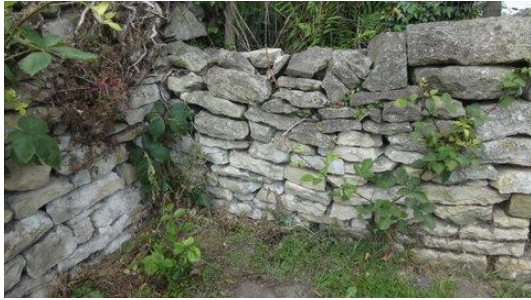
Photograph 13. Position G (External Wall)

- G The southern garden wall to Brookfield shown in Photograph 13 where deterioration of the wall over a length of approximately 1.95 metres has taken place over many years.

- h) The straight joint in the north wall to be retained.
- i) Those walls on Maltongate fronting the garden to Brookfield to be rebuilt to the current heights. Stone to be bedded in lime mortar with deep recessed joints. All existing coping stones to be removed, numbered, recorded and re-bedded in their existing positions using lime mortar.

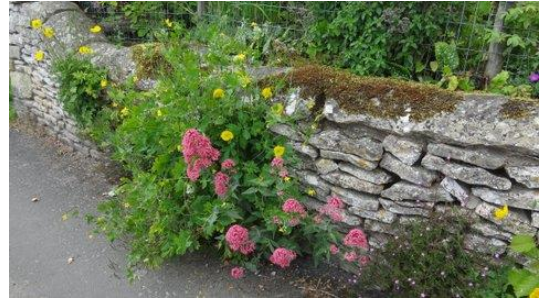
Photograph 14. Position H (External Wall)

- H The eastern garden wall (fronting Maltongate) to Brookfield shown in Photograph 14 where deterioration of the wall over a length of approximately 0.9 metres has taken place over many years.

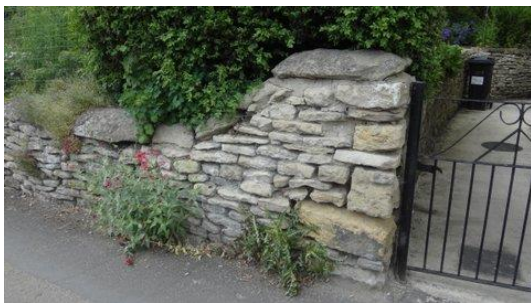
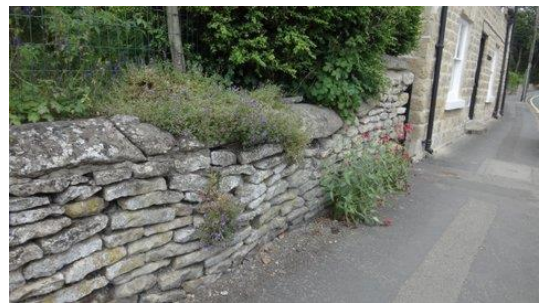
Photograph 15. Position J (External Wall)

- J The eastern garden wall (fronting Maltongate) to Brookfield shown in Photographs 15 and 16 where deterioration of the wall adjacent to the pedestrian entrance gate to Brookfield over a length of approximately 3.45 metres has taken place over many years.

Photograph 16. Positions H and J (External Wall)

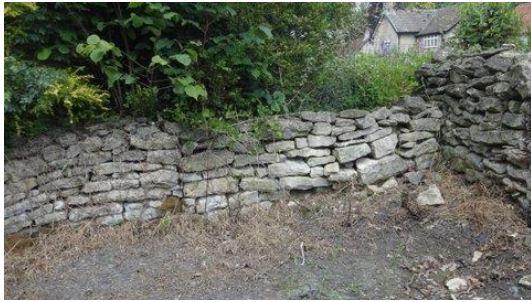
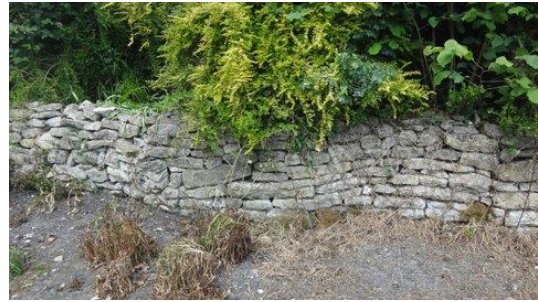
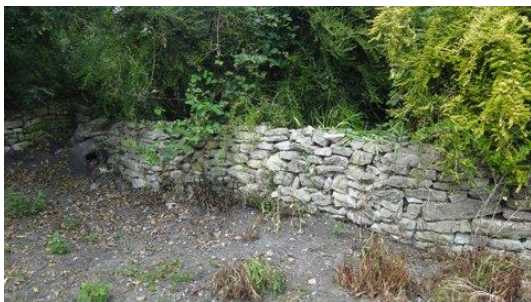
Photograph 17. North East Corner

Photographs 17 to 20 show the northern wall of length approximately 9.9 metres and 21 to 23, the western wall of length approximately 9.1 metres. With the exception of the access from the garden of Brookfield (photograph 20) the state of repair is generally satisfactory.

Photograph 18. North Side Adjoining Brookfield

Photograph 19. North Side towards North West Corner

I believe that these walls should be restored by removing the top 300mm and then rebuilding and increasing the height in specific areas by up to a further 300mm as appropriate. These works are best looked at in the course of a further site meeting and will need to be specified to any contractor.

- g) The walls to the northern and western boundaries to be repaired by carrying out very selective reconstruction to consolidate the existing height and coursing.

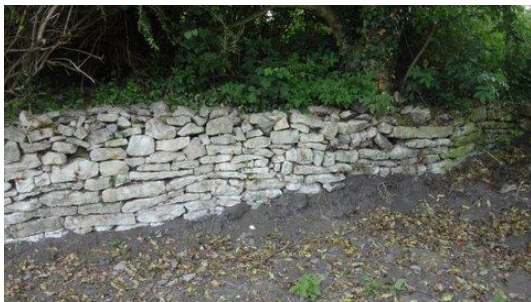
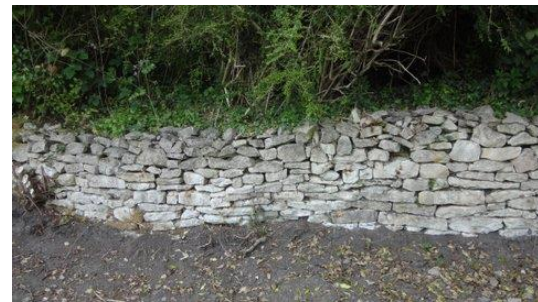
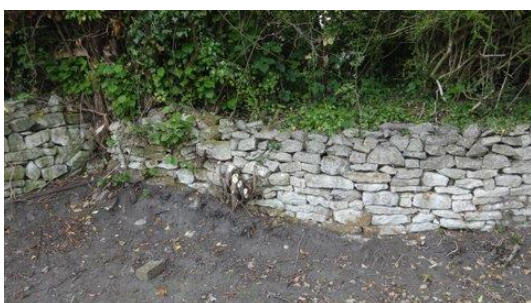
Photograph 21. West Side towards North West Corner

Photograph 22. West Side adjoining Brookfield

Photograph 23. South West Corner

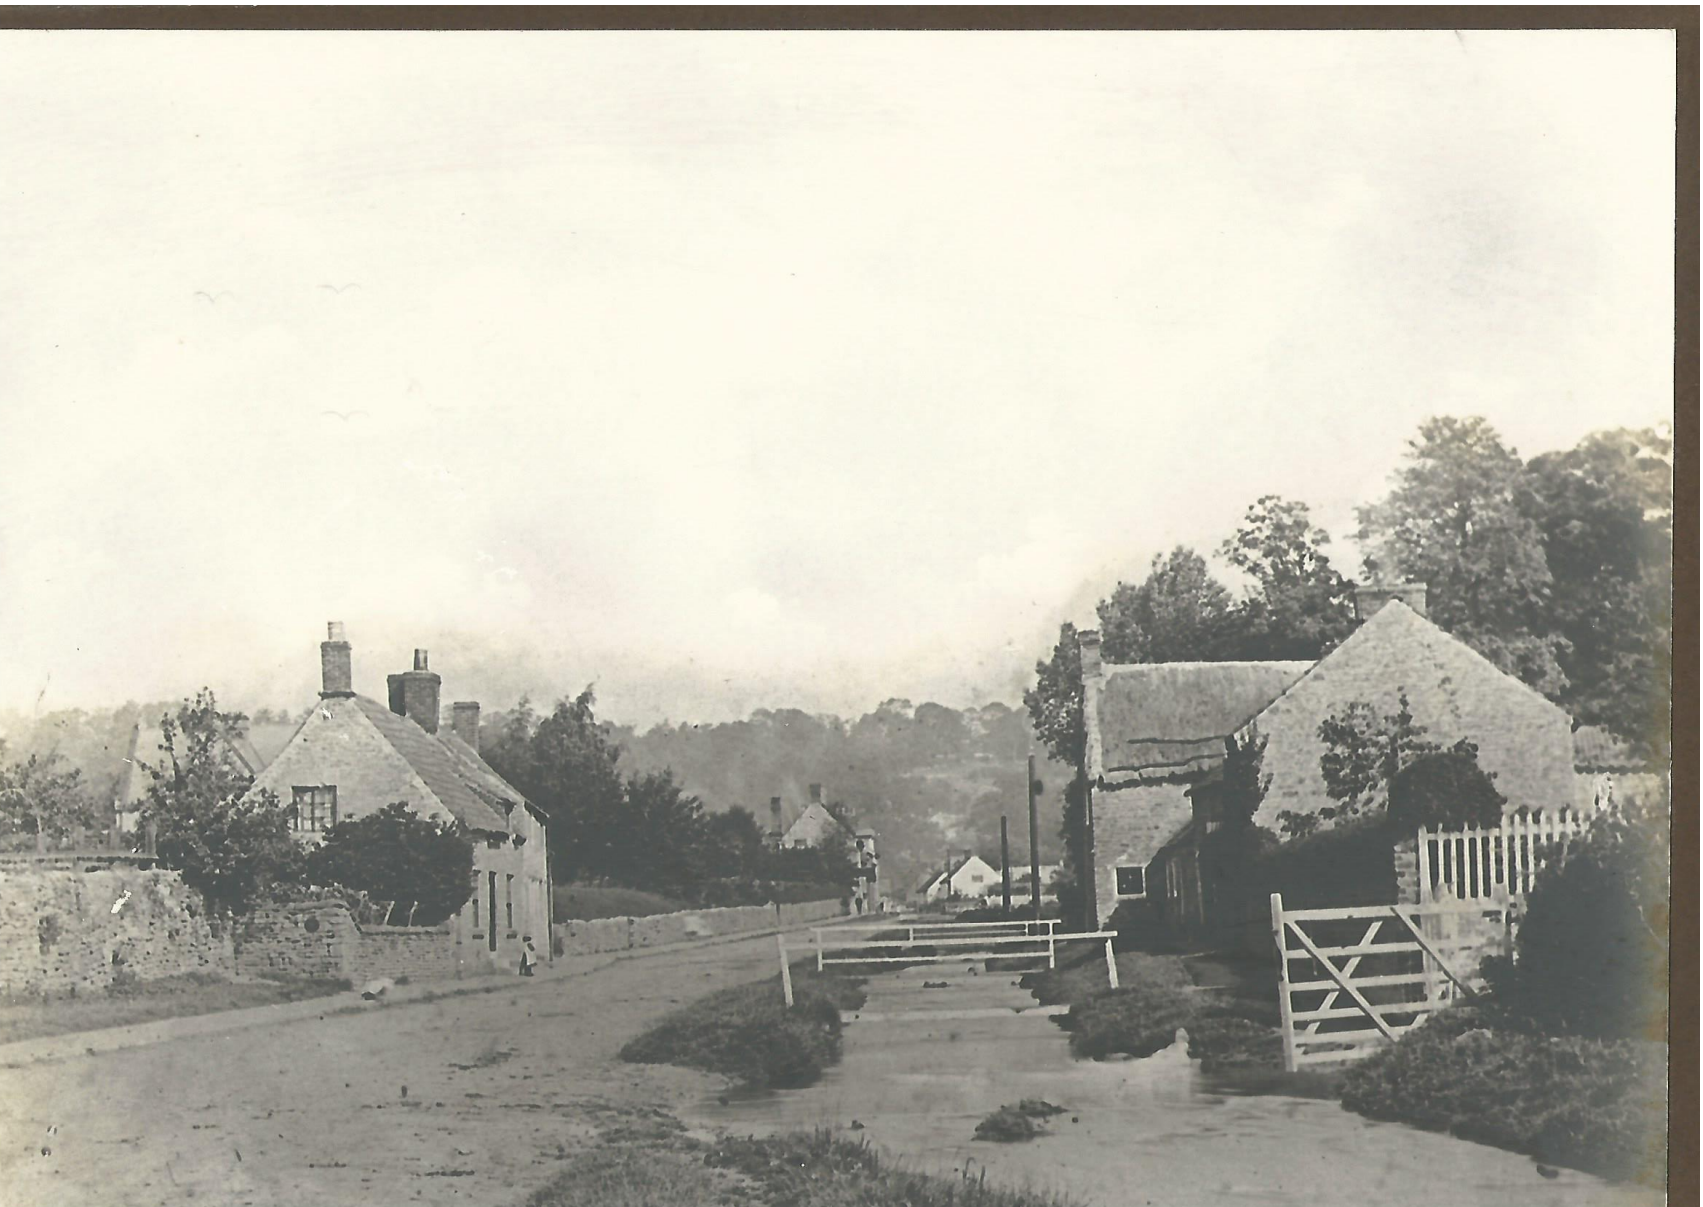
PINFOLD AT BROOKFIELD, MALTONGATE

The plan identifies seven specific areas in need of rebuilding and one where the former gated entrance may be reinstated. It also identifies the North and west walls of the structure which are in need of extensive general repair.
