BAT SURVEY REPORT

Sandfield House Farm
Sandsend Road
Sandsend
Whitby
YO21 3SR

Date: 11th September 2020

Reference no: CE0871

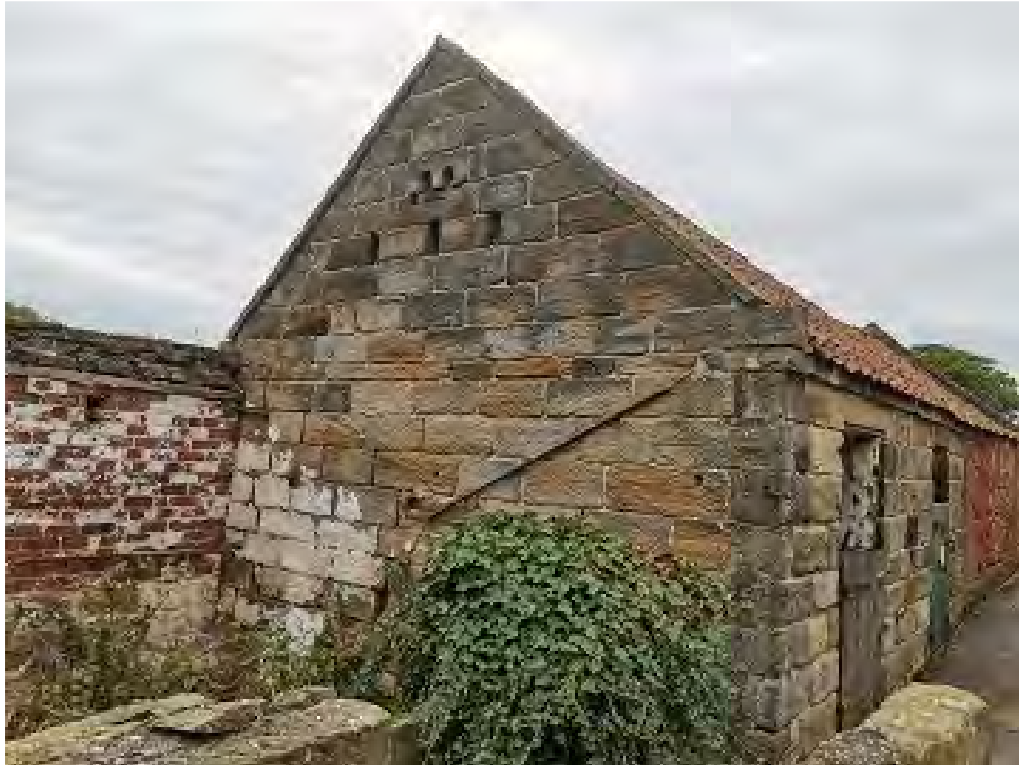
Plate 1. Shows east gable and north elevation of Building 1

Building 1 is a single storey stone walled barn with a pantile roof covering. The external walls all have varying degrees of age-related decay, with several deeper holes noted in the stonework where the mortar was missing on both the north and south elevations. At some point part of the north elevation and the west gable had been rebuilt with brick, which appeared to be in good condition with only minor decay of the mortar lines noted. Traditional style ventilation holes were noted at eaves level on the east gable. Two timber framed stable doors were found on the north elevation with gaps noted between the frame and the surrounding stonework. The west gable had a large timber framed opening, gaps were noted between the timber lintel and the brickwork above.

Internally the barn was divided into three separate rooms by solid stone walls, all the walls had varying degrees of age-related decay with some deeper holes noted where the mortar had come away entirely. A timber framed opening is found between the two rooms to the east end of the building at eaves level, with several gaps between the frame and surrounding stonework, as well as between the two timber lintels at the top of the opening.

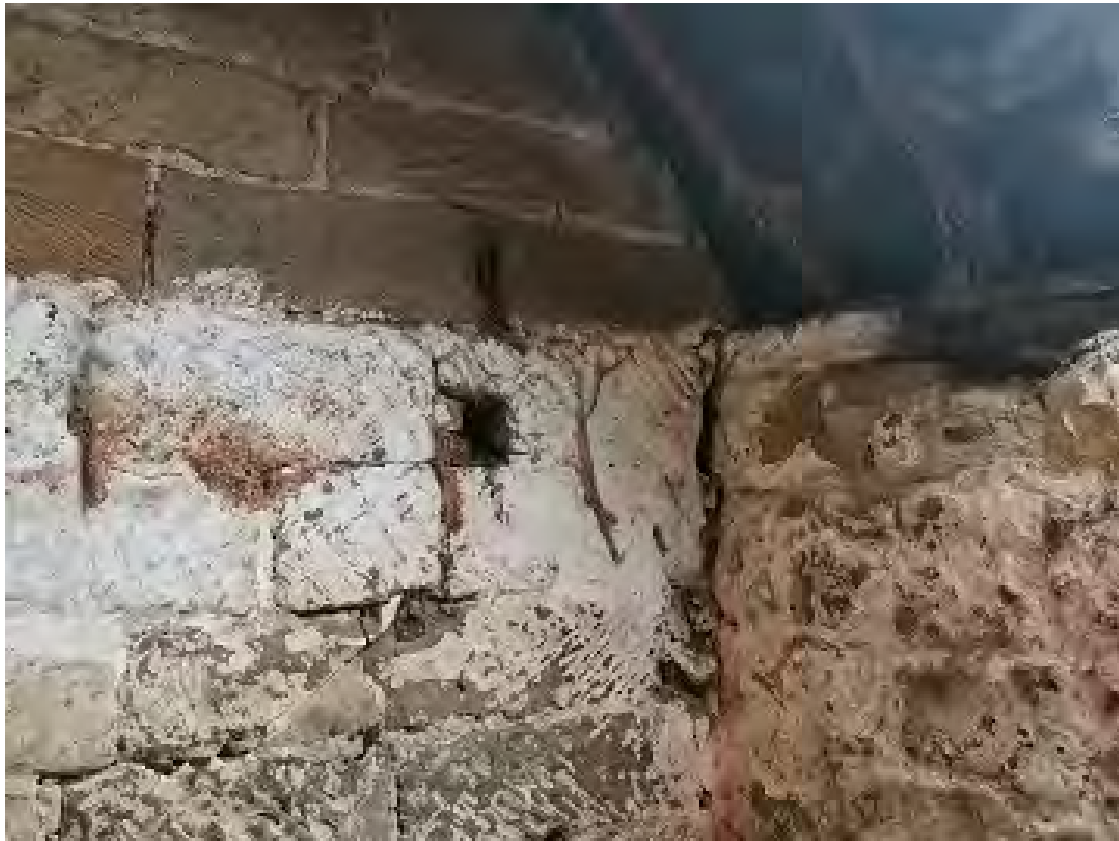
- Holes/Gaps in both external and internal walls
- Gaps around timber frames
- Lifted/Slipped pantiles

Plate 2 Example of holes in internal walls

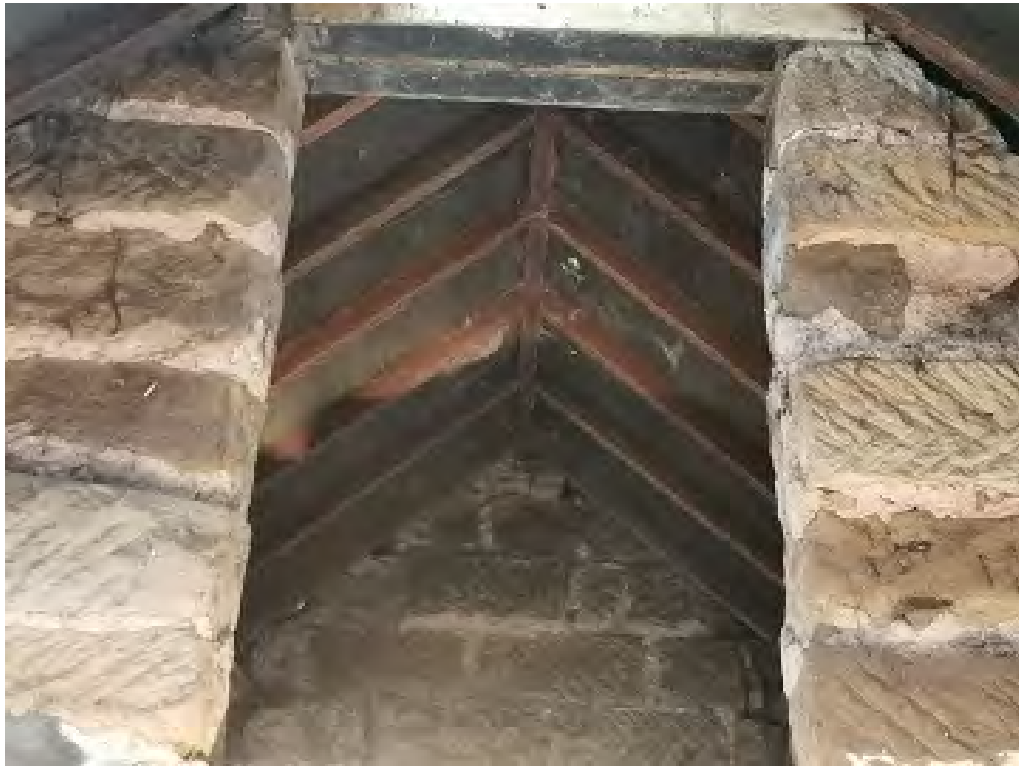
Timber rafters and a central ridge board supported the pantile roof covering, a number of tiles were noted to have slipped/moved leaving gaps. Two clear corrugated Perspex roofing sheets were found spaced evenly on the south aspect of the roof. Bitumastic felt lining was found throughout the entire building.

Plate 3. Shows timber roof supports and opening between rooms.

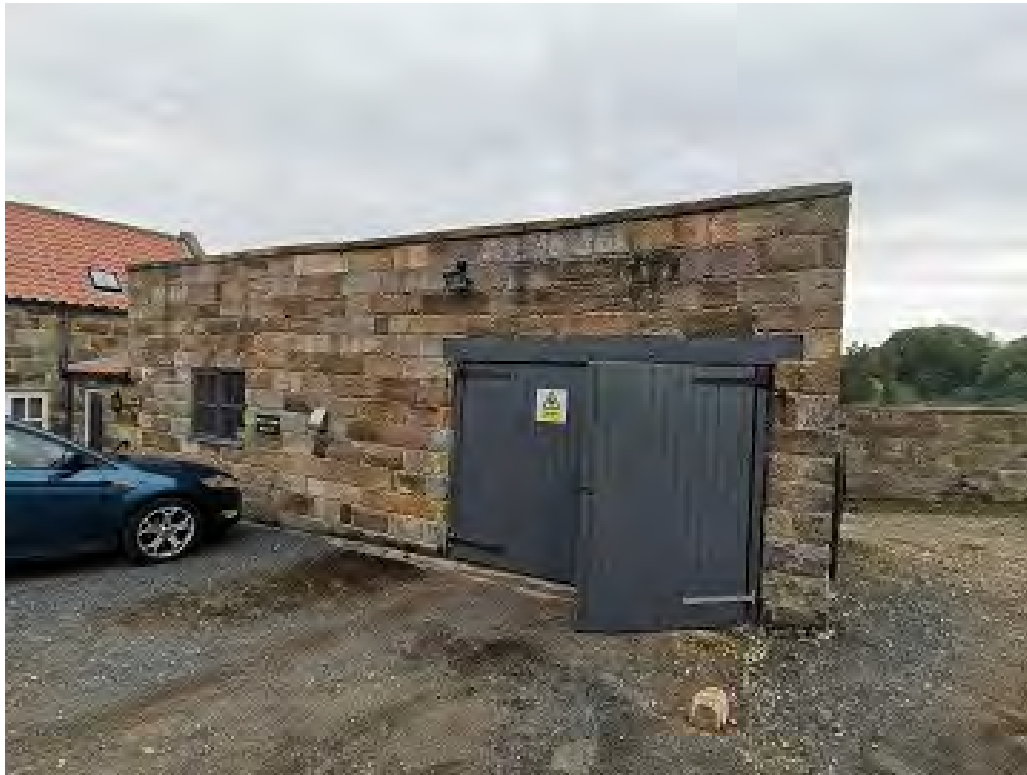
Plate 4. Shows north elevation of Building 2.

Building two is a single storey stone walled mono pitch building with a pantile roof covering. The majority of the external walls looked to be in good condition with only minimal decay of the mortar lines. A double timber framed door and glazed window were found on the north elevation, several small gaps were noted between the timber door frame and surrounding stonework. Internally the walls all appeared to be in good condition with only superficial cracks noted.

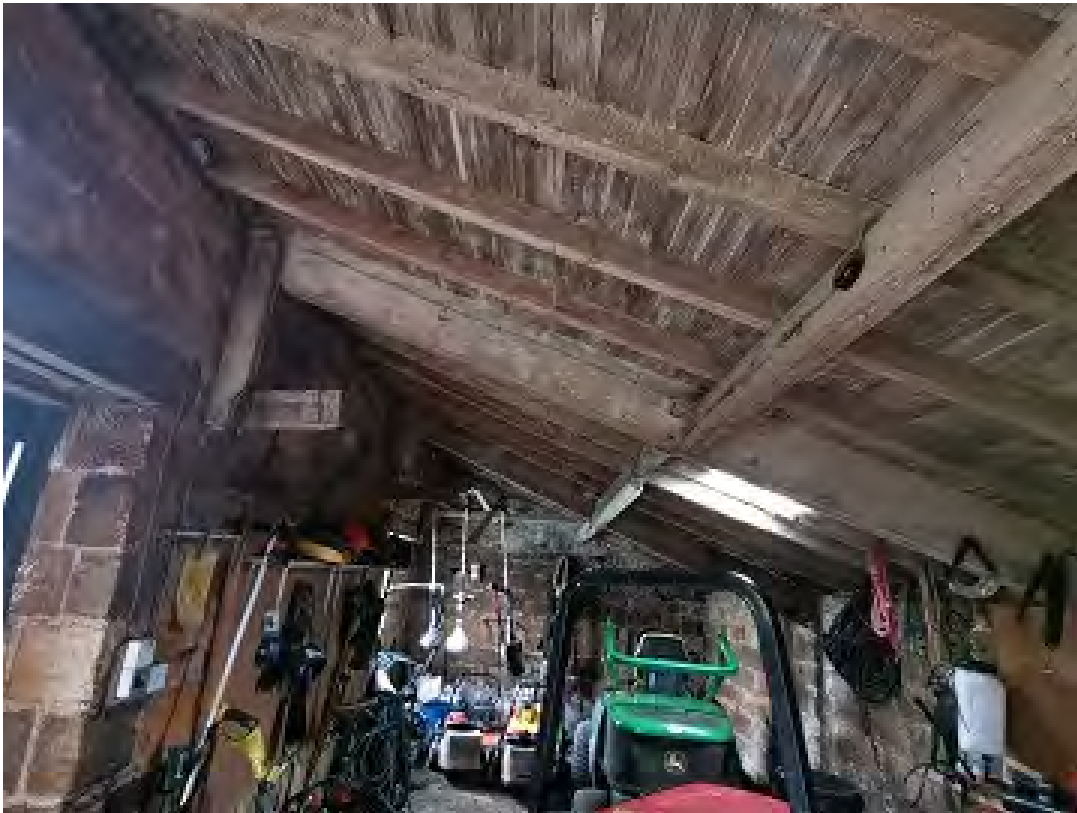
Timber beam, purlins with rafters supported the pantile roof covering, several pantiles were noted to have been lifted/slipped. Traditional lath and plaster under drawing was present throughout the study building.

Plate 5. Shows internal roof supports and lining in Building 2.

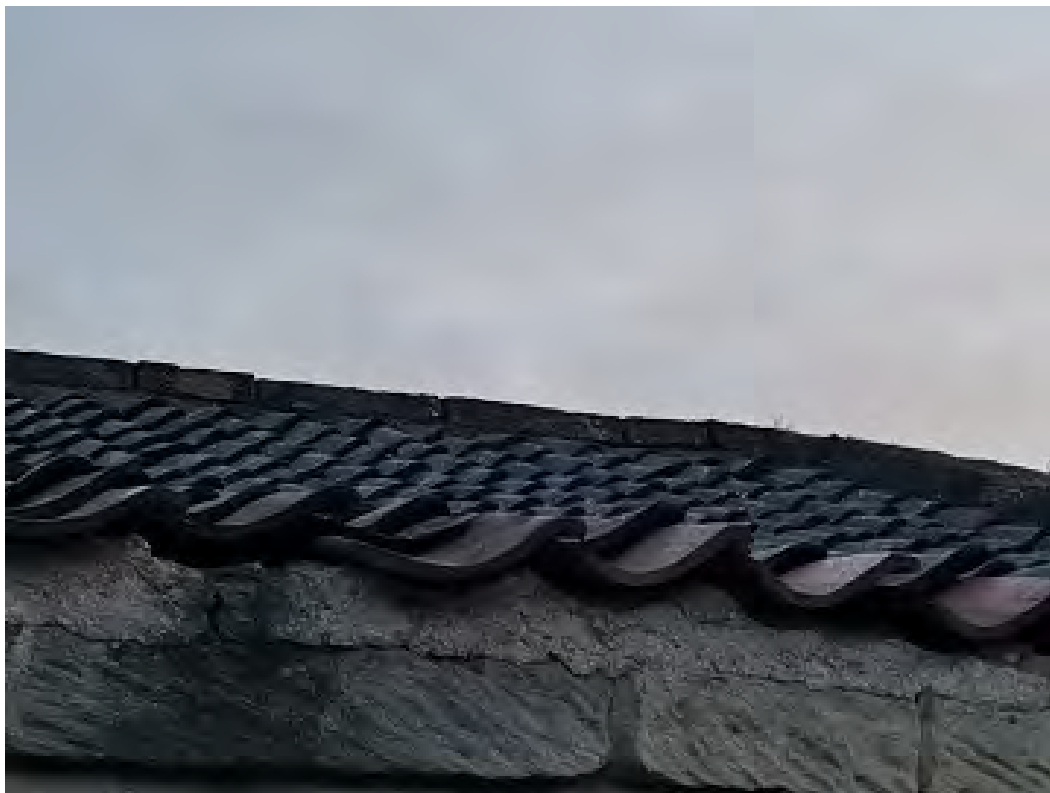
- Lifted/Slipped pantiles
- Gaps surrounding timber framed door.

Plate 6. Shows lifted pantiles

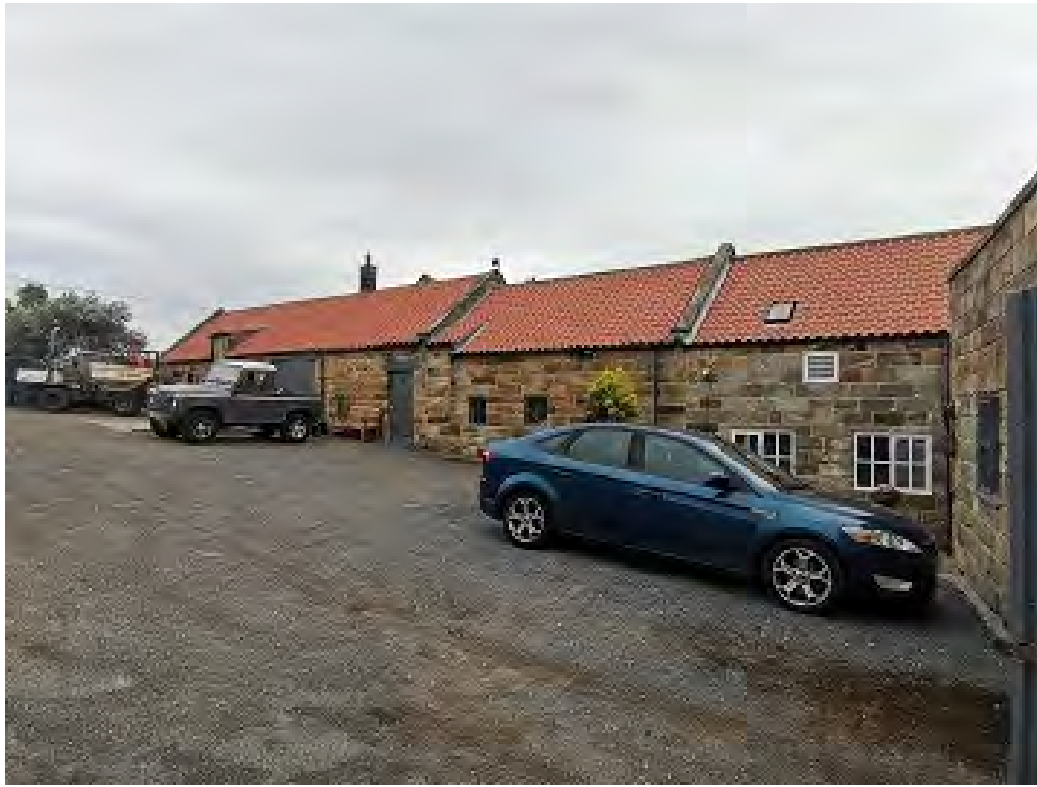
Plate 7. Shows west elevation of Building 3.

Building 3 is a row of three, one and a half storey high, stone-built store rooms and a holiday cottage all with a pantile roof covering. The external walls all appeared to be in good condition with only minor decay of the mortar lines. A mix of timber and UPVc glazed windows along with timber framed doors were found on both the east, west elevations and the south gable, all of which were well fitted to the surrounding stonework with no visible holes or gaps.

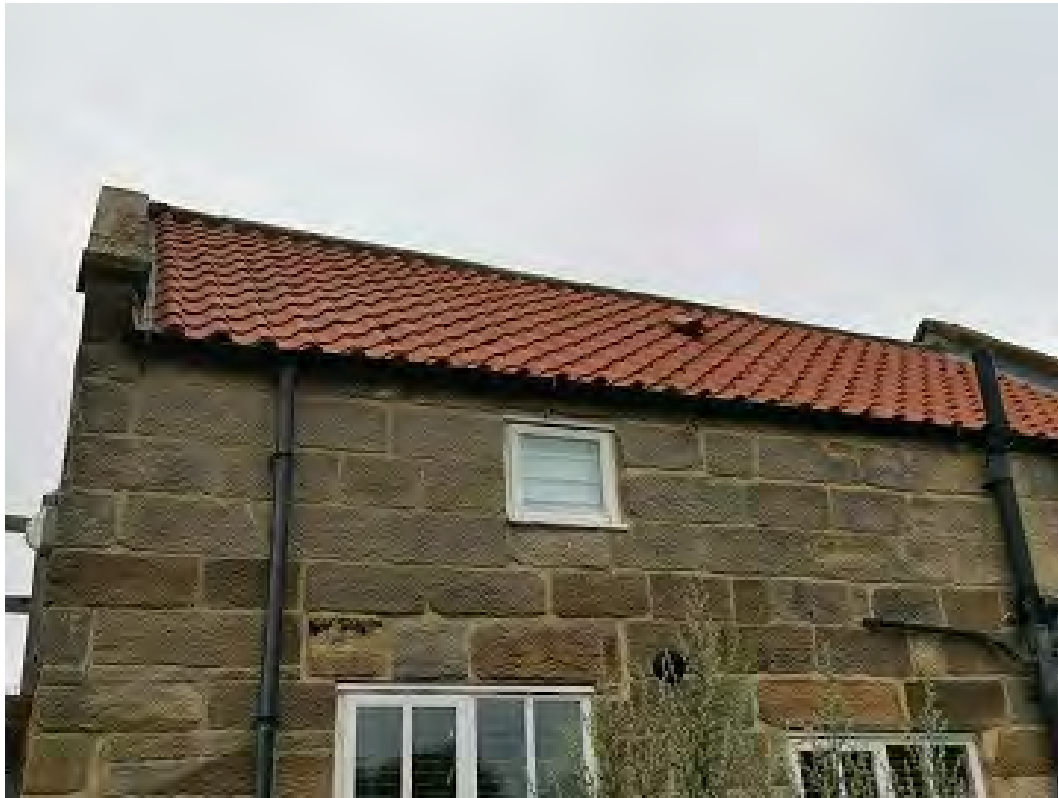
The pantile roof covering was mostly well fitted, with only the occasional tiles noted to be lifted on the west elevation. One Velux roof window was found on the west aspect of the roof with the surrounding tiles well fitted to the flashing beneath. UPVc bird spikes were seen under the tiles at eaves level on both the west and east elevation.

Plate 8. Shows east elevation of Building 3

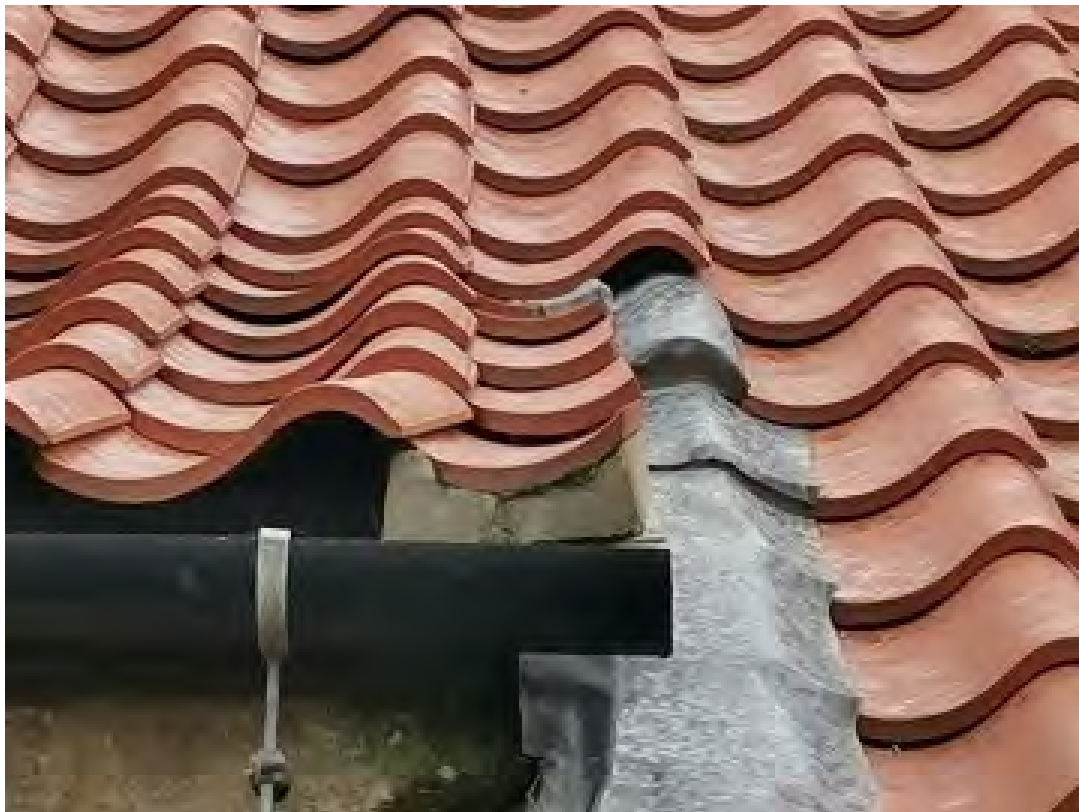
- No access into roof void.
- Two or Three lifted tiles

Plate 9. Shows lifted pantile and bird spikes under header tiles on the western elevation.

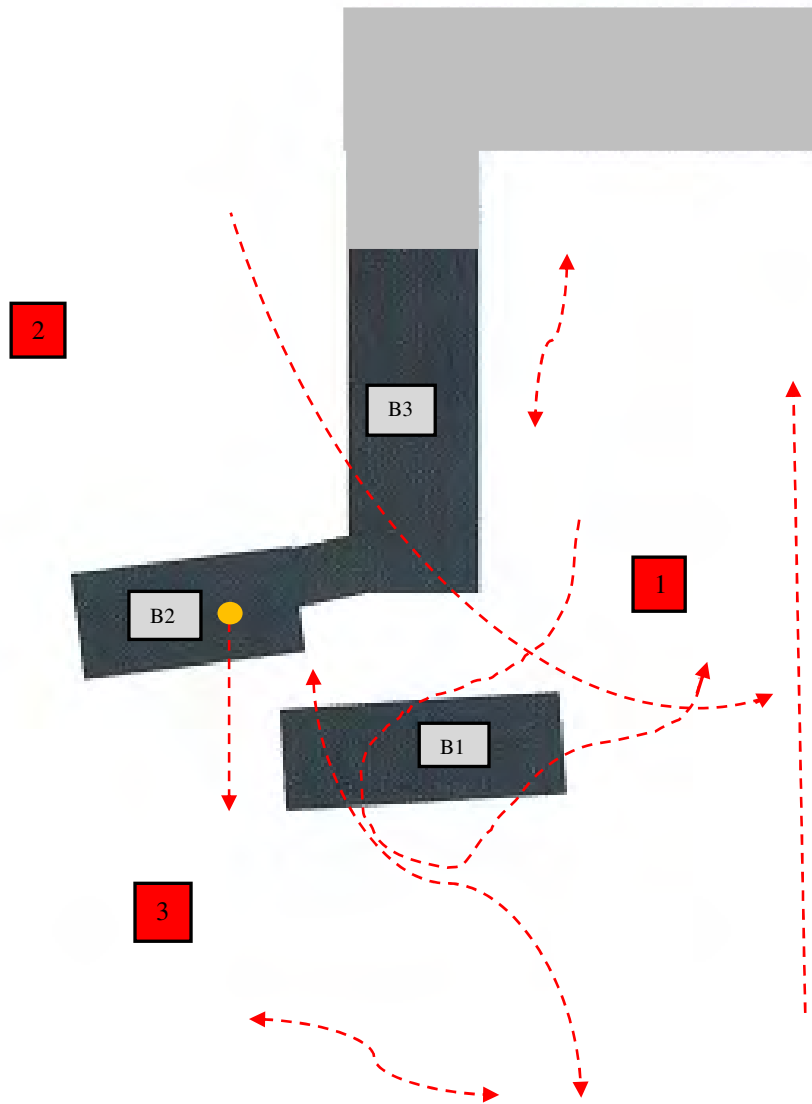
Dusk Activity Map 2nd August 2020

Location	Time	Observations made
	20.40	Survey start
1 & 3	21.25	1 Common pipistrelle emerged from under a tile on the south elevation of Building 2
2	21.28	1 Common pipistrelle heard briefly; direction not ascertained
1 & 3	21.27 – 21.30	1 - 2 Common pipistrelle foraging around and over Building 1
1 & 3	21.37 – 21.43	1 - 2 Common pipistrelle foraging over Building 1 and to the south of the site
1	21.42	1 Common pipistrelle commuting south to north
1	21.45	1 Common pipistrelle foraging to the east of the site
3	21.47	1 - 2 Common pipistrelle foraging to the south of the study site.
1 & 2	21.52	1 Common pipistrelle commuting north to south east over Building 3
1	21.53 – 21.59	1 - 2 Common pipistrelle foraging to the east of Building 1
3	21.52 – 22.01	1 Common pipistrelle foraging to the south of the site
1 & 2	22.00	1 Noctule heard commuting; direction not ascertained
	22.45	Survey End

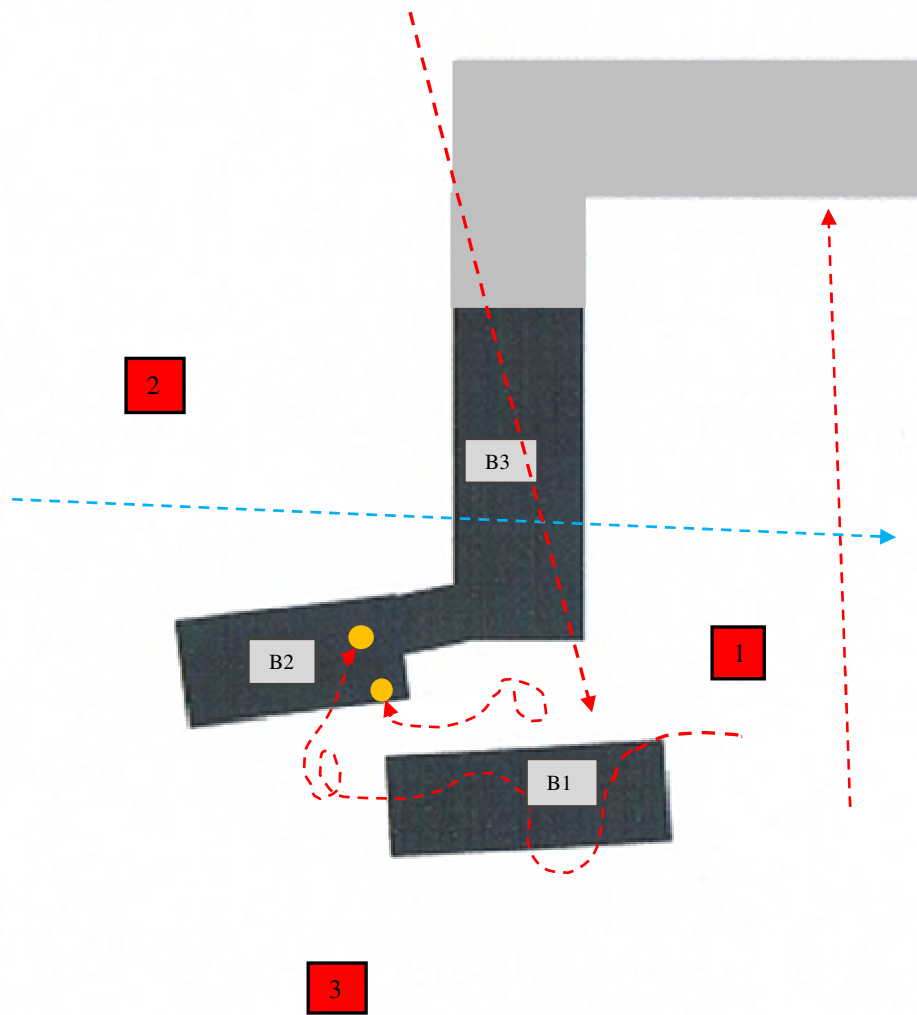
Dawn Activity Map 18th August 2020

Location	Time	Observations made
	03.55	Survey Start
1 & 3	03.55 – 04.13	1 - 2 Common pipistrelle heard foraging; direction not ascertained
2	04.00	1 Common pipistrelle heard commuting direction not ascertained
2	04.06	1 Common pipistrelle heard briefly: direction not ascertained
1 & 2	04.24	1 Common pipistrelle commuting north to south over Building 1
1 & 3	04.50	1 Common pipistrelle foraging above Building 1 before swarming south elevation of Building 2 and entering a day roost under tile at 04.57hrs
1	05.02	2 Common pipistrelle commuting south to north
3	05.02	1 Common pipistrelle foraging to south of the site.
1	05.05	1 Common pipistrelle swarmed around the south elevation of Building 2 before entering a day roost under a tile at eaves level at 05.09hrs
1 & 2	05.13	1 Whiskered/Brandt's commuting west to east
	06.00	Survey End

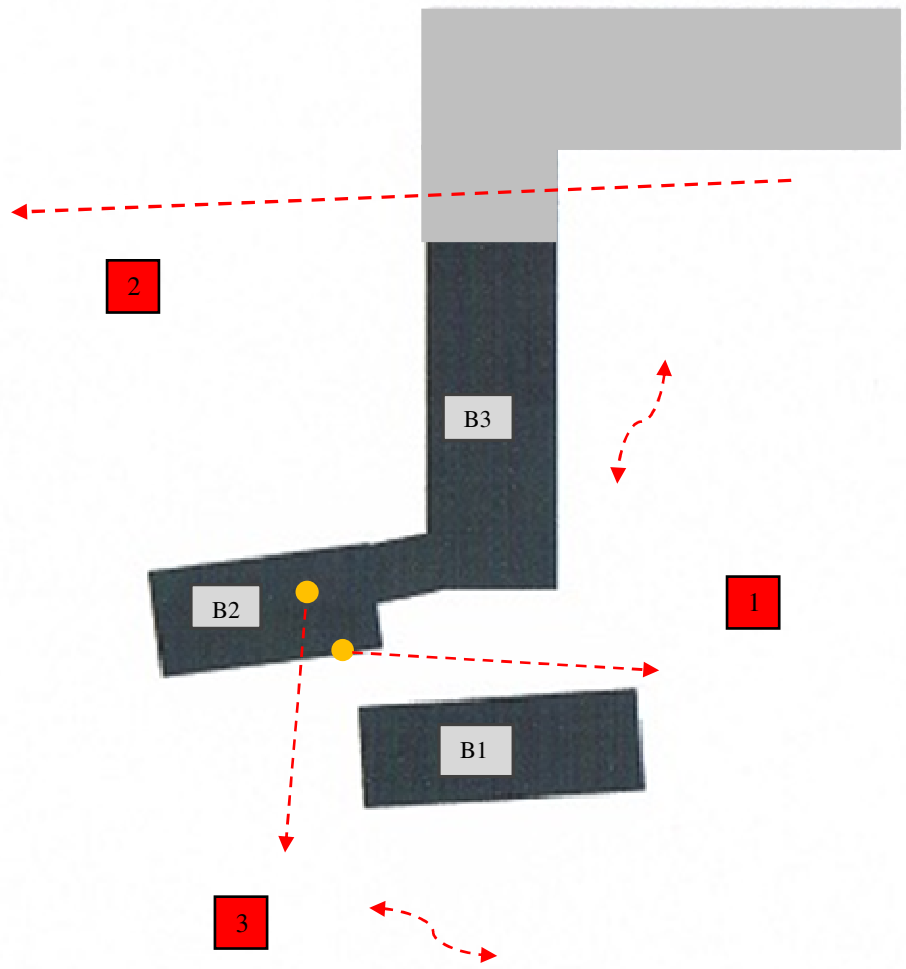
Dusk Activity Map 4th September 2020

Location	Time	Observations made.
	19.25	Survey Start
1 & 3	20.04	1 Common pipistrelle emerged from a day roost under a tile on the south elevation of Building 2
1	20.15 – 20.21	1 Common pipistrelle emerged from a day roost under a tile at eaves level on the south elevation of Building 2 at 20:15 hrs before foraging to the east
3	20.17	1 Common pipistrelle foraged briefly to the south of the site
1	20.23	1 Common pipistrelle briefly foraged to the east of Building 3
1 & 2	20.28	1 Common pipistrelle commuting east to west
2	20.29	1 Common pipistrelle heard briefly; direction not ascertained
1 & 2	20.33	1 Noctule heard commuting; direction not ascertained
2	20.48	1 Common pipistrelle heard commuting' direction not ascertained
	21.25	Survey End

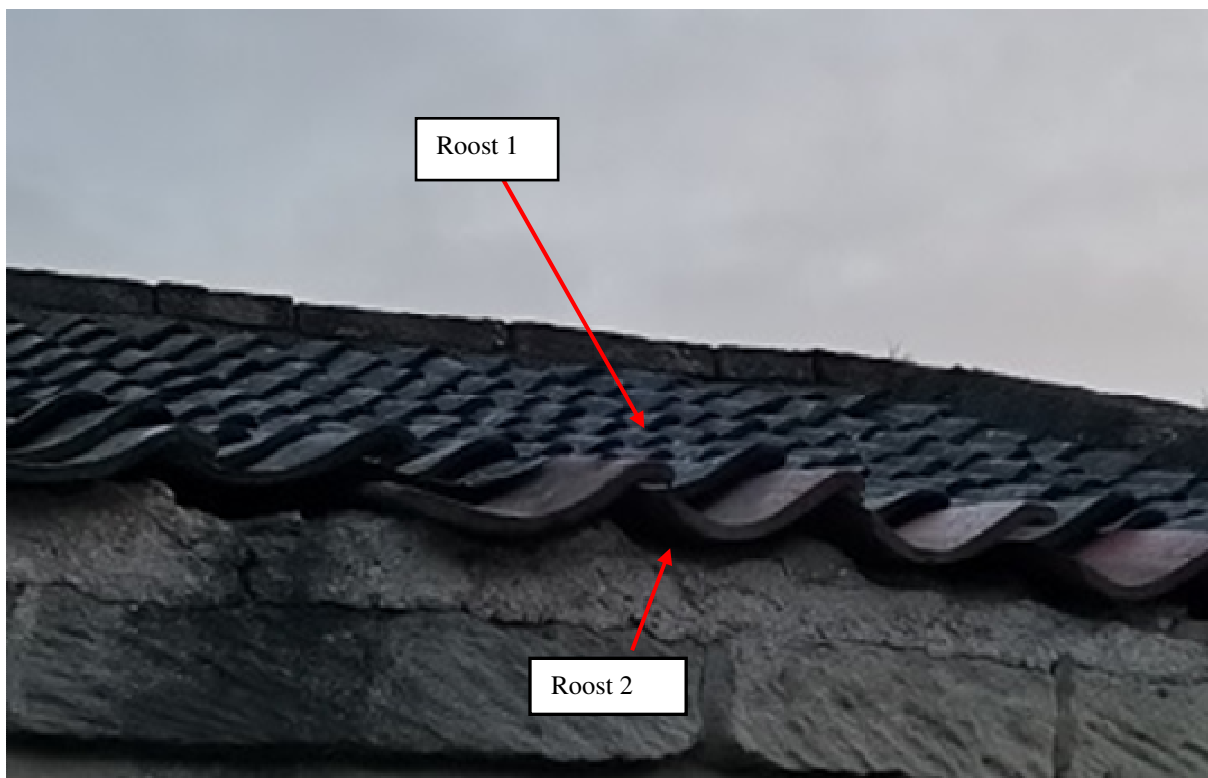
Results from the nocturnal surveys undertaken on the 2nd, 18th August and 4th September 2020 indicated the presence of two individual day roosts, used by two Common pipistrelle *Pipistrellus pipistrellus* within the roof structure of Building 2. No maternity roosts or significant numbers of bats were observed at the times of the nocturnal surveys.

Plate 10. Shows the position of two day roosts on the south elevation of Building 2.

The identified day roosts will be destroyed as part of the conversion phase to the building, therefore a European Protected Species Mitigation Licence approved by Natural England, will be required before any conversion work on Building 2 can commence. This licence can only be applied for once planning approval has been obtained from the Local Planning Authority.

- 7.1.8. 1 x Vivaro Pro Chilton Low Profile Woodstone bat box or woodcrete equivalents, is to be installed in a suitable position found with the application site, prior to any conversion works on Building 2 been undertaken. Advice on positioning to be agreed with ourselves. These bat boxes can be obtained from NHBS www.nhbs.com or any other reputable wildlife habitat supplier.

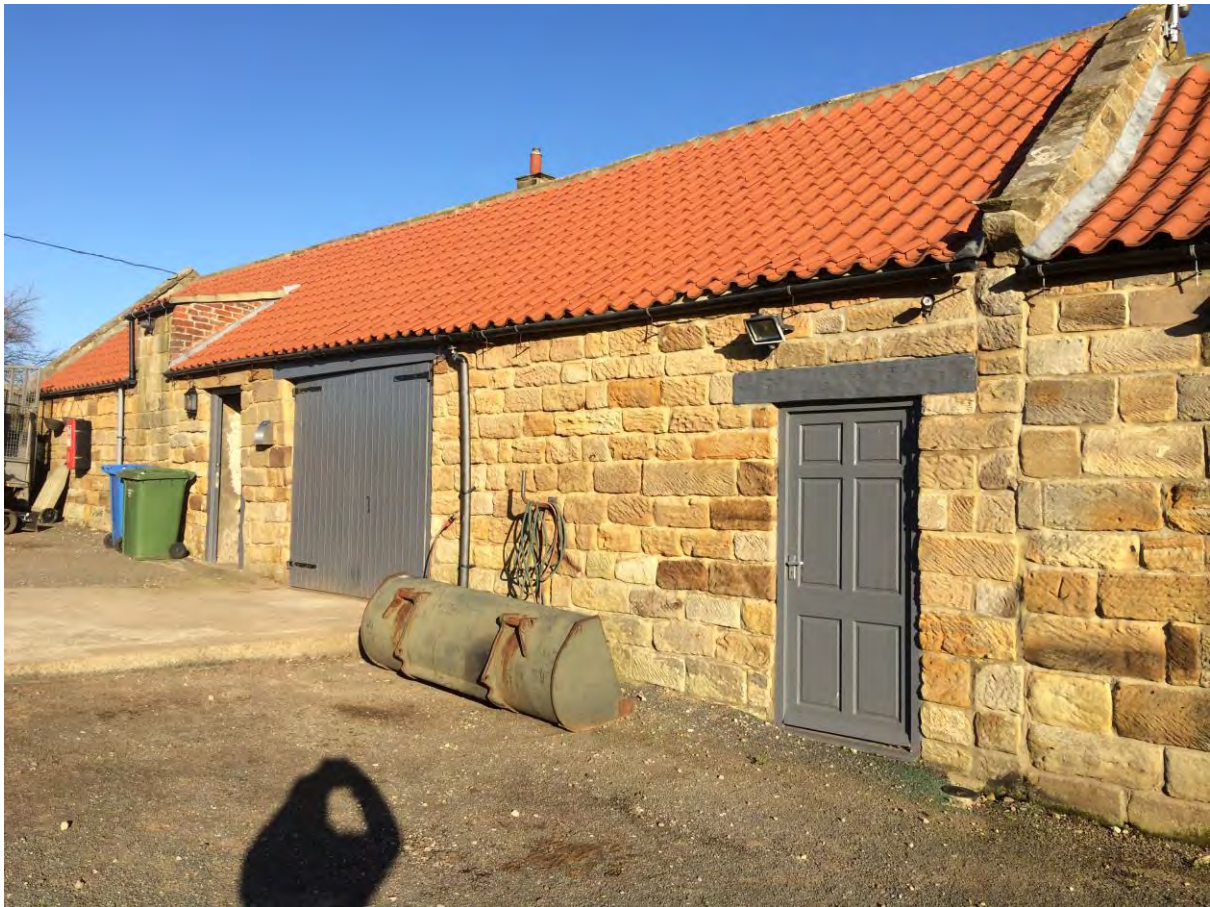
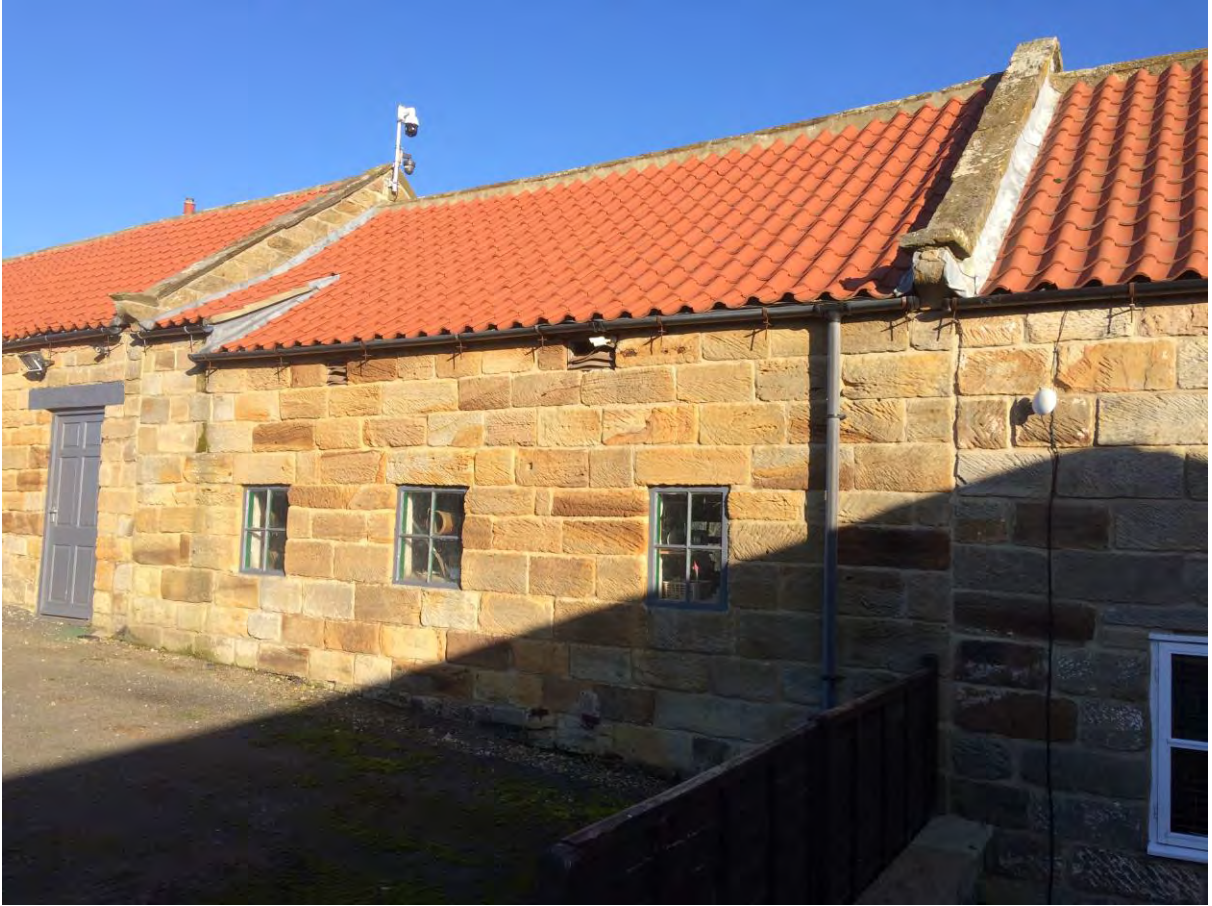
Photograph 1
Sandfield House Farm, Whitby, YO22 4DS

- 2.1 The front (south-west facing) elevation of Outbuilding A can be seen in photographs 1 and 2. The external walls of the northern building are 400mm thick, while the thickness of the walls on the southern building are 250mm. The walls are in reasonable condition except the bearing of some of the stone lintels are inadequate, see photograph 3.

- 2.3 It can be seen in photograph 1 that the roof is in reasonable condition.
- 2.4 The roof support structure is in reasonable condition, see photographs 7 and 8. The first-floor timber joists are in reasonable condition, see photograph 9.

- iv) All timber lintels should be replaced or supported on hidden steel lintels. Any stone lintels with inadequate bearing should be sat on hidden steel lintels. Any embedded timbers in the walling should be removed.
- v) The external walls should be repointed and local repairs carried out where necessary.
- vi) All of the works should comply with current Building Regulations.

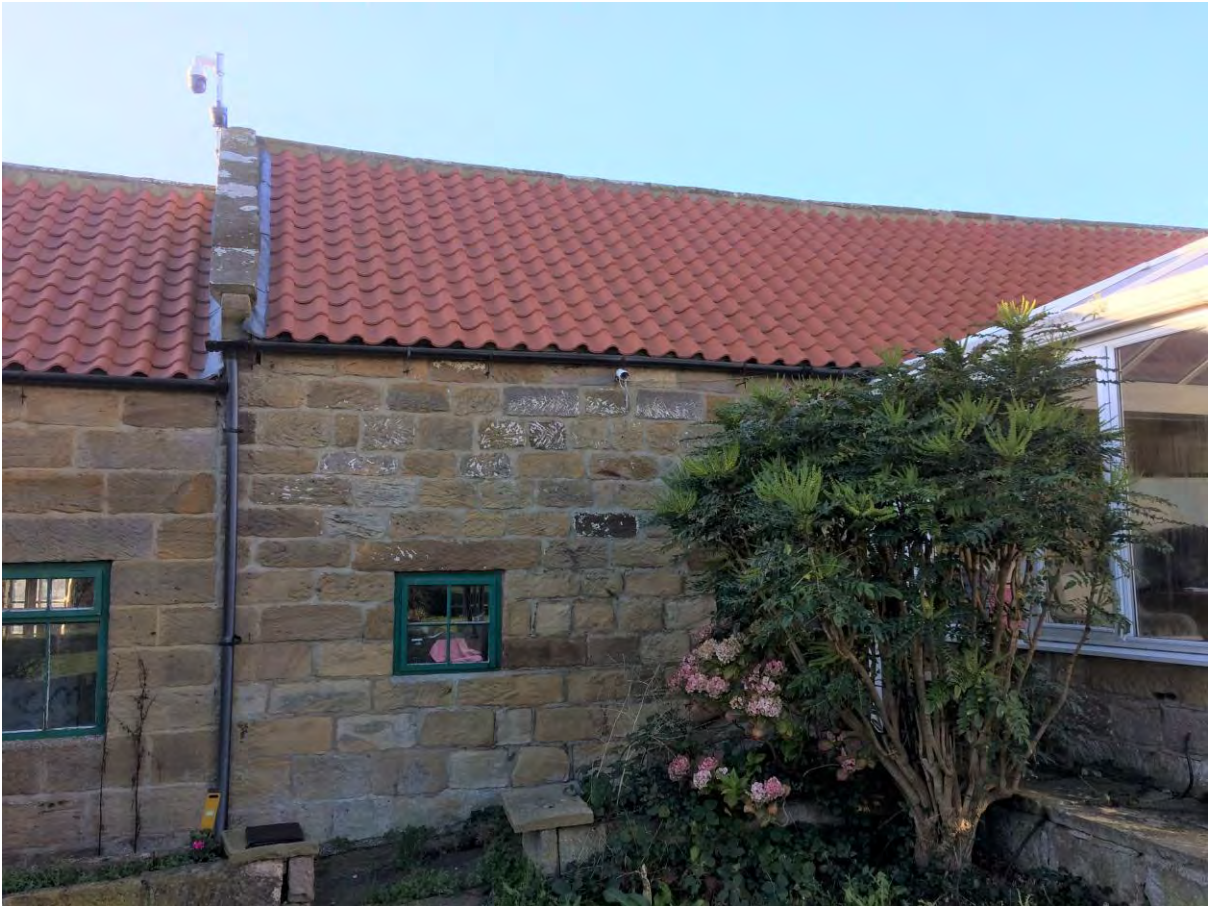
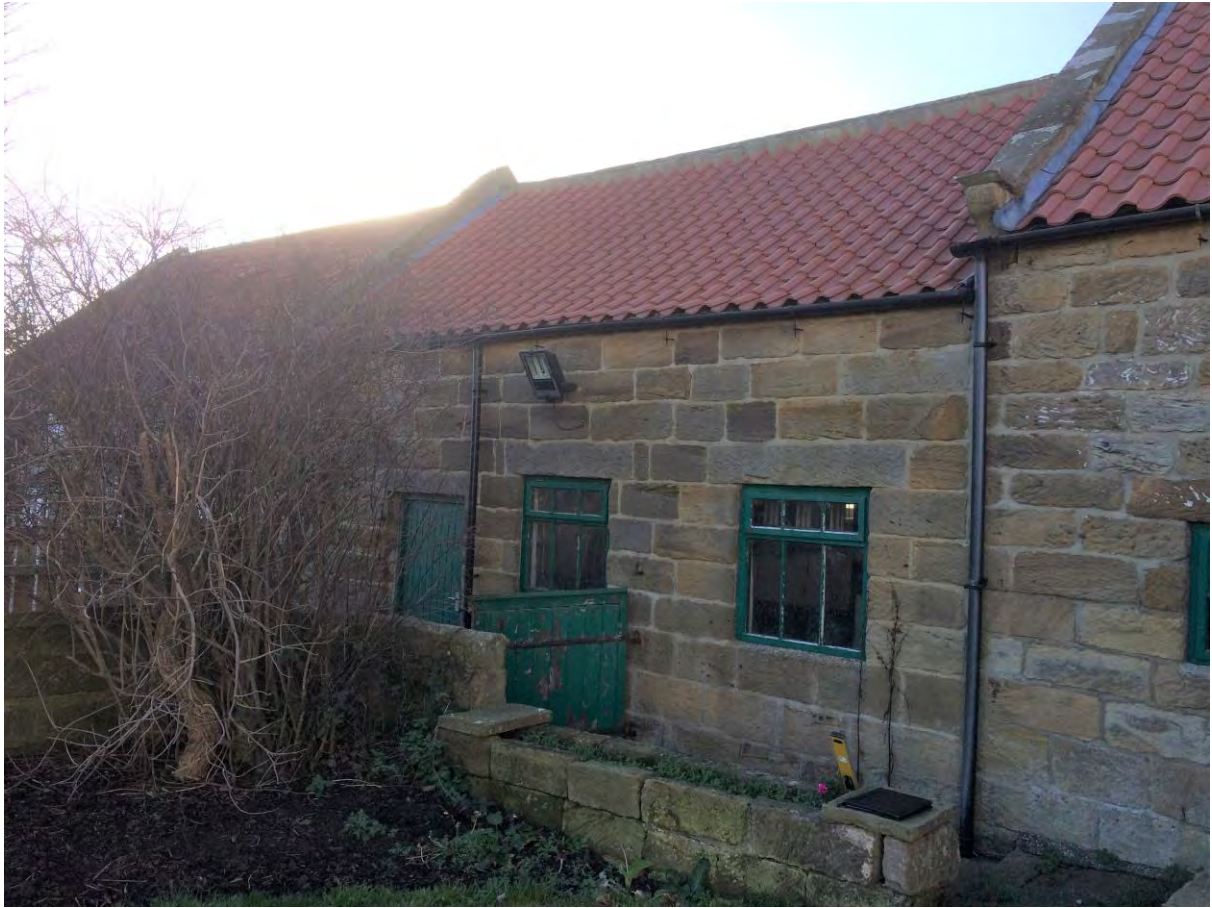
Photograph 4
Sandfield House Farm, Whitby, YO22 4DS

- 2.2 The rear (north-east facing) elevation can be seen in photographs 4 and 5. The wall is in reasonable condition except for some slight damage adjacent to the door into the barn, see photograph 6.

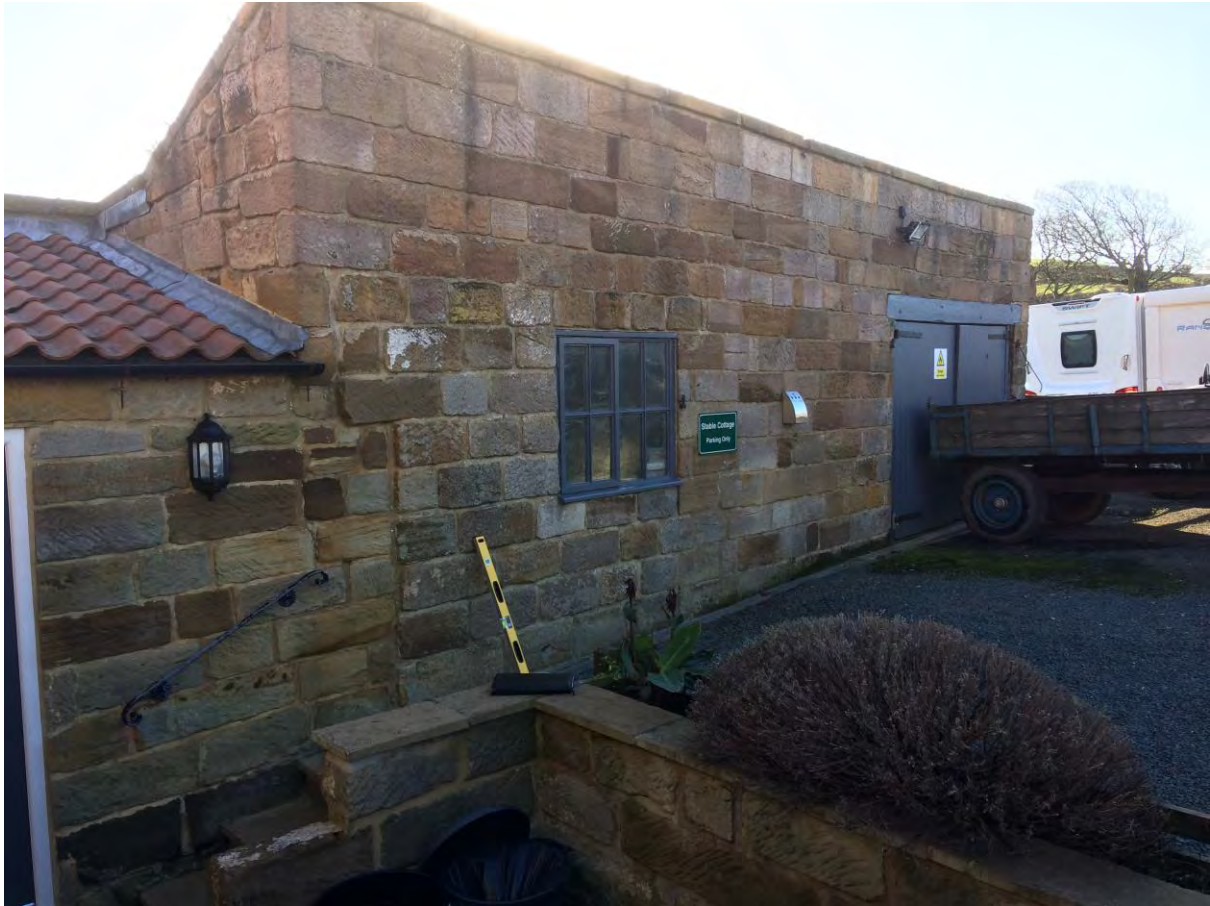
Photograph 10
Sandfield House Farm, Whitby, YO22 4DS

- 3.1 The front (north facing) elevation of Building B can be seen in photograph 10. The walls are generally 450mm thick sandstone except for a short length at the eastern end which is 150mm thick. The wall is in reasonable condition except for some movement over the double doors, see photograph 11 and 12.

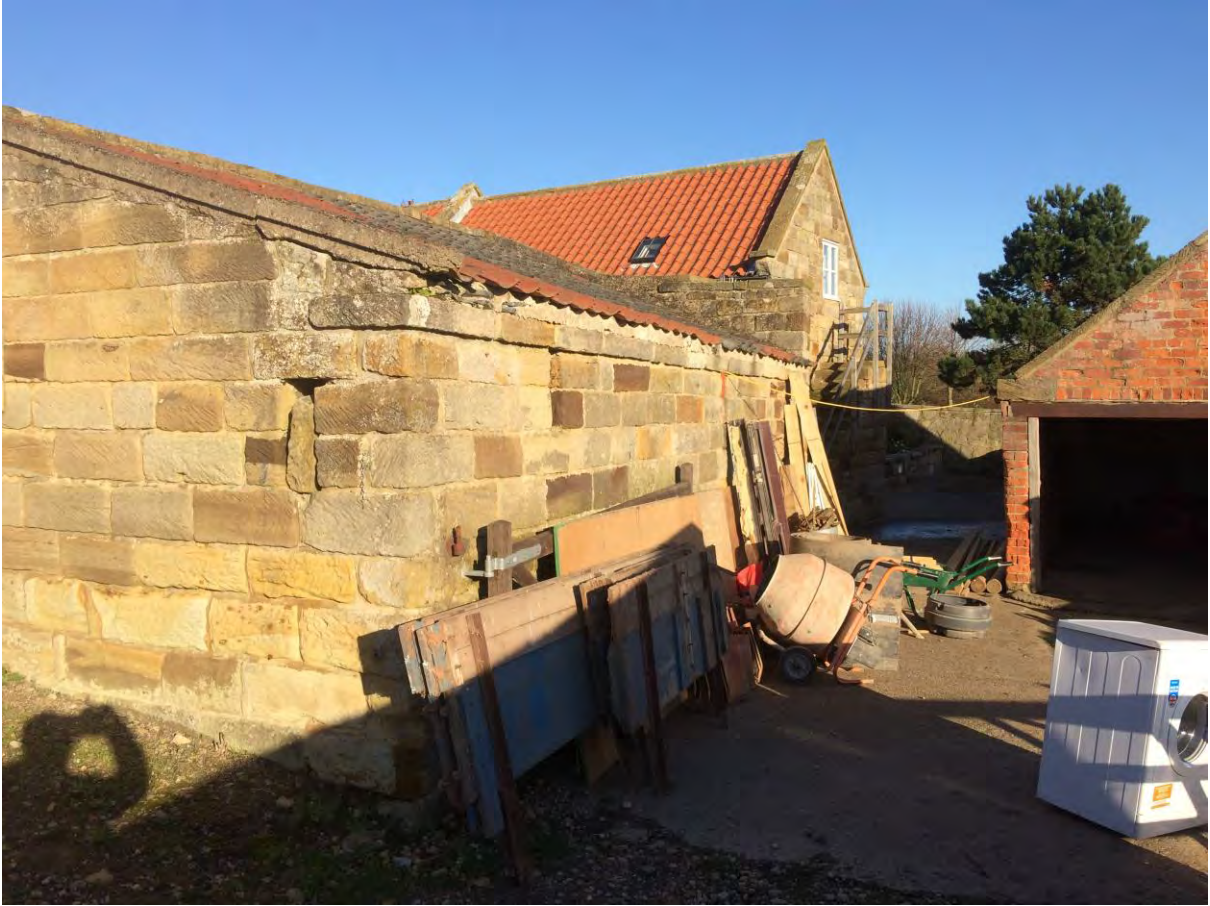
Photograph 13
Sandfield House Farm, Whitby, YO22 4DS

- 3.2 The rear (south-facing) elevation can be seen in photograph 13. The wall is in reasonable condition except for some slight disturbance at eaves level at the south-west corner.

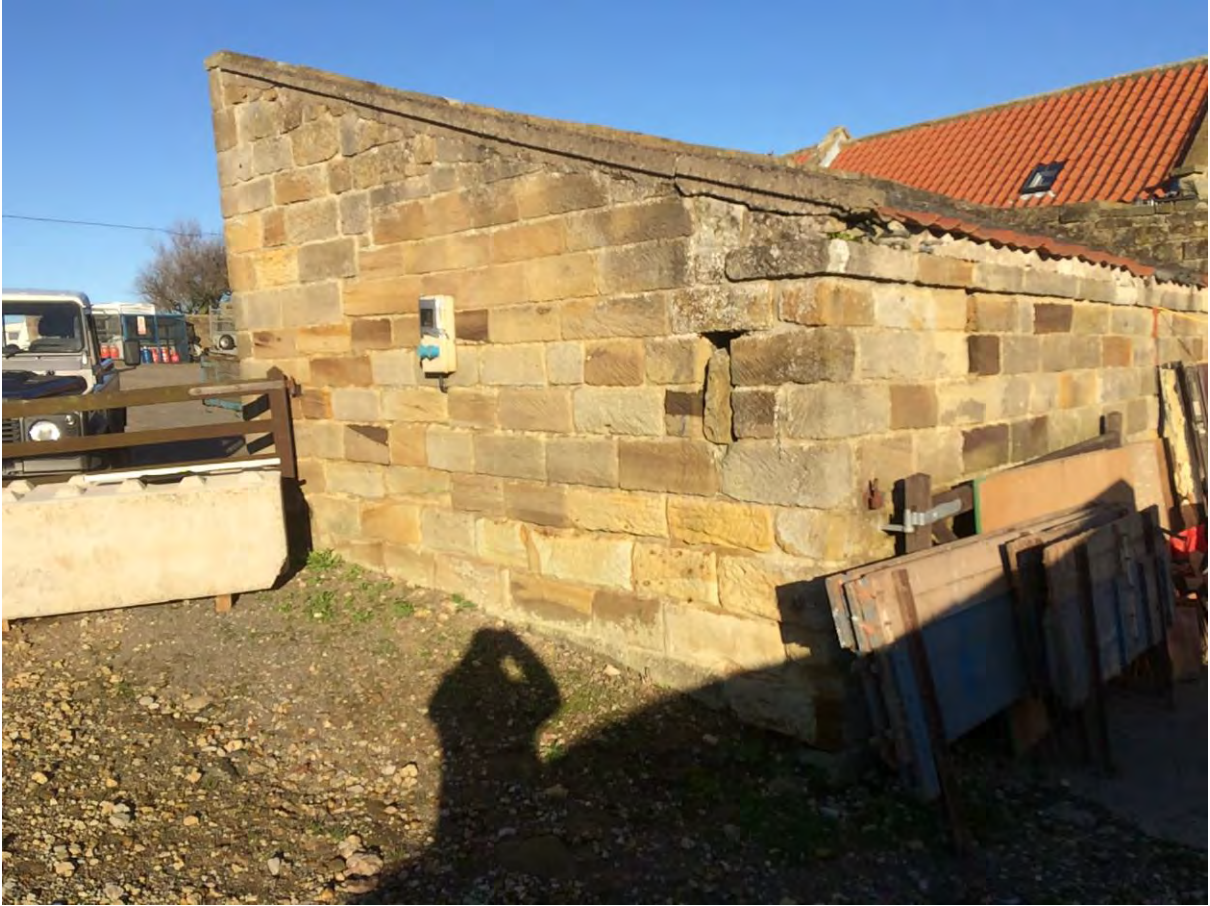
Photograph 14
Sandfield House Farm, Whitby, YO22 4DS

- 3.3 The west facing gable wall can be seen in photograph 14. The wall is in reasonable condition except for some movement at the southern end, see photograph 15.
