BAT SURVEY REPORT

Sandfield House Farm
Sandsend Road
Sandsend
Whitby
YO21 3SR

Date: 11th September 2020

Reference no: CE0871

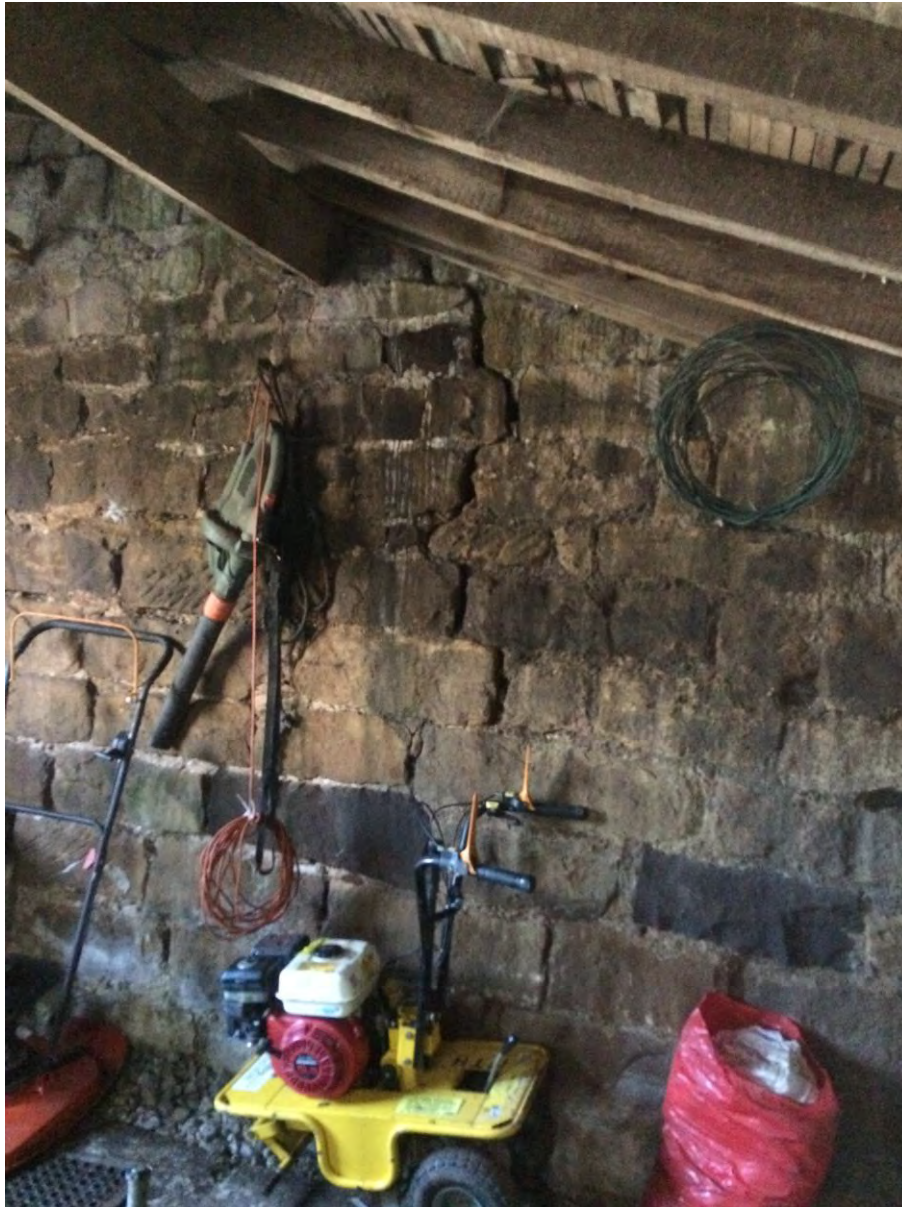
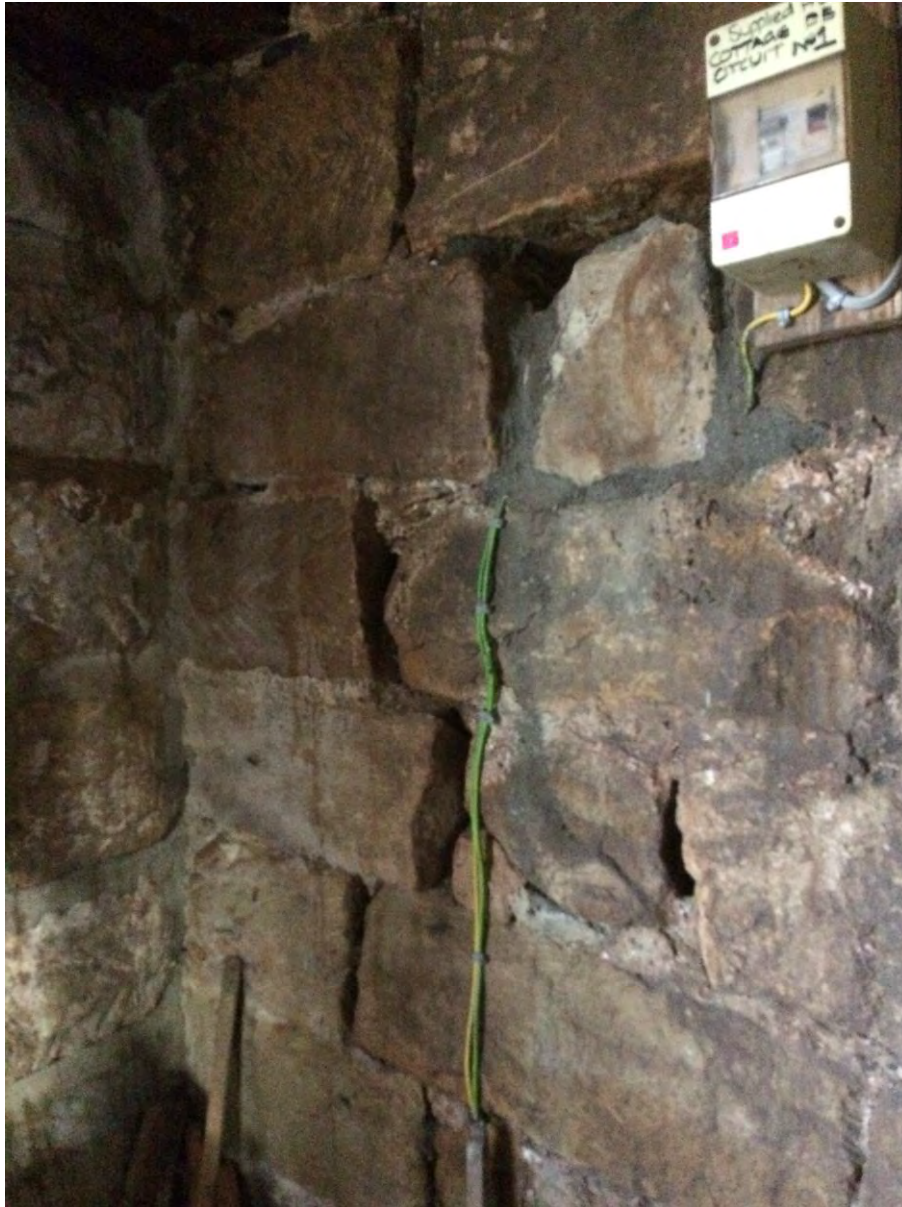
Photograph 16
Sandfield House Farm, Whitby, YO22 4DS

- 3.4 The internal condition of the building is in reasonable condition except for some cracking on the eastern party wall, see photographs 16 and 17.
- 3.5 Building B can safely be converted for residential use subject to the following:

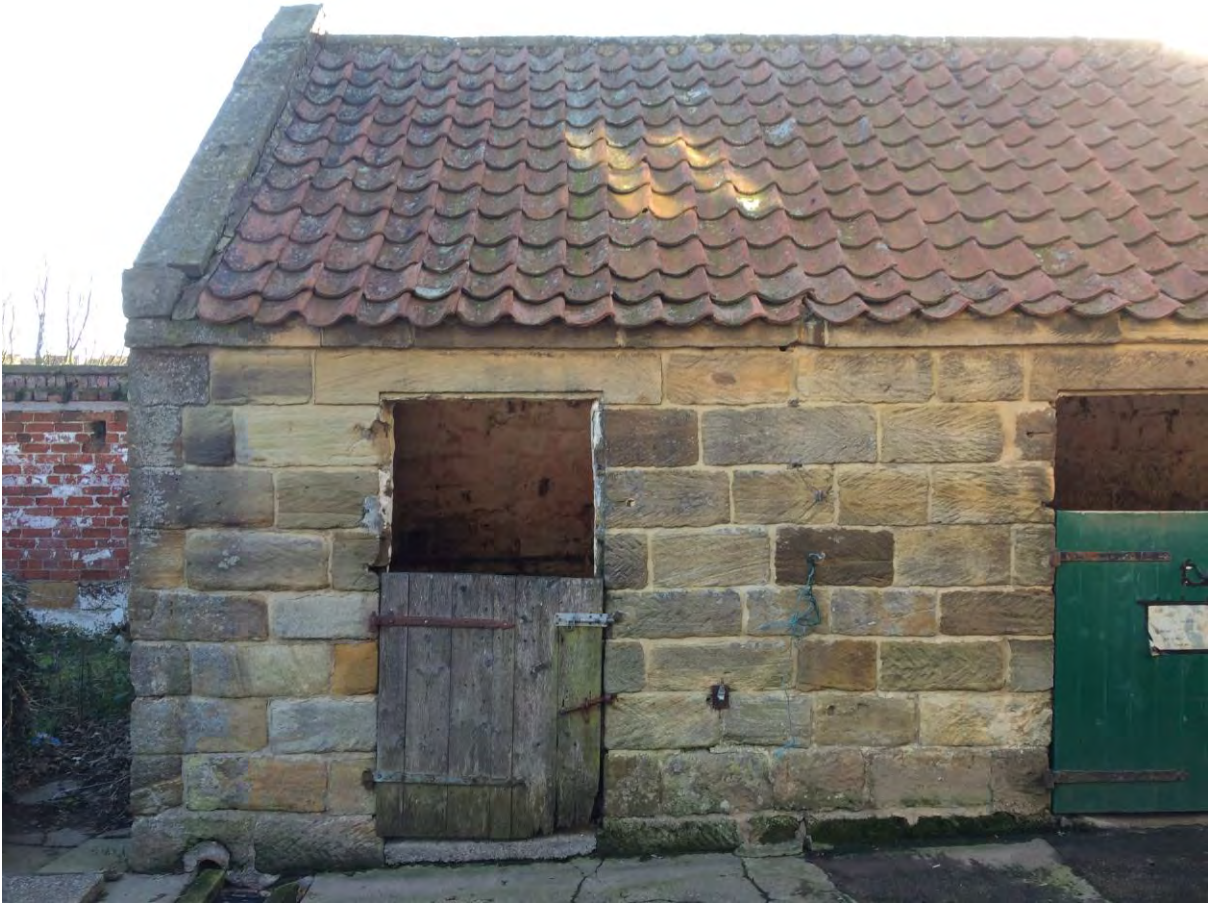
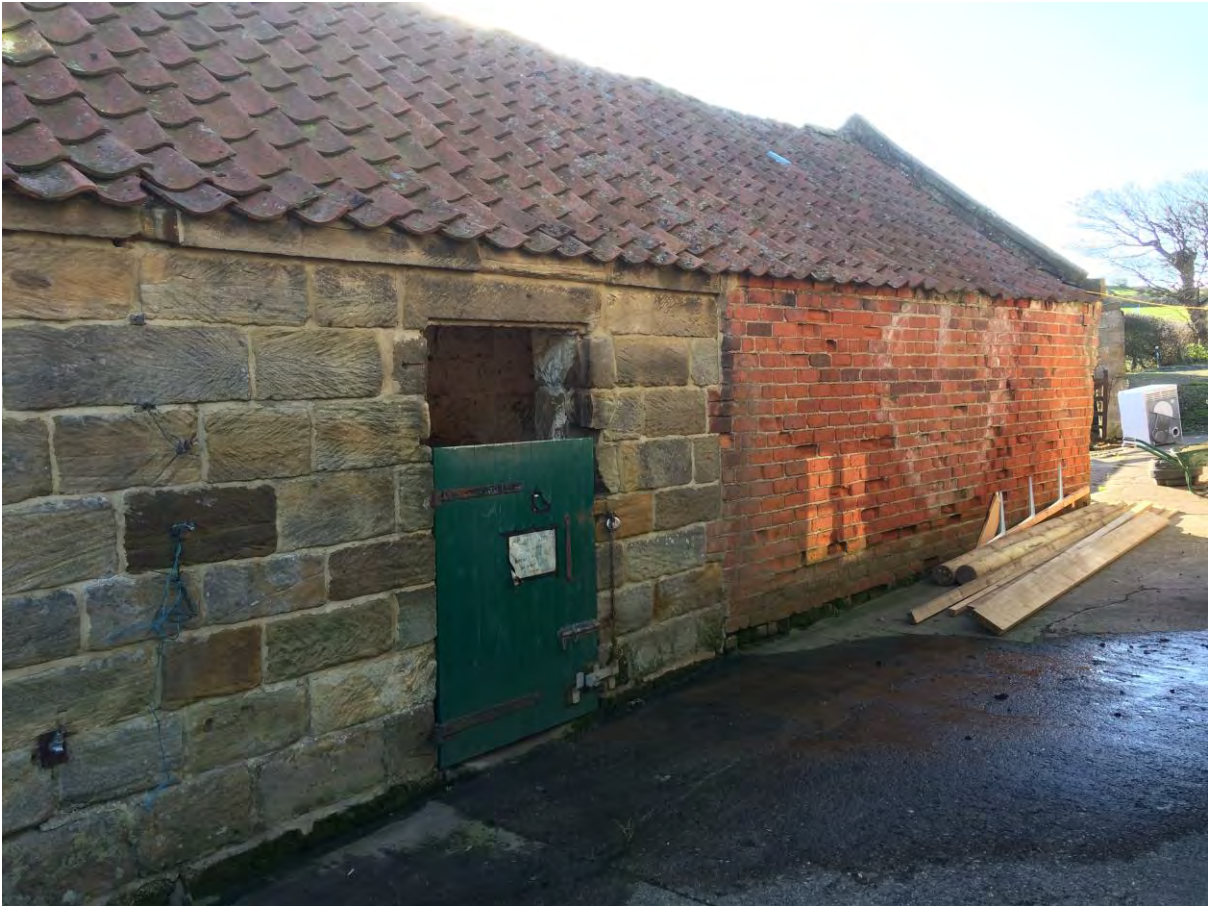
Photograph 18
Sandfield House Farm, Whitby, YO22 4DS

- 4.1 The front (north facing) elevation of Building C can be seen in photographs 18 and 19. The wall is in reasonable condition except for some erosion of bricks, see photograph 20 and inadequate bearing of stone lintel, see photograph 21.

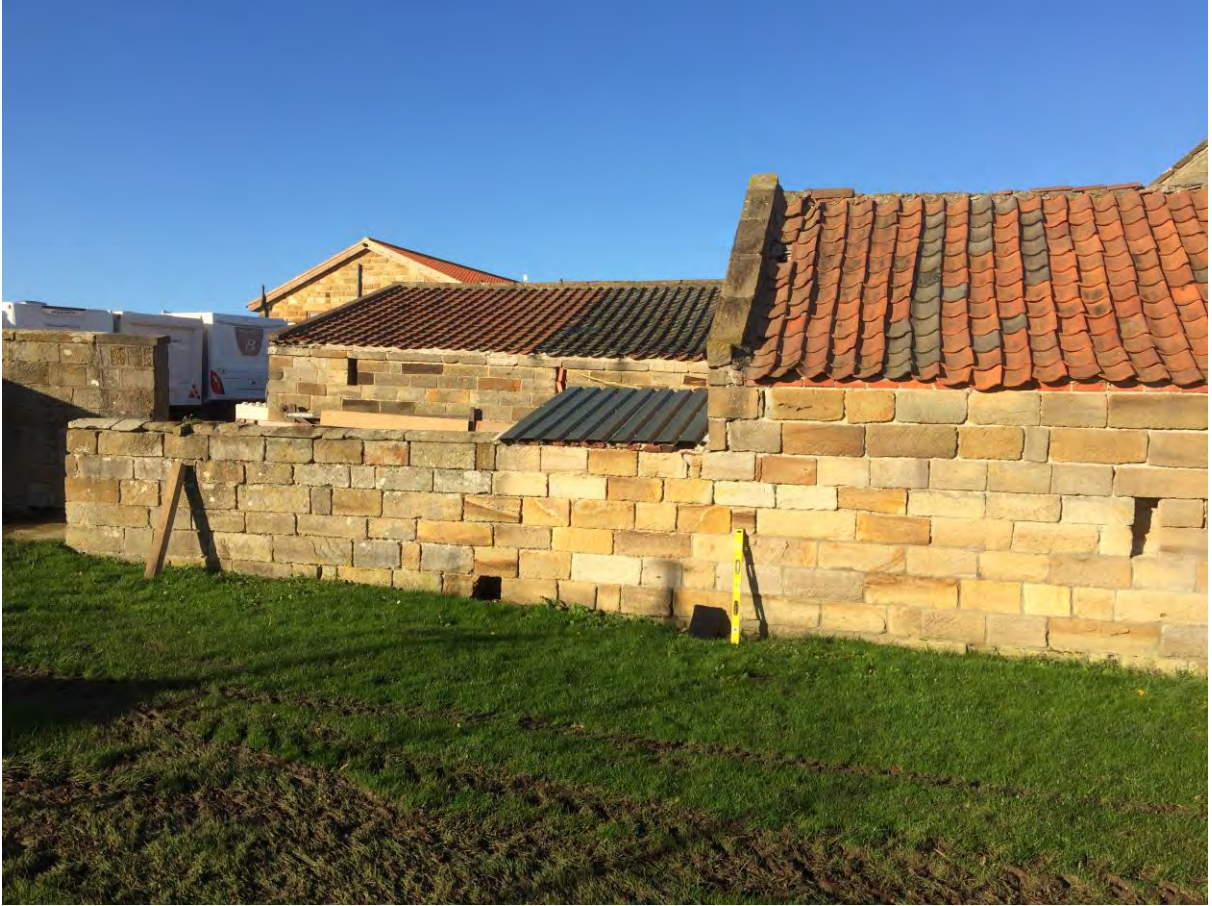
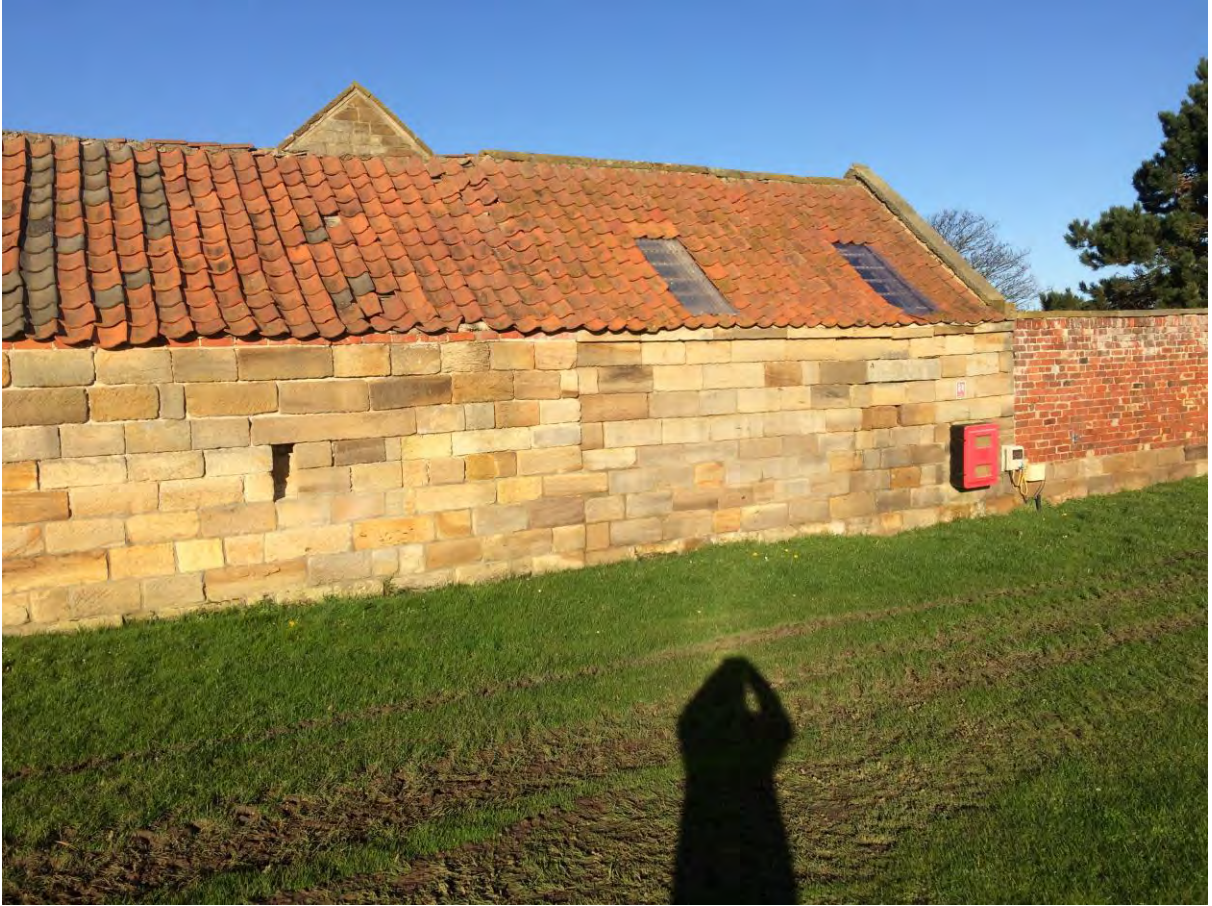
Photograph 22
Sandfield House Farm, Whitby, YO22 4DS

- 4.2 The rear (south facing) elevation can be seen in photographs 22 and 23. The wall is generally in reasonable condition except for some movement near the eastern end, see photograph 24 and at mid-length, see photograph 25.

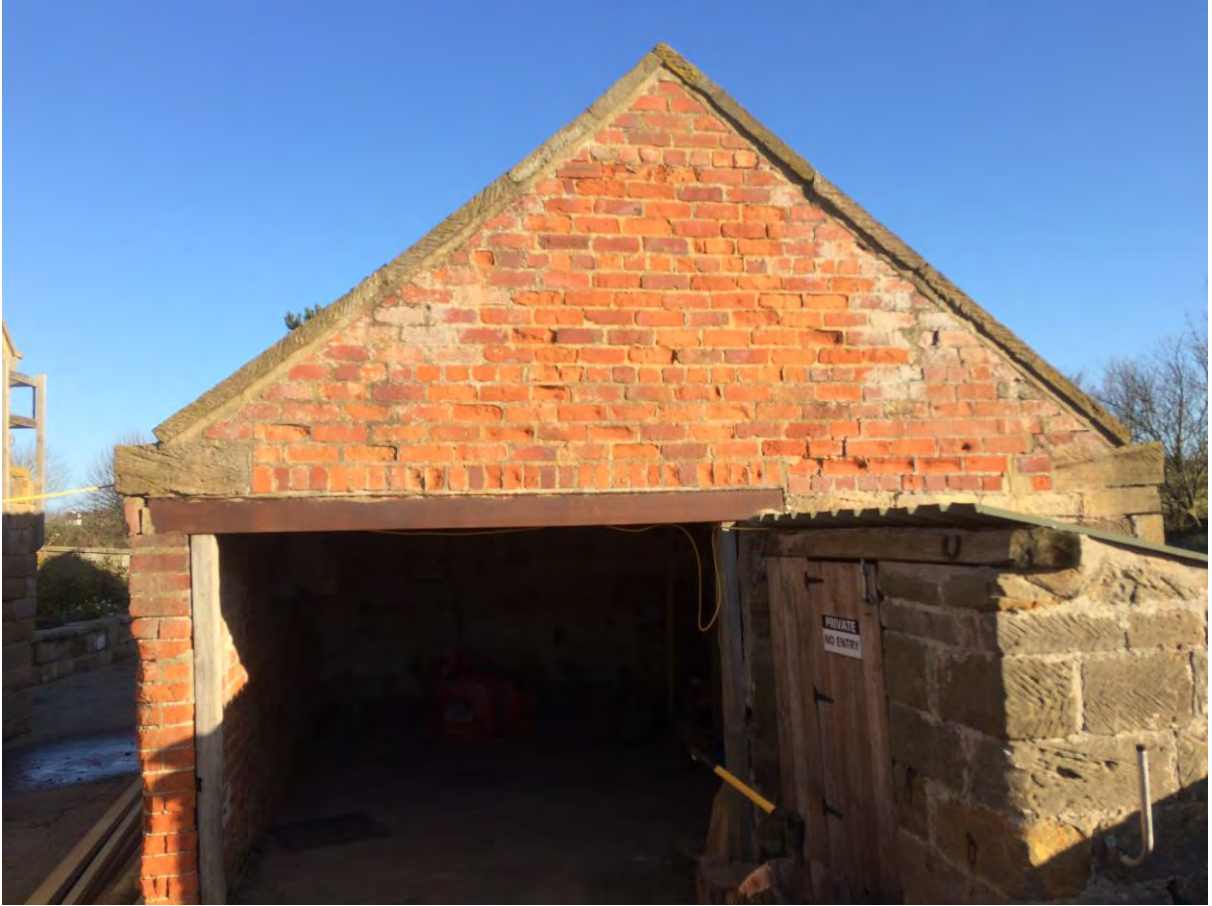
Photograph 26
Sandfield House Farm, Whitby, YO22 4DS

- 4.3 The west facing gable wall can be seen in photograph 26. The wall is in reasonable condition except for some erosion of brickwork.
- 4.4 The east facing gable wall can be seen in photograph 27. The wall is in reasonable condition.

- ii) All bricks suffering from erosion should be replaced.
 - iii) A new blockwork inner skin should be constructed on a concrete raft foundation and the blockwork should support the roof and first floor.

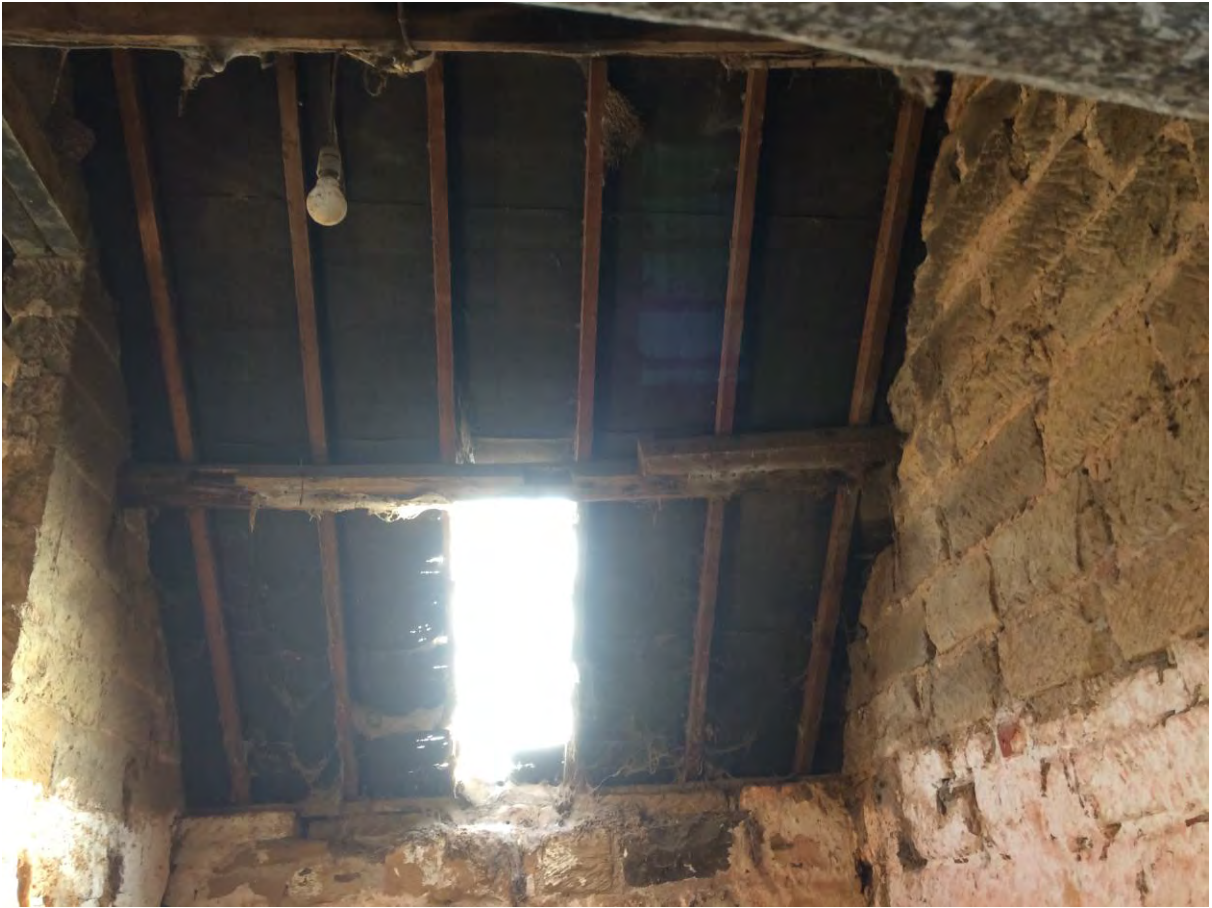
Photograph 28
Sandfield House Farm, Whitby, YO22 4DS

- 4.5 The roof is in poor condition, see photograph 28.
- 4.6 Building C can safely be converted for residential use subject to the following:
 - i) The roof should be completely re-built, although some roof members could be retained if they comply with Building Regulations.
