Bat Survey Report:

Mill Farm, Low Mill, Kirkbymoorside, York, YO62 7UY

Report prepared: 24 December 2020

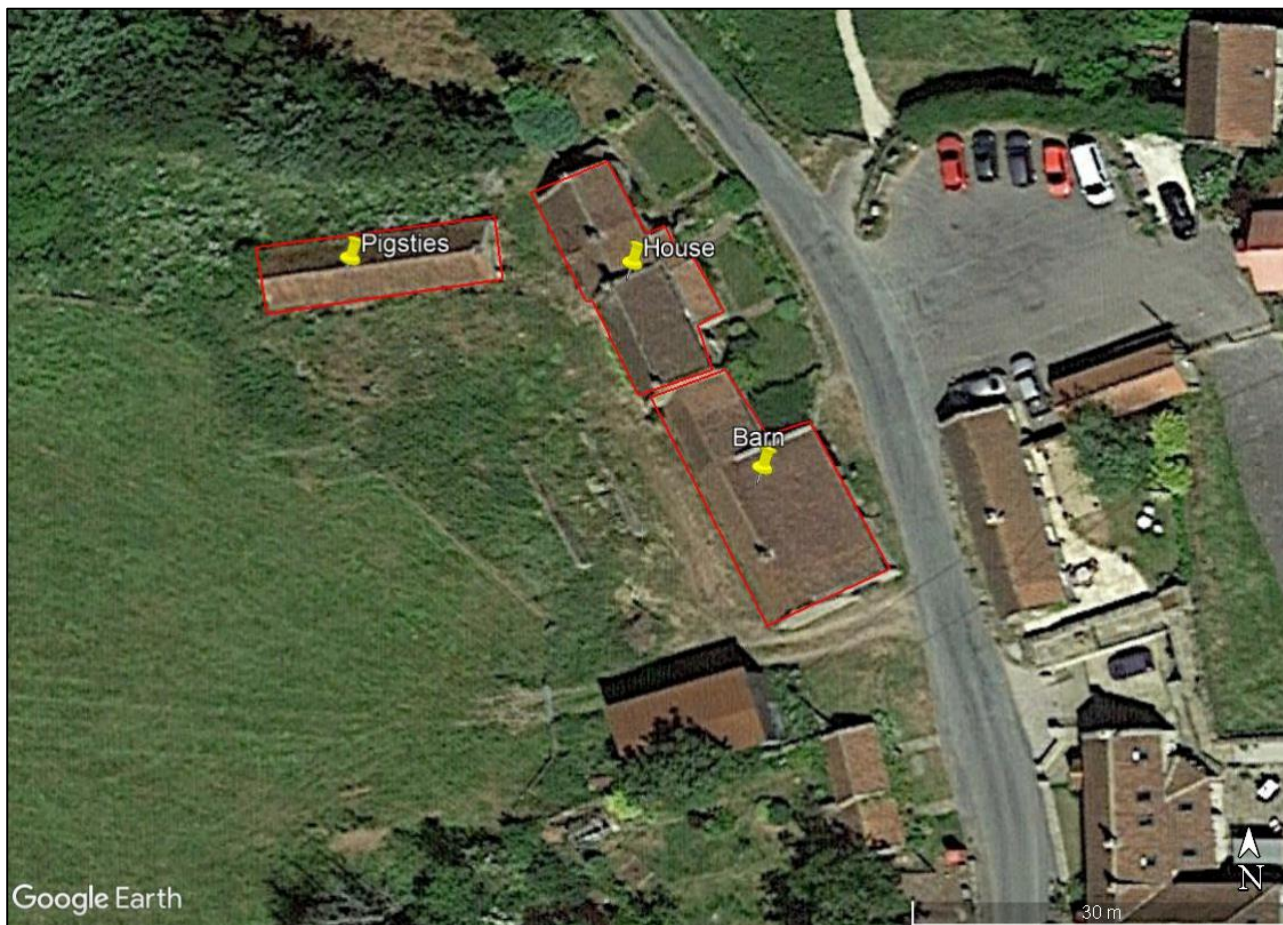
Figure 2: Aerial photograph of survey site with the locations of surveyed buildings indicated

The survey site comprises a range of buildings as illustrated in Fig. 2. In addition, the site includes gardens to the east side of the house and the former farmyard to the west. The farmyard comprises the bases of long demolished buildings and areas of grass. The land to the north of the Pigsties is largely occupied by Hogweed *Heracleum sphondylium*.

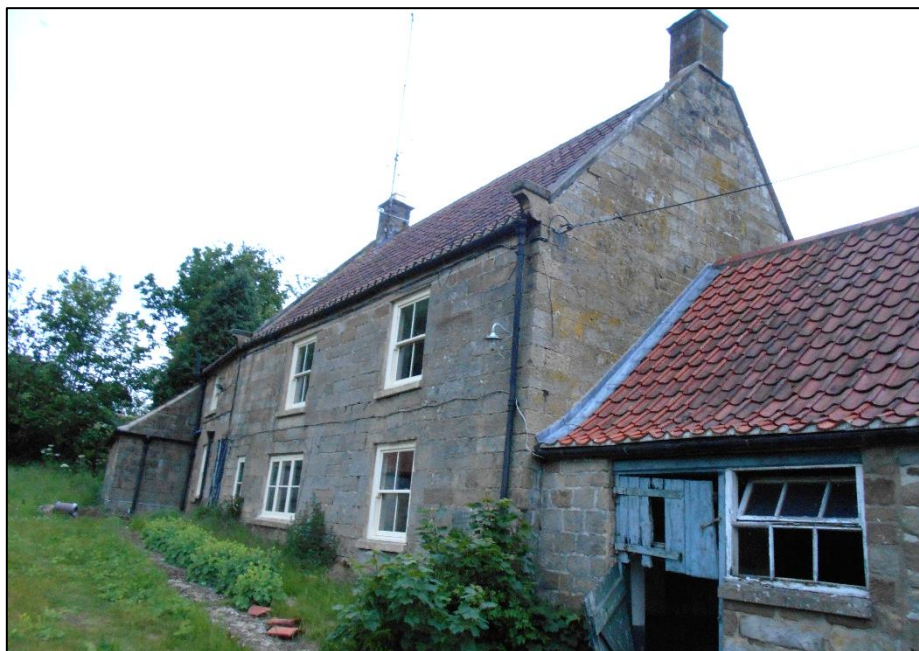
This building is a two-storey stone house with a pantile roof. The building appears to have been extended on several occasions with single storey sections added to the front (east side) and north end. Much of the interior ceiling is boarded and roughly follows the profile of the roof, though there are two loft access points, neither fitted with a hatch at the time of survey. There are some gaps in the external pointing. This building is aligned roughly north to south. Since the first survey in 2012 this building has been re-roofed and the roof lined with a breathable membrane. Since the 2015 survey new windows have been fitted to the building.

Figure 4: West side of the house

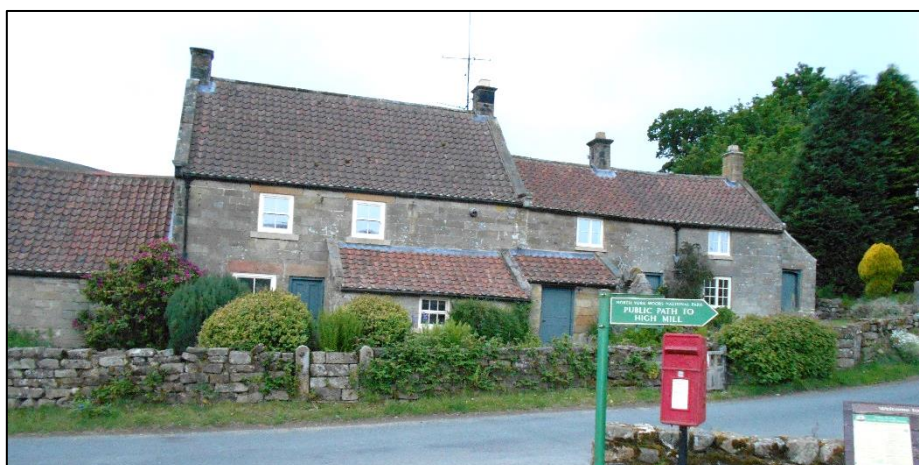
Figure 5: East side of the house

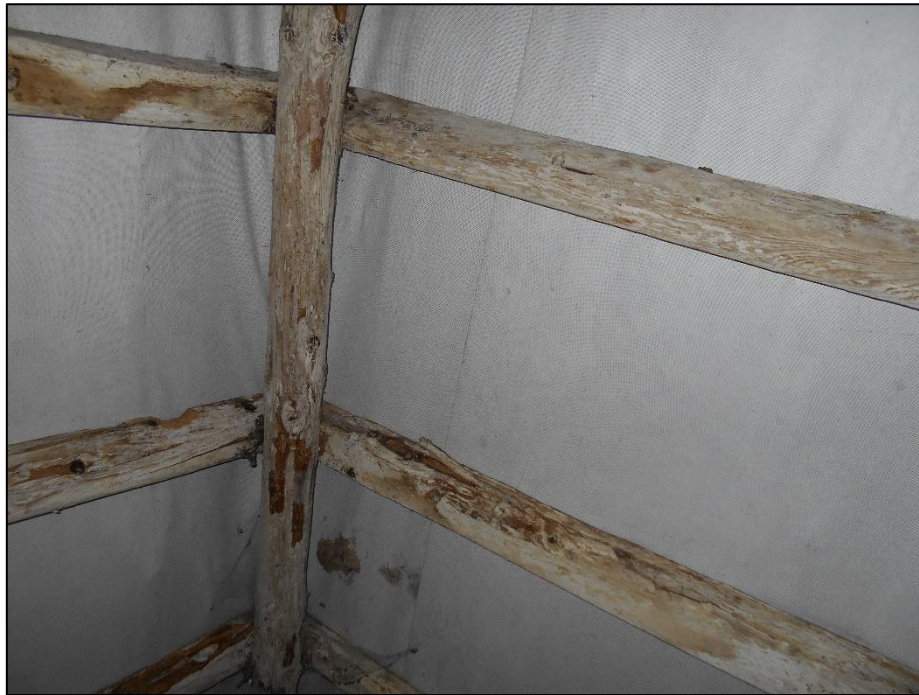
Figure 6: Underside of roof

No bats, bat droppings, feeding remains or other evidence of bats was found in or around this building.

The building still includes a range of exterior crevices in walls that could be suitable for bats and nesting birds.

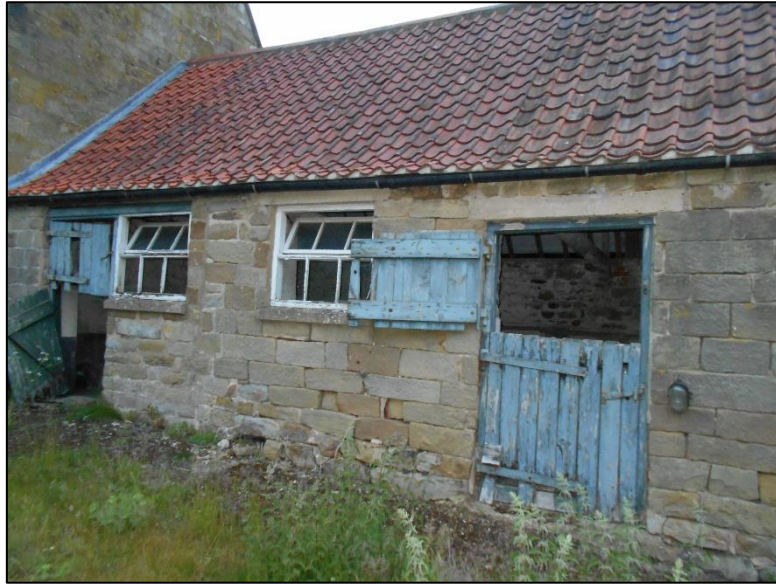
This is a large range of single storey barns attached to the southern end of the house. The range is of stone construction. The pantile roof has been replaced since the 2012 survey and is lined with breathable membrane. At the east side the roof forms a long 'cat-slide'. There is missing pointing in many parts of the walls and above lintels. There are some missing windows and doors which would allow ready access to the interior for bats and birds.

Figure 7: Northern end of barn, west side

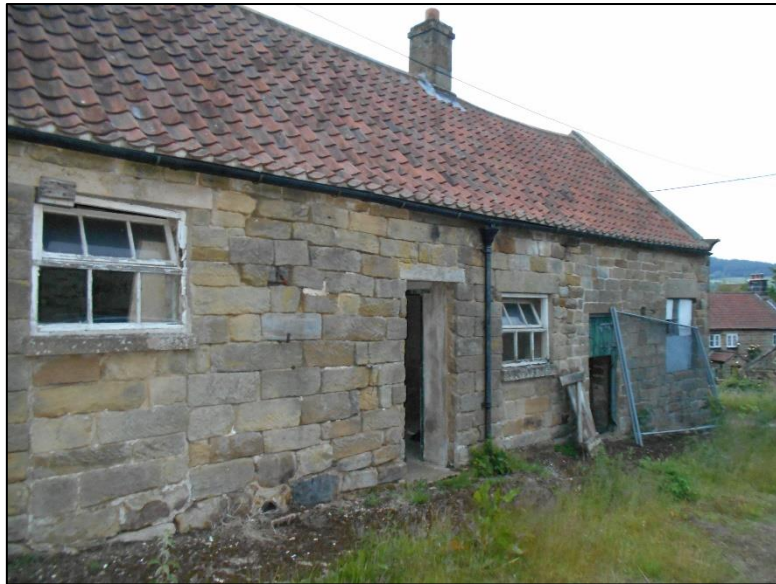
Figure 8: Southern end of barn, west side

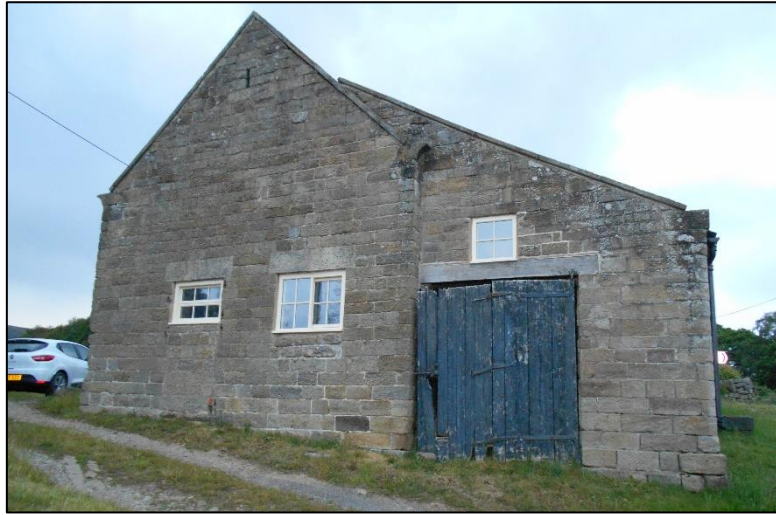
Figure 9: South end of barn

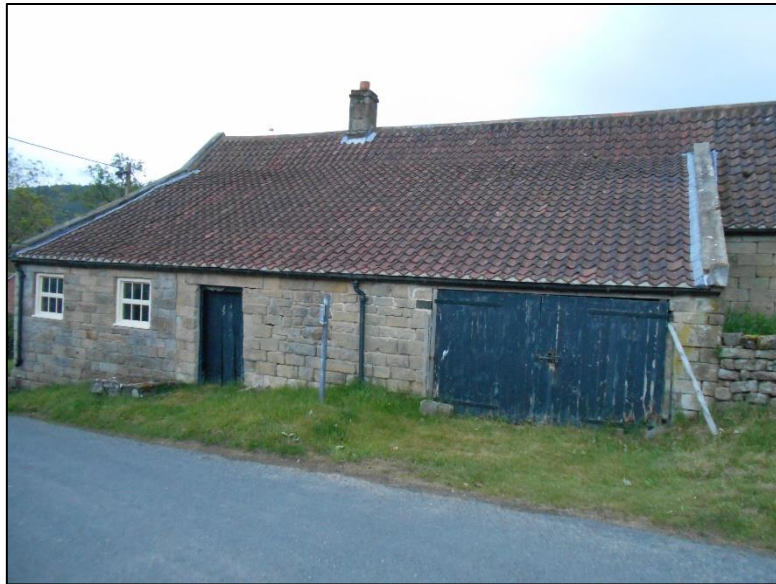
Figure 10: Southern end, east side showing cat-slide roof

Checking during the survey period found no evidence of bats using the Butcher's shop area on the east side of the barn with the cat-slide roof.

A bat loft will be created above the Butcher's Shop area on the east side of the attached barn. This will have a maximum height from floor to ridge of 1507mm along its west wall and will cover an area of approximately 33.5m². This area will be separated from the unconverted part of the building below by a floor of tongue & grooved loft boards. The roof of this area will be lined with Type 1F bitumen based underfelt. The existing breathable membrane within this area will be removed. A small loft hatch will be fitted to give human access to the loft for maintenance and bat monitoring only. A notice will be fitted inside the loft reaffirming the need for consent before entering.

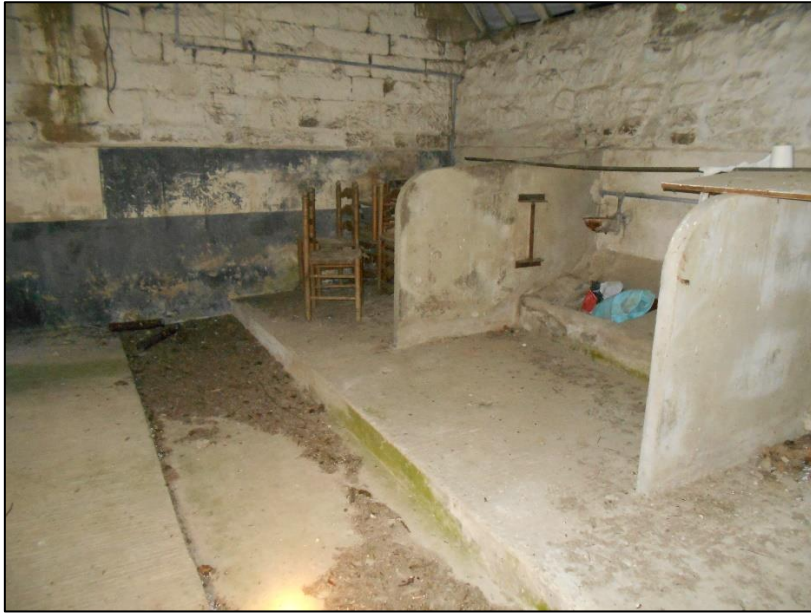
Figure 11: Interior of western side of barn

A small number of Brown Long-eared bat droppings were found inside the barn fitted with animal stalls along the base of its southern wall.

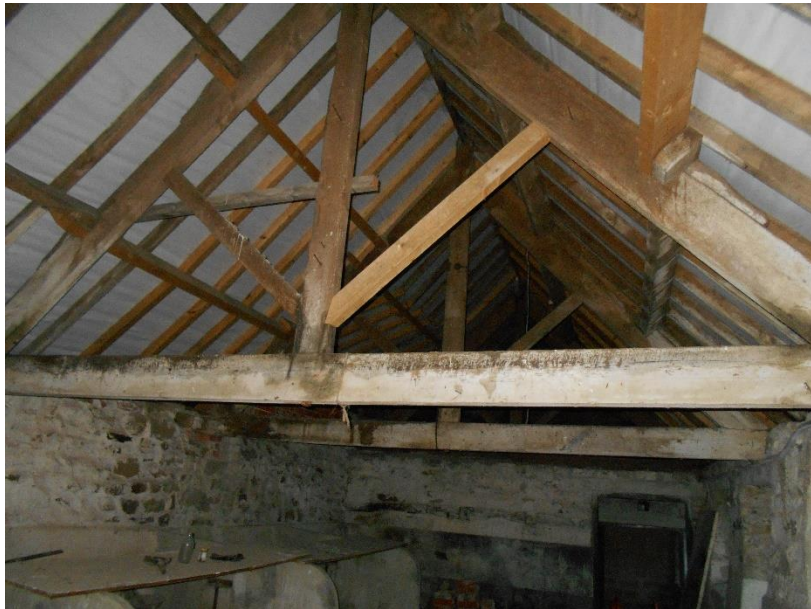
Figure 12: Underside of roof, south end of building

The interior of the barn is easily accessible due to missing and/or open doorways. Although the building has been re-roofed since the earlier surveys in 2012 & 2015, it is still possible for bats to roost among roof timbers and/or in wall crevices, both internal and external. The building supports two small bat roosts.

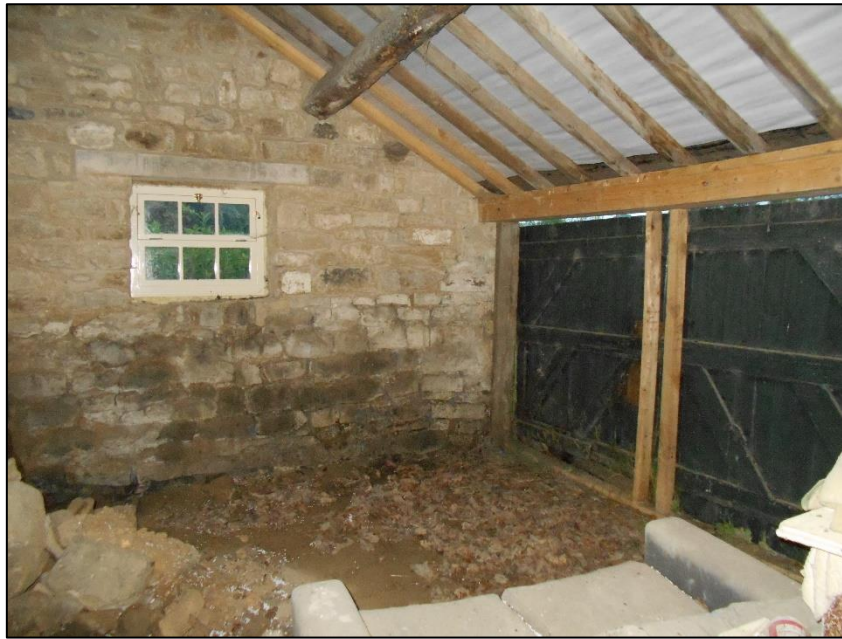
13: Interior of part of eastern single storey section beneath catslide roof

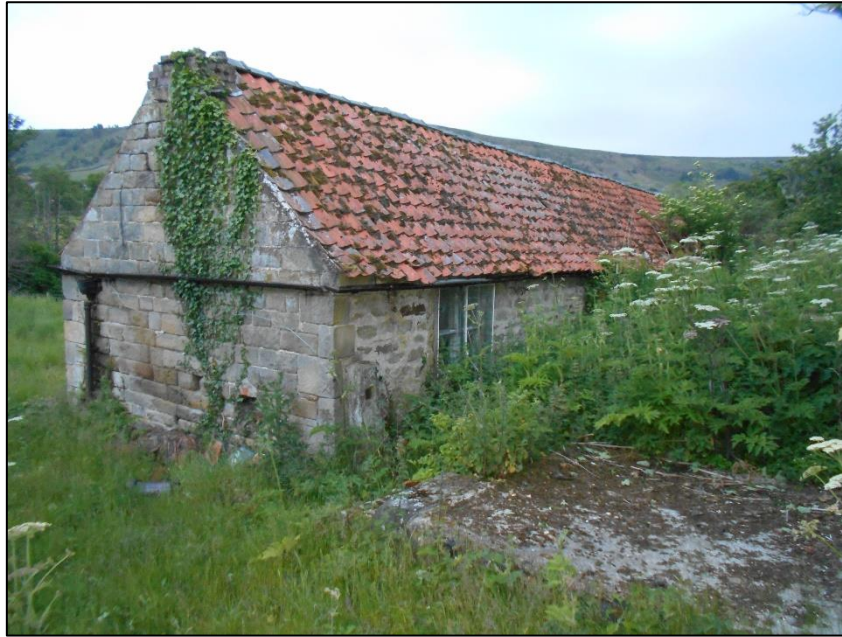
This is a single storey stone building with a pantile roof. The roof is supported on fairly small timbers and is lined with wooden laths. The building is aligned roughly east to west. Some parts of the building do not have a separate roof void, but the east end does have a substantial void which is accessed via a door opening in the upper wall of the most easterly unit. There are open doorways to most parts of the building, gaps in the pointing and between roof tiles. The north side of the building is partly set into the slope of the ground and is rather overgrown.

Figure 14: North side of building

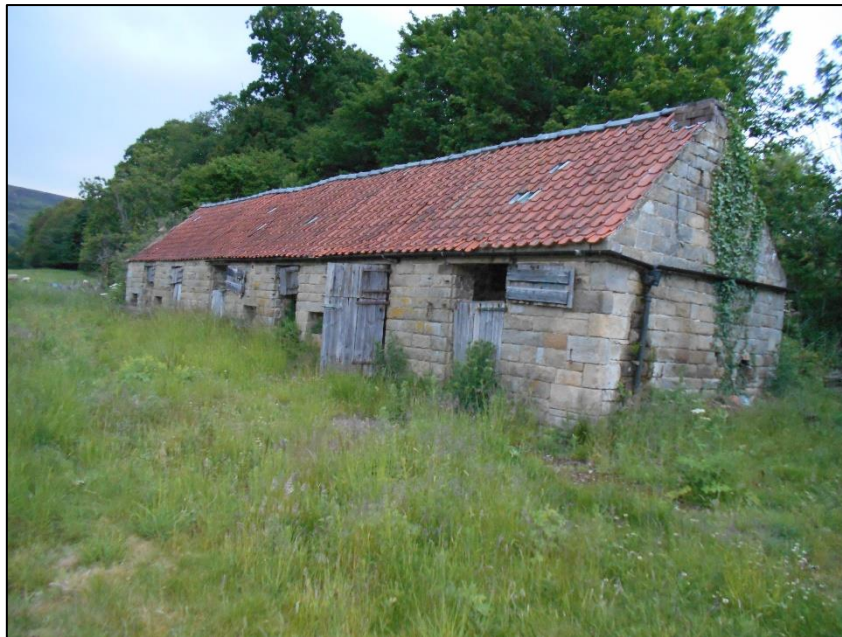
Figure 15: South side of building

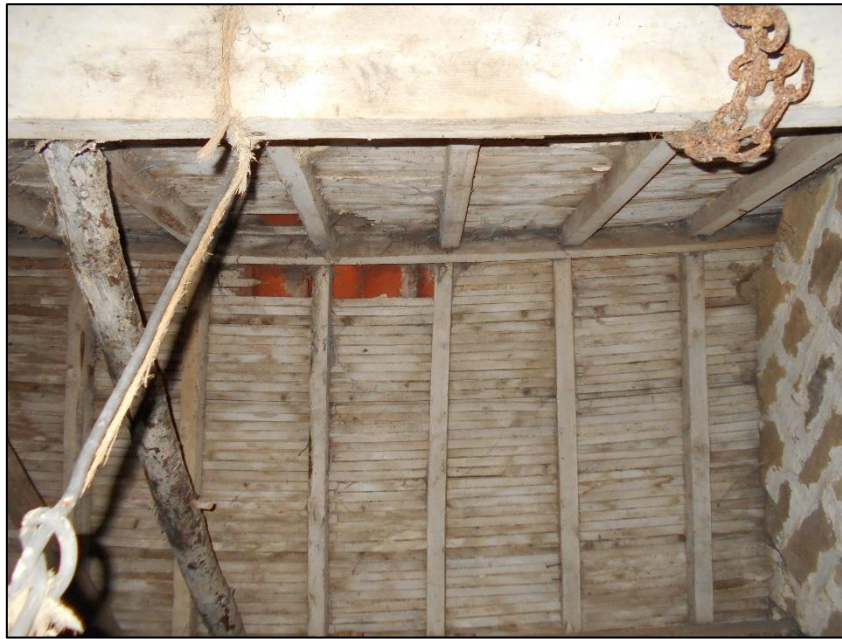
Figure 16: Underside of roof

This is a building with numerous potential access points that would allow bats to access the roof void, gaps within the stone walls and gaps between roof tiles and wooden laths. It is considered to have moderate to high bat roost potential, although surveys have repeatedly found no evidence of bats using the building.

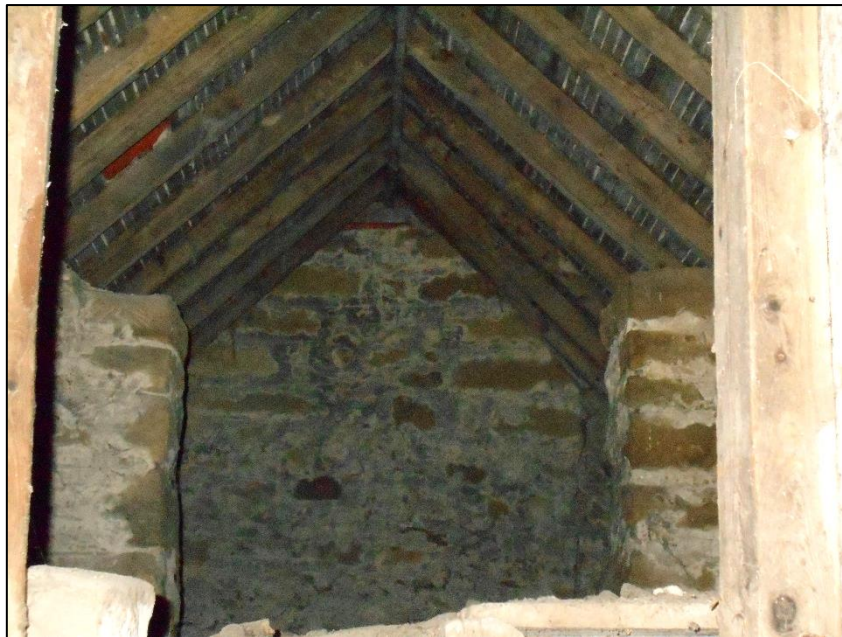
Figure 17: View westwards through roof void

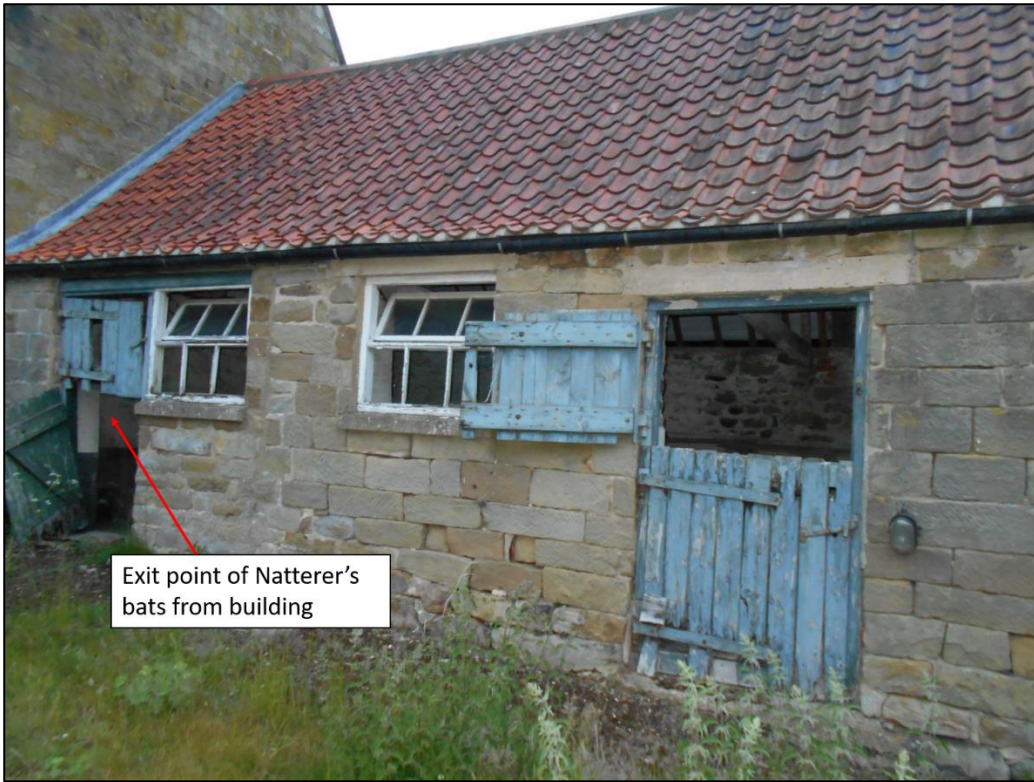
At the north end of the attached barn six Natterer's bats were confirmed to be roosting between the pantiles and underfelt. Judging by the sound of bats moving over the underfelt the bats are roosting towards the north-eastern corner of the building, but are emerging into the inside of the building from behind the last timbers against the north end wall at the north-west corner.

Figure 19: Emergence / access point of Natterer's bats from building

Provided that a licence has been granted, bats will be excluded from their existing roosts prior to the 15 April 2021. The exclusion will be carried out by fitting one way valves to existing roost entrances that will allow bats to leave the roosts, but not return. Monitoring of the exclusion will be by observation and/or automatic cameras. Roost entrances will only be finally blocked after no bats have been recorded emerging over three continuous nights.

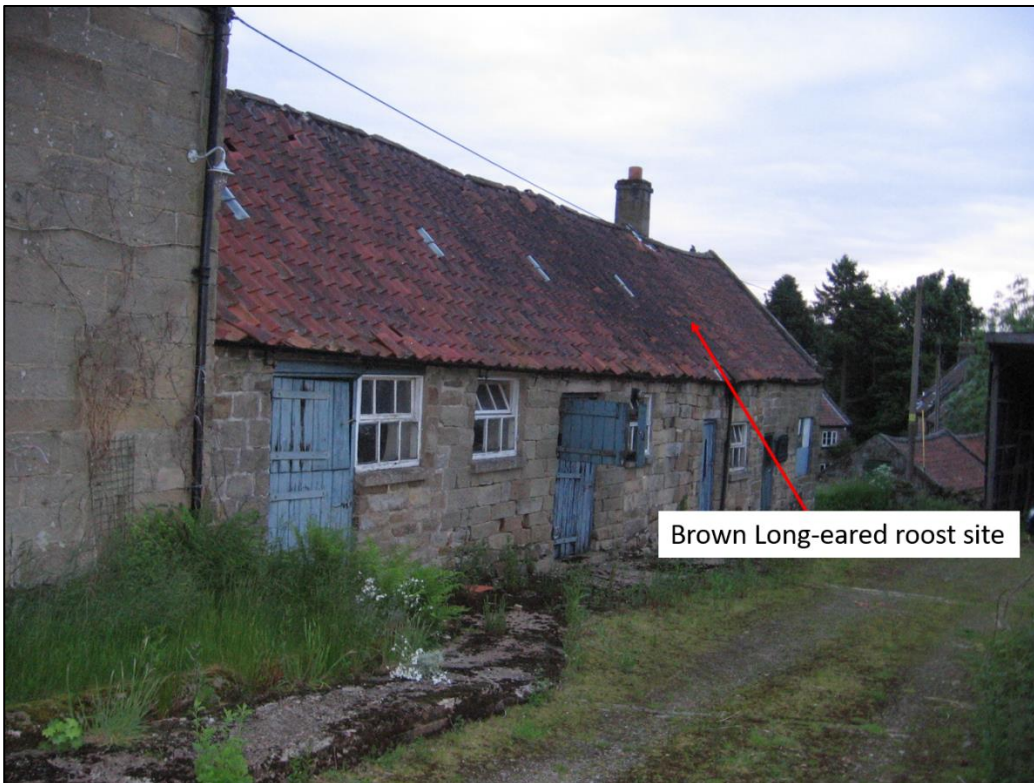
At the south end of the barn five Brown Long-eared bats are roosting between the pantiles and underfelt at the extreme south-west corner. These bats enter and emerge from their roost at the internal gable apex of the building, reaching their roosting site by scrambling between the pantiles and underfelt.

Figure 20: Approximate location of Brown Long-eared roost
