The Old Sawmill,
Sandsend, North Yorkshire
Car Park Proposals

Preliminary Ecological Assessment Report

Report for The Mulgrave Estate

FLOOD RISK ASSESSMENT

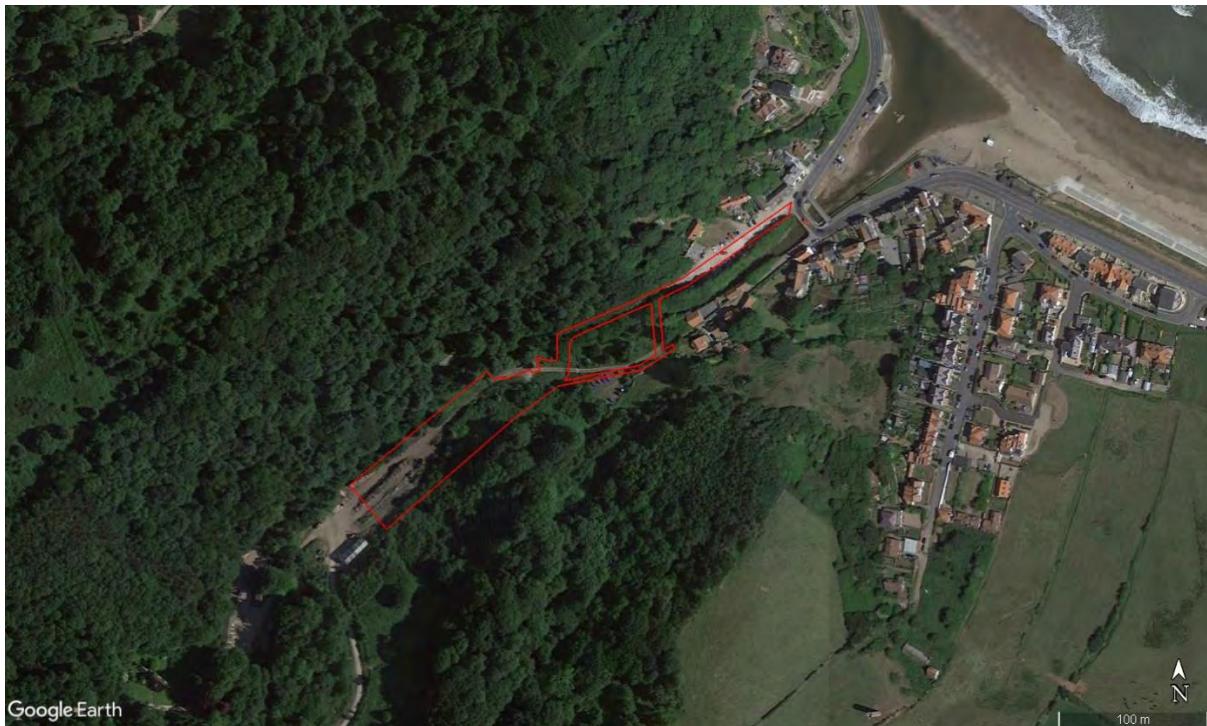
Fig 1: Plan showing the site boundary.

The area covered by this report includes the red line boundary plan for the planning application as shown in Figure 1 below. As such it extends from the point where the A174 passes over East Beck on the sea front, runs alongside the left bank of East Beck before crossing over to the right bank of East Beck to the site of the Old Sawmill. The site includes two crossings of the beck on the line of proposed vehicle and pedestrian bridges.

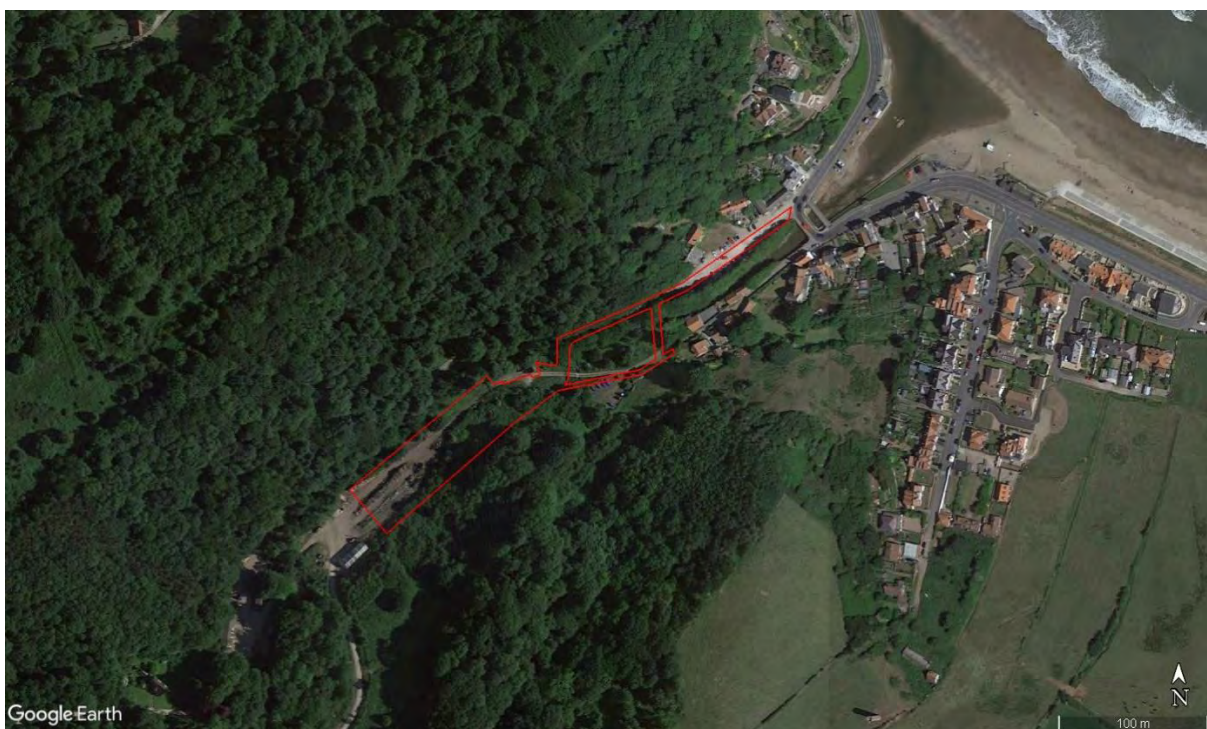
Fig 1: Plan showing the site boundary.

The area covered by this report comprises the red line boundary plan for the planning application as shown in Figure 1 below. As such it extends from the point where the A174 passes over East Beck on the sea front, runs alongside the north bank of East Beck before crossing over the beck to the Old Sawmill site. The site includes proposed vehicle and pedestrians crossings of the beck.

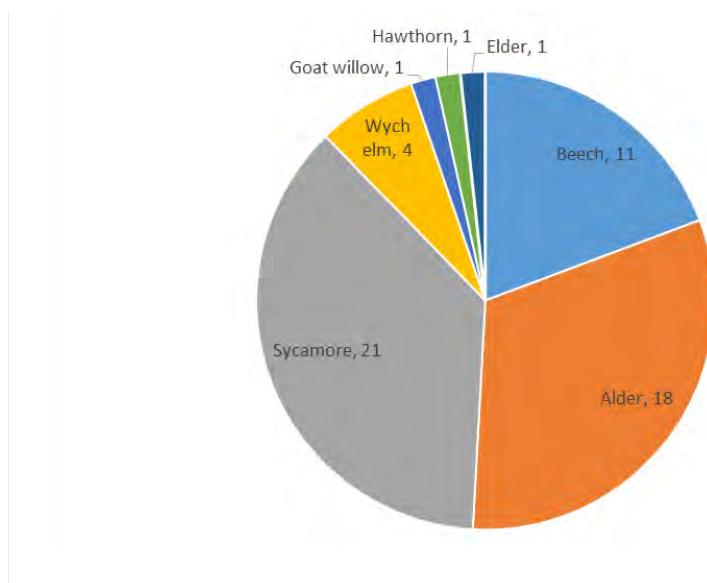
The diagram below provides an illustration of tree diversity and frequency.

Fig 1: Species recorded for individually surveyed trees.

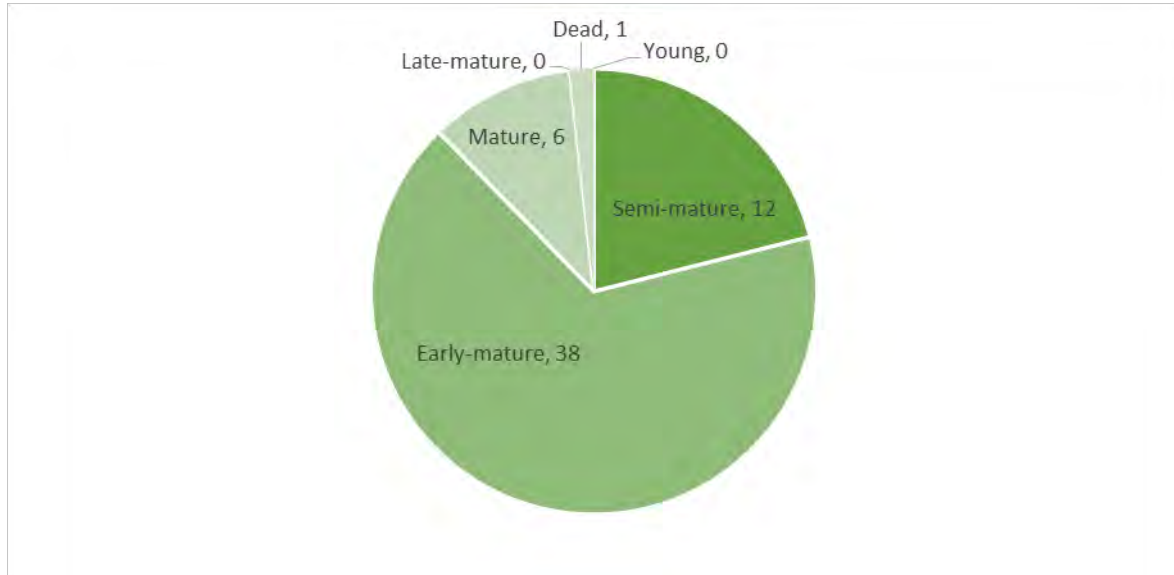
The diagram below provides an illustration of the profile of tree age at the site.

Fig 2: Age distribution of individually surveyed trees.

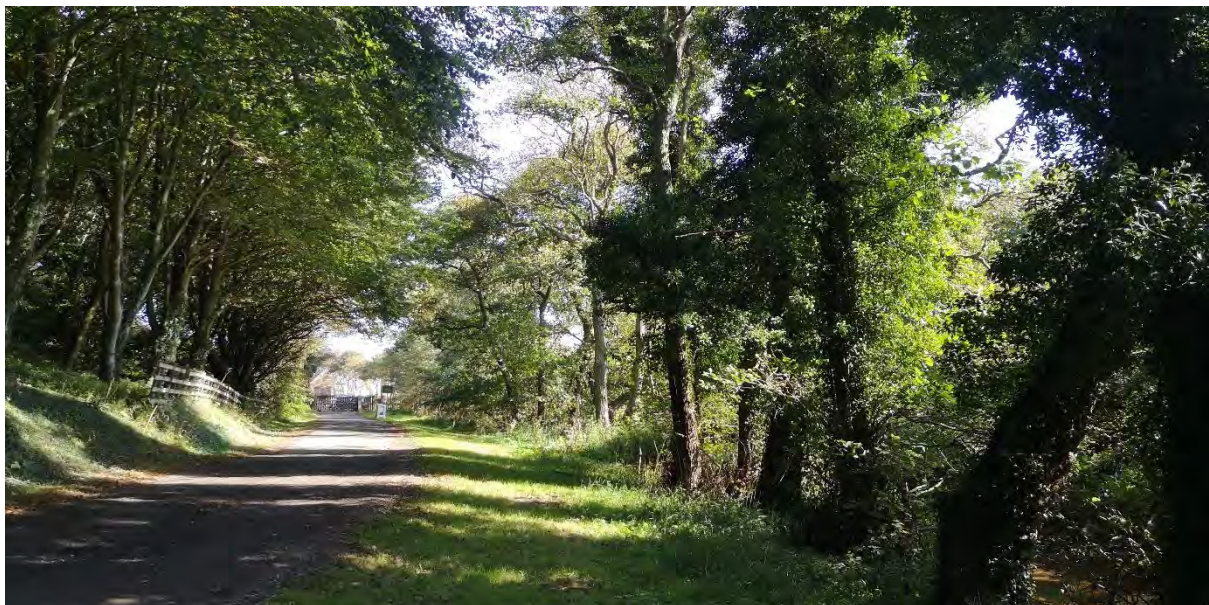
Photo 1. View looking east along track with the bankside woodland G4 to the left and riverside alder trees G2 to the right.

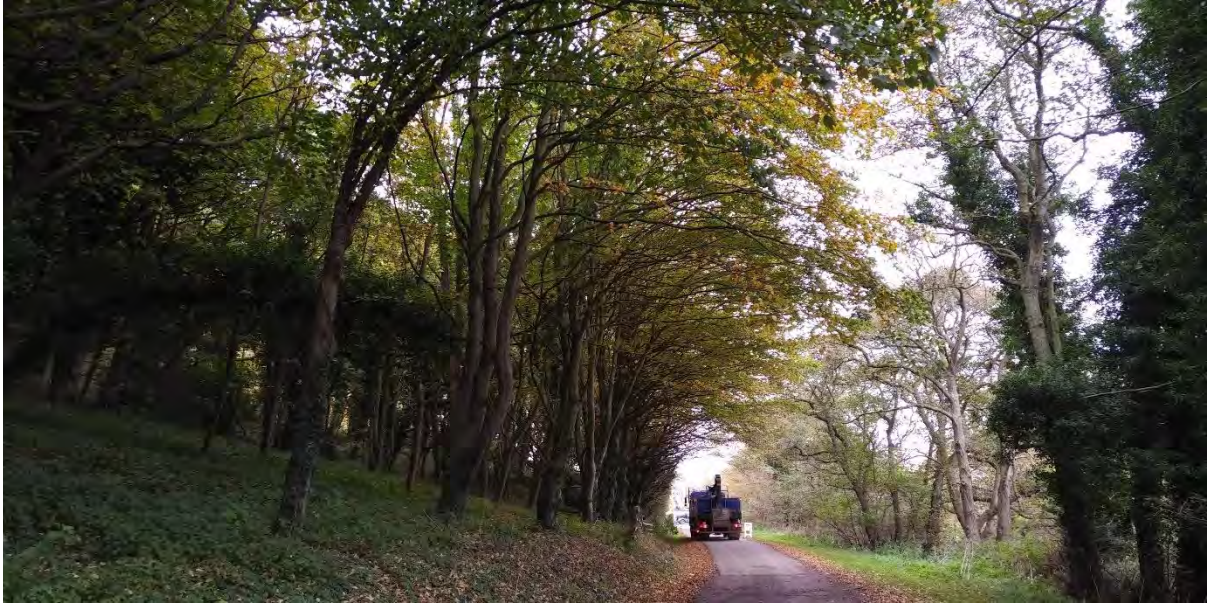
Photo 2. View looking east along track with beech trees T1-7 in view on the edge of the bankside woodland G4.

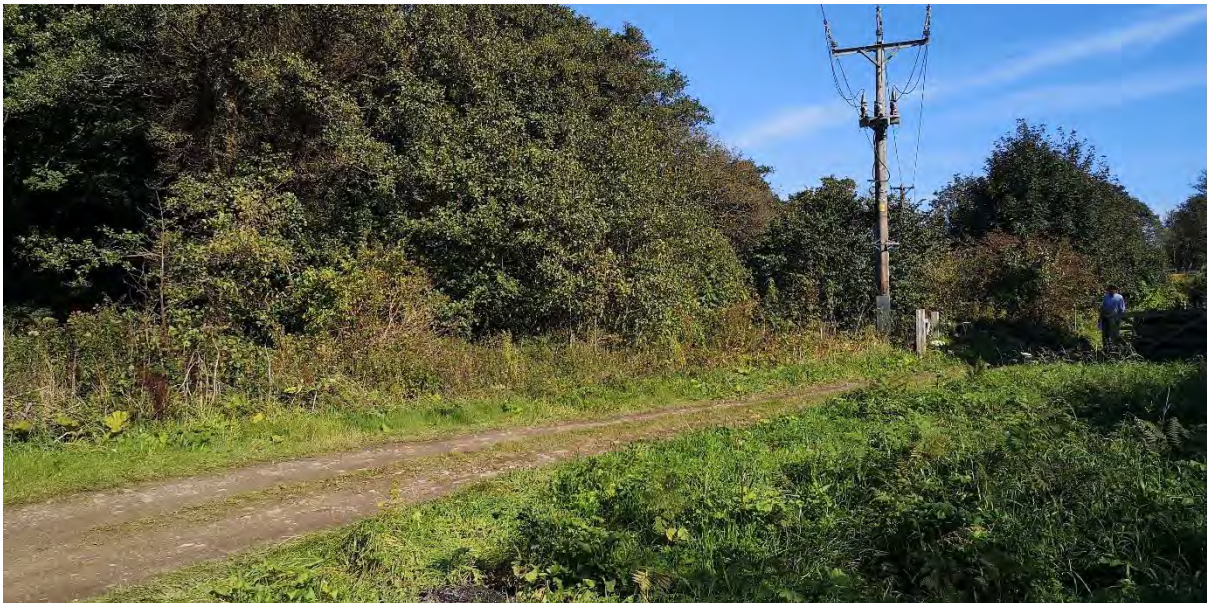
Photo 3. View from south side of East Beck of the riverside alder trees G2 and scrub G8.

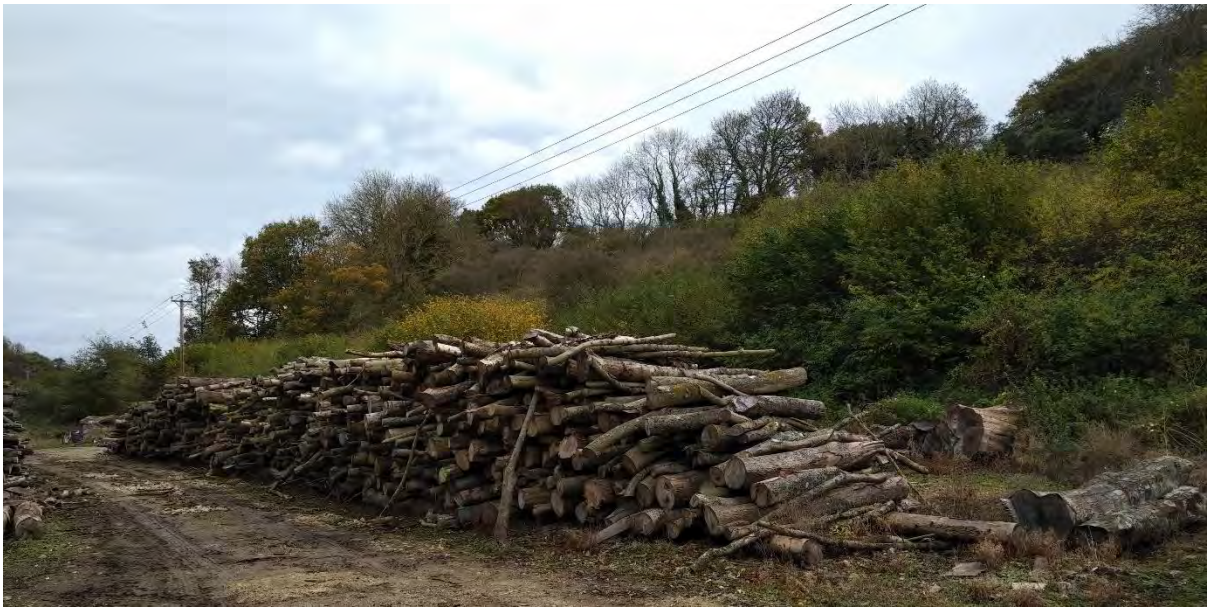
Photo 4. View looking south-east across sawmill site, with fringing scrub G6 and G7 in view.

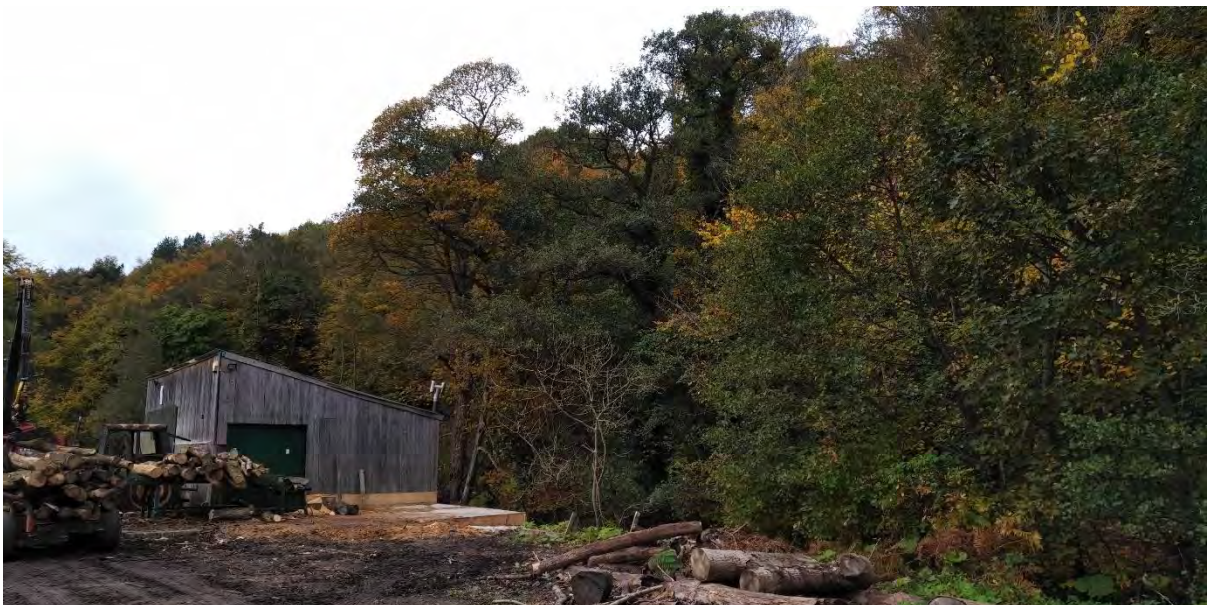
Photo 5. View looking north west across sawmill site, with riverside alder and sycamore trees T39-42 and G5 in view.

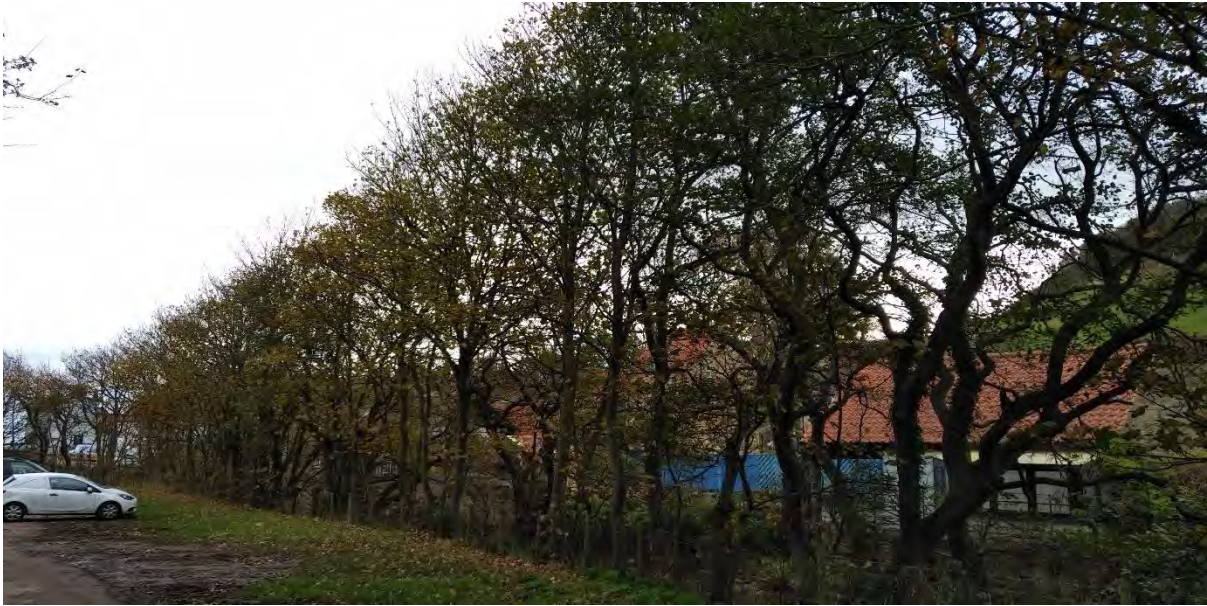
Photo 6. View looking east across roadside carpark and with streamside row of alder and sycamore G1 in view.

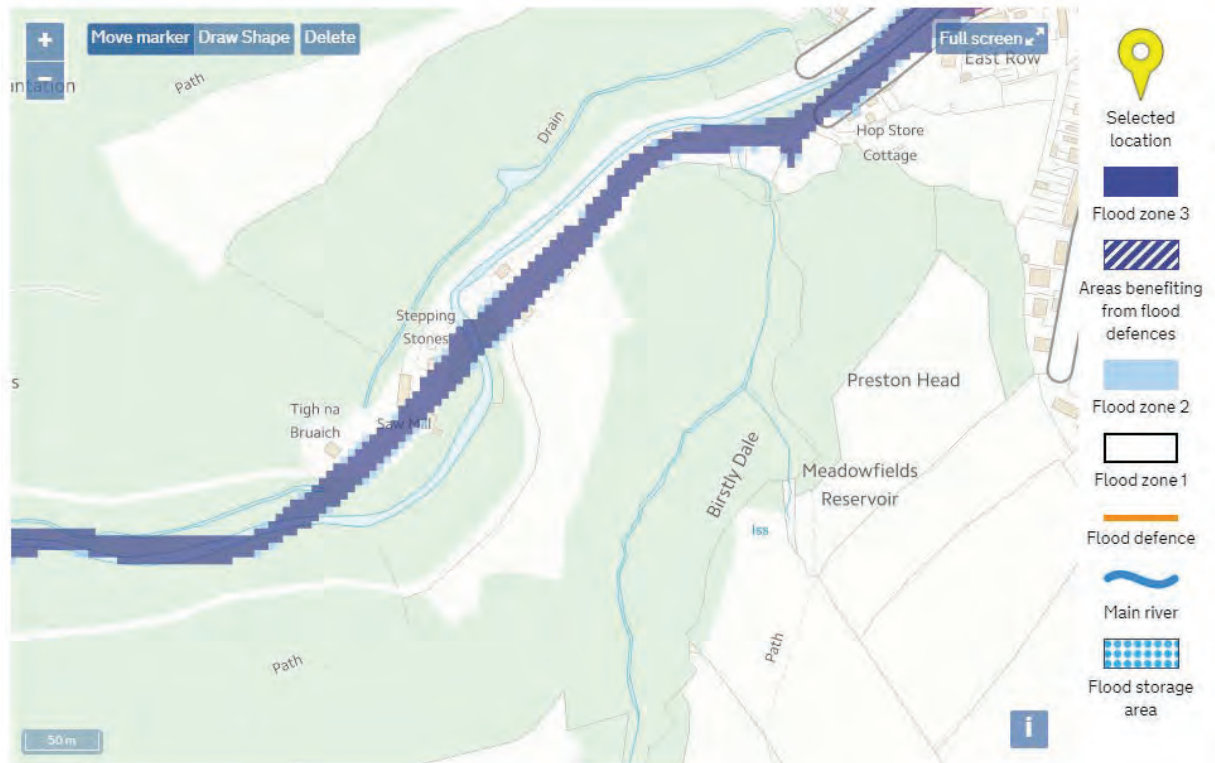
Figure 2 – Environment Agency Flood Map Extract (05.10.2020)

As can be seen in Figure 2 above the level of accuracy in flood maps is somewhat questionable. Therefore, the extent of flood zones will be assumed as being 5m either side of the watercourse which ties into the overall extent of the flood zone.

Taking into account the inaccurate line of the flood zones it is assumed that the flood zones should be realigned with the watercourse. This placing the northern most extent of the proposed car park within flood zone 2 & 3 and the rest of the development flood zone 1.

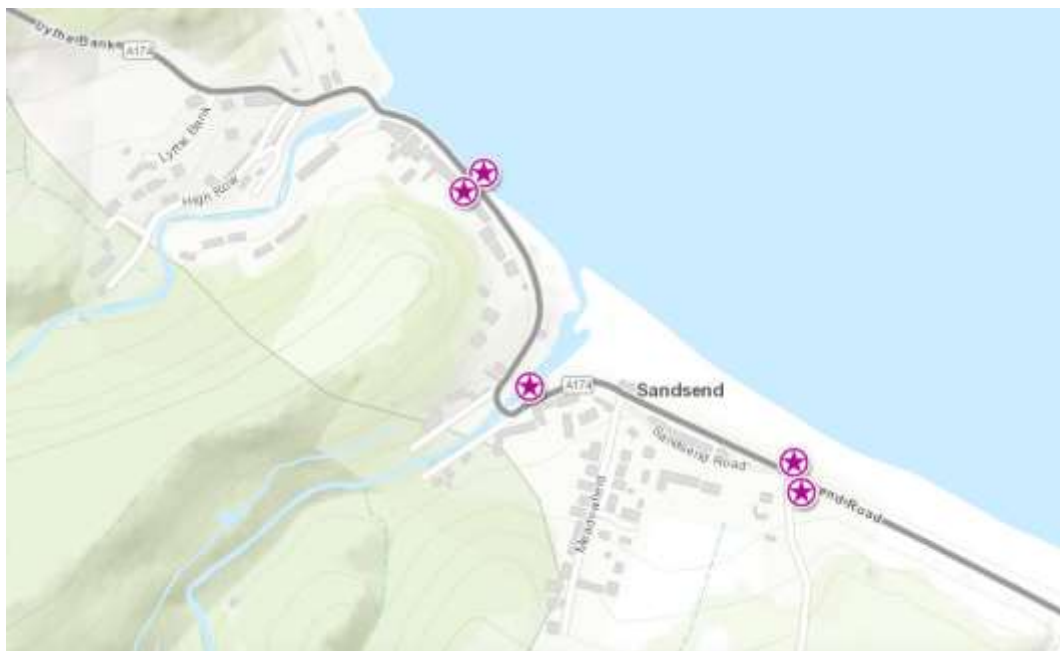
Figure 3 – Location of Bus Stops

4.4.1 The location of bus stops in proximity to the site are shown on **Figure 3**. These stops provide access to service numbers X4 and X4a which are operated by Arriva and run every 30 minutes (60 minutes on an evening) between Middlesbrough and Whitby via Loftus.
