## Design and Access Statement

Conversion of Redundant Barn to form 2 Holiday Cottages  
South East of the Granery, Suffield, YO13 0BJ

Conversion of Redundant Barn to form 2 Holiday Cottages  
South East of 'The Granery,' Suffield, YO13 0BJ

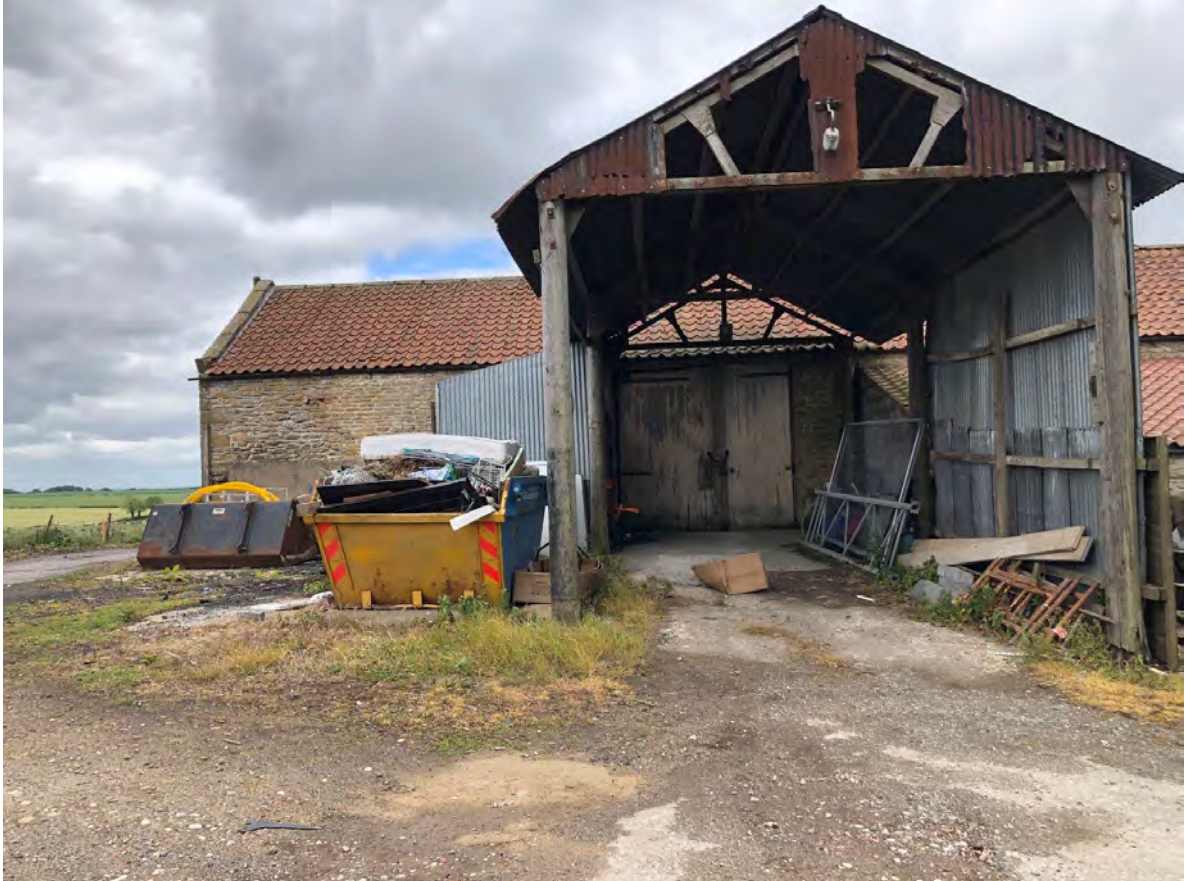
Photograph 1  
East Elevation inc. Pole Barn

To the east is a 'Pole Barn,' with sheeted roof and part clad side.

The large opening to the east is partly covered by this Pole Barn.

Externally the Pole Barn will be refurbished to provide external covered amenity space for both cottages.

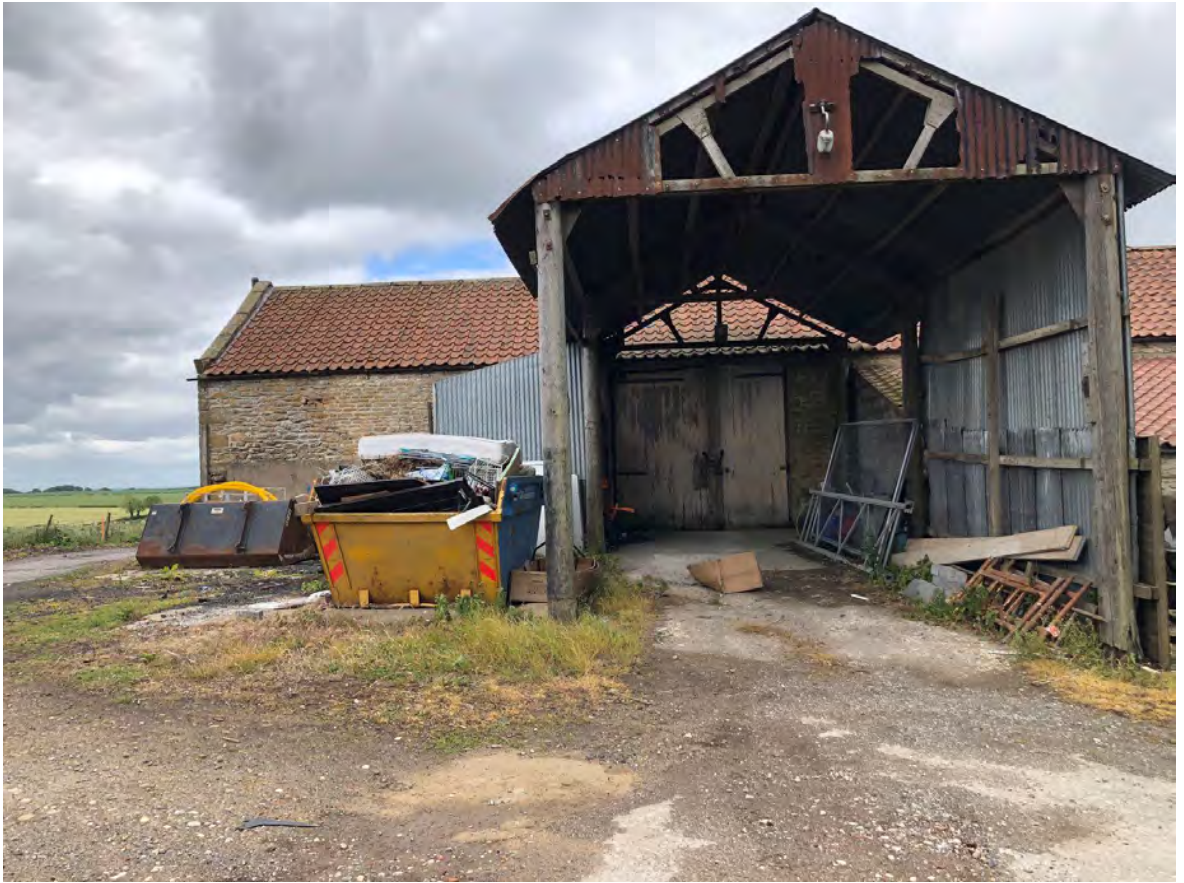
Photograph 1  
East Elevation inc. Pole Barn

Parking areas and storage are located on the east elevation.

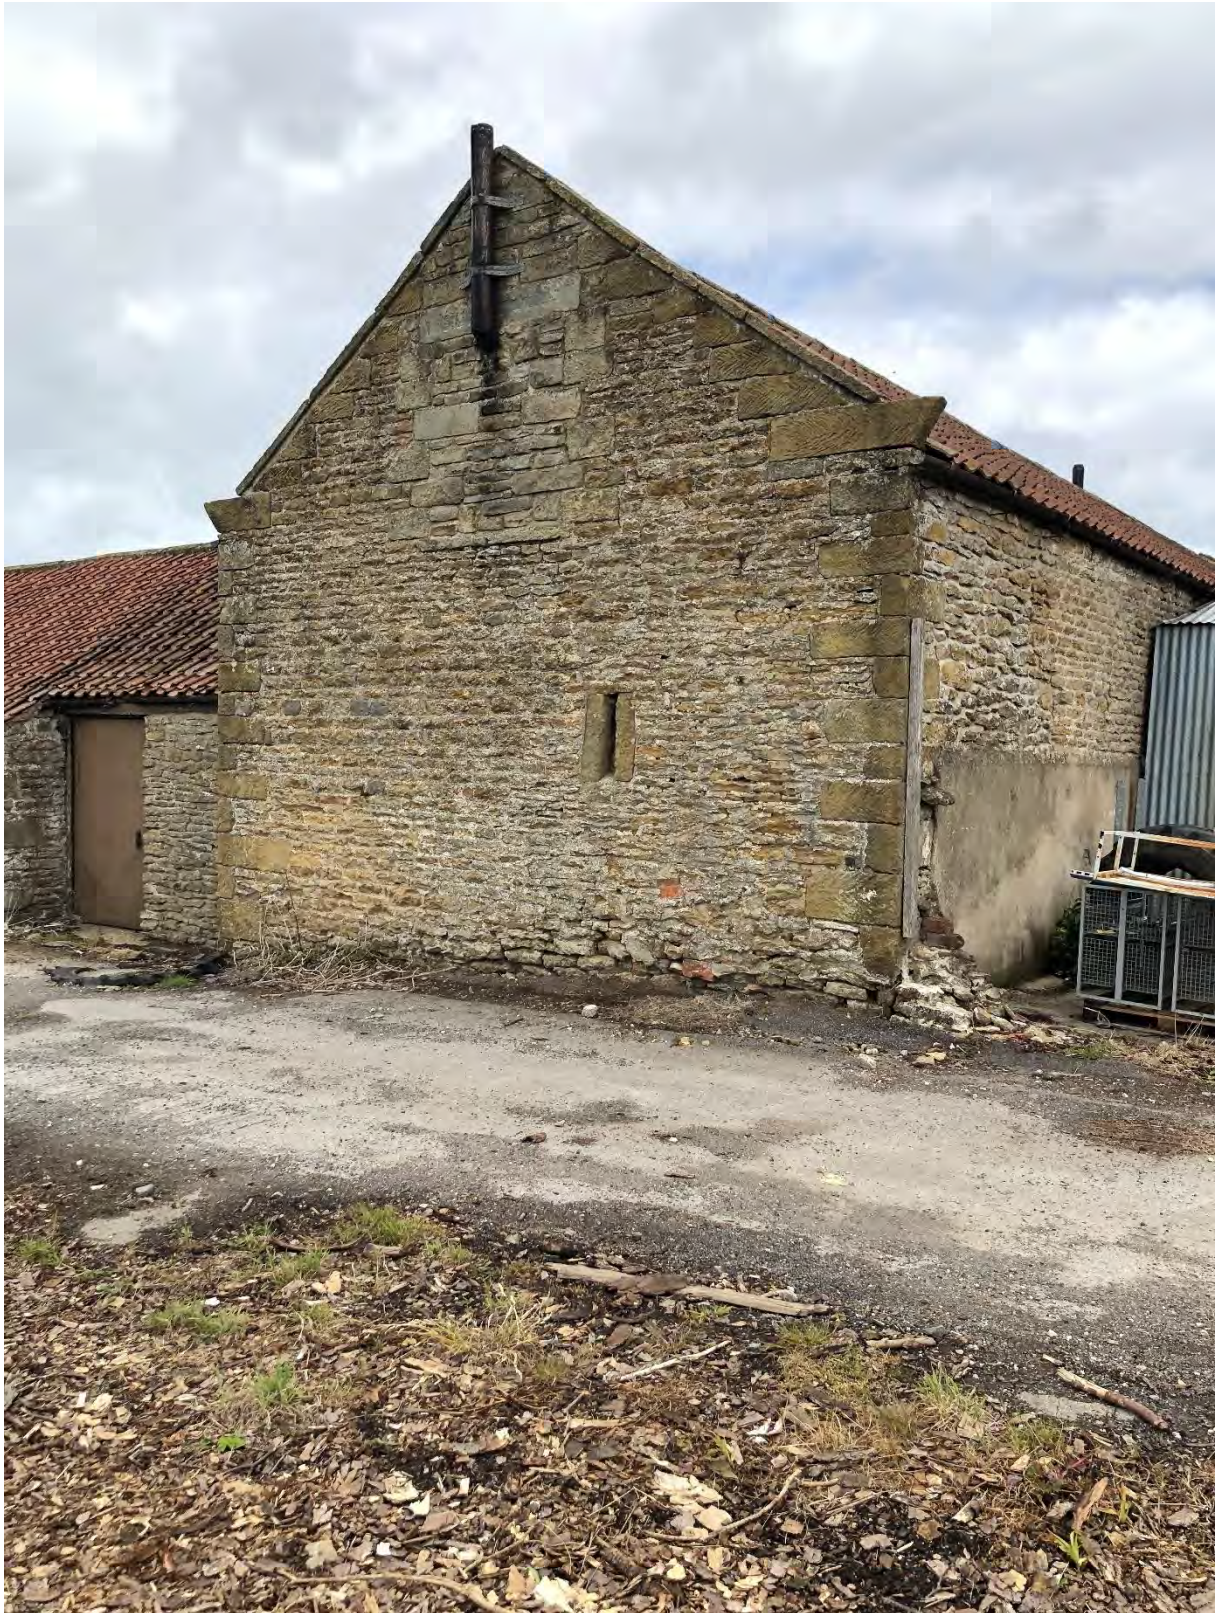
Photograph 3  
South gable with outline of previous opening visible

In respect of the south gable wall, a first-floor window is to be inserted within a previous opening.

Two further openings are proposed in this gable to the ground floor. They traditionally sized at 1m square and plain in appearance. They have been positioned to give symmetry to the gable.

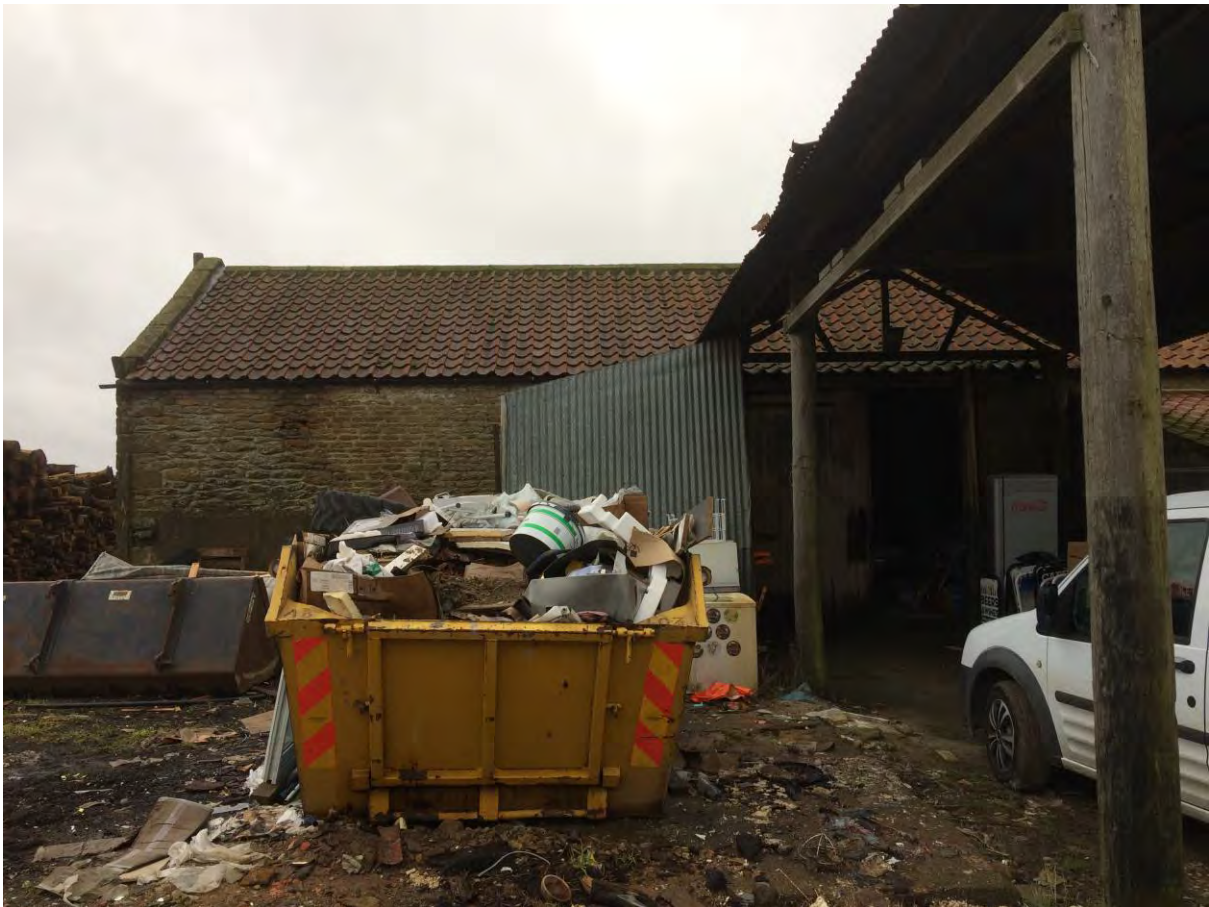
Photograph 1  
Northfield Farm, Suffield, YO13 0BJ

- 2.1 The east facing elevation can be seen in photograph 1. The wall is in reasonable condition except for some isolated areas with lack of mortar, see photograph 2. Some render has been applied over the lower part of the wall, see photograph 3. There is a timber lintel over the doorway, see photograph 4.

- 2.5 The external face of the roof is in reasonable condition, see photographs 1 and 7.
- 2.6 The internal roof support consists of timber rafters, timber purlins and 3 no. timber roof trusses, see photograph 11.

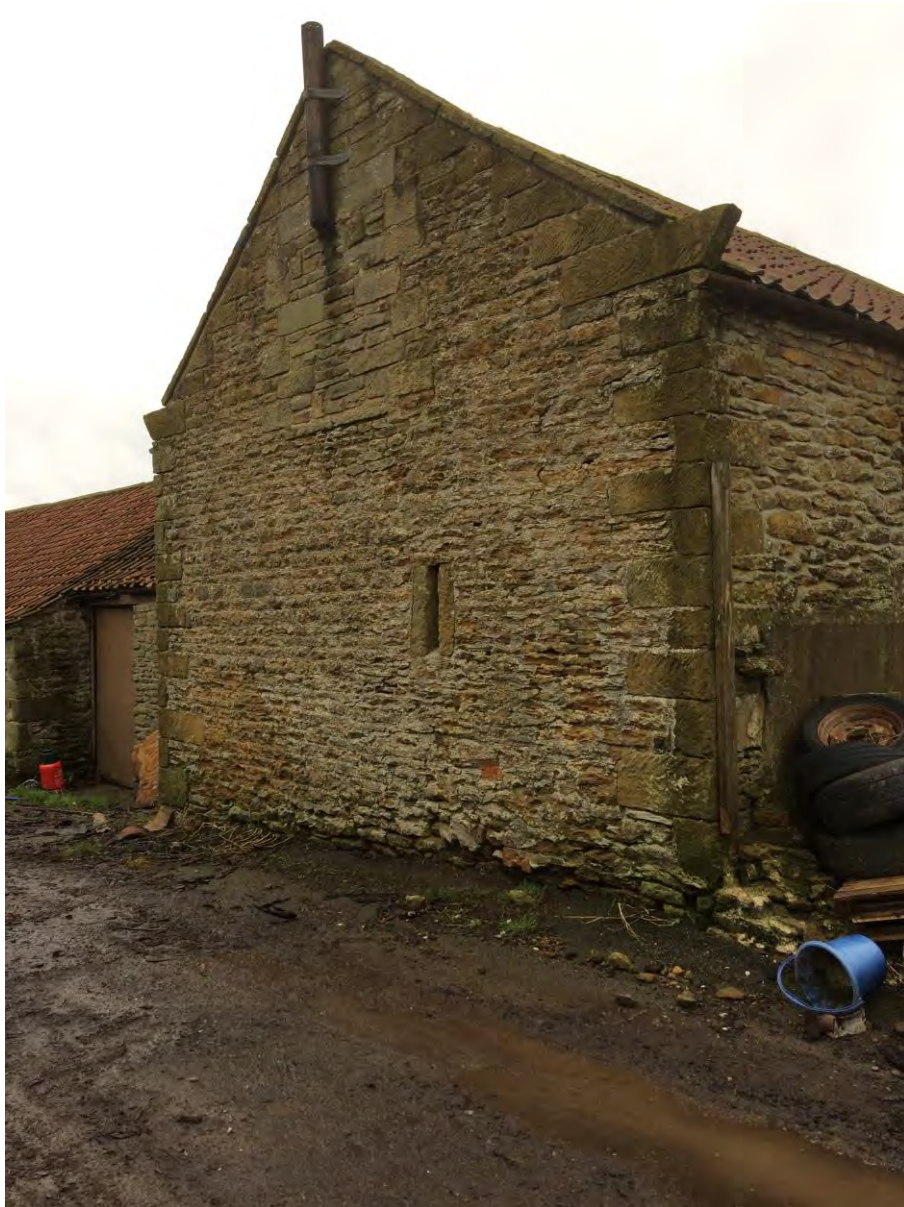
Photograph 5  
Northfield Farm, Suffield, YO13 0BJ

- 2.2 The south facing gable wall can be seen in photograph 5. The wall is in reasonable condition except for some slight cracking near the northern corner, see photograph 6.

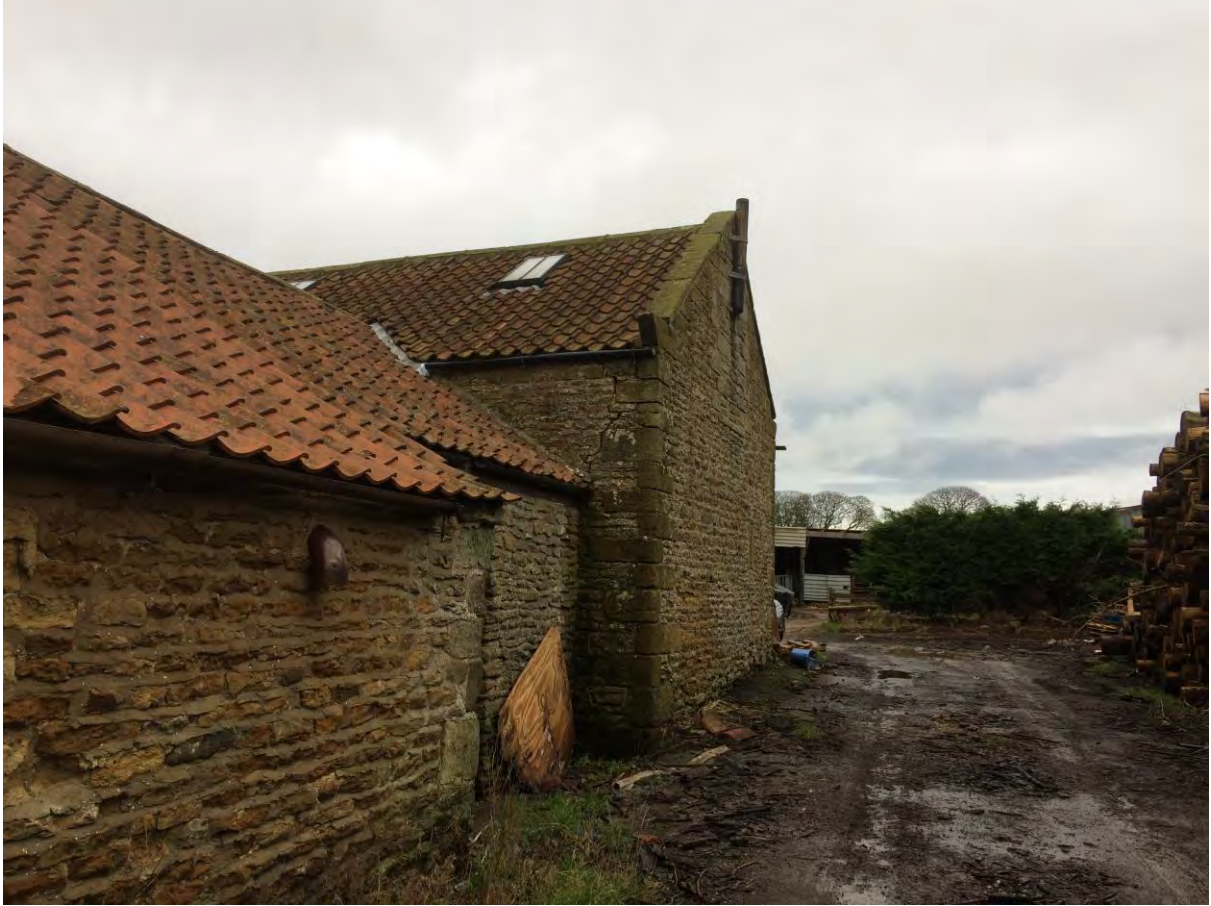
Photograph 7  
Northfield Farm, Suffield, YO13 0BJ

- 2.3 Part of the west facing wall can be seen in photograph 7. A diagonal and vertical crack can be seen in photograph 8.
- 2.4 The main part of the west facing wall can be seen in photograph 9. The wall is in reasonable condition except for an area at the south end, which will need to be filled with masonry, see photograph 10.

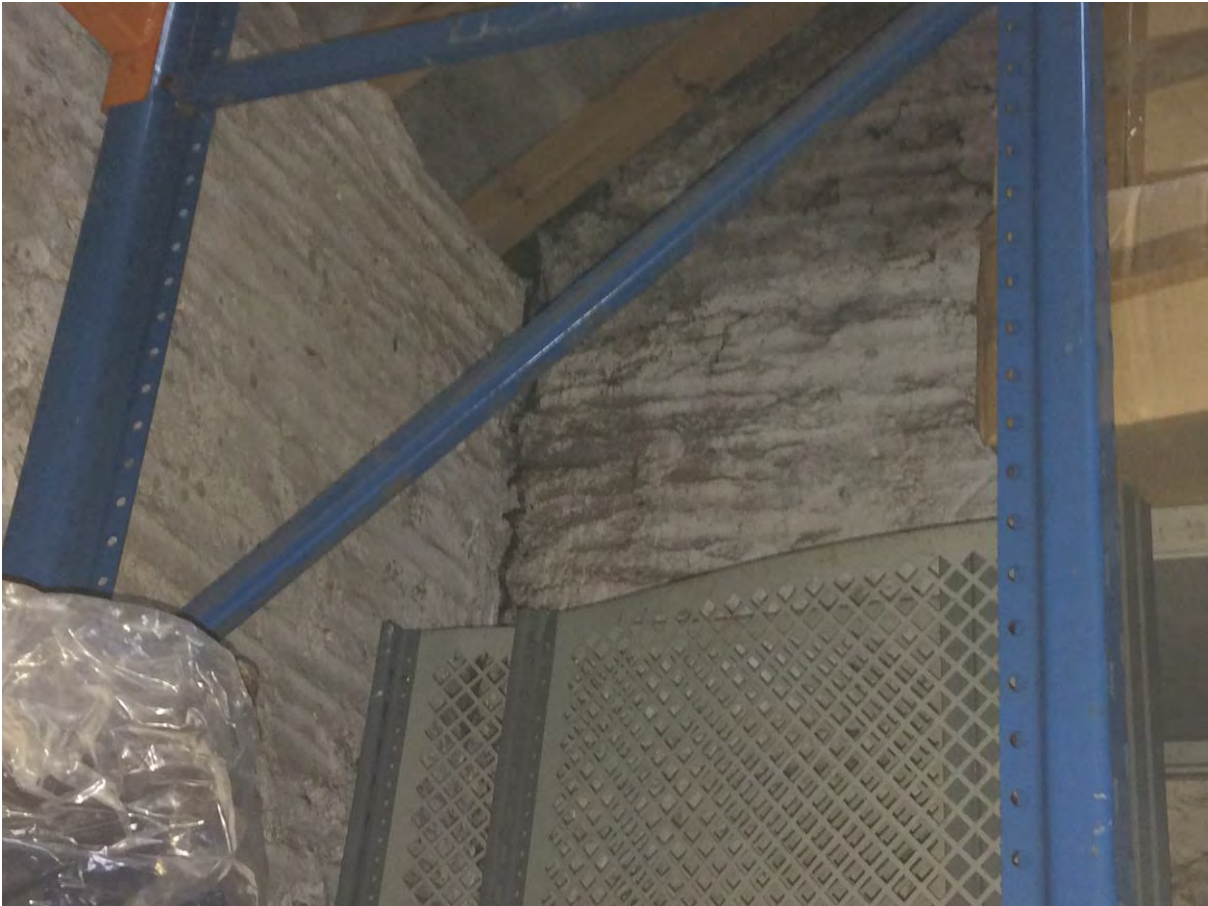
Photograph 12  
Northfield Farm, Suffield, YO13 0BJ

- 2.7 The internal face of the walls are in reasonable condition except for some cracking in the south-east corner, see photograph 12. Also, there is an area on the south gable which will need to be re-constructed, see photograph 13.

- 3.3 Timber lintels should be replaced with hidden steel lintels.
- 3.4 The external walling should be re-pointed and all areas of cracking carefully repaired.

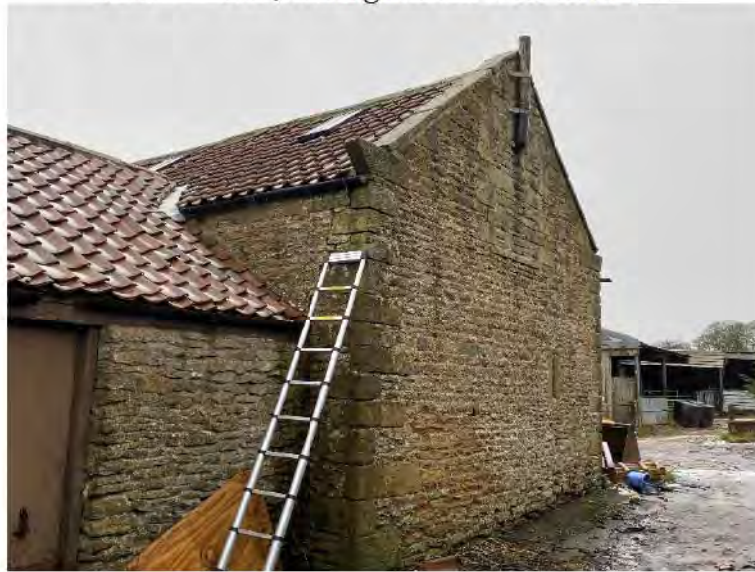
Plate 1 – barn, south gable and west elevation.

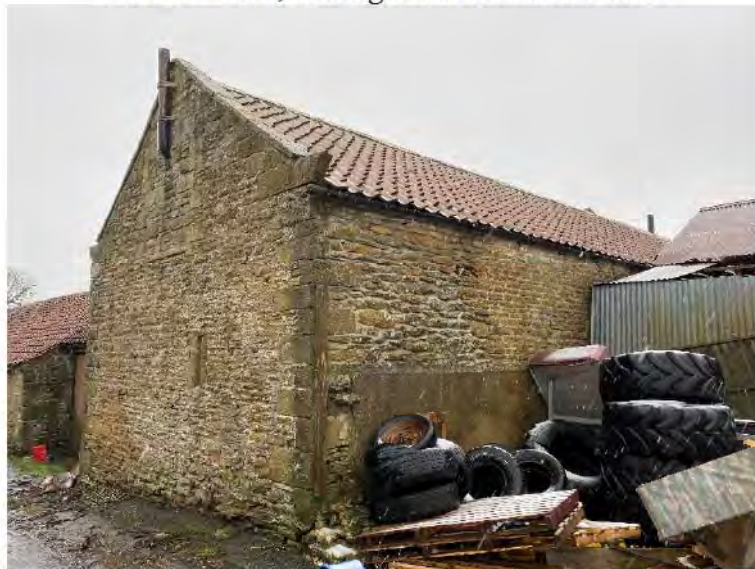
Plate 3 – barn, west elevation.

5.2.2 **Barn** (see 5.5 plates 1 - 4) – a small number of roosting opportunities were present within the fabric of the barn but are unlikely to support roosting bats due to the following:

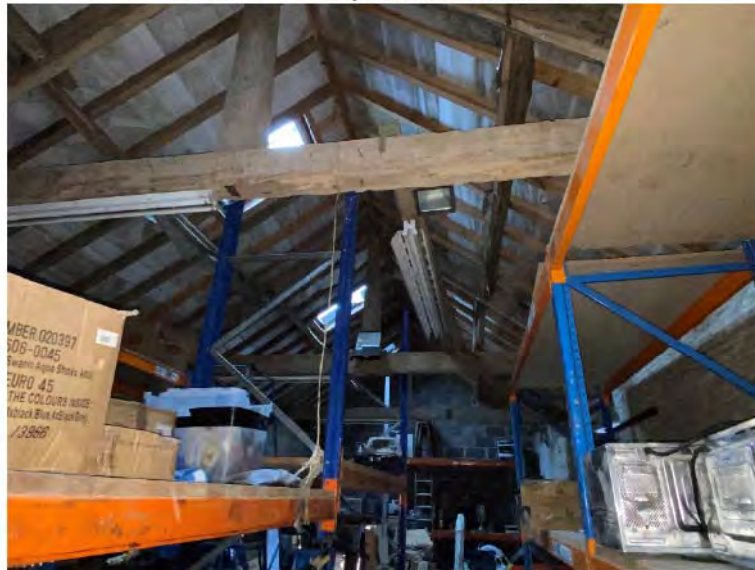
- The timber roof frame was tightfitting.
- A small number (less than 5) of gaps in the external mortar were inspected with an endoscope and no evidence of bats were observed. The majority of the gaps were either too shallow or thick with debris and cobwebs.

Plate 4 – barn, internal roof void.
