**DESIGN AND ACCESS STATEMENT:**

**Location:** Deepdale Farm, Bickley Gate, Langdale End, YO13 0LL

**Proposal:** Proposed new link extension, new water store extension, new greenhouse and conversion of existing stable into gym.

**STRUCTURAL REPORT  
ON BARNs TO  
DEEPDALE FARM  
BICKLEY  
LANGDALE END  
SCARBOROUGH  
NORTH YORKSHIRE  
YO13 0LL**

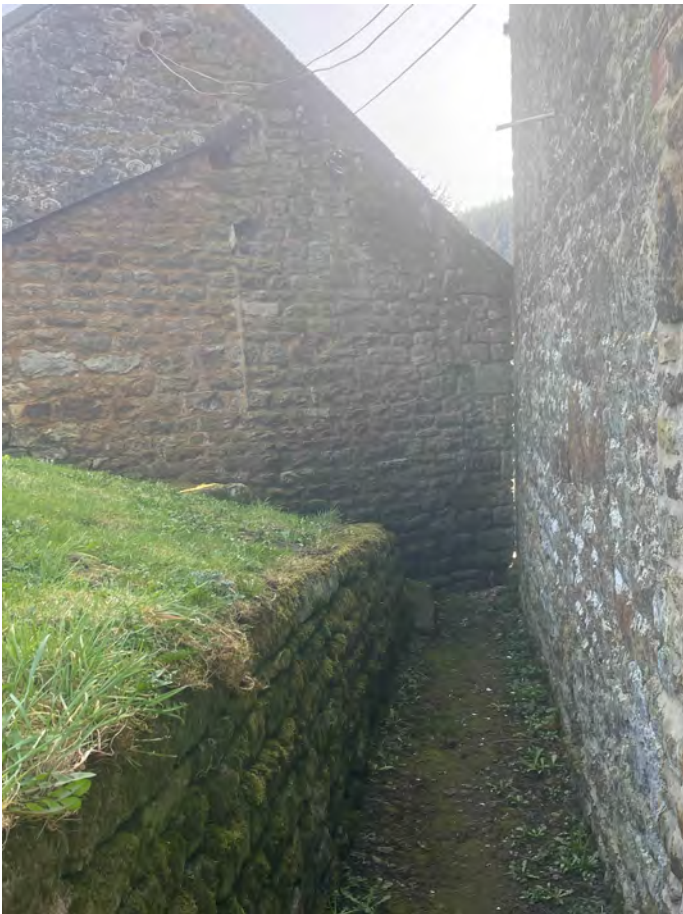
Rear where link extension is proposed and retaining wall to be built.

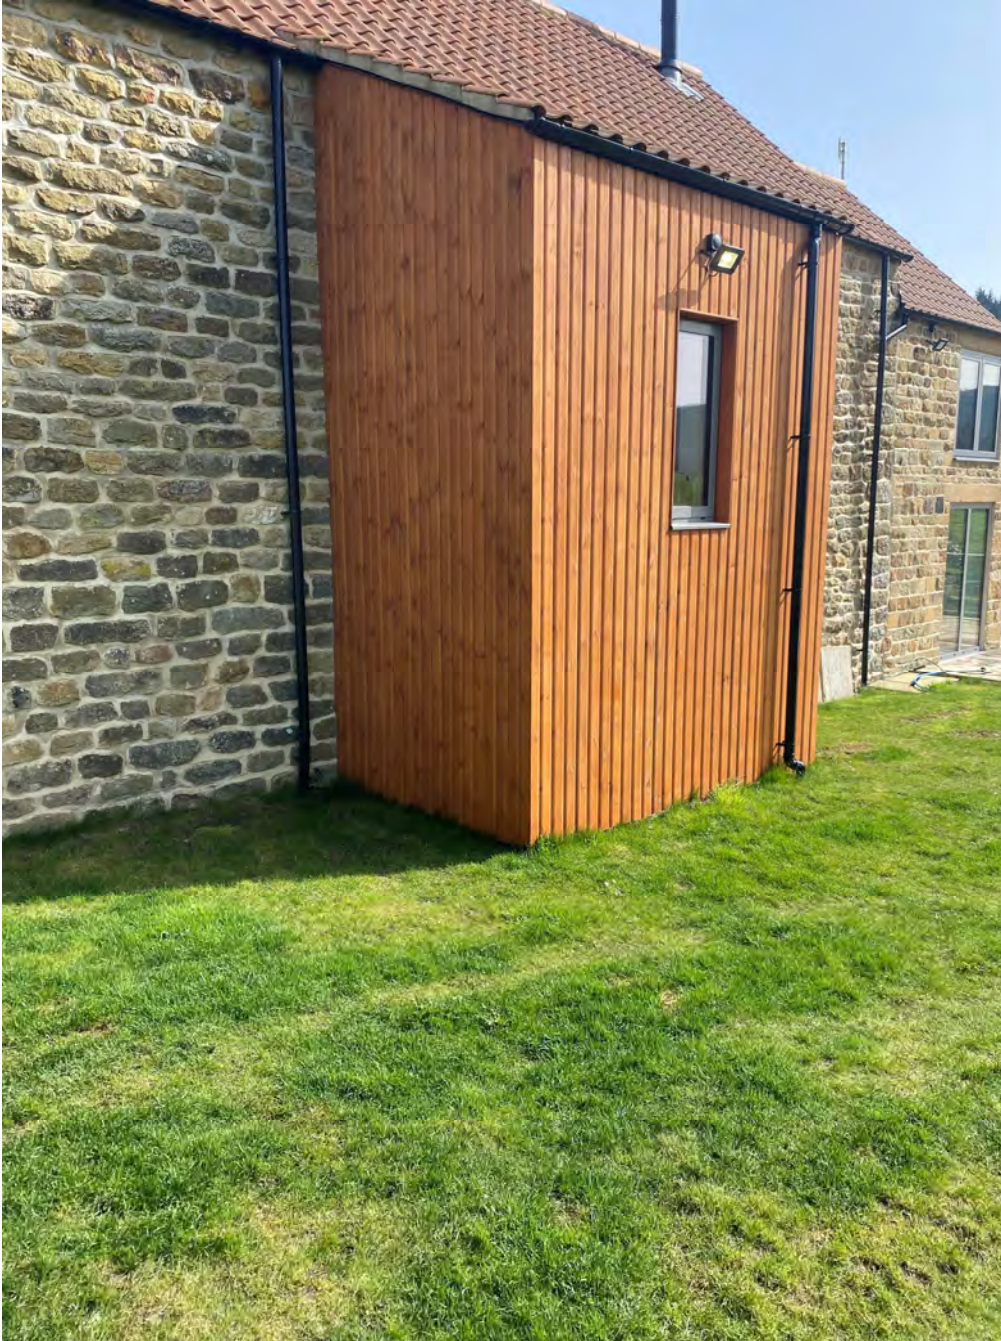
View at the rear showing existing staircase extension.

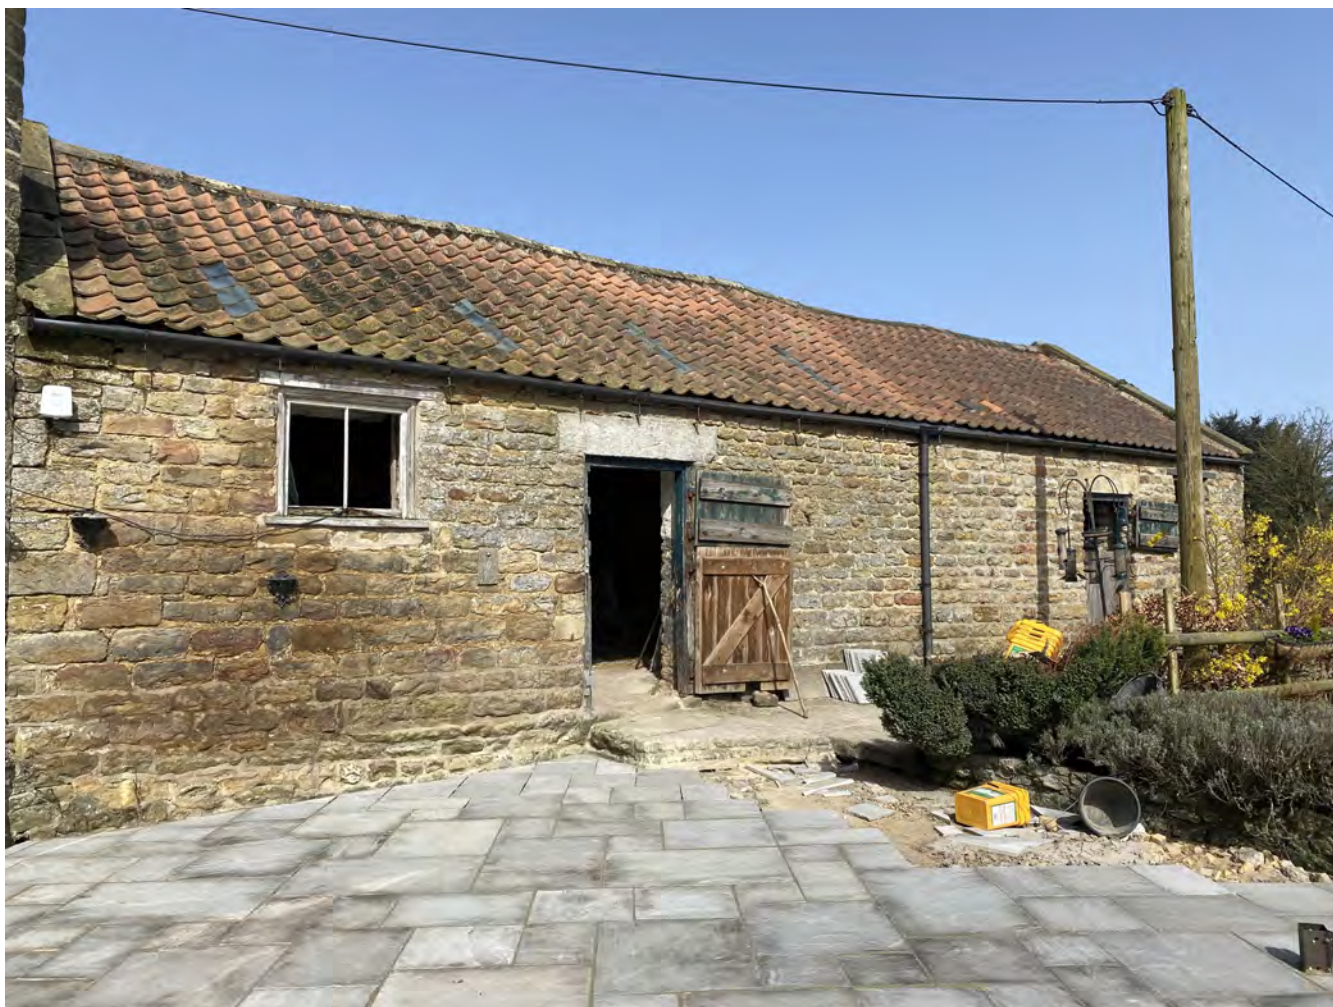
External view of existing stable block.

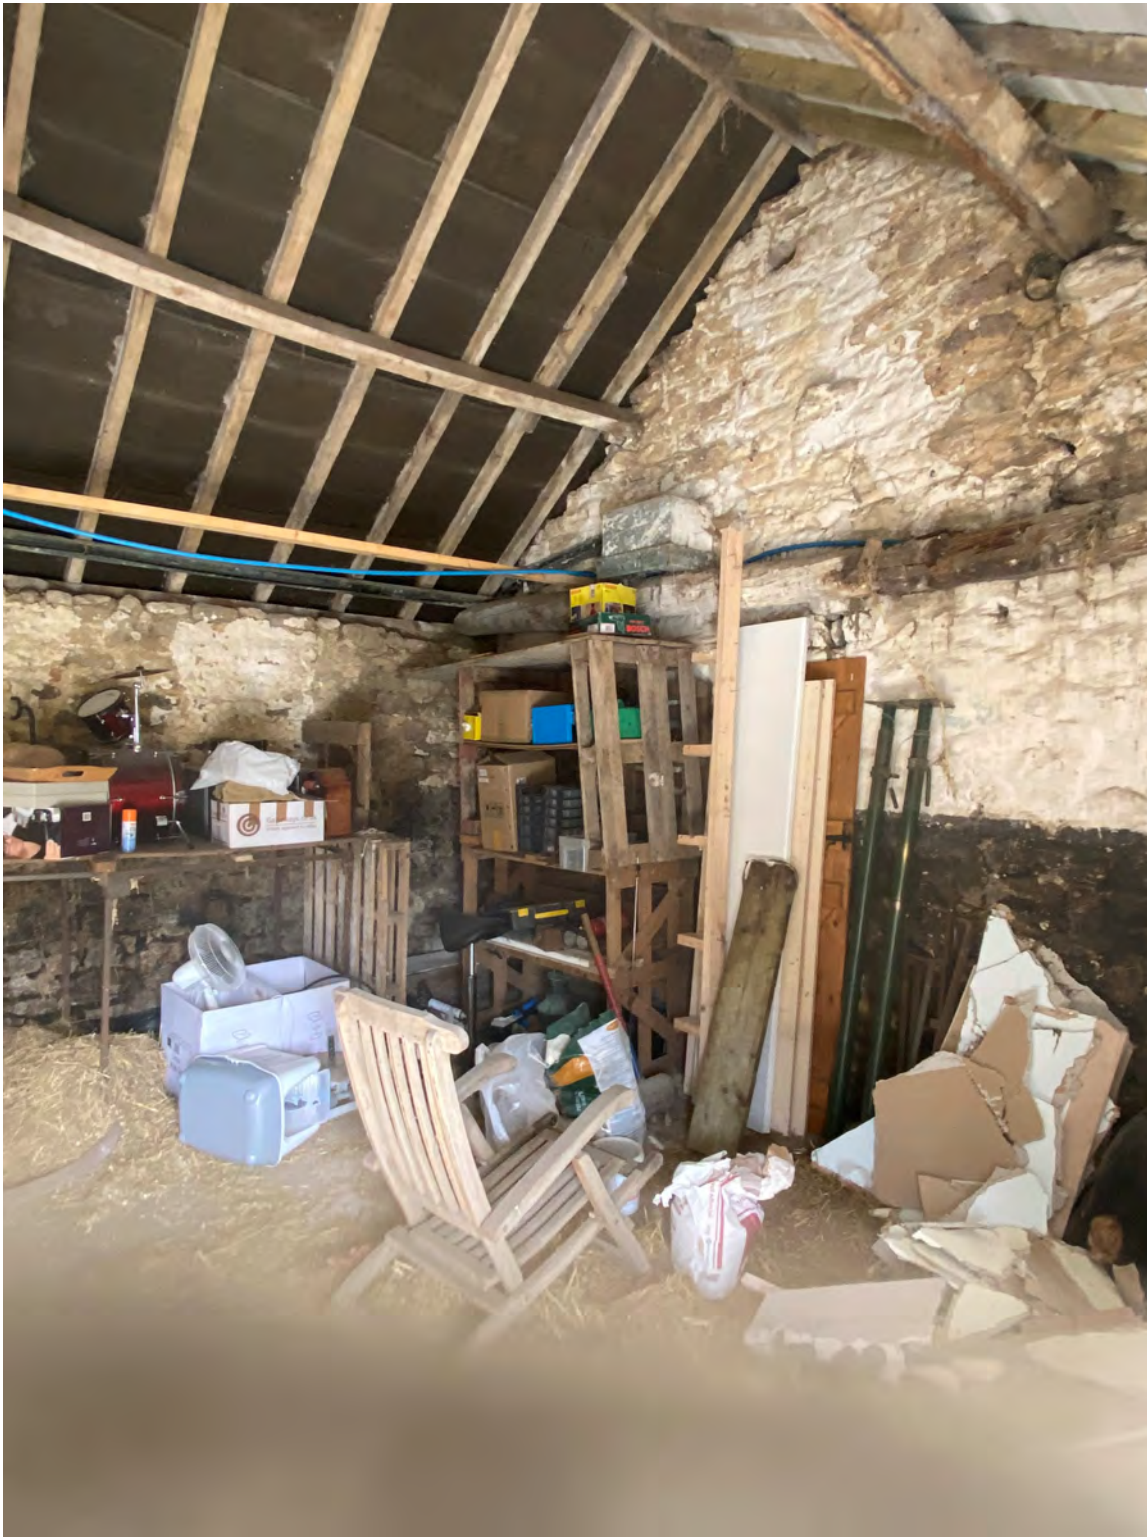
Internal view of existing stable block

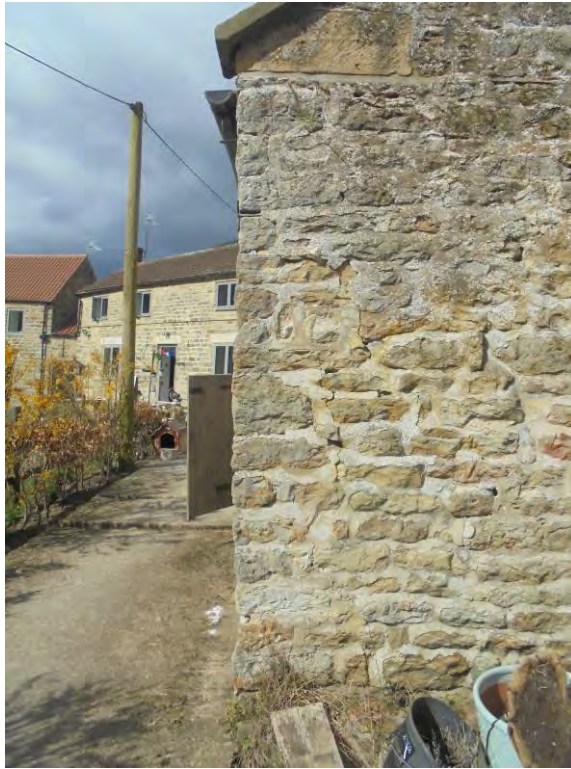
**Photograph No. 5**

- 3.5 To the east gable elevation there is a near vertical separation crack, close to the junction of the south elevation. This corresponds with the bulge to the south elevation. (See photo 5)

- 5.2 The cracking to wall junctions and the gable elevation should be repaired by fixing chemical “sock anchors” through the north and south elevations into the gable and cross walls. Anchors should be installed over the full height of the wall at approximately 450mm centres, and the cracking should be filled with a none shrinking grout material.

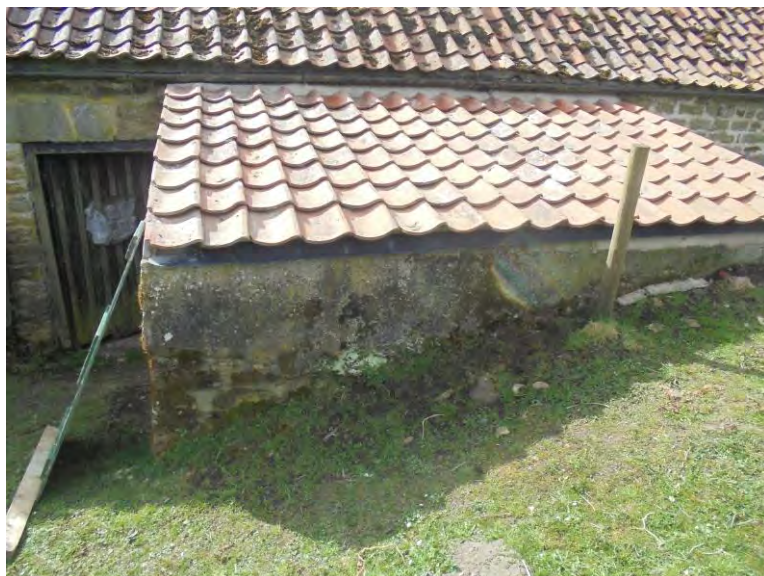
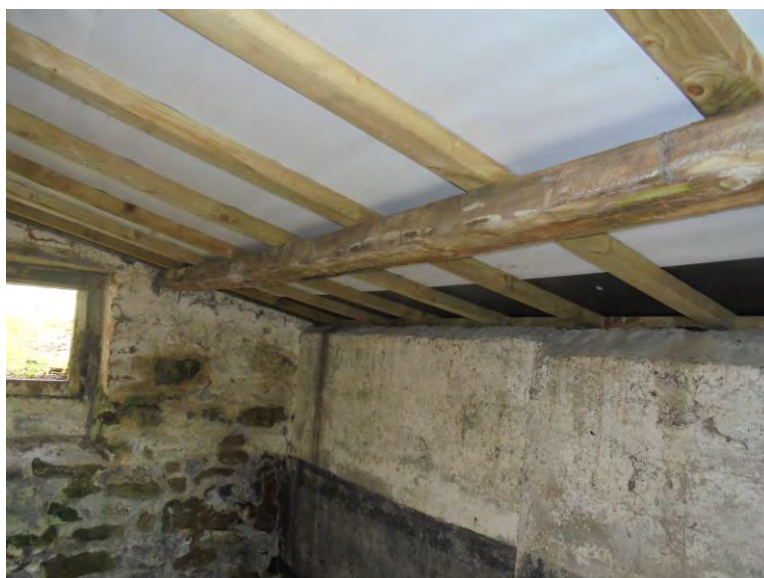
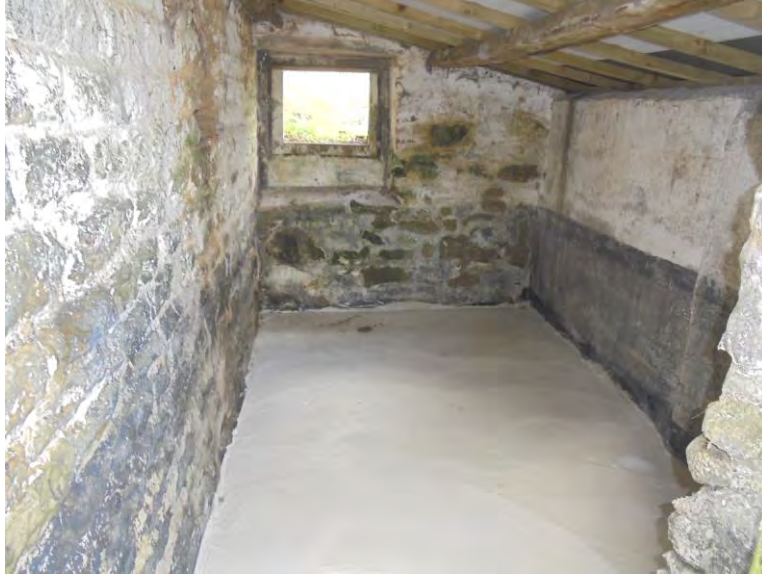
- 3.6 The roof covering and rafters to the rear lean to have been replaced and the floor to this area has also been re-cast. (See photos 7 to 9)
- 3.7 The exposed stonework to the north elevation is in a serviceable condition, though where it forms a retaining structure we are unable to assess its condition.

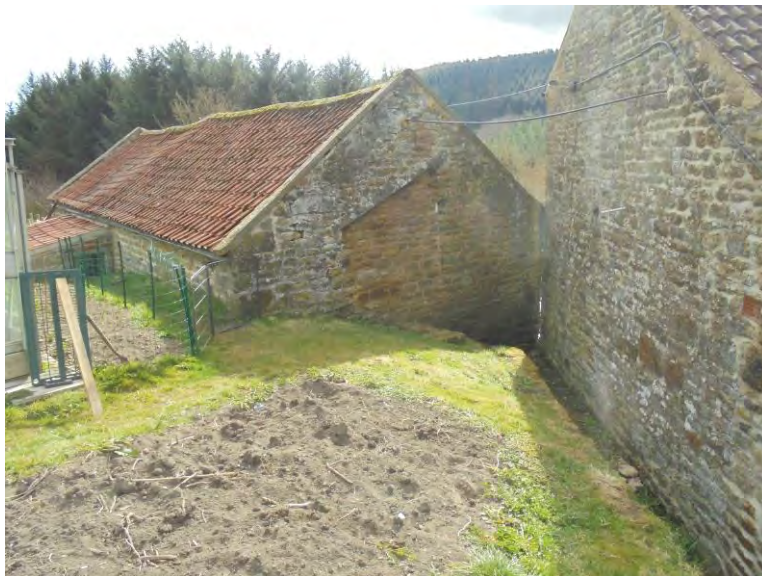
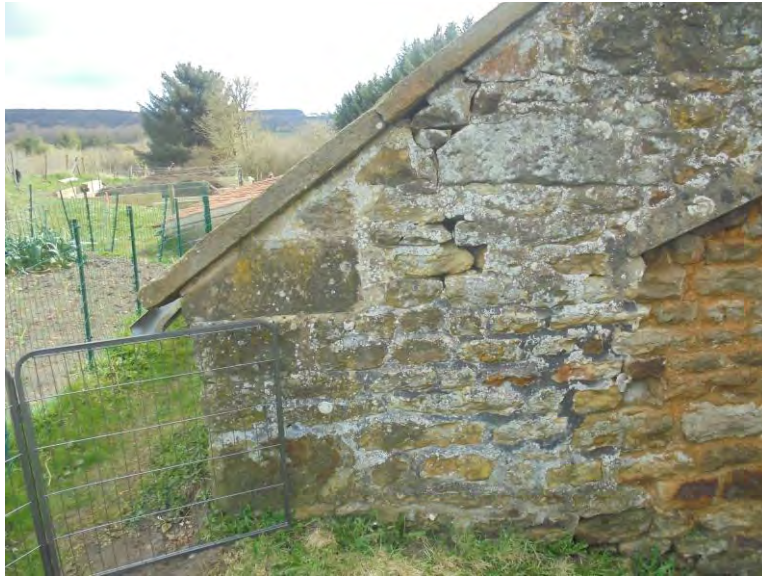
- 3.8 The west gable elevation has previously had a structure attached to it with the previously covered stonework being in better condition than the exposed areas, which has crack damage evident at eaves level. (See photos 10 & 11)

- 5.4 All cracked and severely weathered mortar joints should be raked out to a minimum depth of 30mm and be repointed with a mortar which will give some degree of flexibility such as a 1:1:6 (lime) or plasticised mortar. Any cracked, broken or severely weathered stones should be cut out and new units, of a similar pattern and material, be built in using a mortar similar to that as used in the repointing.

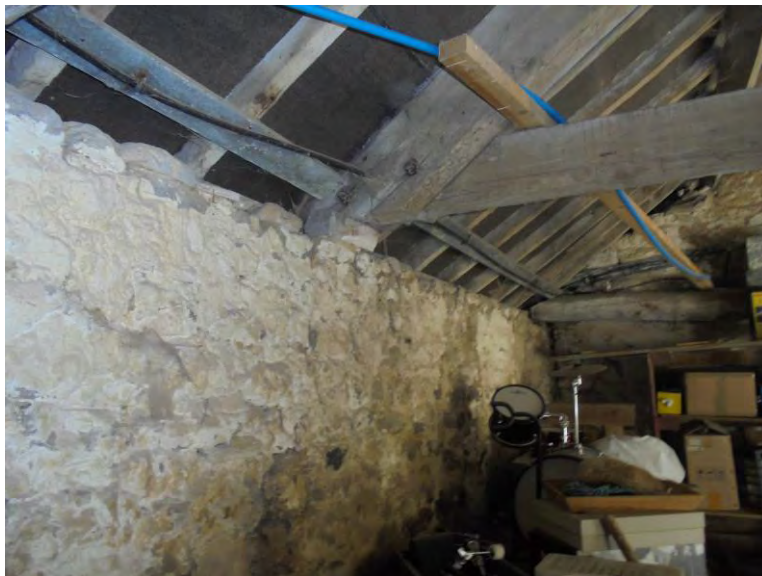
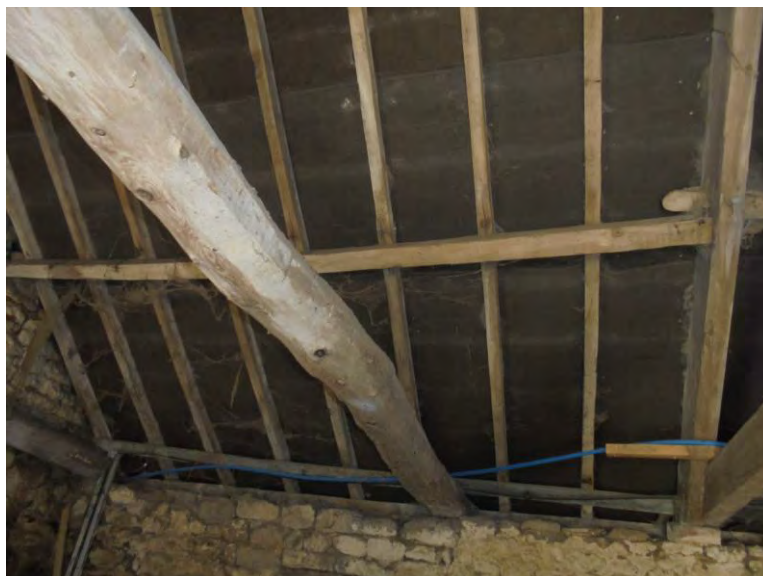
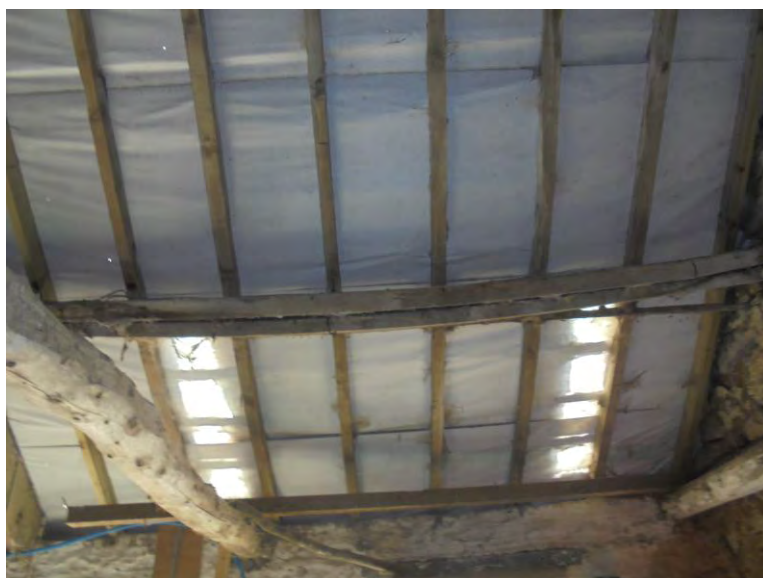
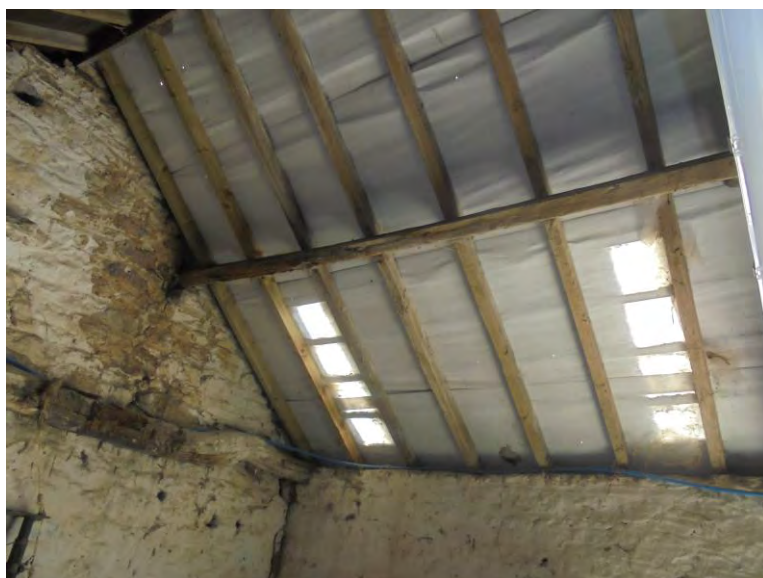
- 3.9 Within the barn to the west, the roof structure is exposed and comprises of central truss supporting purlins to each slope. Eaves ties are also present. The foot of the truss to the rear of the building is precariously supported on a single brick. The purlins throughout the barn deflect between supports. The rafters to some slopes have been replaced and a breathable membrane has been installed beneath the pantiles to some area. (See photos 12 to 15)

- 4.2 The distortion of roof structure is a result of its inadequate design.
- 4.3 We understand that the intention is to convert these spaces to a gymnasium and incorporate ceilings internally at eaves level, leaving the roof structure accessible for the nesting birds.

- 5.1 The existing roof structure is of inadequate design, and should be replaced with either gang nail trusses or a traditional roof with correctly designed members.

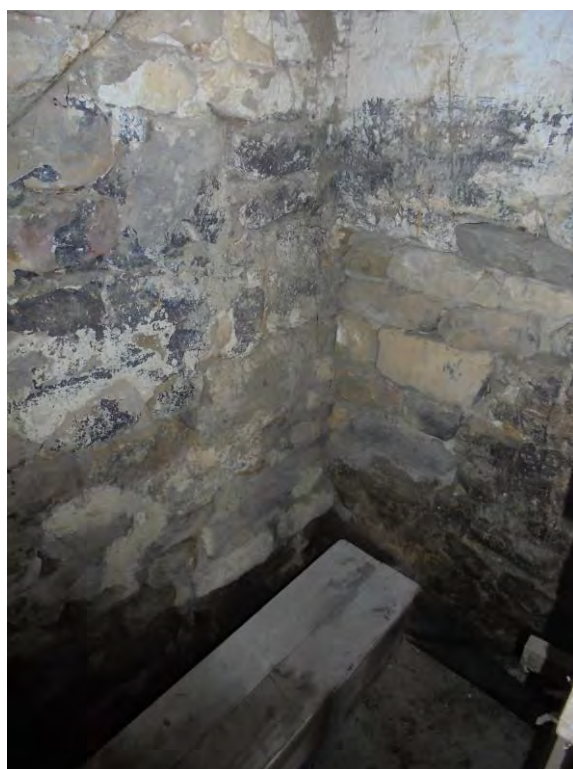
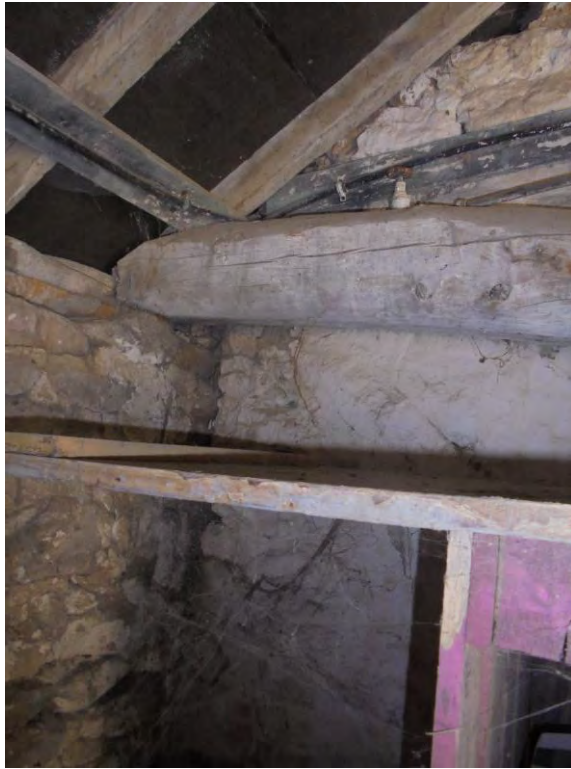
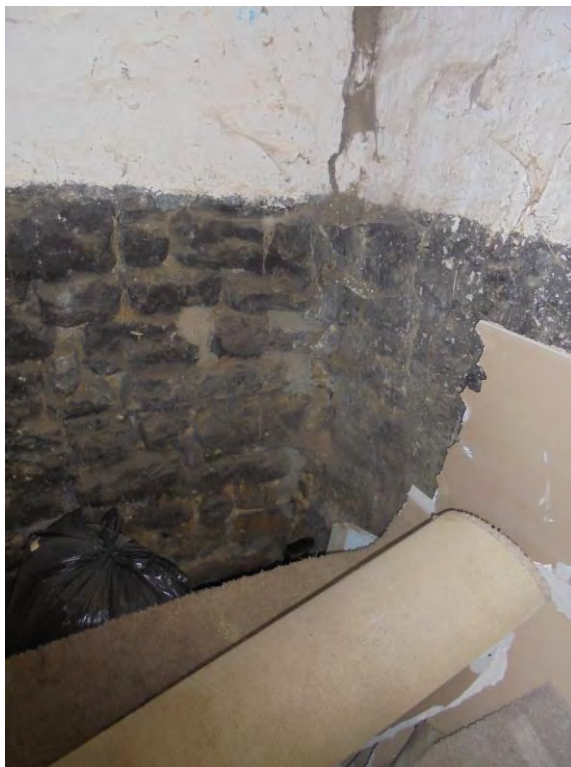
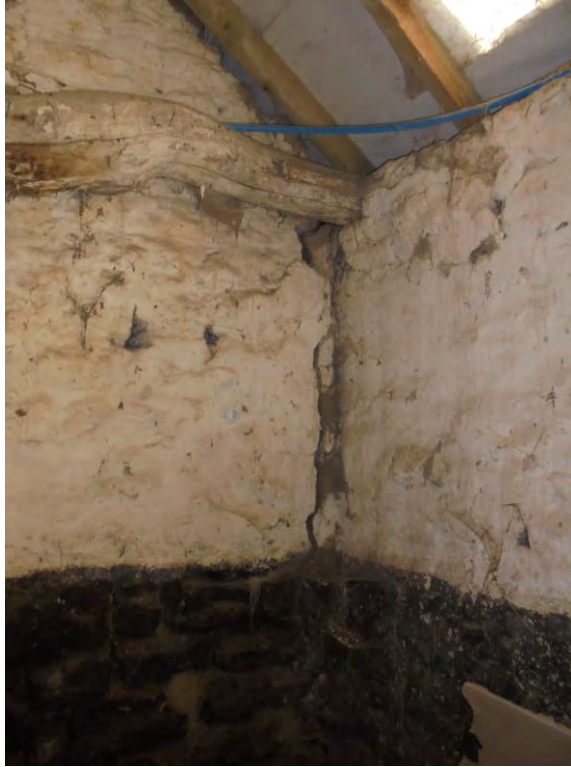
- 3.10 The stone dividing wall between the two barns has cracking noted to the junction with the south elevation, and a poor connection exists at the junction with the north elevation. (See photos 16 to 19)

- 4.1 The barn buildings are generally in a reasonable to good condition for this type of agricultural building, particularly when you consider the exposed location. The cracking noted to the walls at their junctions with elevations is a result of slight ground movement together with the poor tie present at these locations. The ground movement and cracking noted is all aged and historic, and likely a legacy of shallow foundations responding to seasonal changes in ground conditions.

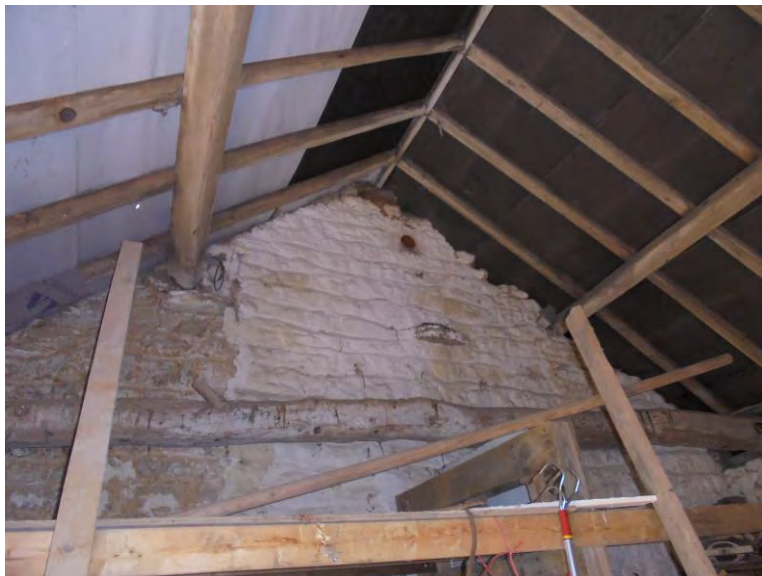
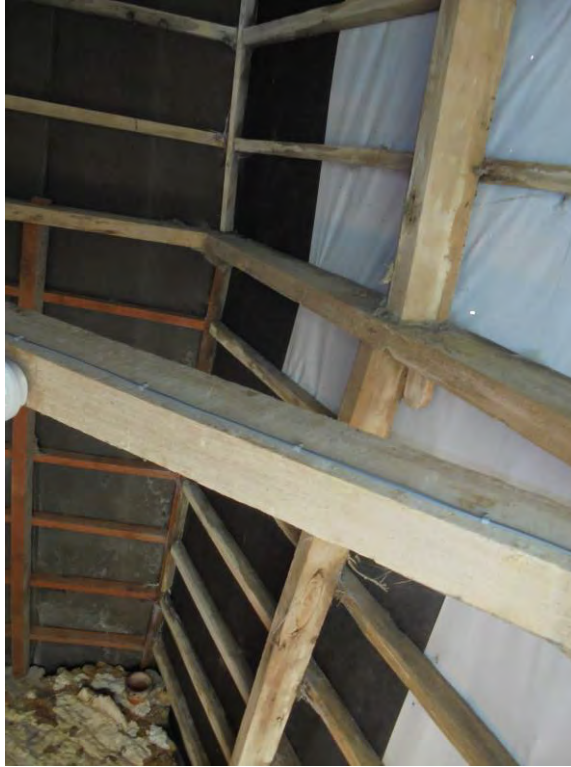
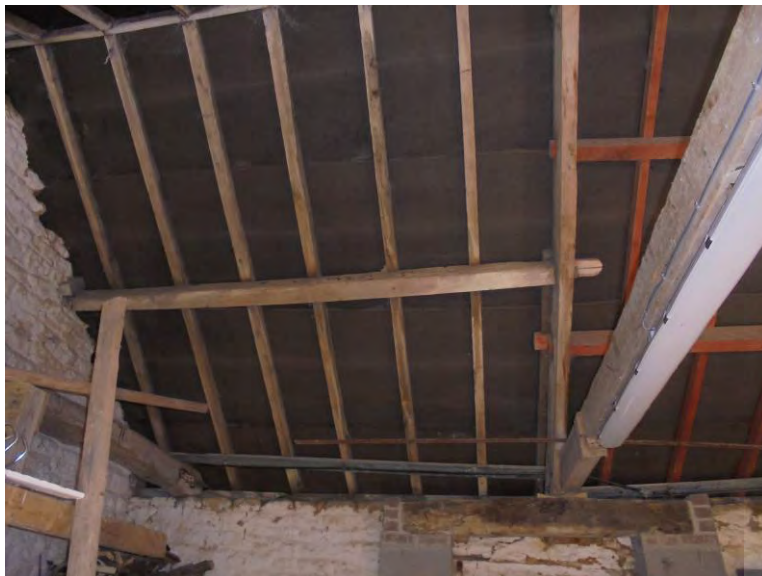
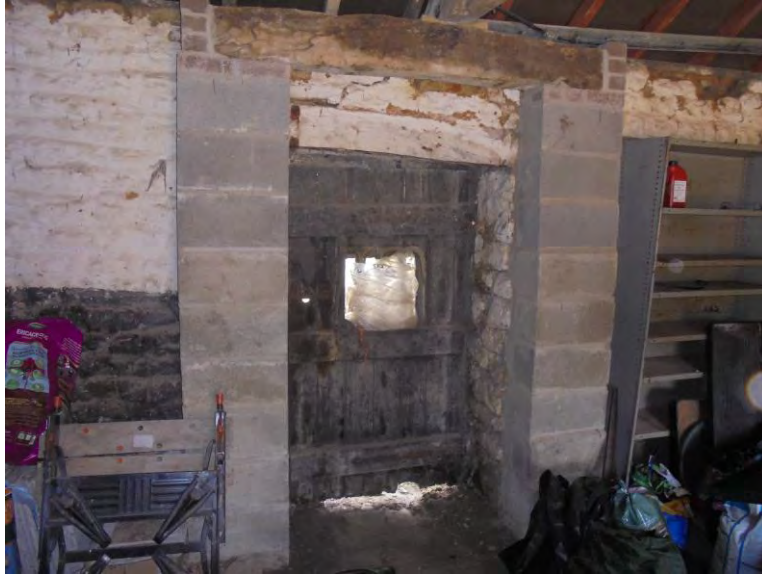
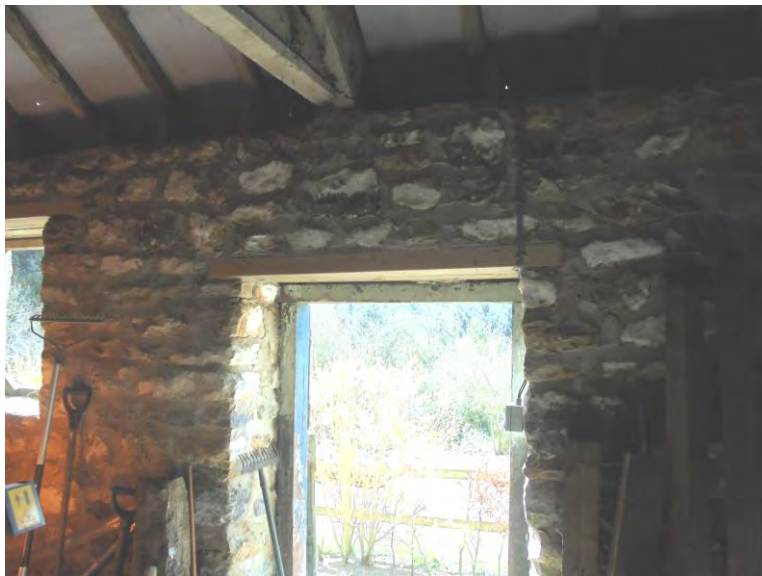
- 3.11 Within the eastern barn, the roof has been subject to repairs, with replacement rafters to some areas; breathable felt has been installed, though the timber purlins deflect between supports. Blockwork piers have been installed to both sides of the rear entrance to this barn. These appear to have constructed to support the roof truss above. The timber lintel to the south elevation entrance has also been replaced and the stonework above rebuilt to carry the truss. (See photos 20 to 24)

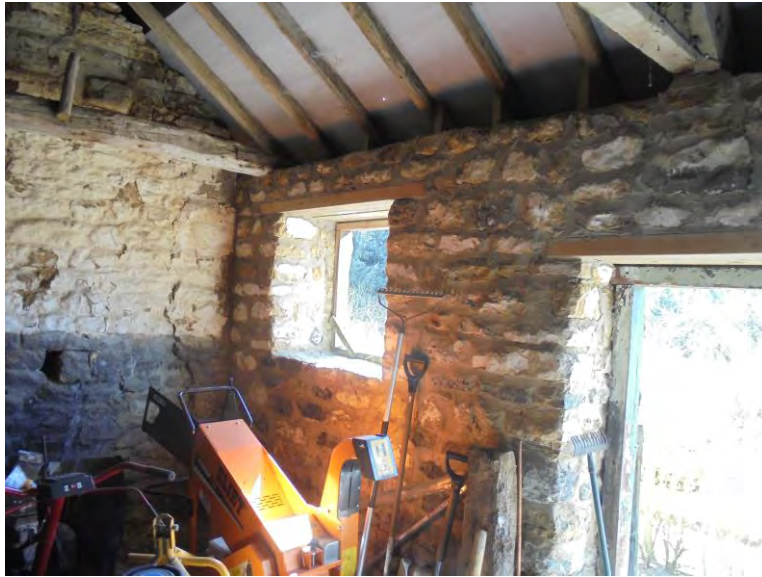
**Photograph No. 25**

- 3.12 At the junction of the south and east elevations there is a vertical crack evident, corresponding with that noted externally. (See photo 25)

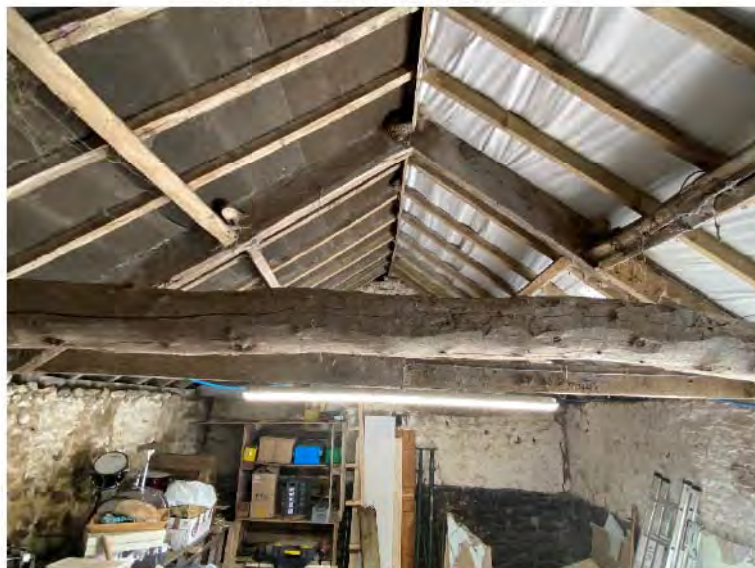
Plate 3 – internal roof void.
