Project  
Mount Misery Farm

Content  
Barn Roof Details

Content  
Wood Store Roof Details

Content  
Tractor Shed Roof Details

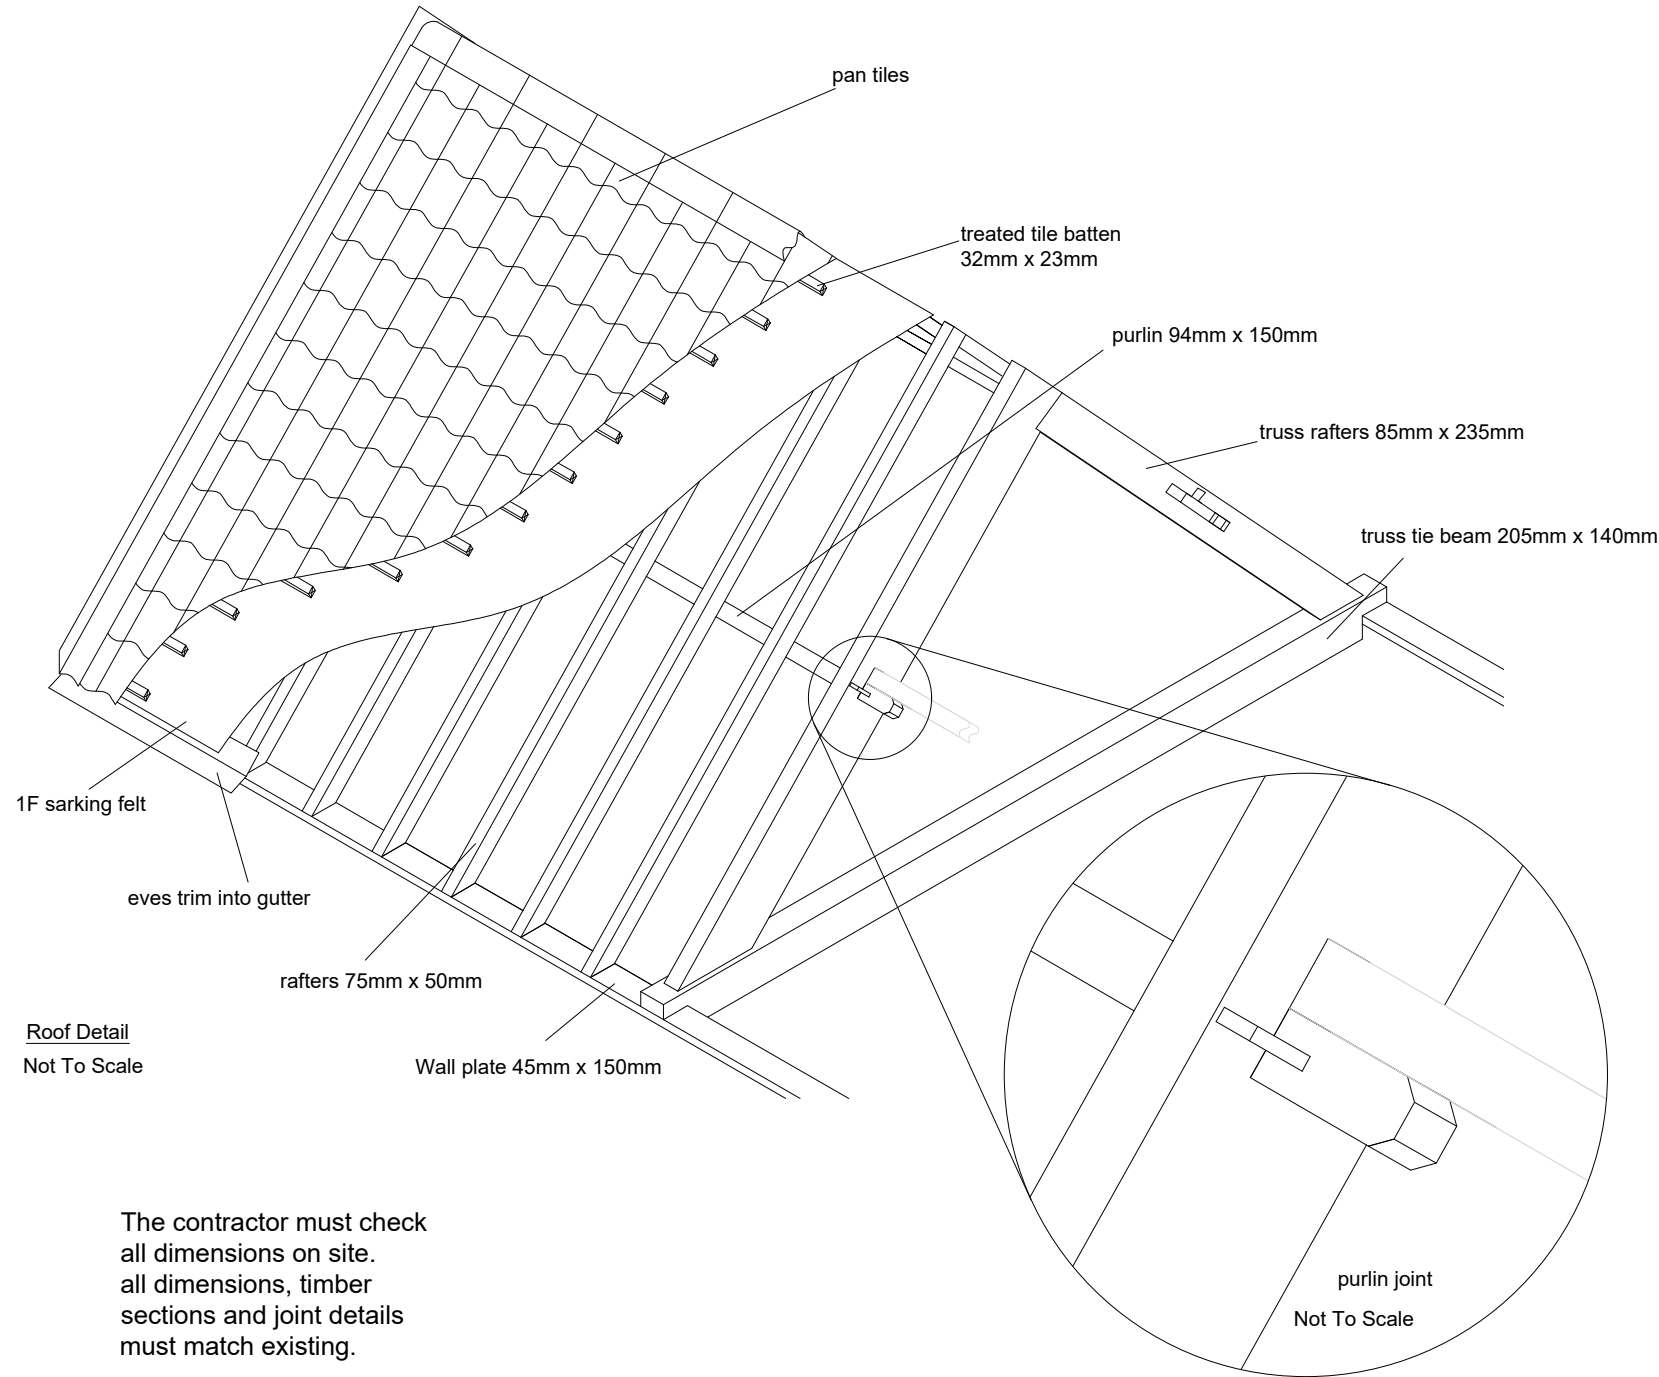
Roof Detail  
Not To Scale

The contractor must check all dimensions on site. all dimensions, timber sections and joint details must match existing.

Some high level details could not be identified due to access restrictions

The contractor must ensure the replication of these details.

All new timbers and any remaining timber must be treated to prevent insect infestation.

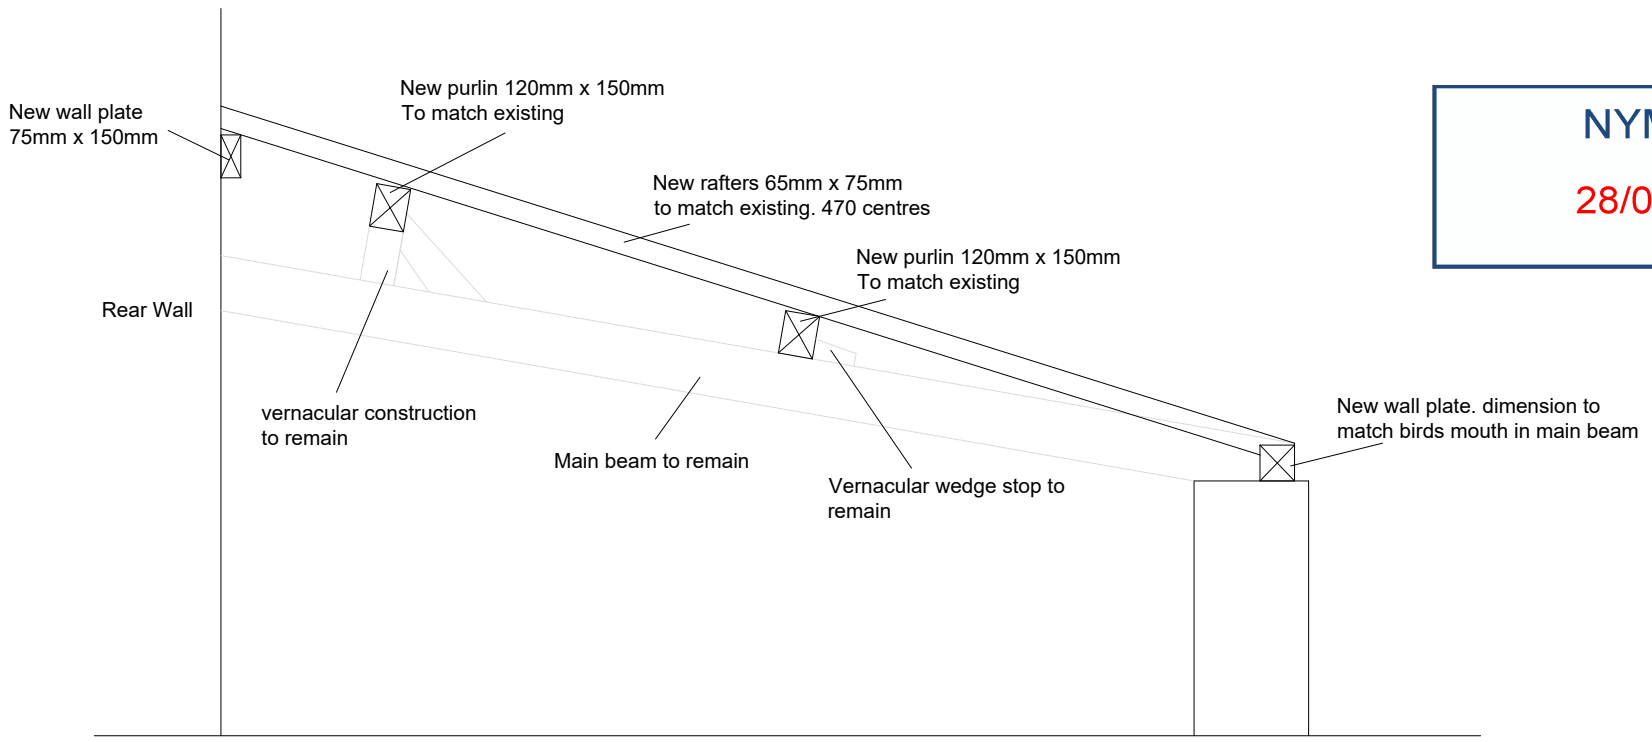
Roof Detail  
Not To Scale

The contractor must check all dimensions on site. all dimensions, timber sections and joint details must match existing.

Some high level details could not be identified due to access restrictions.

The contractor must ensure the replication of the existing details.

All new timbers and any remaining timber must be treated to prevent insect infestation and rot.

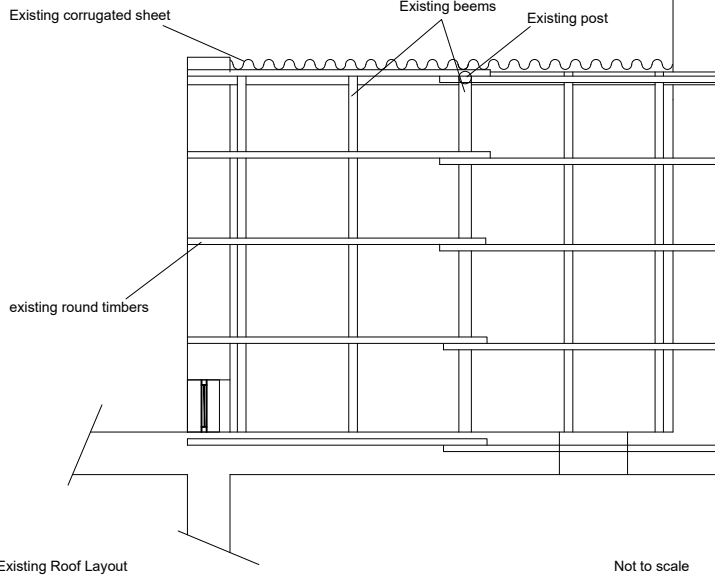
Existing Roof Layout

The contractor must check all dimensions on site. all dimensions, timber sections and joint details must match existing.

Some high level details could not be identified due to access restrictions

The contractor must ensure the replication of the existing details.

All new timbers and any remaining timber must be treated to prevent insect infestation and rot.

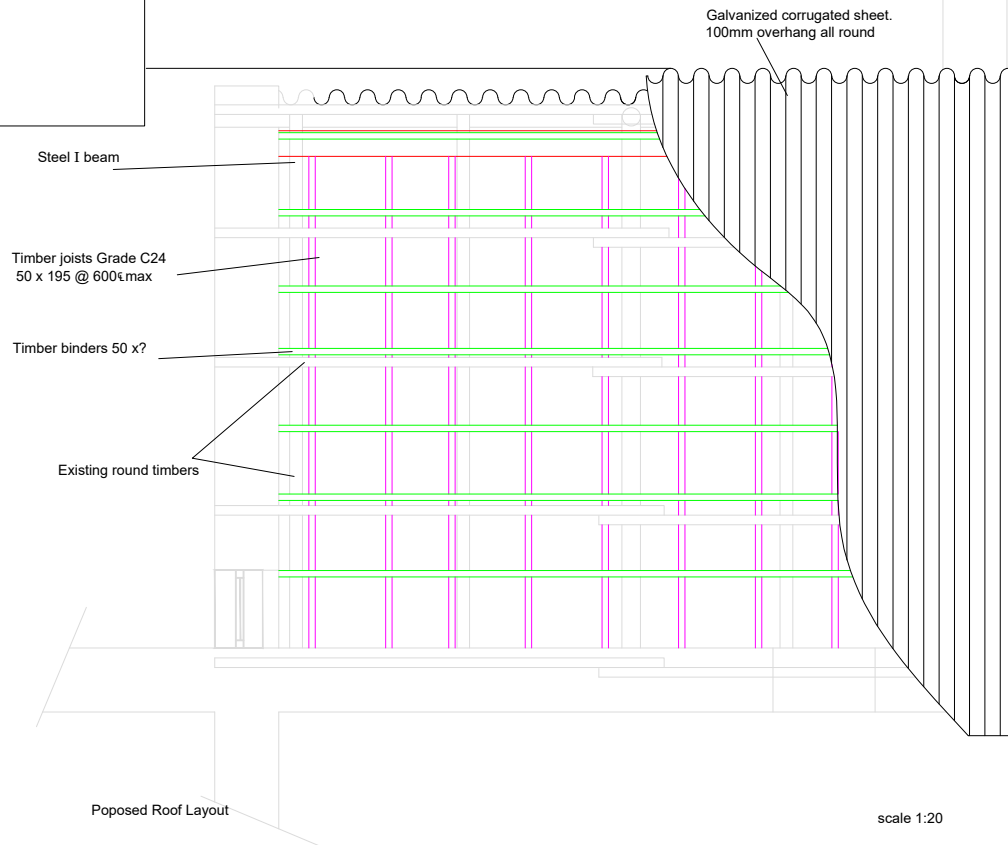
Proposed Roof Layout

Steel beam to be set in wall and to underside of existing beams

New timber joists to be set in I beam and wall to the underside of existing round timbers.

New timber binders sit on top of joists to be at least the same thickness of existing round timbers

All new timbers and any remaining timber must be treated to prevent insect infestation and rot.
