**Bat, Breeding Bird and Barn Owl Scoping Survey**  
**Foss Farm, Sneaton**

August 2021

## Building Condition and Structural Survey Report

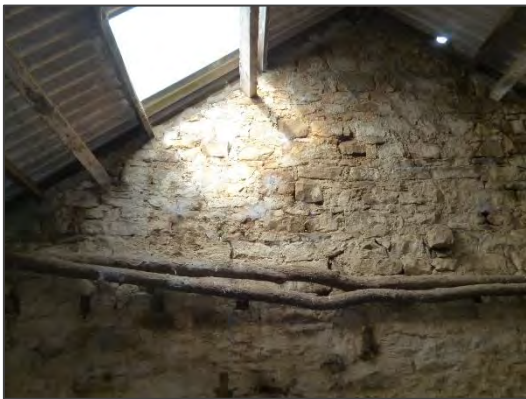
Building ref.	Description	Features with potential bat roost habitat (PBRH).
<b>1a</b> <b>Low suitability for bat roosts</b>	<p>Potential crevice roost habitat identified within extensive masonry crevices (internal and external), timber lintel and beam crevices.</p> <p>The interior is accessible to birds and bats via open large doorway, gaps around doors on the gable and gaps at the eaves and ridge vents. The interior is dry and bright, there are clear panels in the roof. The internal ridge is open and exposed. There is a double ridge beam. The roof is unlined. No bat droppings or signs of bat use were found.</p> <p>3x old swallow's nests were present on roof beams.</p> <p>Barn owl pellets and adult feathers were visible in 3 locations (11x pellets in total). Some were fresh. No signs of barn owl nesting or suitable nesting habitat were identified.</p>	Masonry and timber crevices.
<b>1b</b> <b>Negligible suitability for bat roosts.</b>	<p>The building is open sided and exposed. The roof is unlined. No crevices suitable for roosting bats were identified.</p> <p>No signs of nesting birds were evident.</p>	Negligible pbrh

Photo 10: Internal crevices in 1a.

9.2.5 Replacement crevice roosting habitat will be provided on site through the incorporation of integral bat bricks into the new build and/or the installation of professional long-lasting crevice bat boxes on site, in suitable locations to be agreed by the ecologist. It is recommended that a total of 2 habitat features are provided. Integral bat bricks can include ibstock bat roost entrance brick (leading into a cavity wall) or enclosed bat box 'B'; or Schwegler Type 1FR bat tube. External bat boxes should be Schwegler Type 1FF wall bat roosts which can be affixed to external walls and/or Type 2F general purpose bat boxes affixed to retained trees on site.

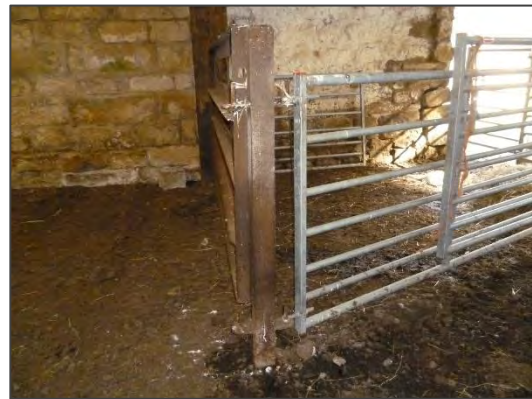
**No signs of nesting barn owl were found during the surveys, but signs of roosting barn owl were found within Building 1 and 3. Section 9 sets out a method statement to minimise disturbance to barn owl during works. Permanent provision for barn owls will be included as part of the development.**

Photo 11: Barn owl droppings below post 1a.

Birds are nesting in several buildings and there is evidence of use of the site by roosting barn owl. The number of barn owl pellets present in the building indicates regular but occasional use. No signs of nesting barn owl were found during the site visit and emergence survey.

There will be loss of an occasional barn owl roost. No barn owl nesting habitat will be impacted.

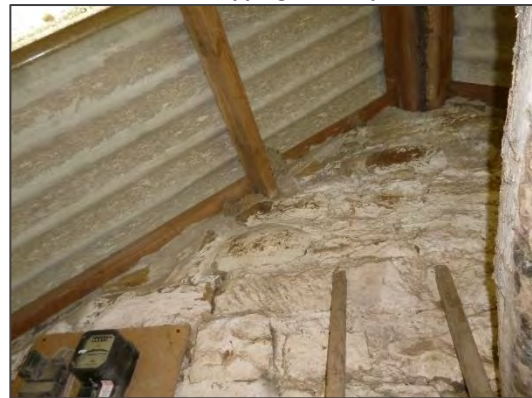
**Birds, including barn swallow, are using the buildings for nesting, therefore works should avoid the bird nesting season if possible. If this timing is not possible then a check should be made for active bird nests immediately prior to works. If any nests are discovered, where possible, work to these areas shall be carried once any chicks have fledged in order to avoid disturbance. Two bird nest boxes should be installed on site. We also recommend creation or retention of an open sided building, suitable for use by breeding swallow on site.**

Photo 13: Swallow's nest in 1c.

If work takes place during the bird breeding season, then a check should be made prior to work for any active bird nests within buildings to be worked on. If nests are found, then no work to these immediate areas will take place until any chicks have fledged. Two bird nest boxes should be installed on site eg a swift brick and sparrow terrace. We also recommend creation or retention of an open sided building, suitable for use by breeding swallow on site.

9.2.7 It is recommended that works are carried out outside of the bird breeding season. If this timing is not possible then a check should be made for active bird nests in areas to be worked on, immediately prior to works. If any nests are discovered, work to these areas shall be carried out once any chicks have fledged in order to avoid disturbance.

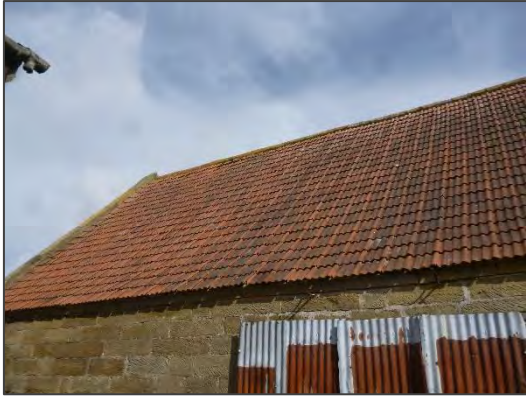
<p><b>3a</b> <b>Low suitability for bat roosts</b></p>	<p>Potential crevice roost habitat identified within extensive masonry, tile and beam crevices (internal and external). Several visible gaps under coping stones.</p> <p>The interior is accessible to birds and bats via gaps around doors and an open window on the south gable and gaps at the eaves and ridge vents.</p> <p>The interior is dry and undisturbed. The roof is underlined with part bitumen and part lath which is missing in areas. No bat droppings or signs of bat use were found.</p> <p>Barn owl pellets and adult feathers were visible in 3 locations (7x pellets in total). Some were fresh. No signs of barn owl nesting or suitable nesting habitat were identified.</p>	<p>Masonry and timber crevices.</p> <p>Access available under lined roof.</p>
<p><b>3b</b> <b>Negligible suitability for bat roosts</b></p>	<p>Windows missing allowing internal access for birds and bats.</p> <p>Roof sheets are sealed and roof is unlined. Internal walls are plastered – no visible crevices internally or externally.</p> <p>5x past swallow's nests were present on roof beams.</p>	<p>Negligible crevices.</p>

Photo 16: West pitch of roof, 3a.

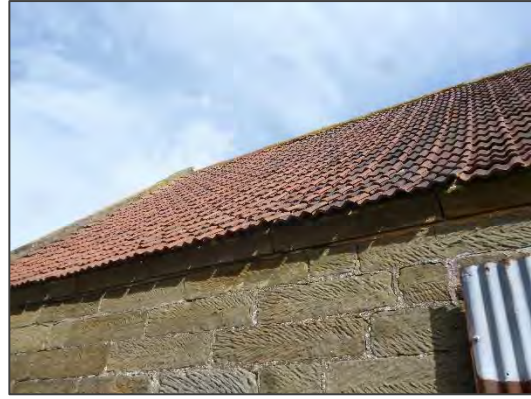
Photo 17: East pitch of roof, 3a.

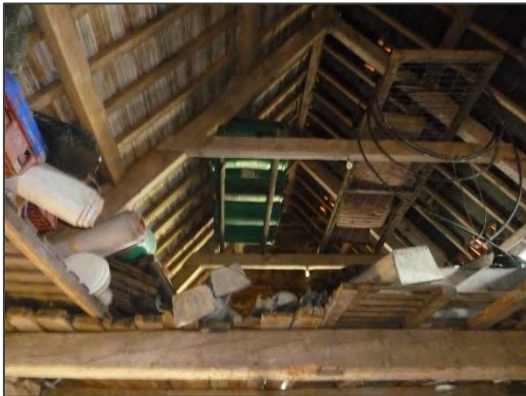
Photo 18: Internal roof 3a.

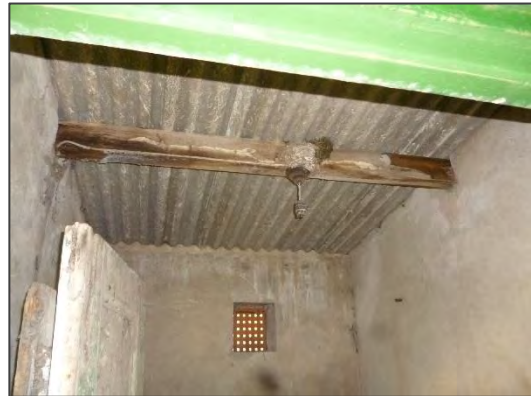
Photo 19: Swallow's nest in 3b.

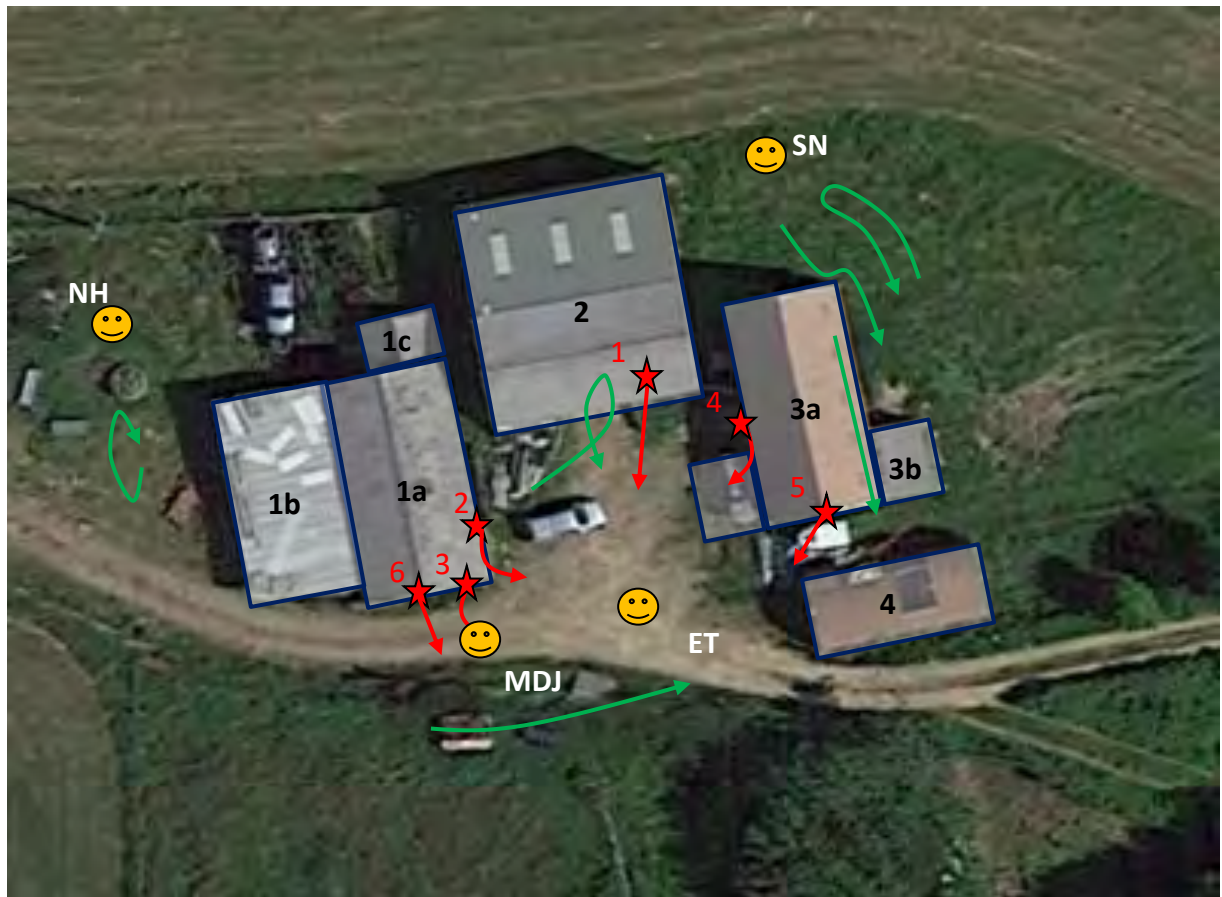
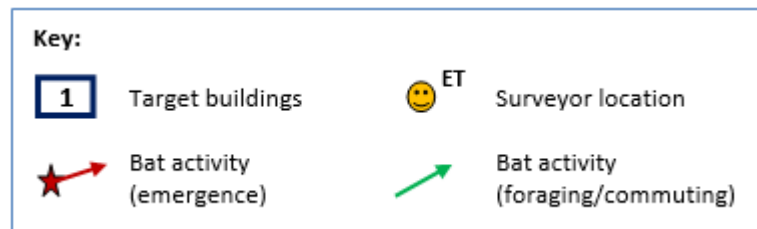
Bat activity was relatively high throughout the survey. Common pipistrelle bats emerged from dispersed crevices within building's 1a, 2 and 3a. Foraging behaviour was intermittent throughout. A barn owl was also identified flying over and around the site, but not into any of the buildings.

Building Ref.	Species	Count	Emergence location/access point
1a	Common pipistrelle, <i>Pipistrellus pipistrellus</i>	5	Emerged via masonry crevice, and doors of building
2	Common pipistrelle, <i>Pipistrellus pipistrellus</i>	2	Emerged from pole barn
3a	Common pipistrelle, <i>Pipistrellus pipistrellus</i>	2	Emerged from eaves and window of building

Figure 6 – Surveyor locations and bat activity recorded during survey 1 (02/06/2021).

Prior to commencement of works, a second dusk bat emergence survey will be carried out, and a NE licence applied for, if necessary. Replacement crevice roosting habitat will be provided on site through the installation of two professional quality and long-lasting bat boxes on site. Due to low numbers and non-breeding status, such mitigation is considered to be proportionate to the level of bat use and will ensure that ecological functionality is maintained post-development.

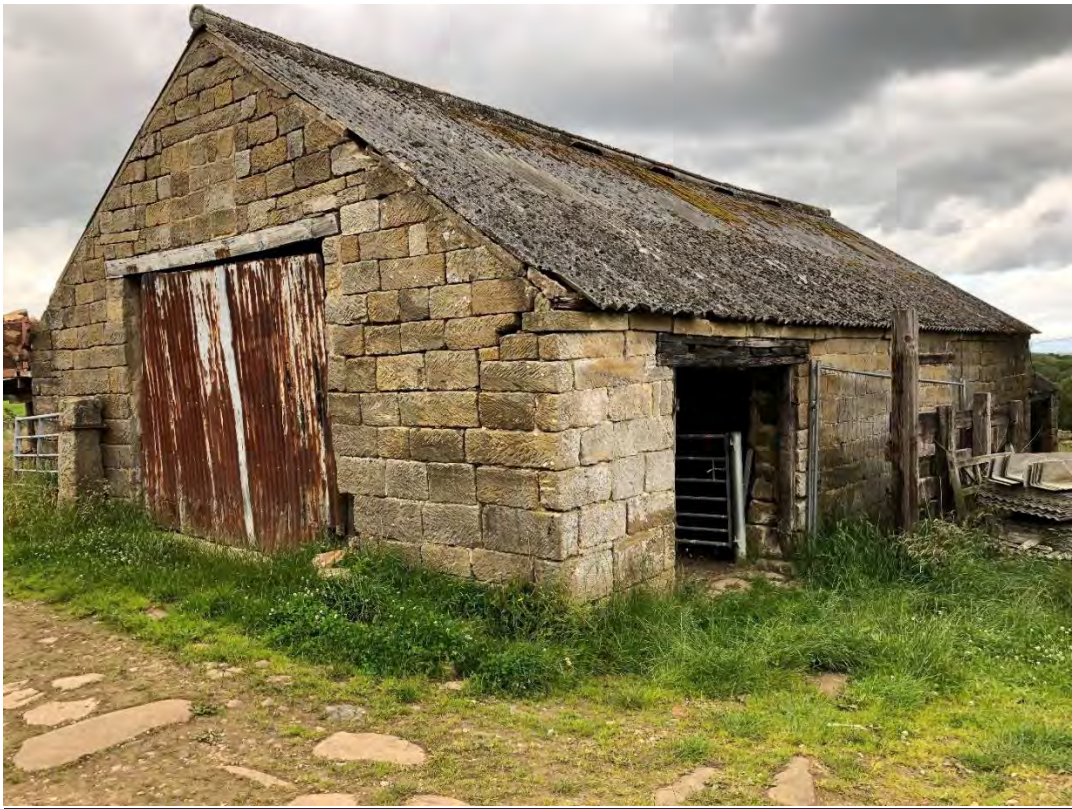
Overall, they are generally level and vertical to the north gable and for the majority of the east and west elevations. However, there is some deflection of the timber lintels over the large openings to the south gable and the south end of the east elevation, with resultant damage caused to the stone walling above and to each end particularly to the south east corner. These walls also have loose or missing pointing.

Photograph 1 – Barn B, South Gable and East Side

- Carefully replace existing timber lintels with reclaimed stone lintels or oak beams over the wider openings.
- Carefully repair the affected areas of damaged stone walling in these locations.

- Carefully re-point those areas where it is loose or missing using a lime mortar mix coloured to match existing.
- Repair any cracks in walls using Helifix sustainable structural solutions.

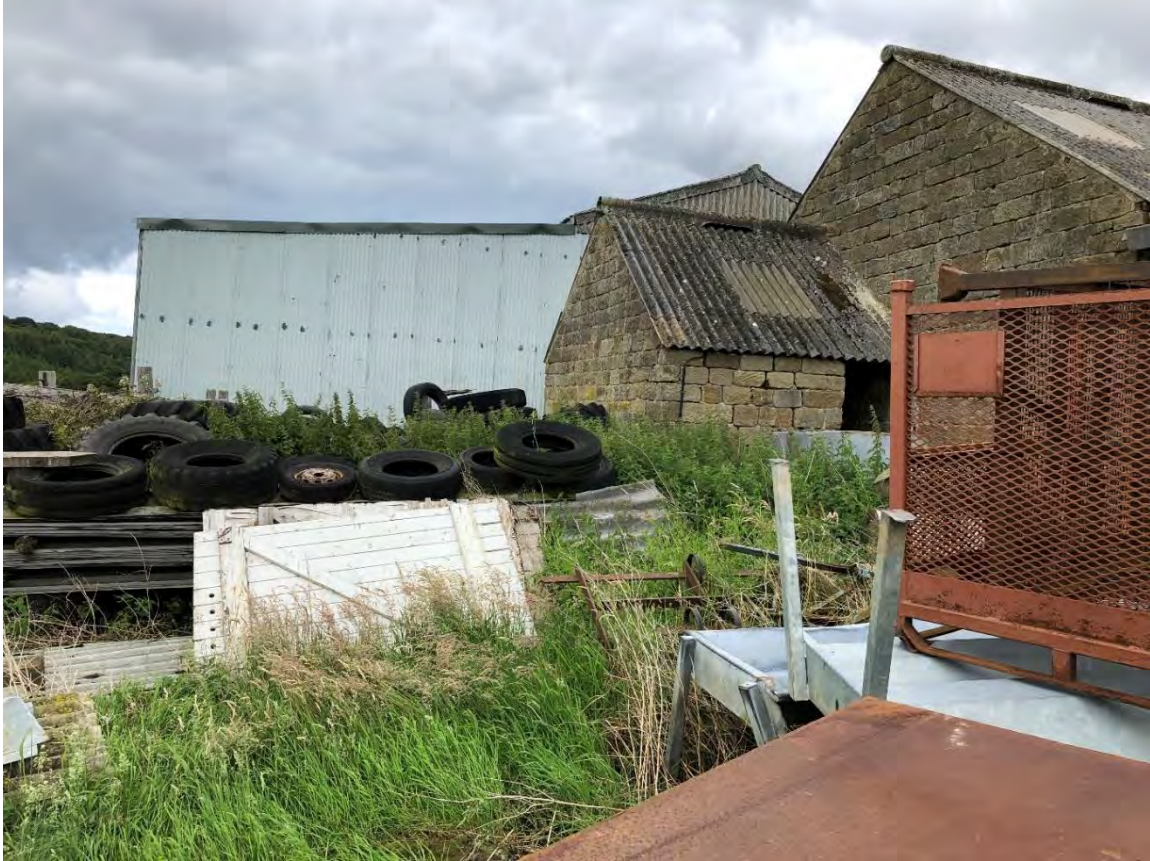
- 4.6 The floor was not visible due to the depth of old compressed bedding in the building.
- 4.7 The rainwater pipes and guttering are all missing.
- 4.8 The small attached outbuilding to the north gable is generally sound but with loose and missing pointing to the external walls and openings to each side, without doors or frames.

- 4.9 The corrugated fibre cement (asbestos) roof sheets are sound but the pointing to the verges is loose or missing and there is not a flashing at the abutment with the main shed, only a mortar fillet which is cracked.

Photograph 5 – North gable and small building

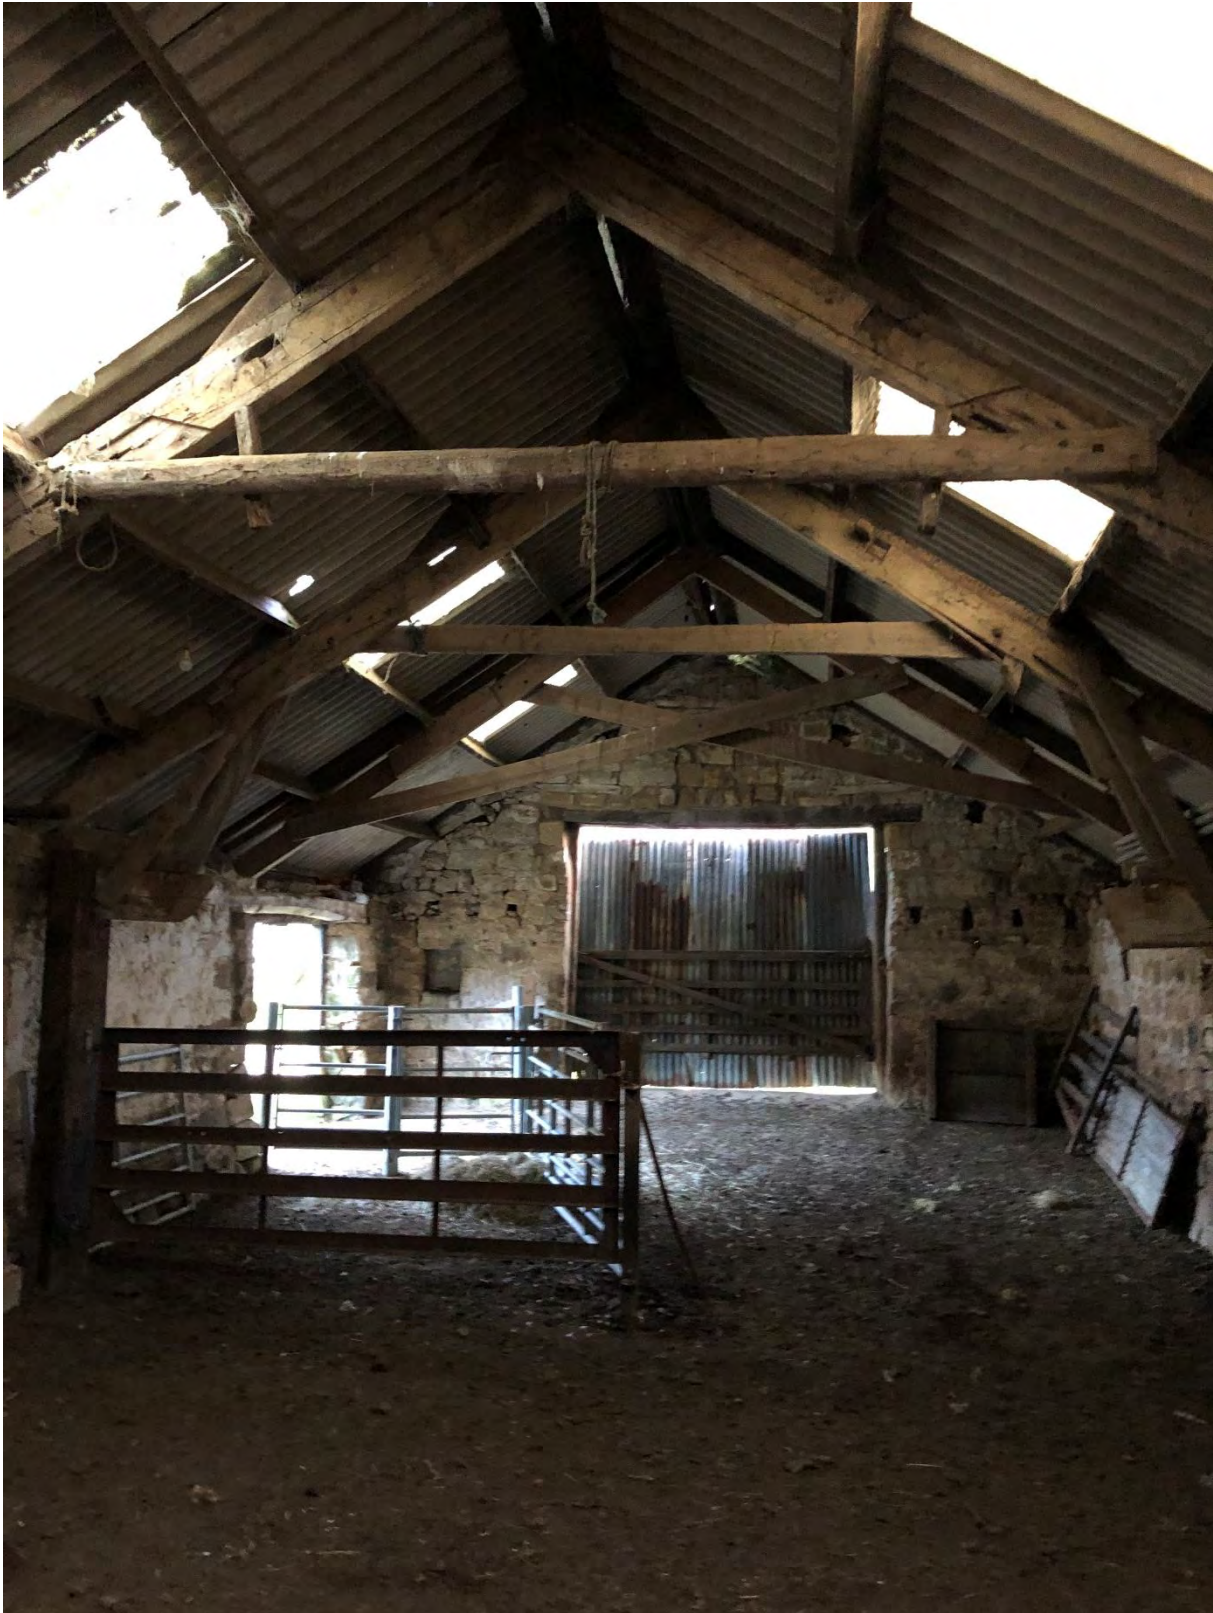
Photograph 12 – South Gable
