Re: NYM/2021/0832/FL and 0835/LB Red Farm Barns, Egton

I am writing in response to the correspondence regarding comments on the ecology relating to Red Farm Barns. I wanted to clarify some of the dates and impacts that may have not been clear in the MAB Environment and Ecology Ltd report submitted with the planning application.

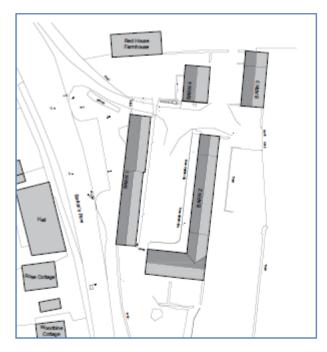
Figure 1 Building reference numbers

A small number of droppings were found in Building A / Barn 2 on Figure 1 below characteristic of pipistrelle species; this building was therefore characterised as high potential by Enviroscope. In fact, it is only the droppings that have influenced that decision and it should be categorised as 'Moderate' potential as the other buildings were. In 2021 this building was resurveyed and again a few droppings were found; some of which were typical of brown long-eared (BLE) bats and again some pipistrelle type. Numbers of droppings are consistent with low numbers of day roosting or foraging bats.

carried out in 2022 to inform the licence. Mitigation of two bat boxes (Schwegler 1 FF or equivalent) mounted on Building 3 (See Figure 1 below) will ensure that mitigation is appropriate for the BLICL.

The MAB Ecology 23rd September survey identified a solitary transient BLE bat roost in Building A / Barn 2. This is typical of autumn where male BLEs are often found singly in barns. It is likely that the pipistrelle droppings were from foraging pipistrelles, as opposed to roosting, as the Building A is open.

Another note in the comments is swallow habitat loss. It is proposed that Barn 4 retains an opening to allow ongoing swallow nesting habitat.

The internal barn owl box will be sited to the north of Barn 3 with an opening on the north wall and a small stone ledge below the box.
