Sandsend visitor car park (NYM/2020/1018/FL) Discharge of Conditions 6, 7, 8 (Planning Portal Ref: PP-11067953)

Former Sawmill Timber Yard, East Row, Sandsend

Archaeological Written Scheme of Investigation
for a Watching Brief

Site	Former Sawmill, East Row, Sandsend, Lythe, North Yorkshire.	
Site Code	FSS21	
Local Planning Authority	North York Moors National Park	
Location	National Grid Reference	NZ 85907 12321
	Easting and Northing	485907, 512321
	Latitude and Longitude	54.498948, -0.67503422
Planning Reference	NYM/2020/1018/FL	
Development	Change of use of the sawmill timber yard to a visitor car park with associated works including surfacing, installation of associated infrastructure (pay stations, CCTV poles, cycle stands/lockers, electric vehicle charging points, boundary treatment and signage), construction of vehicle bridge and the creation of a section of footpath.	
Text and Images	D. Signorelli (Text) L. Signorelli (Images) R. Scott (Edits)	
Date of Issue	September 2021	
Work Commencing	TBC	
Client	Mulgrave Estate	
Summary		
<p>This Written Scheme of Investigation (WSI) details the methodologies for a watching brief to be carried out during groundworks associated with a

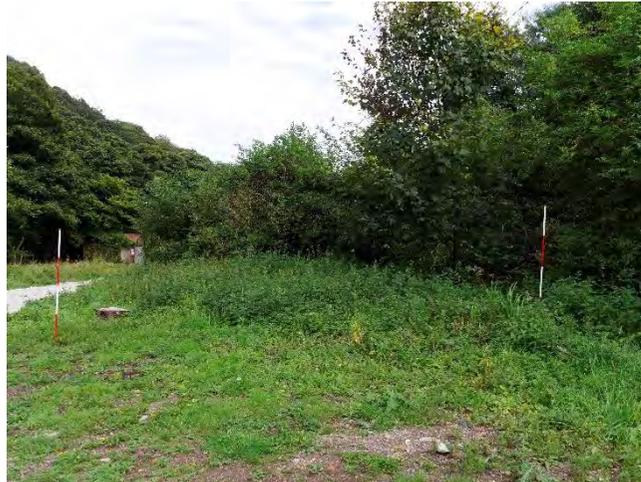
Figure 4: Facing southwest towards the earthenbank.

- An earth bank, currently overgrown with vegetation, is located adjacent to the area comprising the sawmill timber yard. It is possible that the bank formed from the deposition of waste debris, generated from the sawmill timber yard, deposited over time. The bank is to be tested prior to levelling to understand how and with what it was formed. Does it contain any evidence suggestive of a particular period? Is the bank associated with a ditch? Has activity upslope added to the accumulation of debris that formed the bank? Are paleosols present?

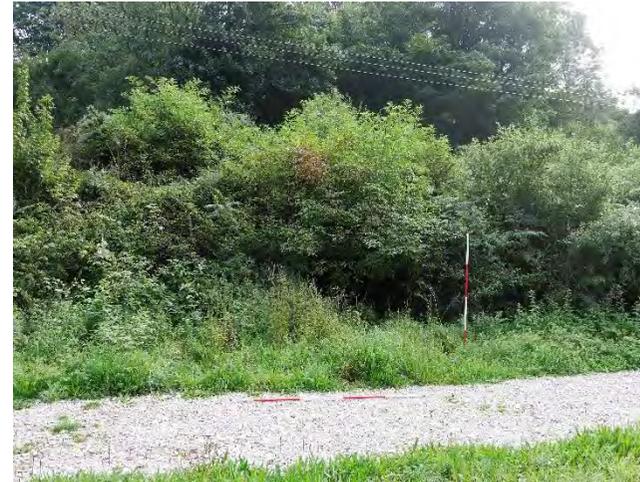
Figure 5: The overgrown earthen bank facing southeast.

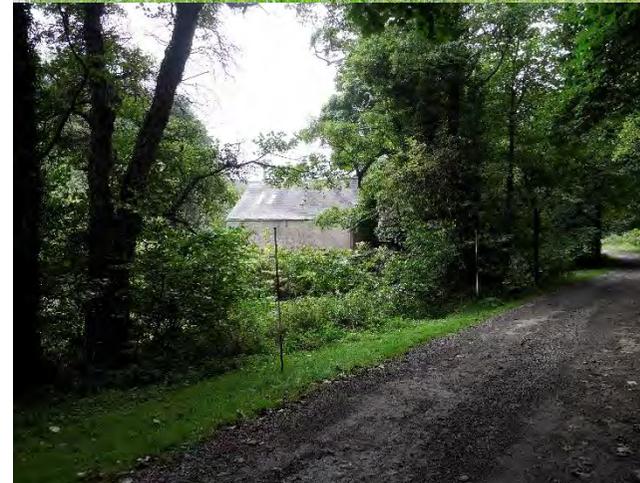
Figure 7: Location of the bank on the East Row Beck.

- Portions of the East Beck banks are to be removed to enable the fitting of Gabion baskets as part of the construction of a vehicular bridge. Both sides of the banks will be tested to investigate the archaeological character of the bank.

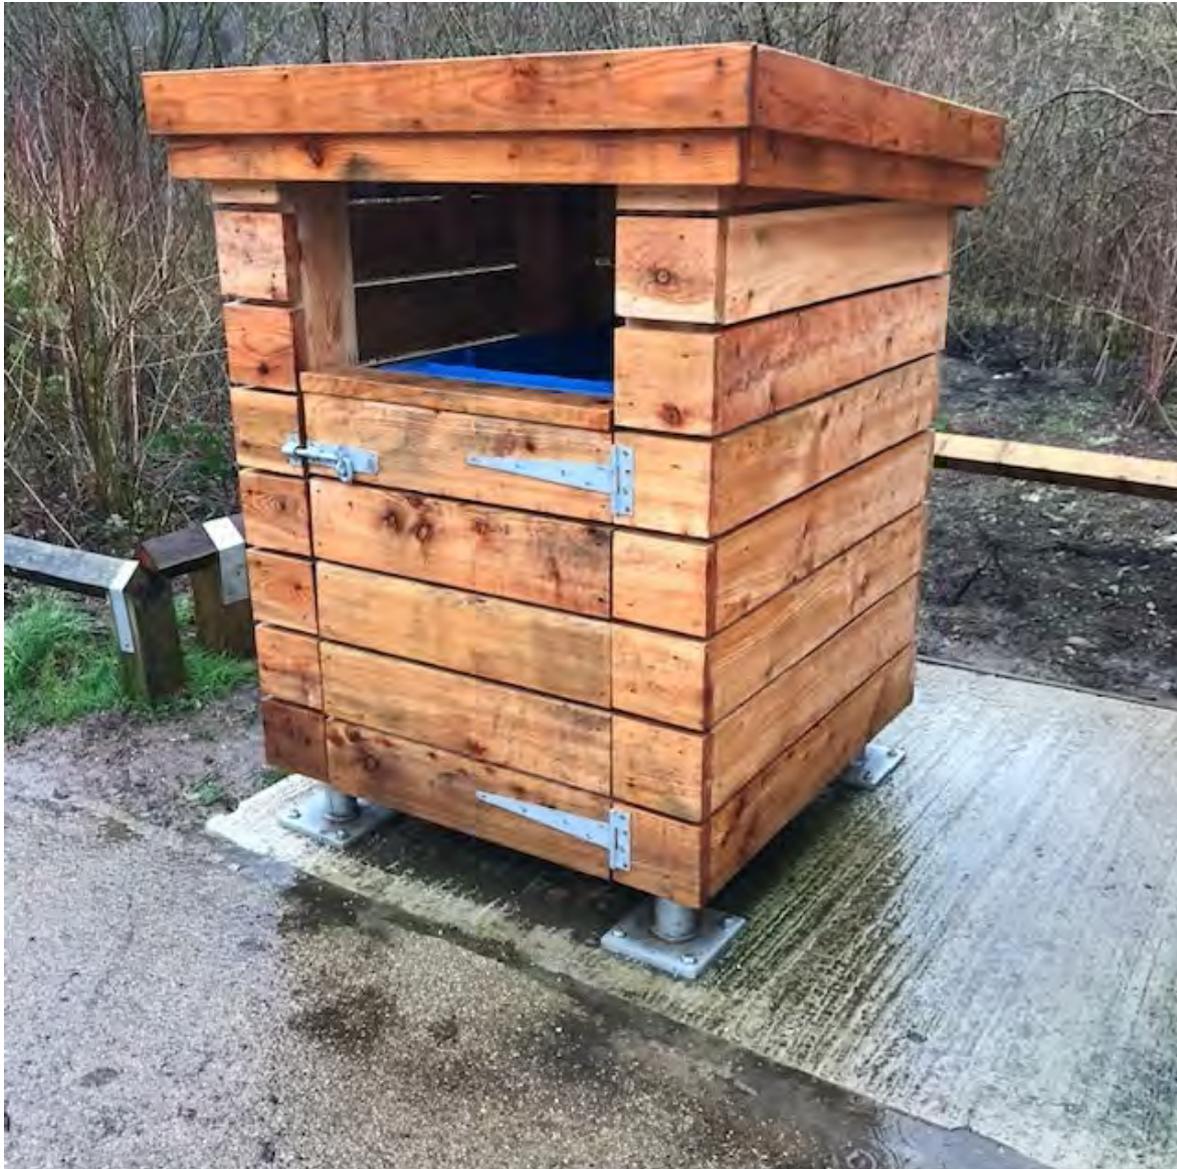
Ref: EBCP/MUL/IL/300

The litter/waste bin will be located adjacent to the pay shelter. The litter bin enclosure's dimensions are: approx. 1m x 1m x1.35 high and constructed of untreated larch wood. A standard wheelie bin will fit inside the timber enclosure. The wheelie bin will be monitored by Estate staff regularly and emptied daily (or when full). The bin will be emptied into an existing skip located at the Sawmill, which will then be dealt with in accordance with the Estate's existing waste contract with Nobel waste contractors.

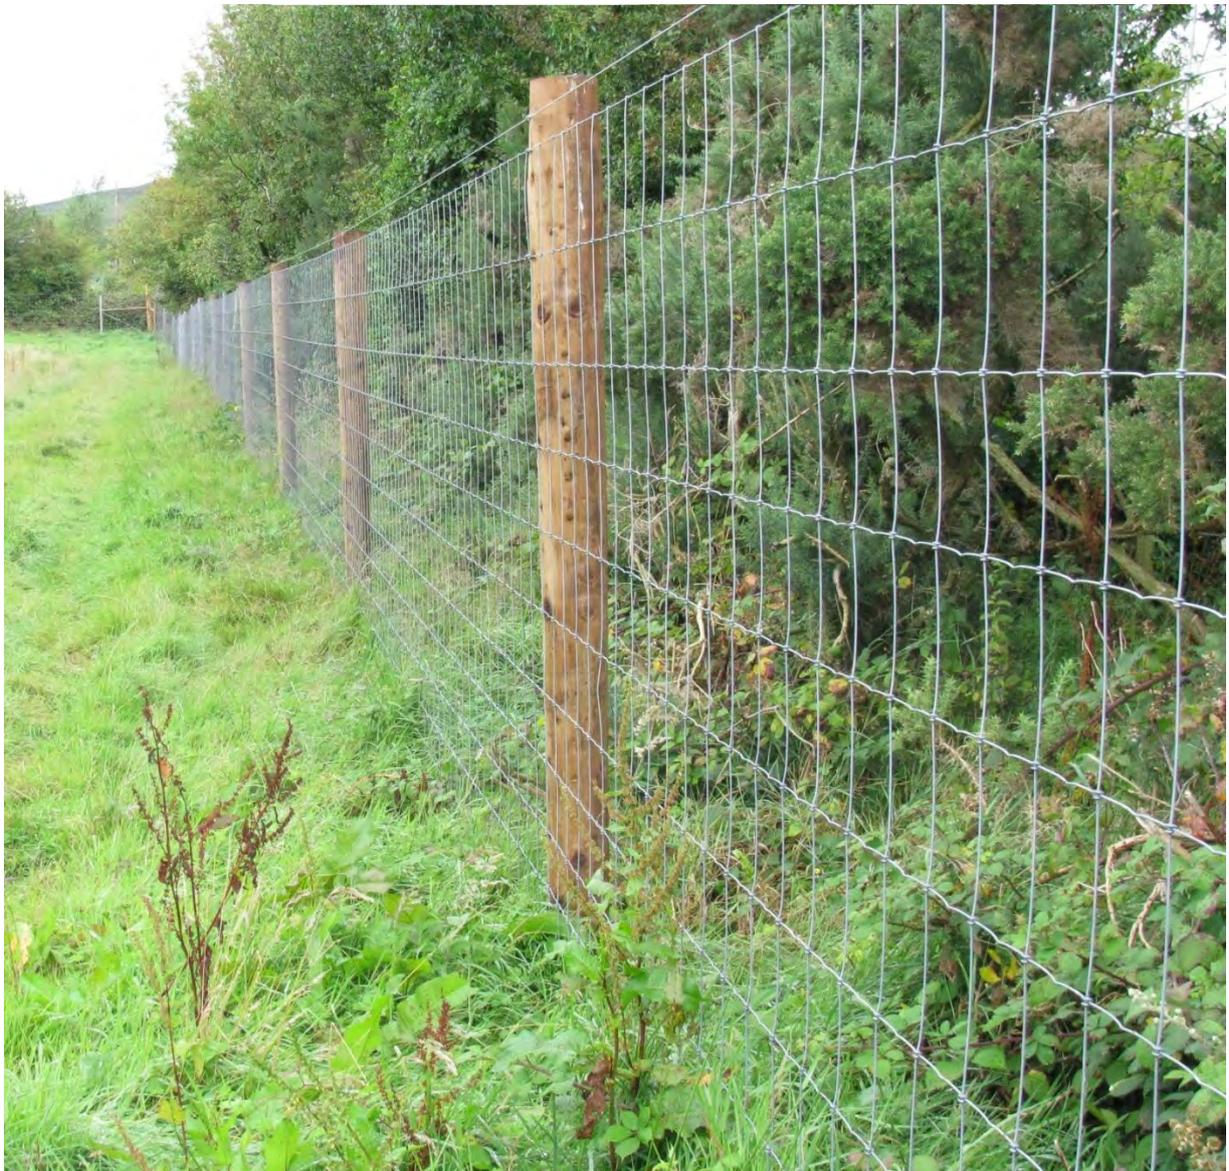
EBCP/MUL/IL/301

Up to 2m high Deer fencing to be erected to the west & South boundaries of the car park. This will be of 100mm diameter tanalised timber softwood posts and galvanised wire. This has been specified to be of low visual impact, yet secure to prevent entrance to the working sawmill.

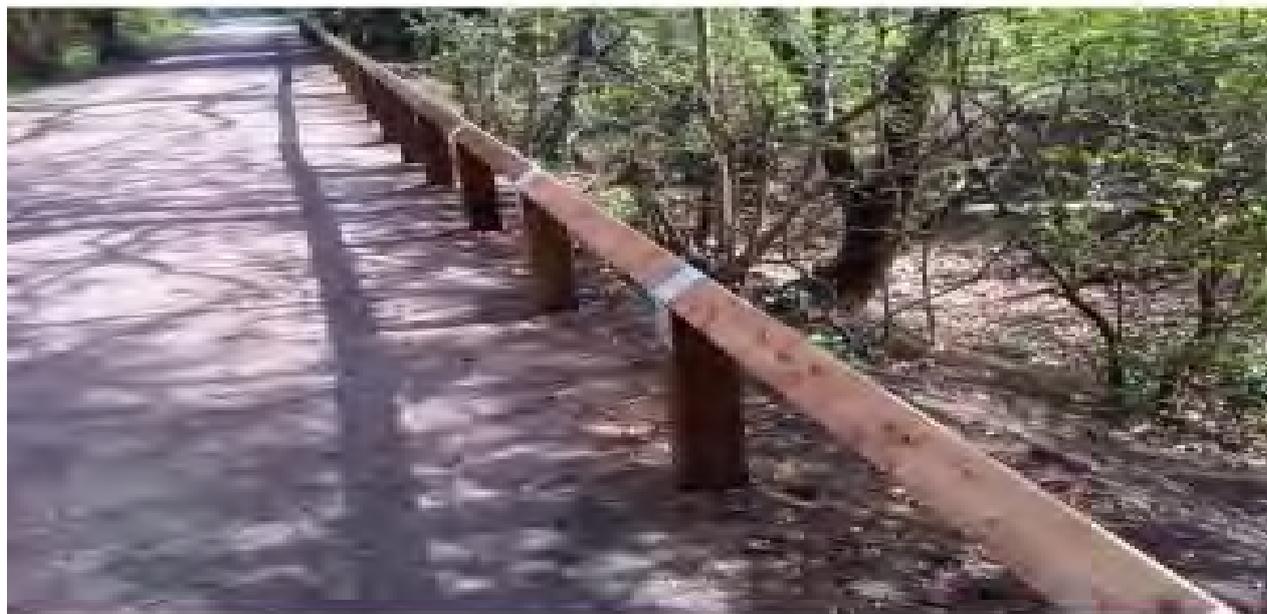
EBCP/MUL/IL/302

400mm high Birds Mouth fencing to West boundary(Beck edge) This low level fencing has been specified to be of low visual impact, but to protect the beck from accidental vehicle entry(handbrake failure).

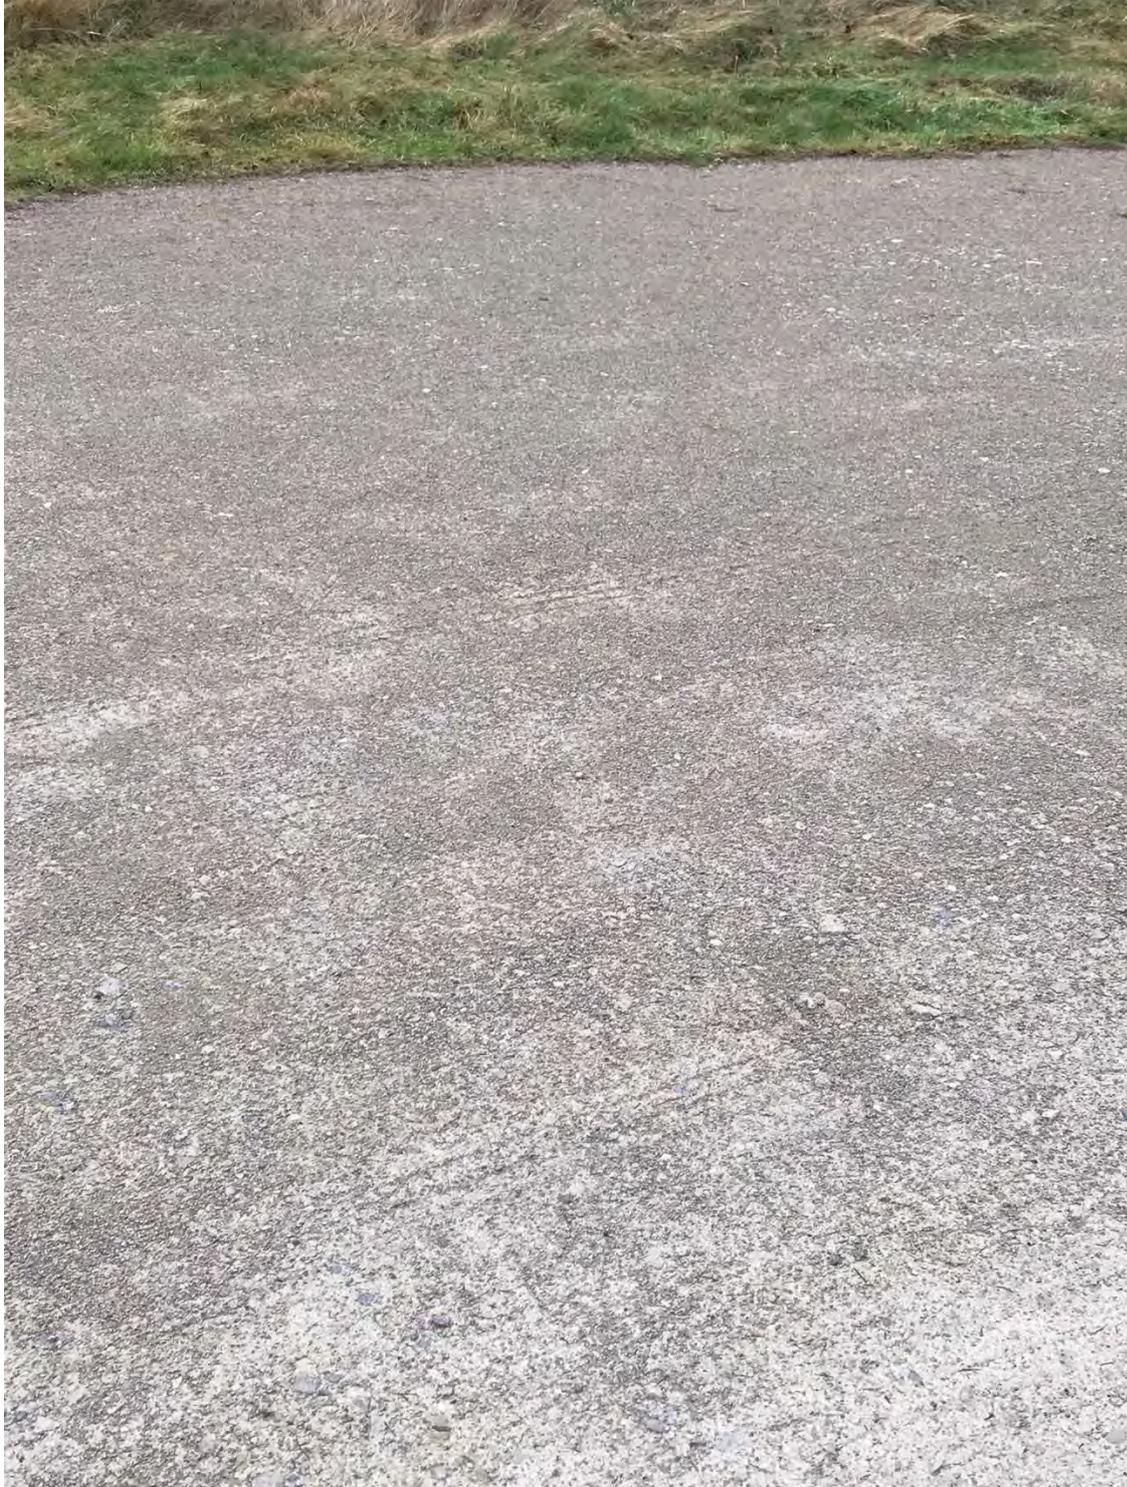
EBCP/MUL/IL/303

Condition no 7- The granular graphite car park surfacing will be finished with a 6-10mm graphite dust which will be rolled and suitable for wheelchair passage

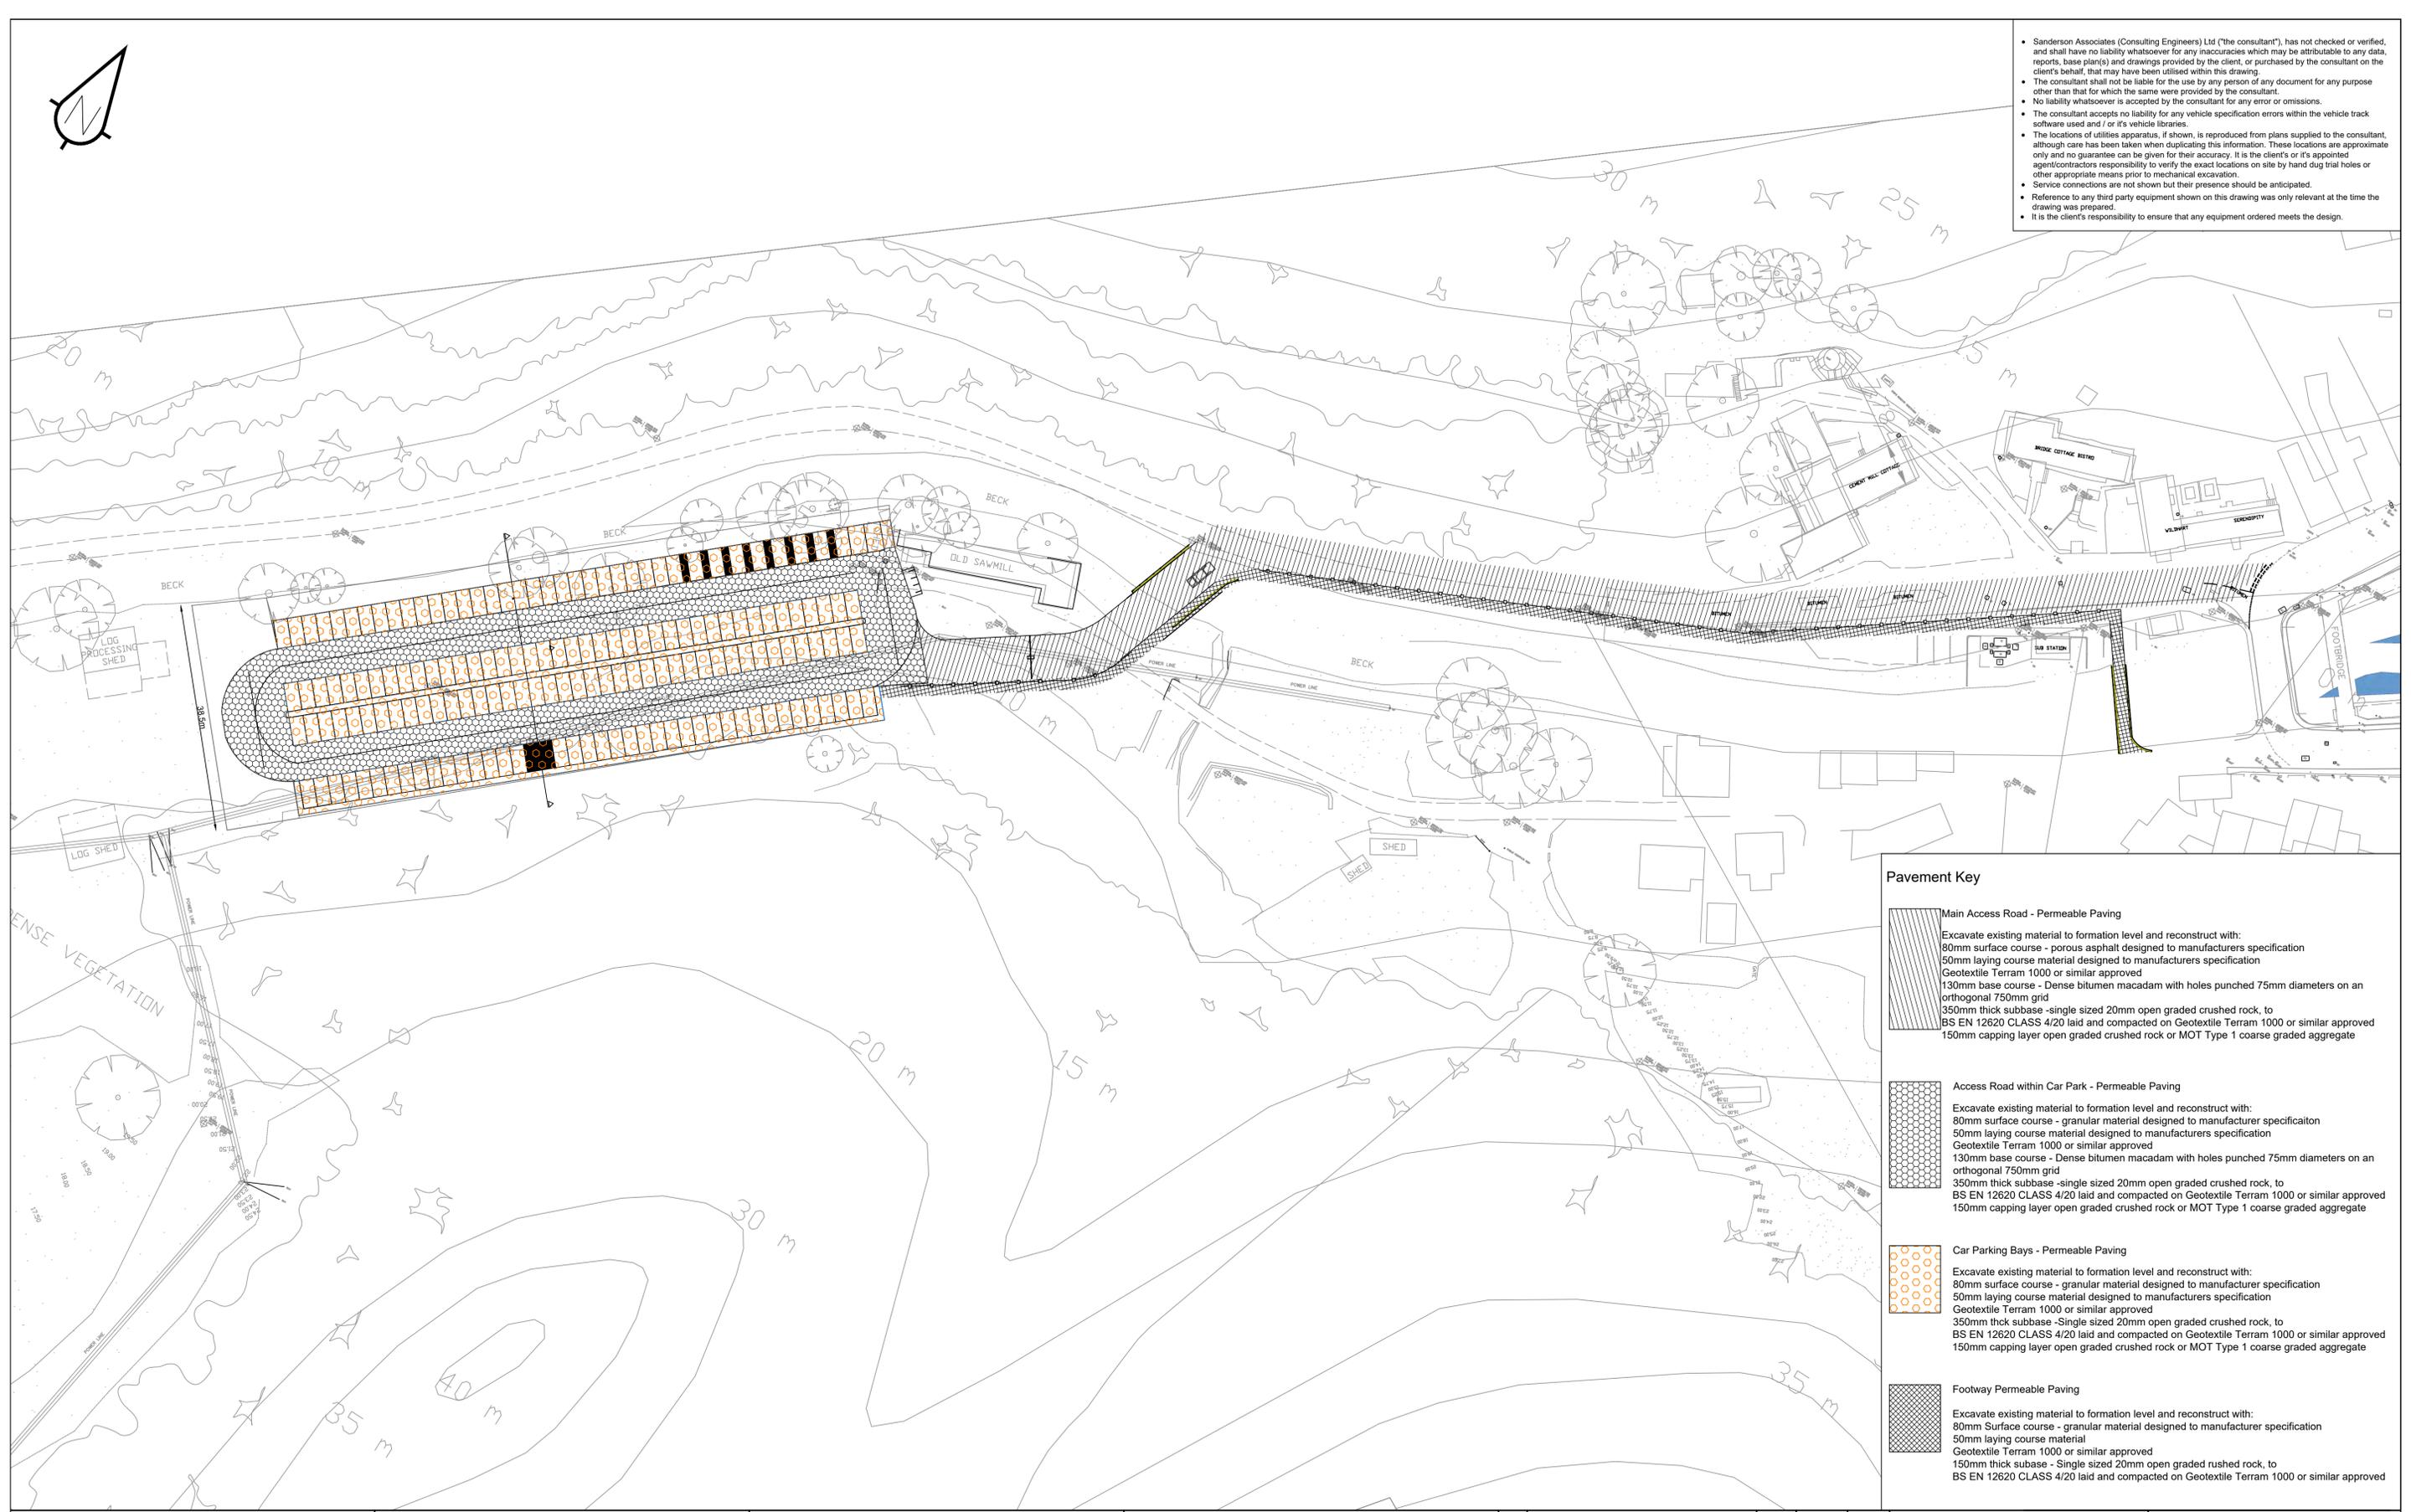
Access road to be constructed using permeable paving system 1 (infiltration into the ground) with permeable bitumen finish or similar approved.
The design depth is calculated for 1 in 100 years plus 40% climate change.
The soil infiltration rate is based on predominantly Clay with an infiltration rate of 10⁻⁶ l/sec.
For construction details refer to drawing number 300630-700-001.

Car parking area to be constructed using permeable paving system 1 (infiltration into the ground) with grey granular finish or similar approved.
The design depth is calculated for 1 in 100 years plus 40% climate change.
The soil infiltration rate is based on predominantly Clay with an infiltration rate of 10⁻⁶ l/sec.
For construction details refer to drawing number 300630-700-001.

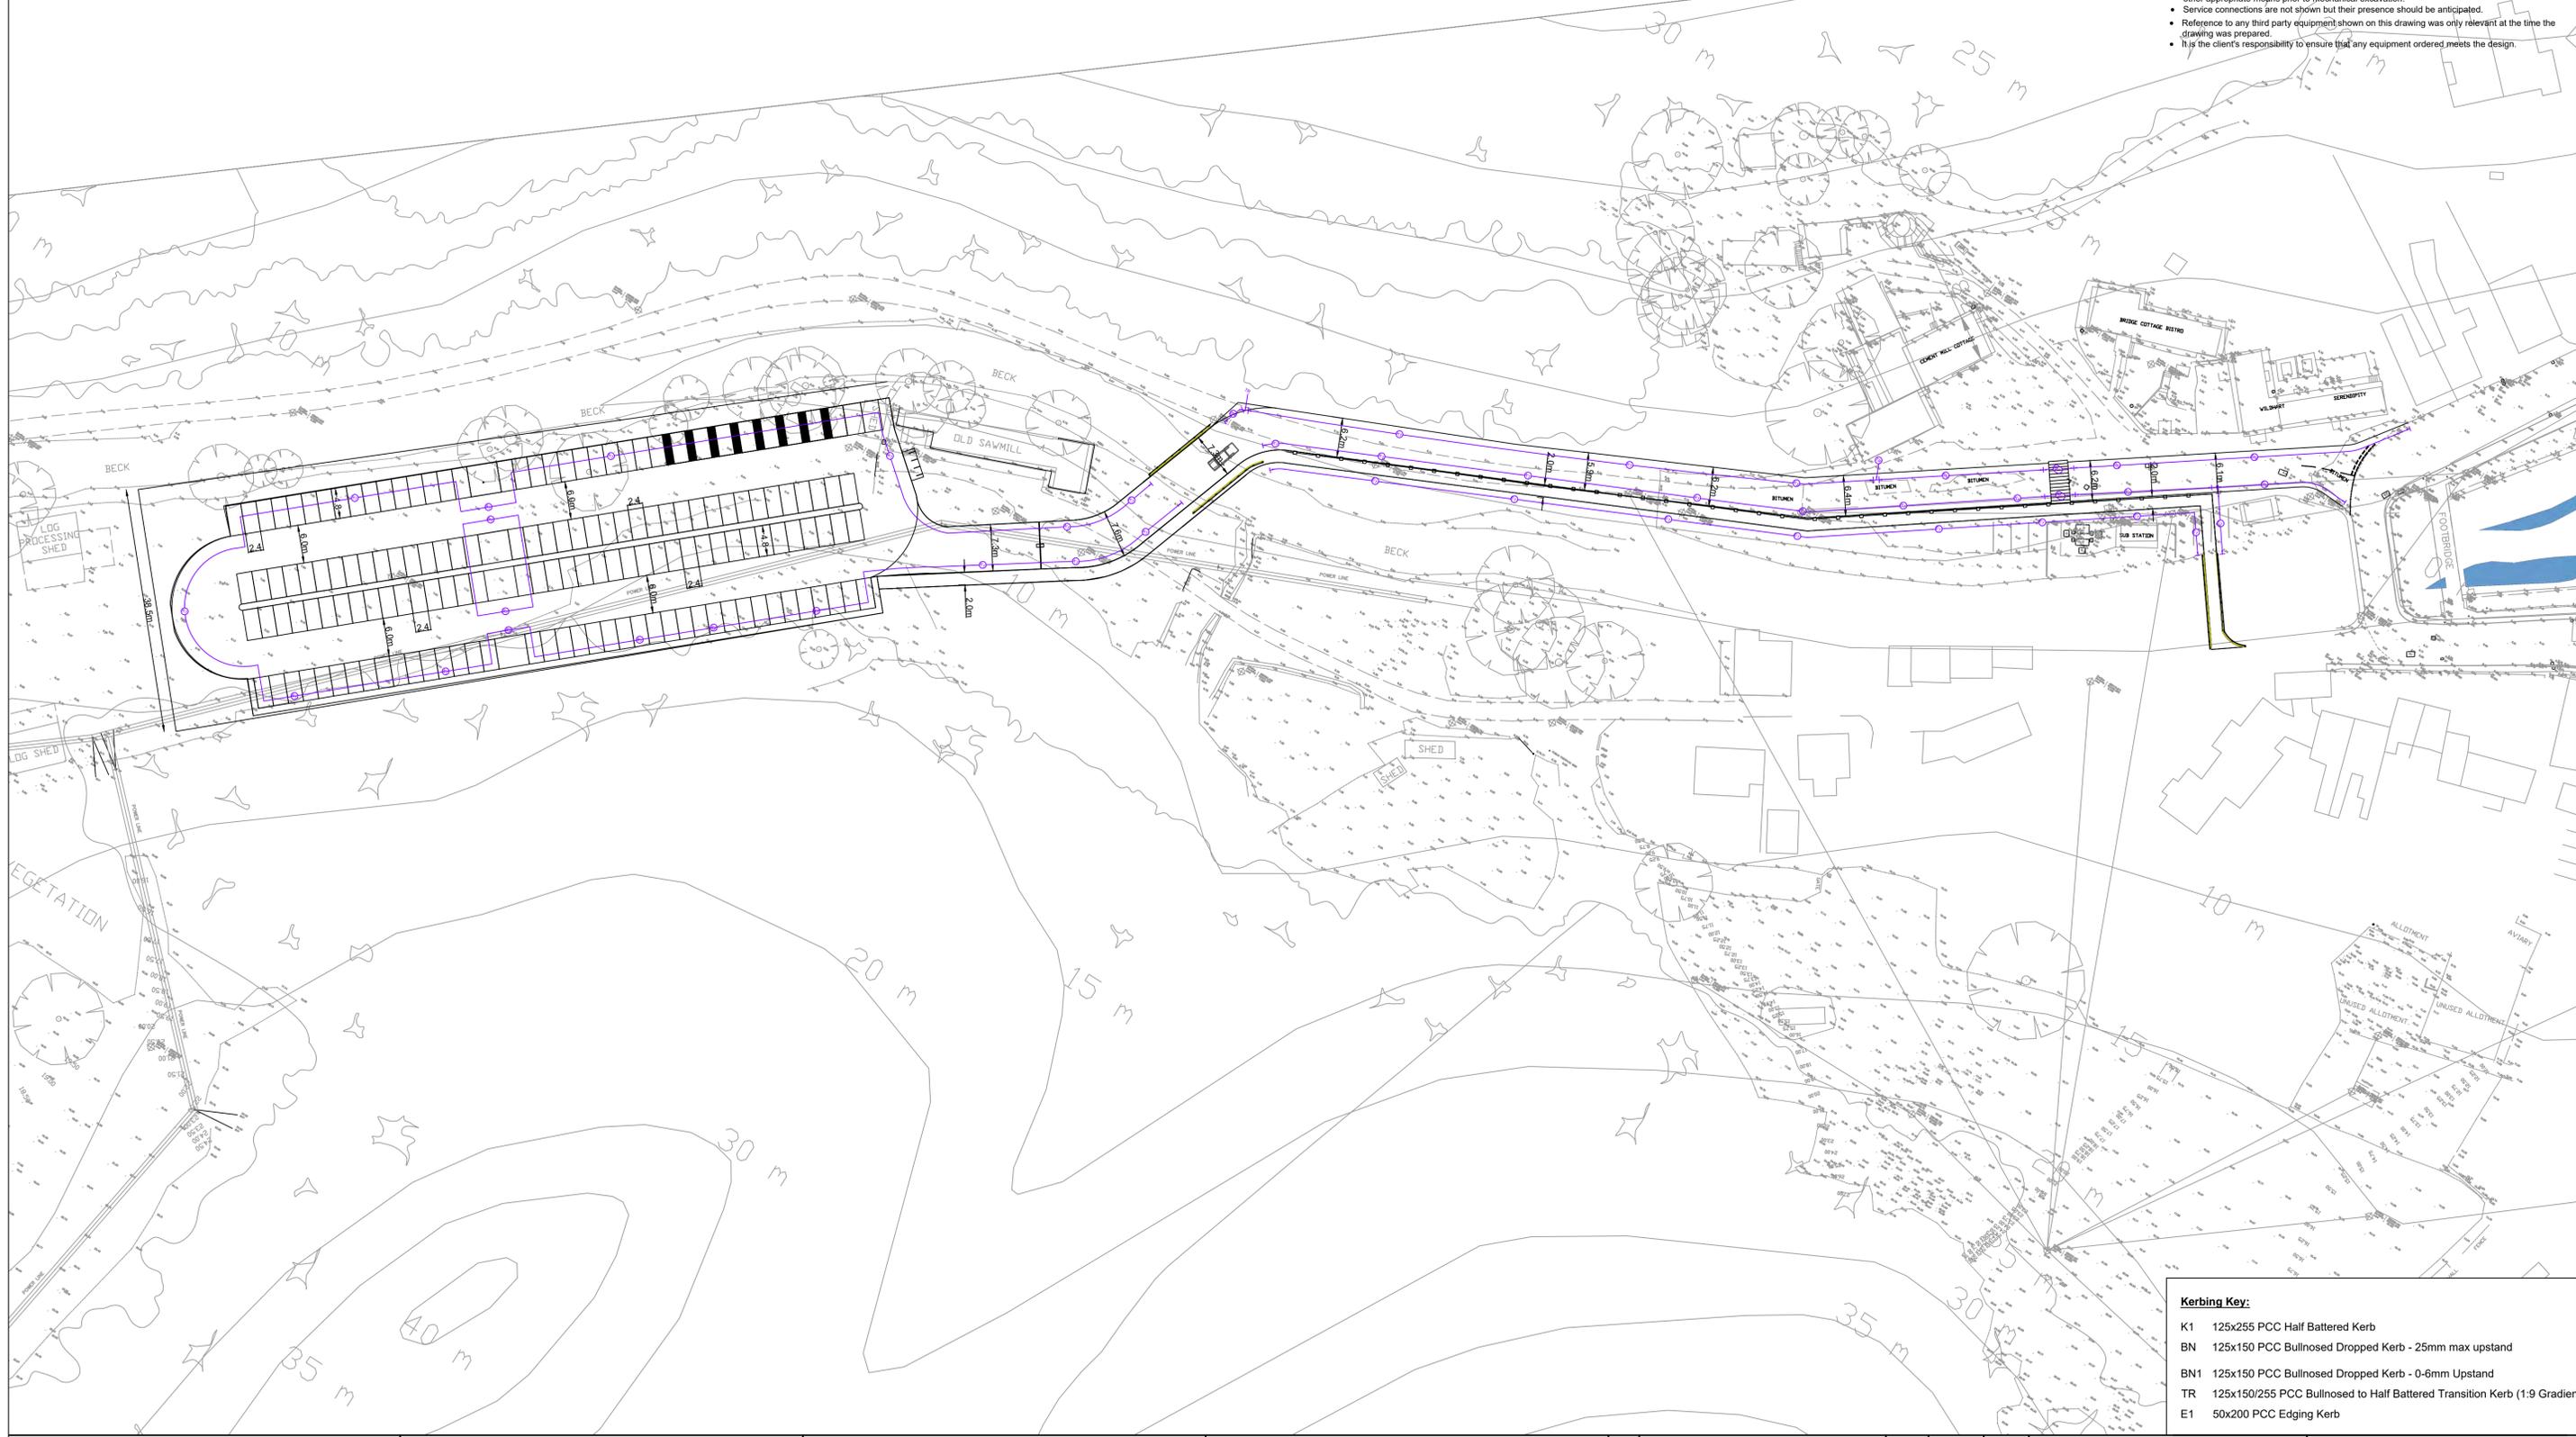
K1	125x255 PCC Half Battered Kerb
BN	125x150 PCC Bullnosed Dropped Kerb - 25mm max upstand
BN1	125x150 PCC Bullnosed Dropped Kerb - 0-6mm Upstand
TR	125x150/255 PCC Bullnosed to Half Battered Transition Kerb (1:9 Gradient)
E1	50x200 PCC Edging Kerb

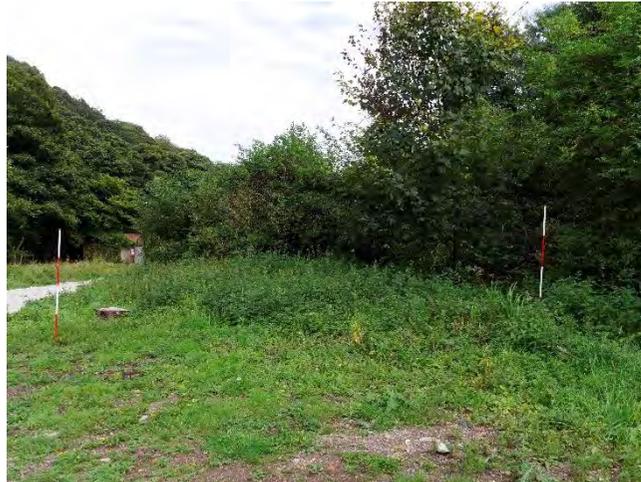
Figure 4: Facing southwest towards the earthenbank.

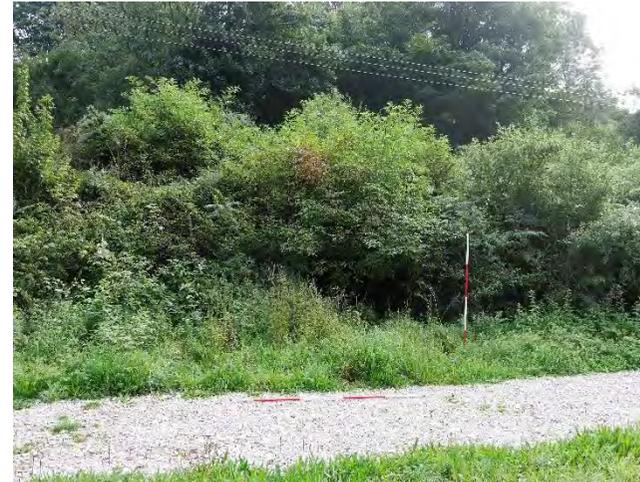
Figure 5: The overgrown earthen bank facing southeast.

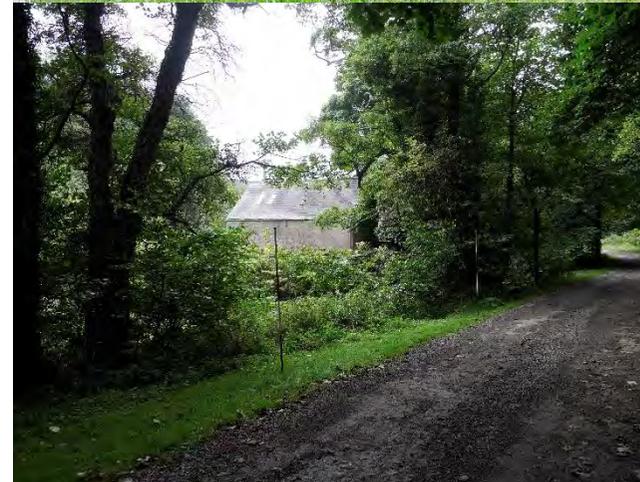
Figure 7: Location of the bank on the East Row Beck.
