## Design and Access Statement

Proposed Residential Development Site  
to  
West of Low Farm, Sneaton, YO22 5HS

<sup>TM</sup>  
**bhd**  
partnership

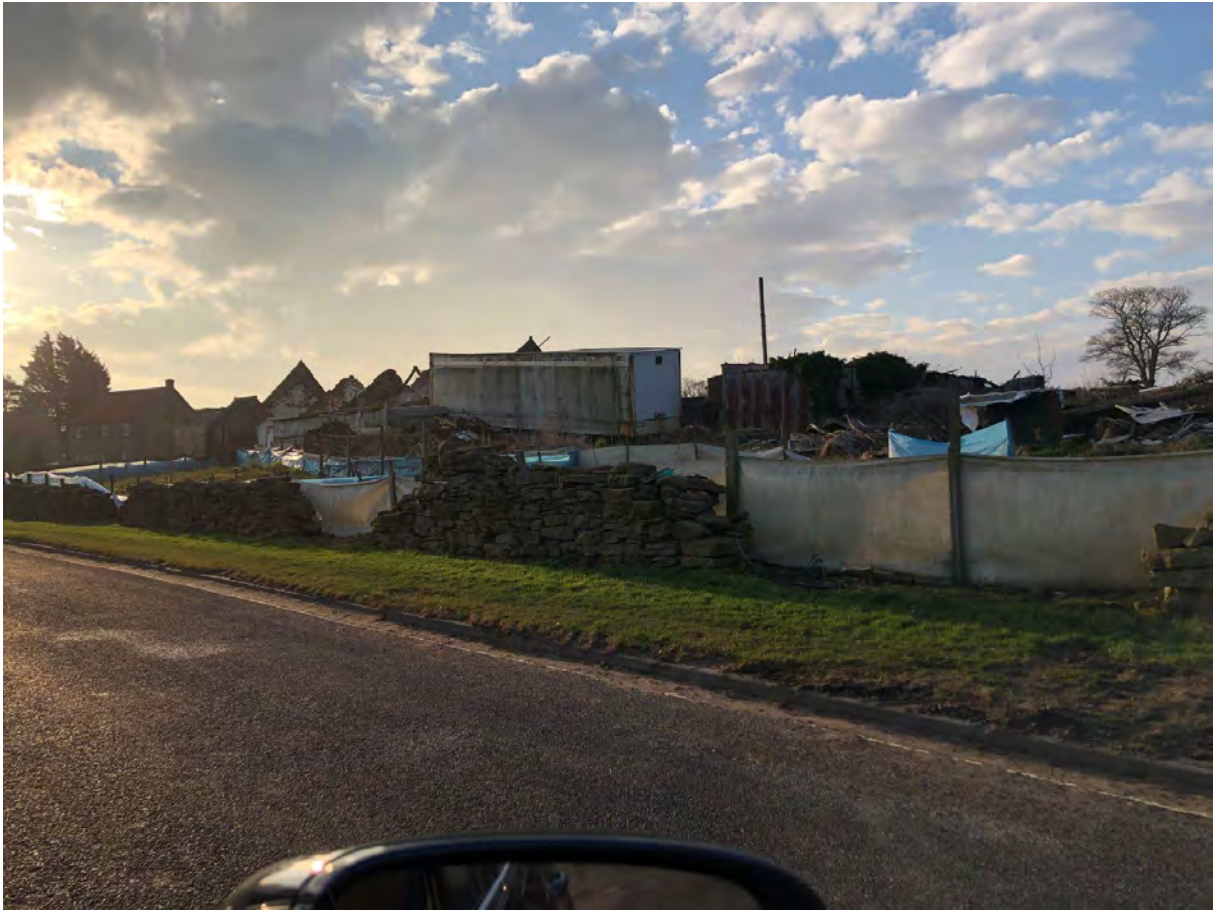
Photographs 1  
View from road on north-west corner of site

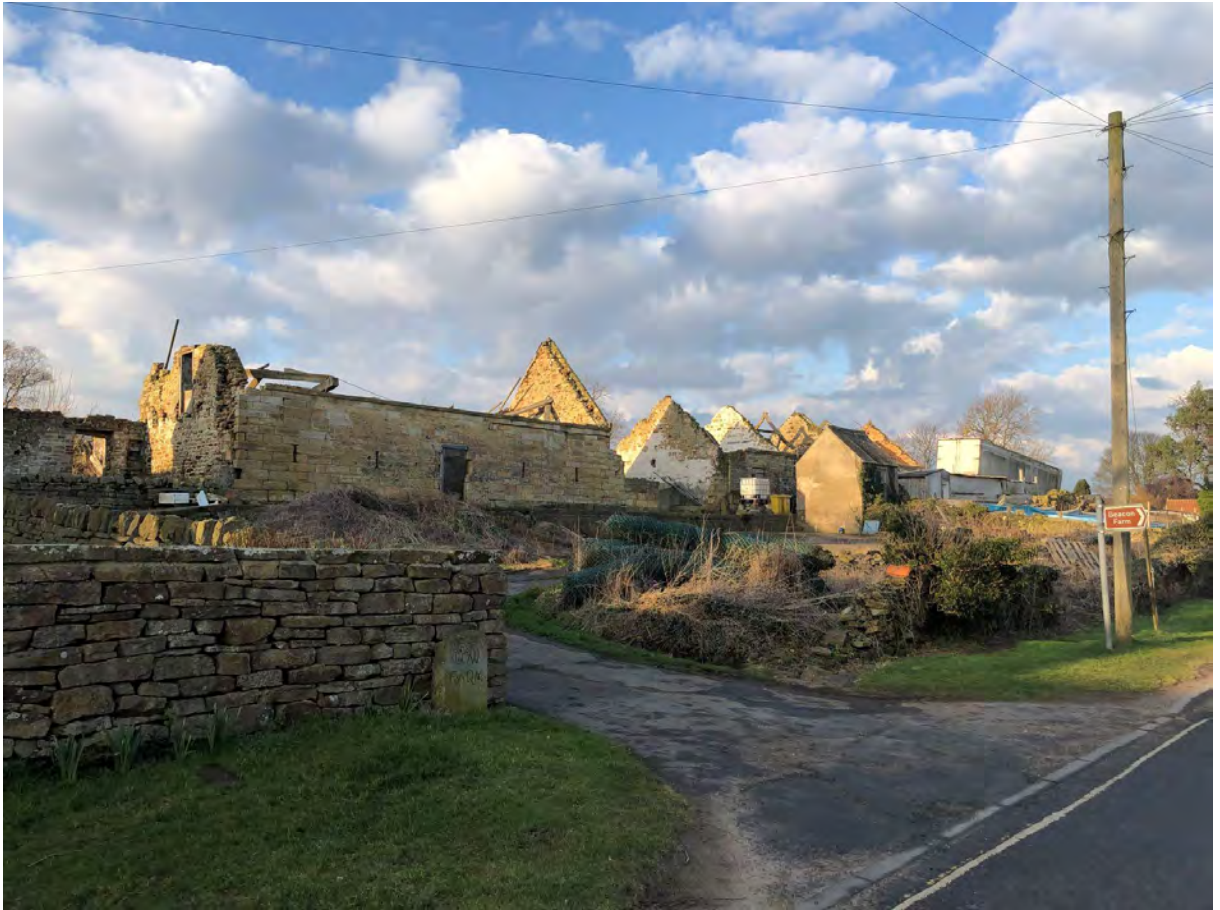
Photograph 2  
View from road on north-east corner of site  
In front of Low Farmhouse

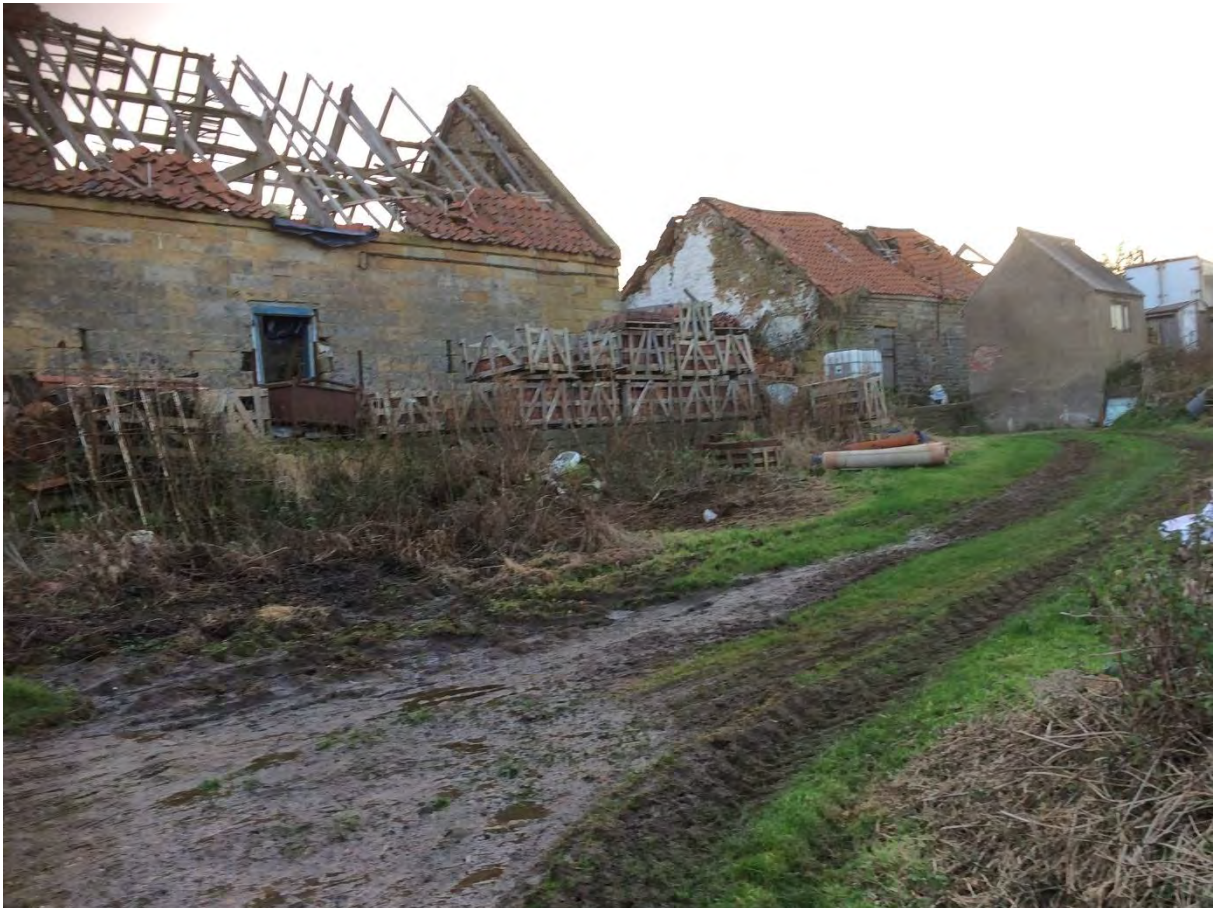
Photograph 4  
Redundant buildings 2017

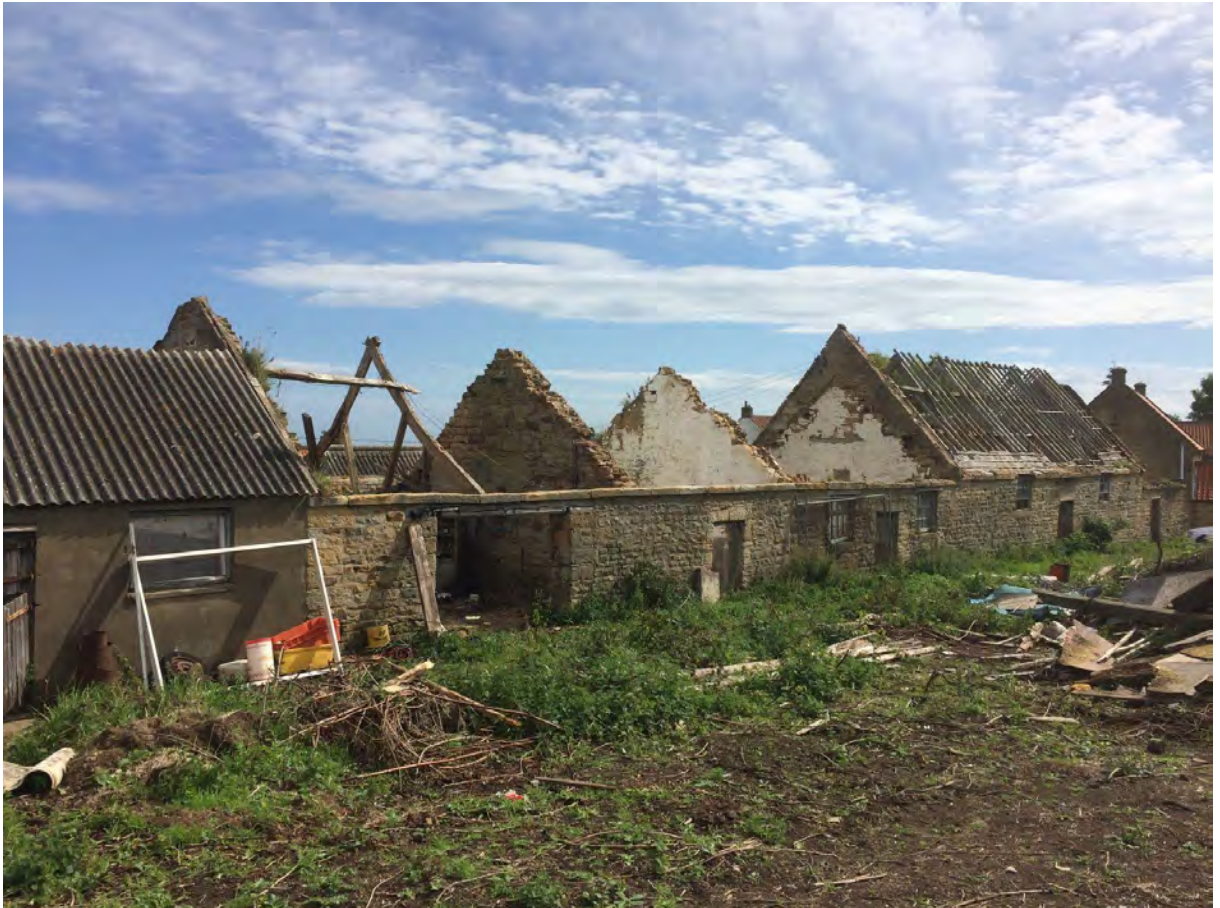
Photograph 5  
Redundant Buildings 2017

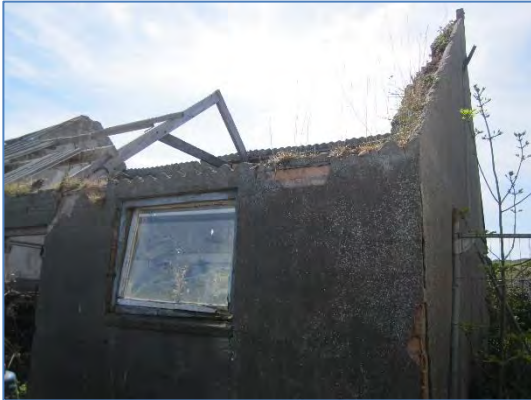
**Photo 5: Building A-Missing roof.**

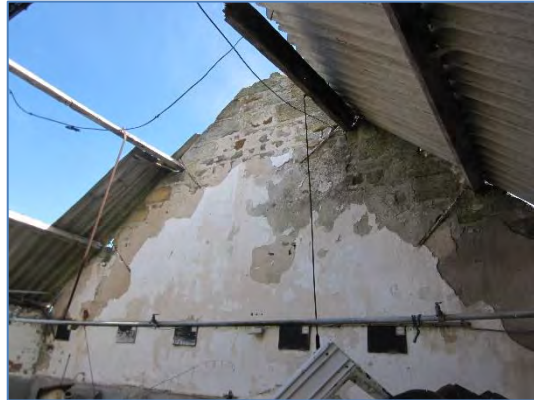
**Photo 6: Building A – Internal roof.**

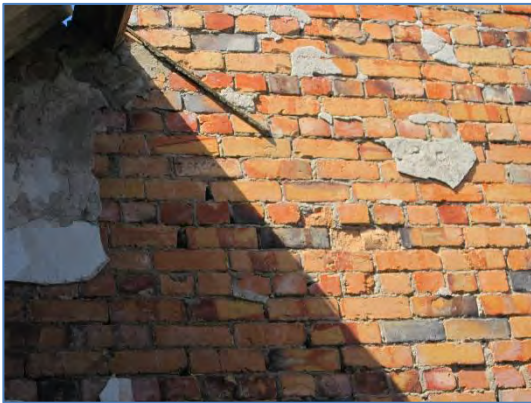
**Photo 7: Building A minor crevices in brickwork..**

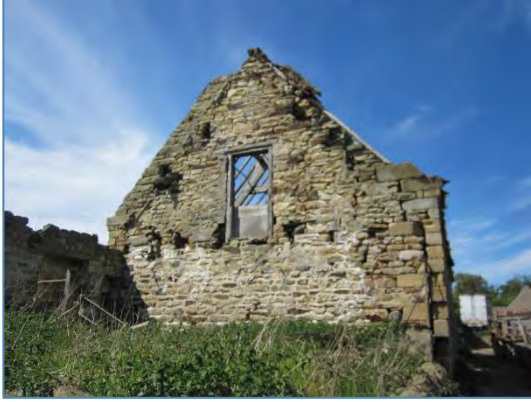
**Photo 17: Building D-Crevices in gable.**

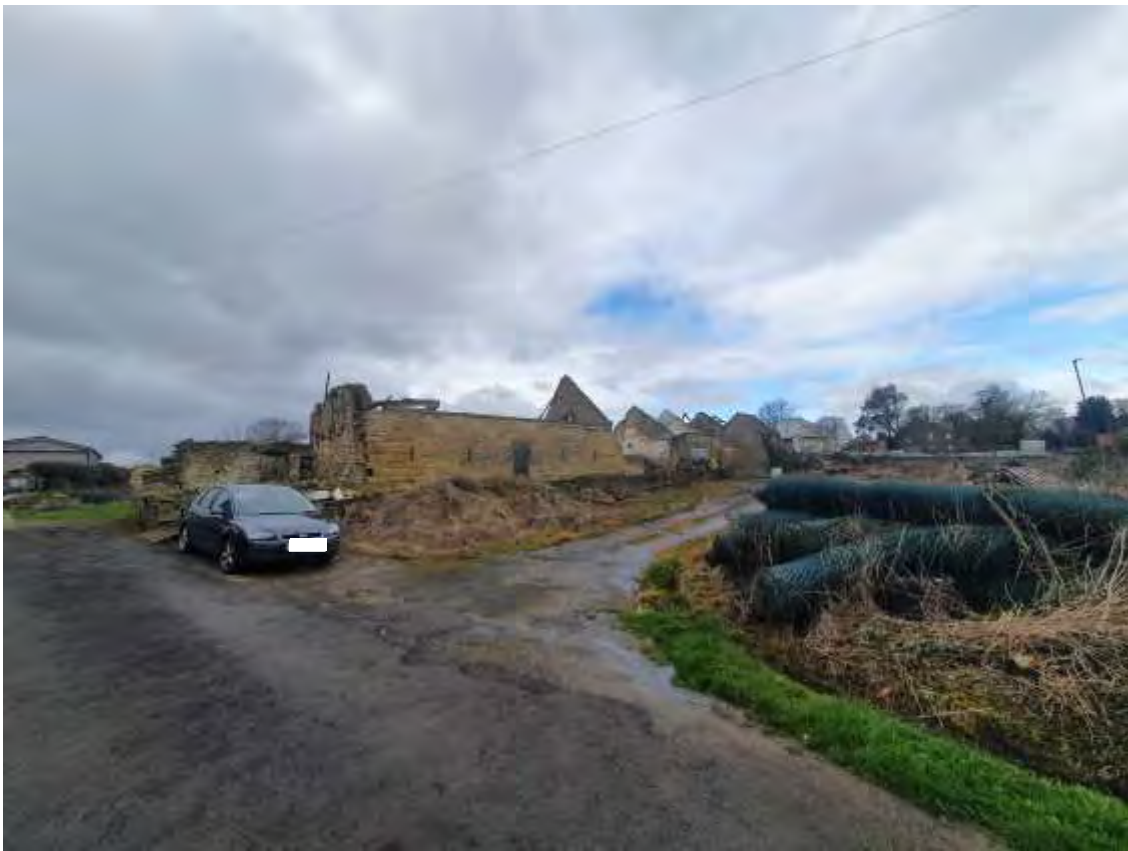
Photo 1. Front view of the traditional buildings and front east yard.

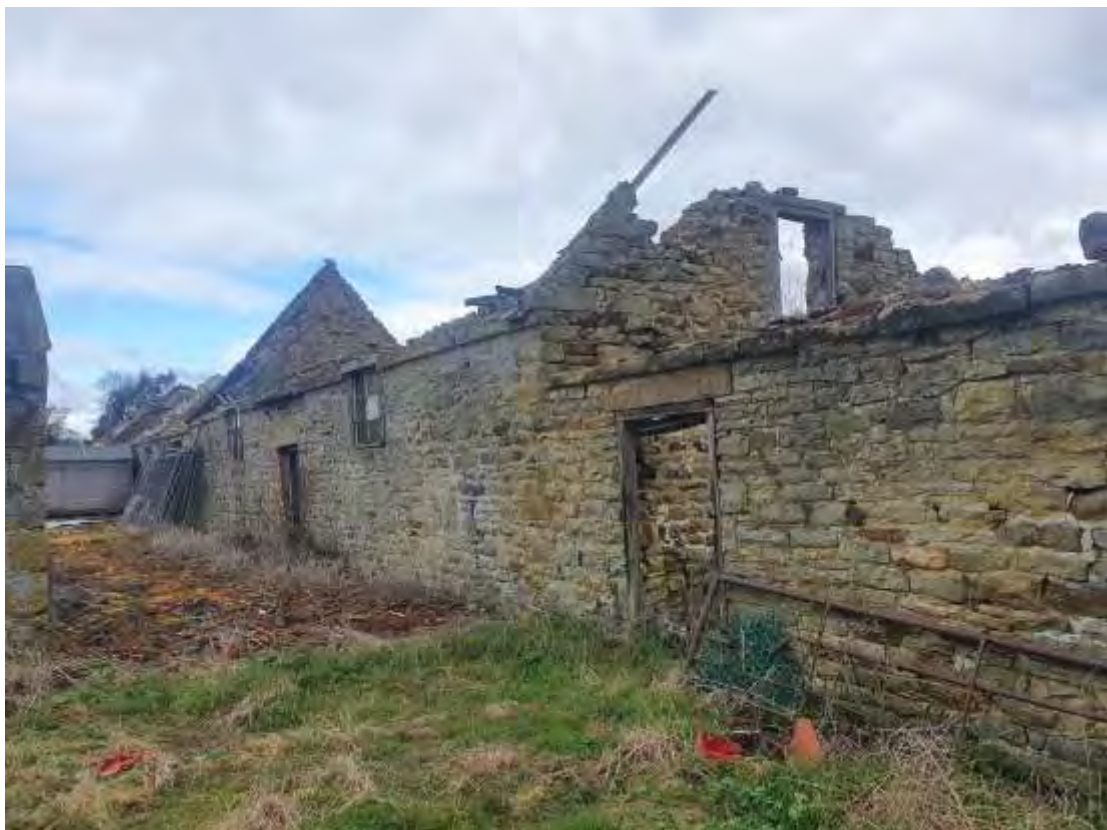
Photo 3. Rear view of the traditional buildings.

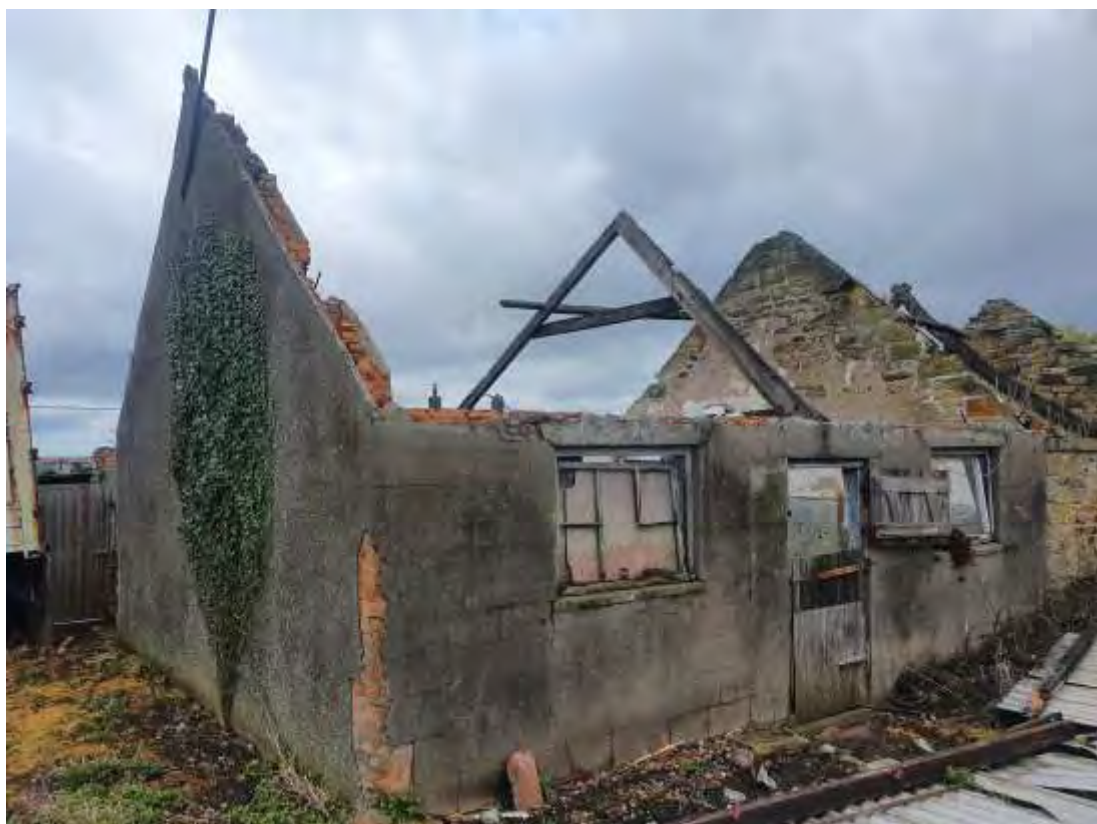
Photo 5. Rear view of the west end of the terrace. This more modern rendered brick section is to be removed.

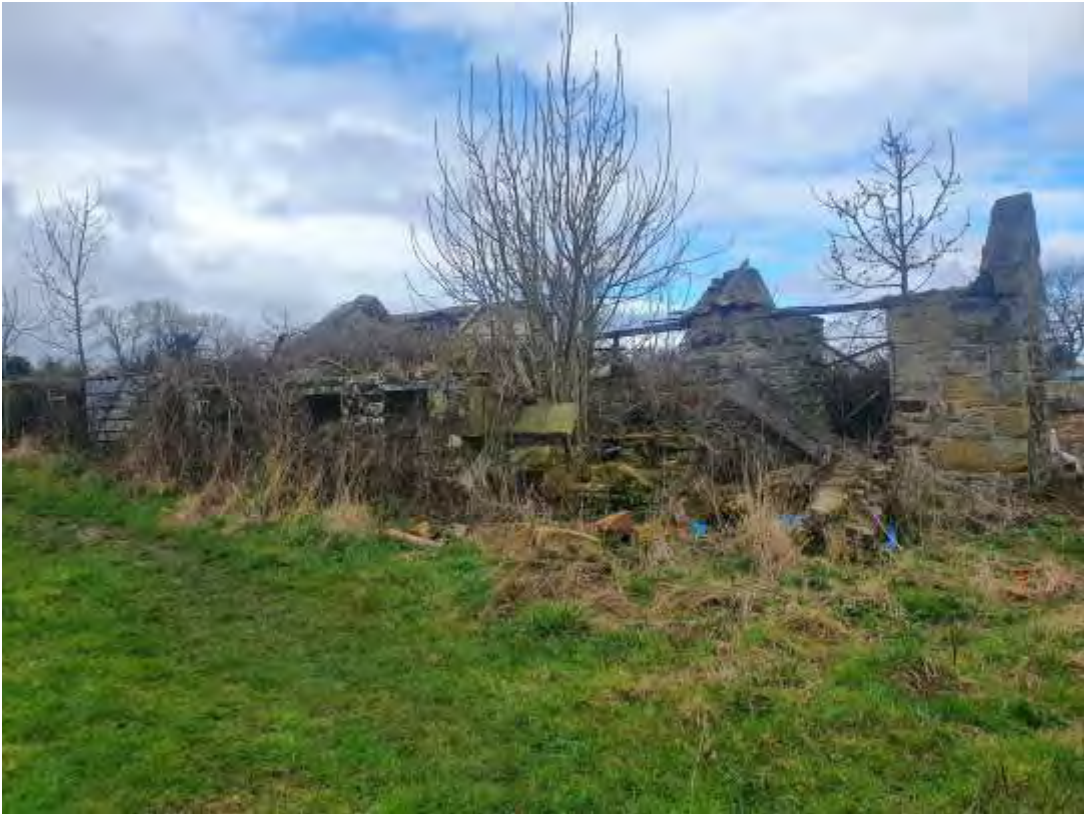
Photo 6. Pigsty's and store to rear of the main block of buildings.

- The rear small range of agricultural buildings, comprising former pigsty's and a store to the south is no longer in use. This small range of buildings are in dilapidated condition but still retaining sections of the walls. To the immediate south of these buildings at the field boundary is a former railway carriage that was used for horse stabling in the 1980/90's but has been vacant since. As part of the proposal this aspect is to be removed. See photo 6.

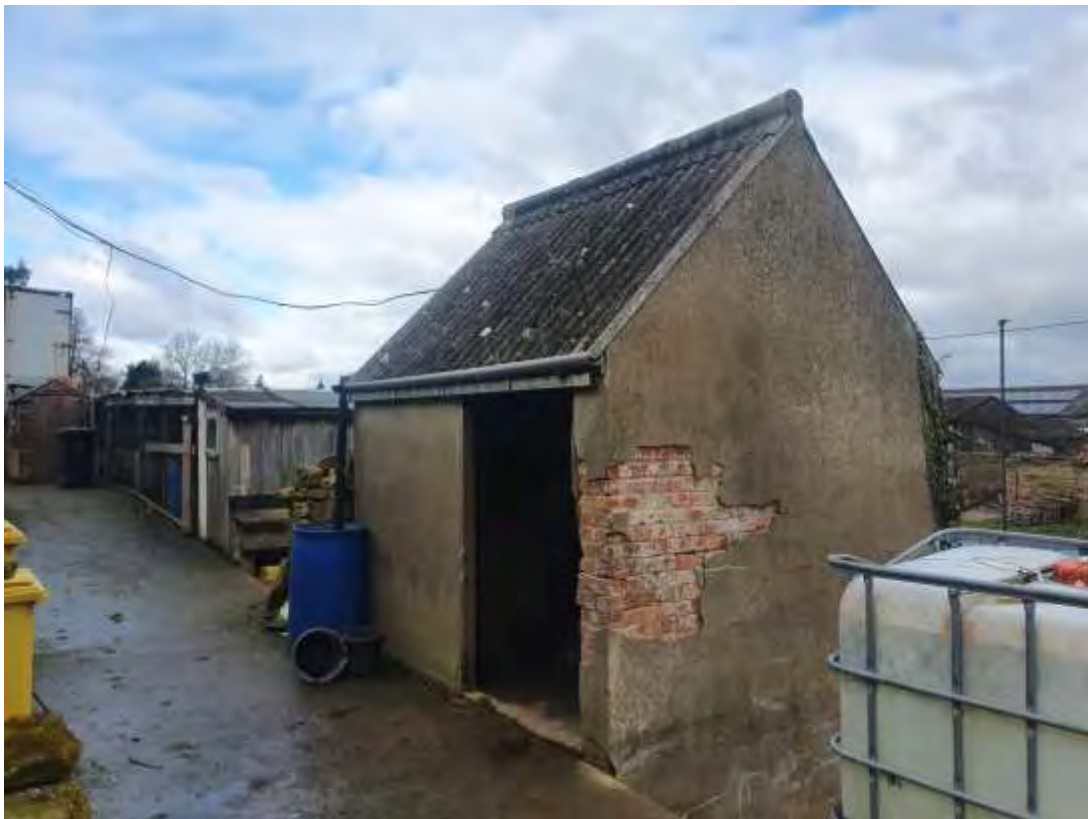
Photo 7. More modern rendered brick store to front of the main terrace to be removed.
