From:**Sent:** 09 June 2022 16:21**To:** Megan O'Mara**Cc:** |**Subject:** Discharge of Conditions at Lawns Farm, Ugthorpe - NYM/2022/0359/CVC

Location:
**Land off Barry Bank
Ugthorpe**

Report Type:
**Arboricultural Survey
Arboricultural Impact Assessment
Arboricultural Method Statement
Tree Protection Plan**

Ref:
ARB/AE/2851

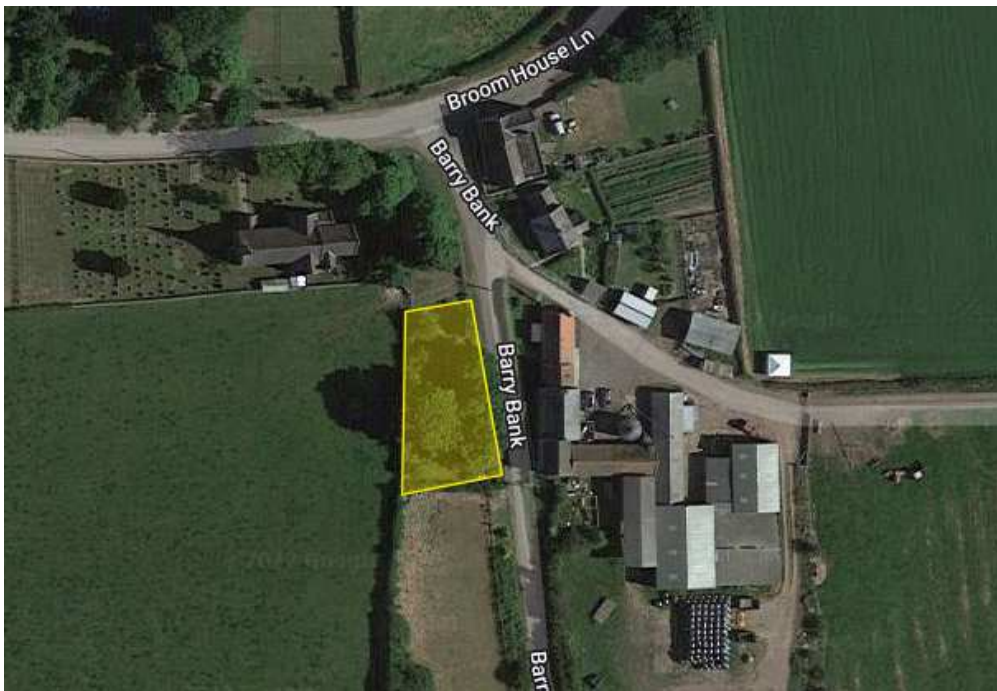
Figure 1: Area surveyed highlighted

- 2.1 The site is a small, grassed paddock / garden area located opposite Lawns Farm in Ugthorpe. It is accessed by foot directly from Barry Bank to the east. Figure 1 shows the extent of the area surveyed (this area may exceed that of the construction redline to ensure all trees within a potential proximity to the proposals are considered).

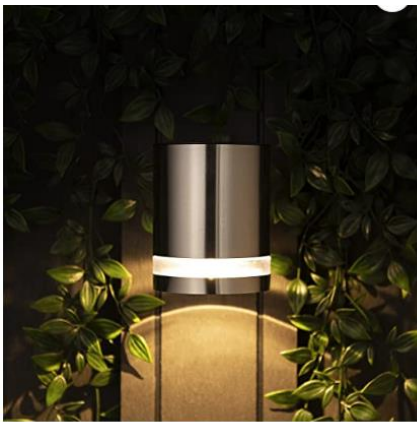
Smartwares Outdoor Wall Light, Solar Powered, Day to Night Sensor, Integrated LED, 35 Lumens, IP44 [Energy Class A++]

Brand	Smartwares
Manufacturer	Smartwares
Product Dimensions	4.61 x 2.36 x 4.21 cm; 460 Grams
Batteries	1 Lithium Ion batteries required. (included)
Item model number	10.030.77
Part Number	GWS-003-DS
Area Lighting Classification	IP44
Number of Items	1
Style	Modern
Colour	Silver
Material	Alloy Steel
Finish types	Brushed
Number of Lights	1
Included Components	Solar wall light, instruction manual, mounting kit
Voltage	0.01 Volts
Special features	Energy Efficient
Shade Colour	Warm white
Shade Material	Stainless Steel
Power and Plug Description:	Solar
Switch Installation Type	Wall Mount
Batteries included?	Yes
Batteries Required?	Yes
Type of Bulb	LED
EU Energy Efficiency Label	A++
Luminous Flux	35 Lumen
Wattage	1 Watts
Colour Temperature	3000 Kelvin
Item Weight	460 g
