## **PLANNING, DESIGN AND ACCESS STATEMENT**

**Snowdon Nab Outbuilding, Egton Grange**

**Change of use to Residential (Principal Residence)**

**Prepared by John Long Planning Ltd on behalf of the Mulgrave Estate**

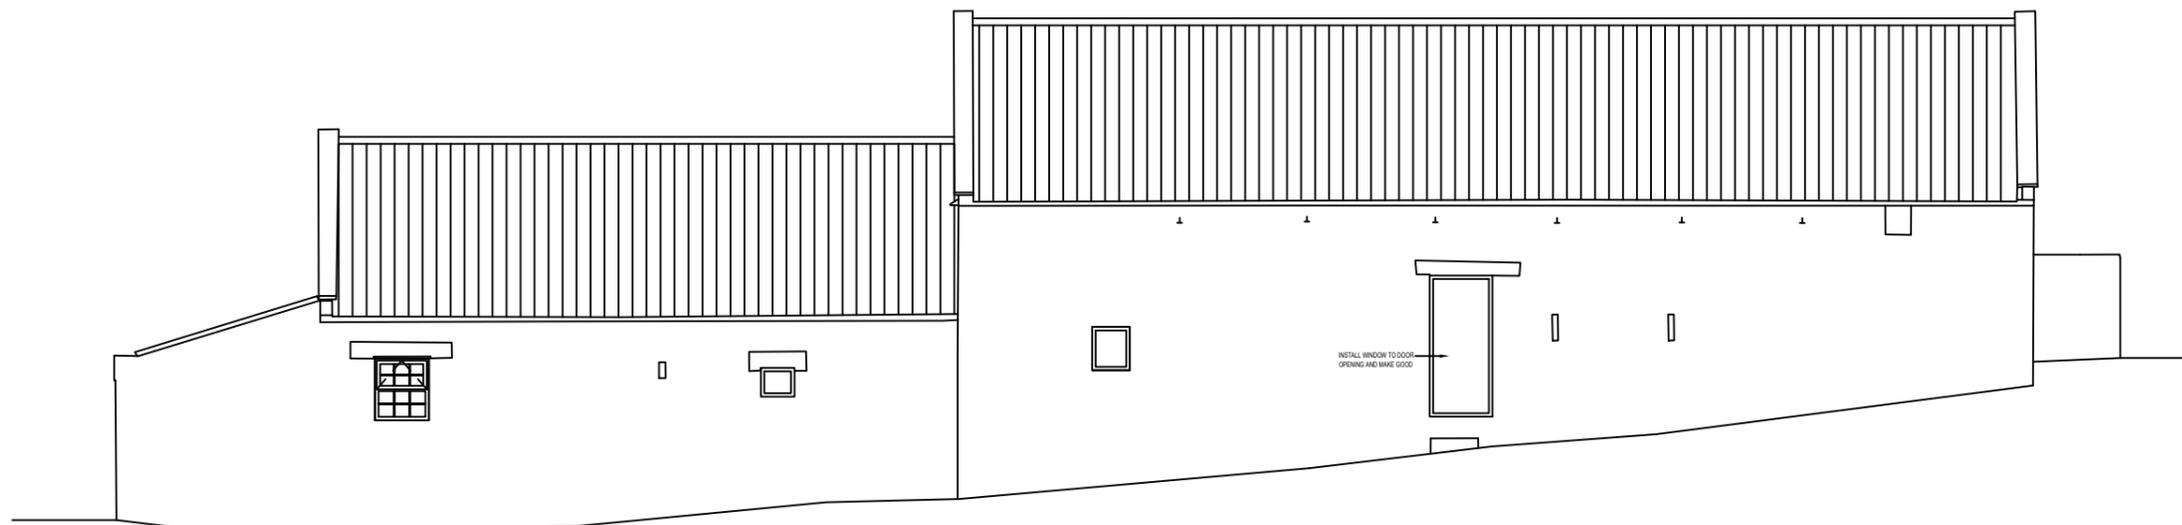
PROPOSED WEST ELEVATION

- EXTERIOR WALLS: REPAIRED WHERE NECESSARY (TO MATCH EXISTING)
- INTERIOR WALLS: TIMBER STUD WITH PLASTERBOARD
- ROOF: RED INTERLOCKING (TO MATCH EXISTING)
- RAINWATER GOODS: BLACK (TO MATCH EXISTING)
- WINDOWS: TIMBER (COLOUR TBC)  
WINDOW LOUVRES (COLOUR TBC)
- DOORS: TIMBER (COLOUR TBC)  
TIMBER GARAGE DOORS (COLOUR TBC)
- BOUNDARY: EXISTING DRY STONE WALLING TO BE REPAIRED WHERE REQUIRED
- ACCESS: ACCESS / EGRESS TO BE RETAINED

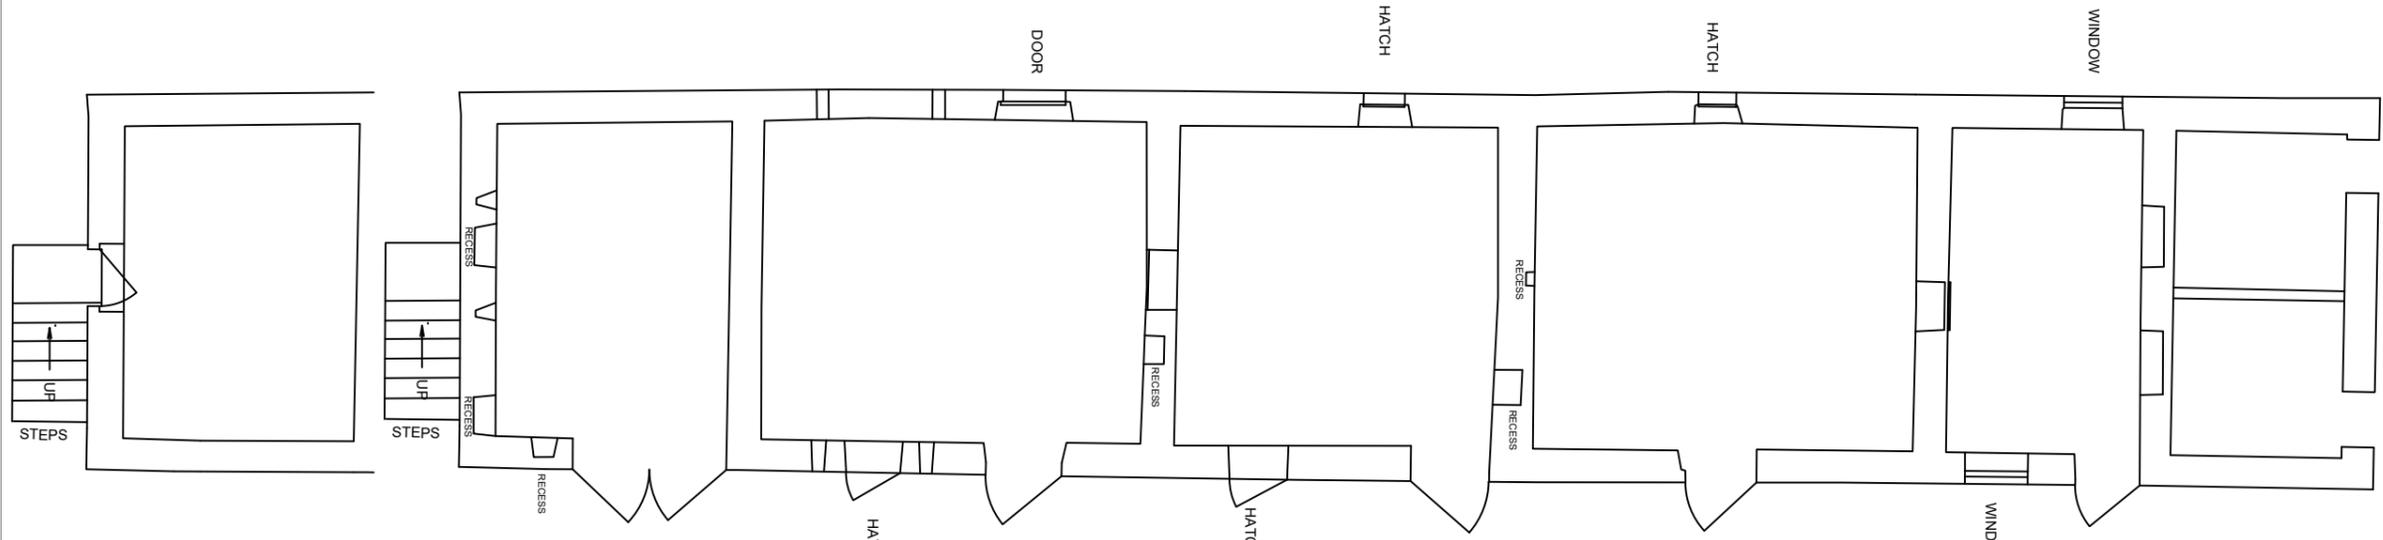
EXISTING FIRST FLOOR PLAN

EXISTING GROUND FLOOR PLAN

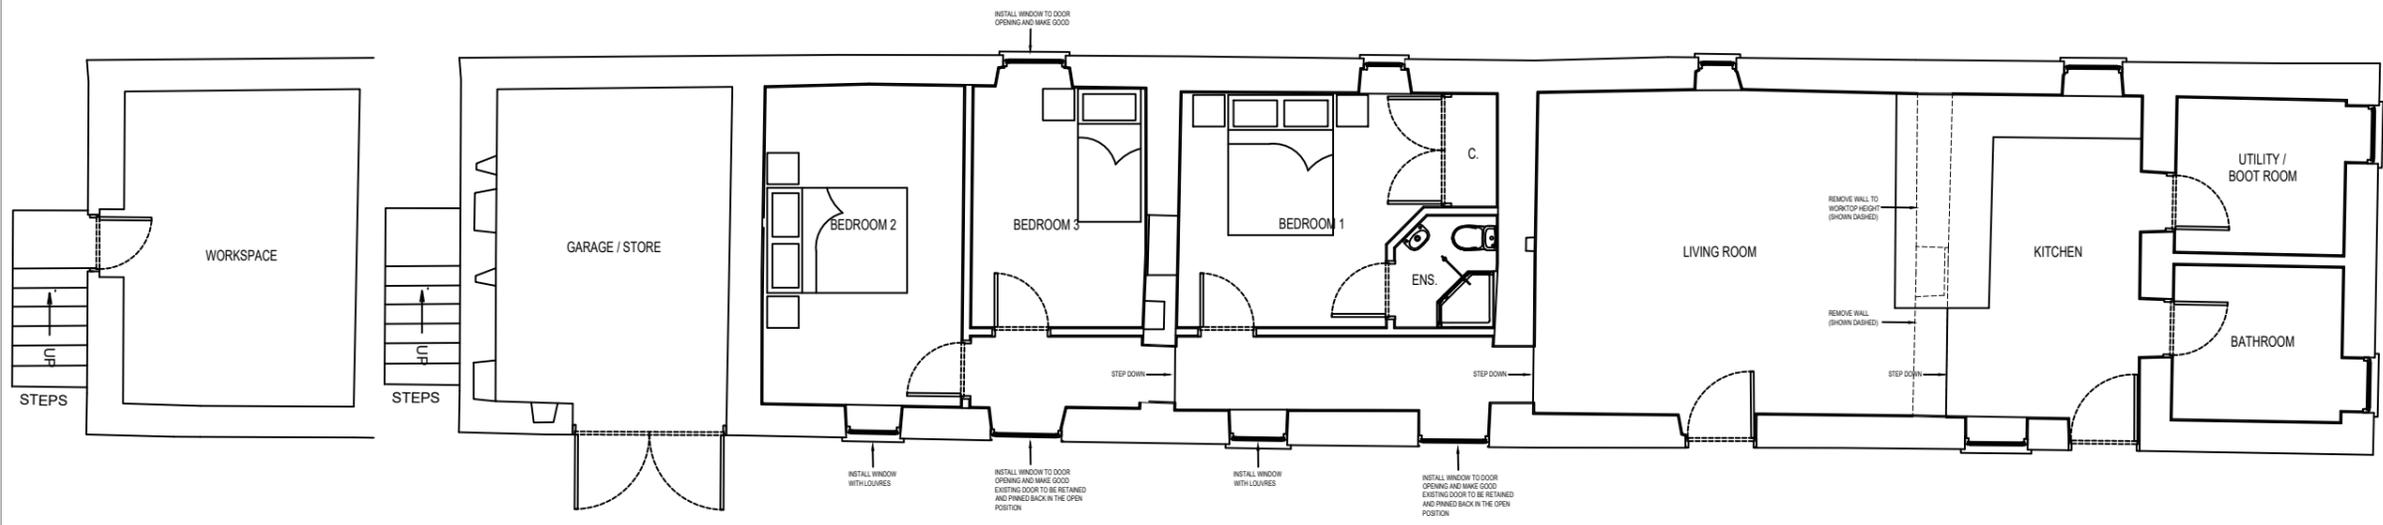
PROPOSED FIRST FLOOR PLAN

PROPOSED GROUND FLOOR PLAN

- 3.3 The external works to the outbuilding are kept to a minimum and limited to repairs, refurbishment and replacements to match existing, using traditional materials and methods. Three doorways (two on the front elevation and one on the rear) are proposed to have glass windows installed, with the doors to be retained and pinned back in the 'open' position. Glazing will be installed to existing openings.

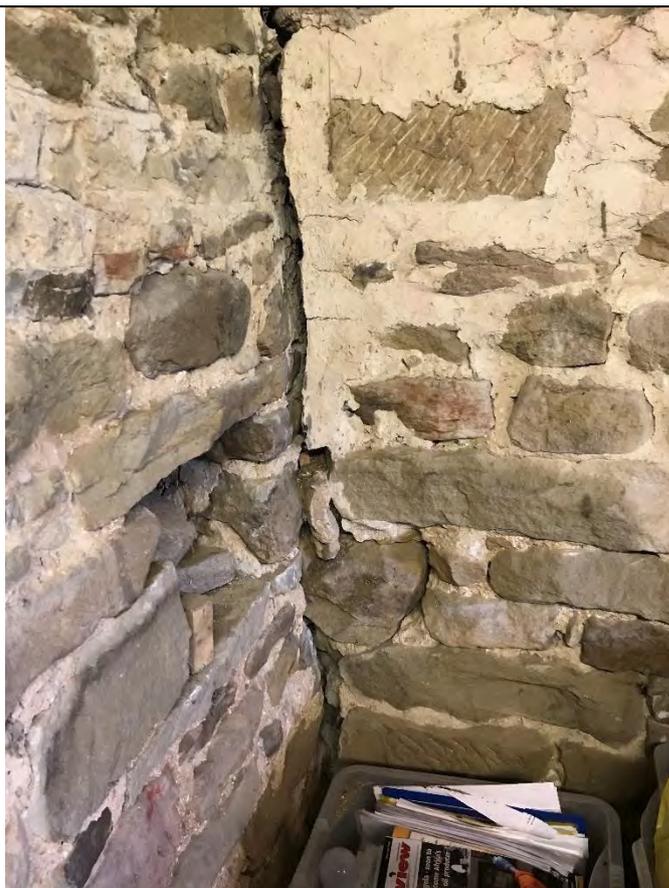
Building 1-Vertical cracking that requires remedial works

- 2.8 The walls are of coursed stonework in lime mortar are sound and vertical in their plane, other than an amount of historic roof spread to building 1, adjacent the mid-west point to building one. This extends upwards, with internal cracking apparent. The building would benefit from repointing to ensure water tightness and protect the facing stone from frost damage and erosion.

The walls are of coursed stonework in Lime mortar, are sound and vertical in their plane, other than an amount of historic roof spread to building 1, adjacent the mid-west point to building one. This extends upwards, with internal cracking apparent. The building would benefit from repointing to insure water tightness and protect the facing stone from frost damage and erosion

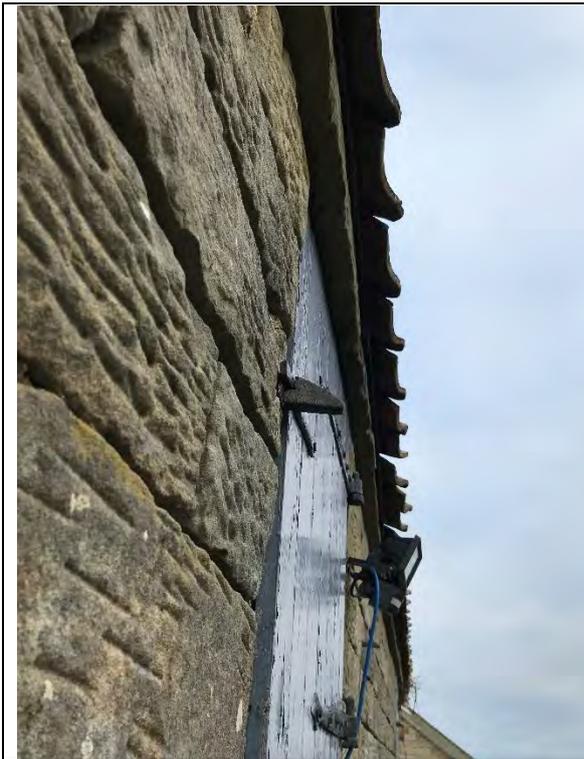
Roof detail

The roof coverings consist of clay pantiles on timber battens without riven timber linings and stone ridges. Generally, the roof coverings are in good condition but will require some renewal/repairs as part of any conversion works, due to building regulation requirements. There are stone water cappings to the gable end which appear to be in good condition for their age.

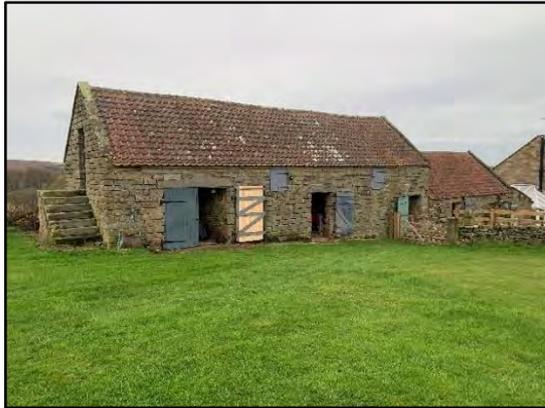
The surveyed buildings are stone-built with bitumastic lined, clay pantile roofs. The buildings are subdivided into sections, separated by internal gable walls. A full description of the buildings can be found in section 6.2.

Photo 1: Eastern aspect of the buildings.

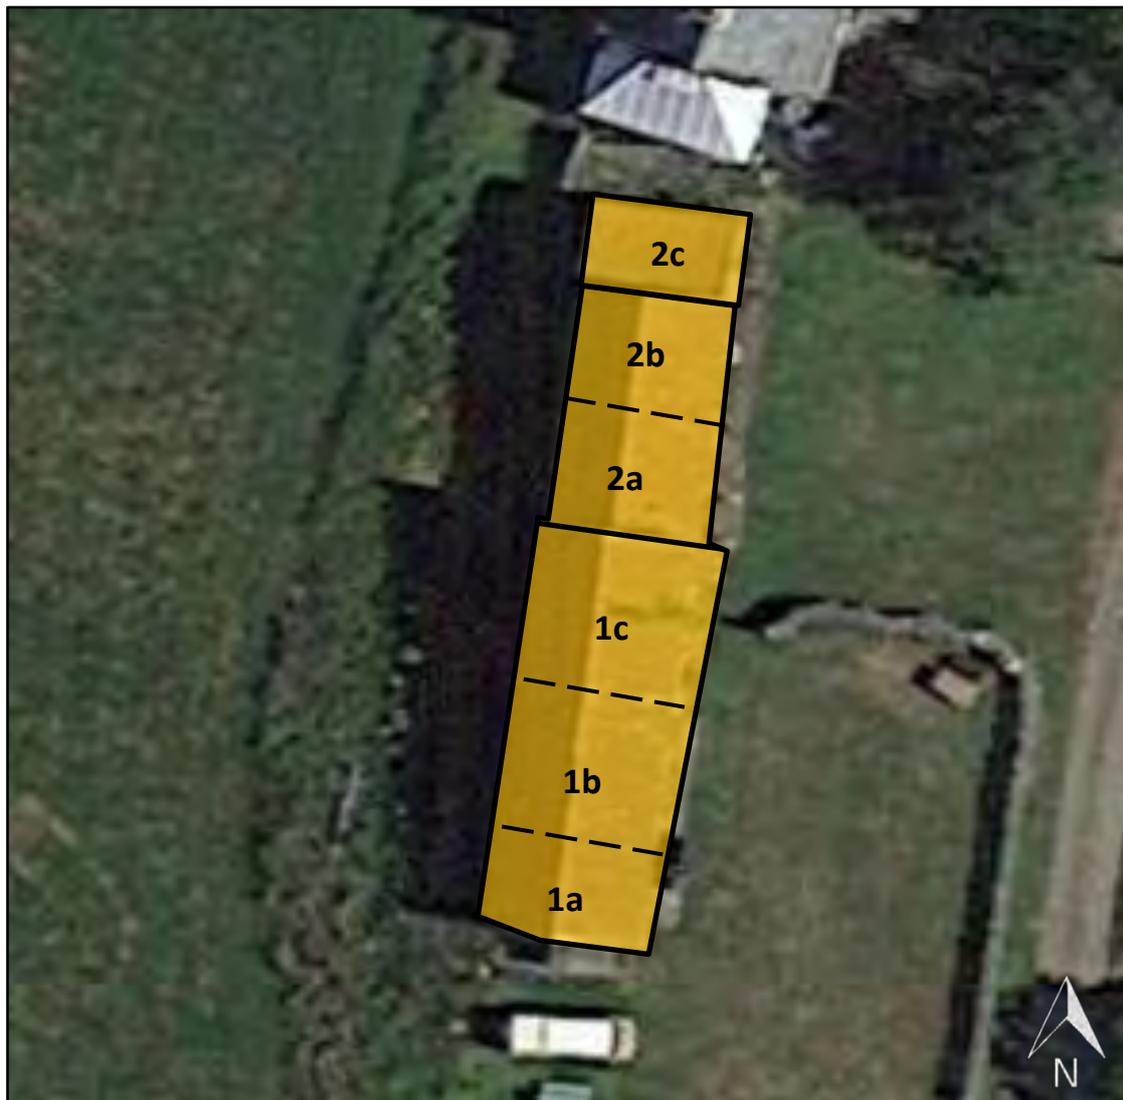
Figure 5: Visual inspection results.

Building ref.	Section	Description	Features with potential bat roost habitat (PBRH).
<b>Building 1 – Moderate potential risk of supporting bats</b>	<b>A</b>	Stone-built barn with a bitumastic-lined, clay pantile roof. Masonry crevices exist in the stonework on all the external walls. Some uplifted tiles on the east and west-facing roofs; a large gap/missing tile at the corner eaves on the western roof (Photo 24). No droppings or feeding remains found in hayloft or ground floor of section 1a.	PBRH between wall tops and gable walls. Roost habitat available between liner and tiles.

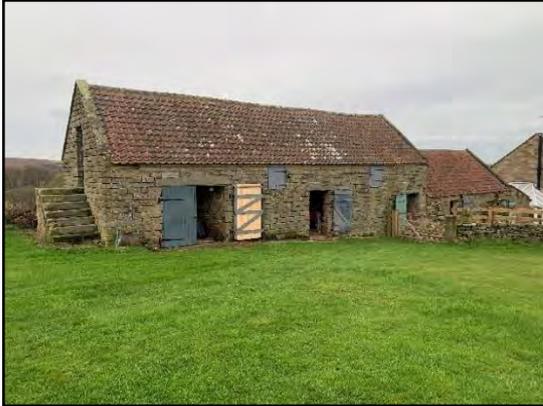
The surveyed buildings are stone-built with bitumastic lined, clay pantile roofs. The buildings are subdivided into sections, separated by internal gable walls. A full description of the buildings can be found in section 6.2.

Photo 1: Eastern aspect of the buildings.

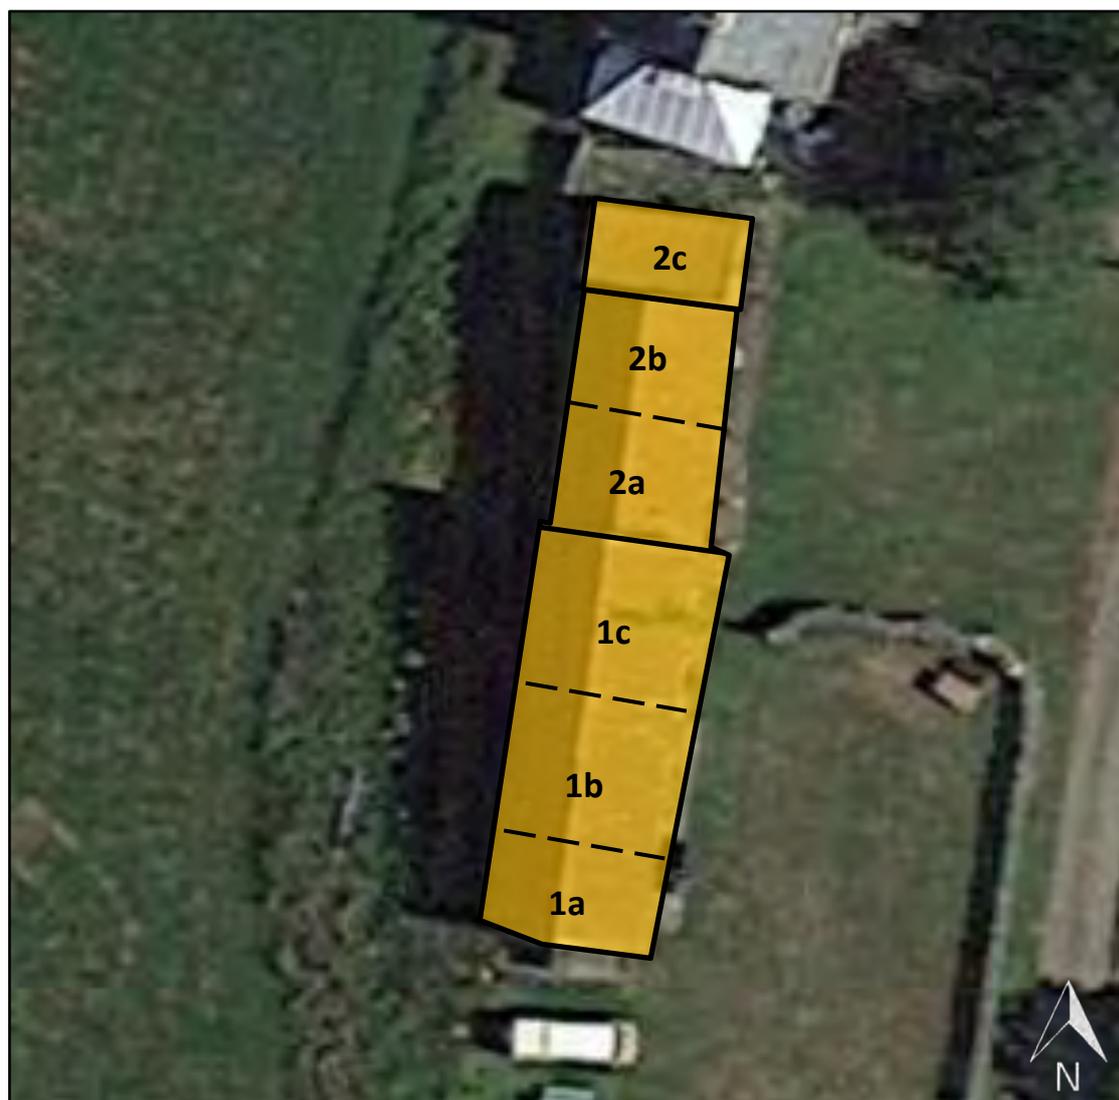
Figure 5: Visual inspection results.

Building ref.	Section	Description	Features with potential bat roost habitat (PBRH).
<b>Building 1 – Moderate potential risk of supporting bats</b>	<b>A</b>	Stone-built barn with a bitumastic-lined, clay pantile roof. Masonry crevices exist in the stonework on all the external walls. Some uplifted tiles on the east and west-facing roofs; a large gap/missing tile at the corner eaves on the western roof (Photo 24). No droppings or feeding remains found in hayloft or ground floor of section 1a.	PBRH between wall tops and gable walls. Roost habitat available between liner and tiles.

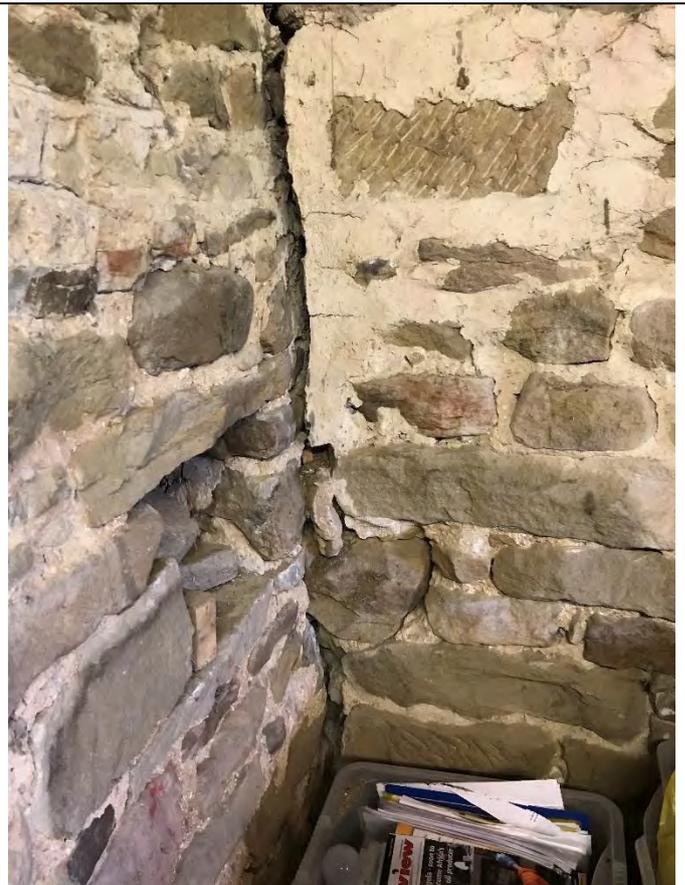
Building 1-Vertical cracking that requires remedial works

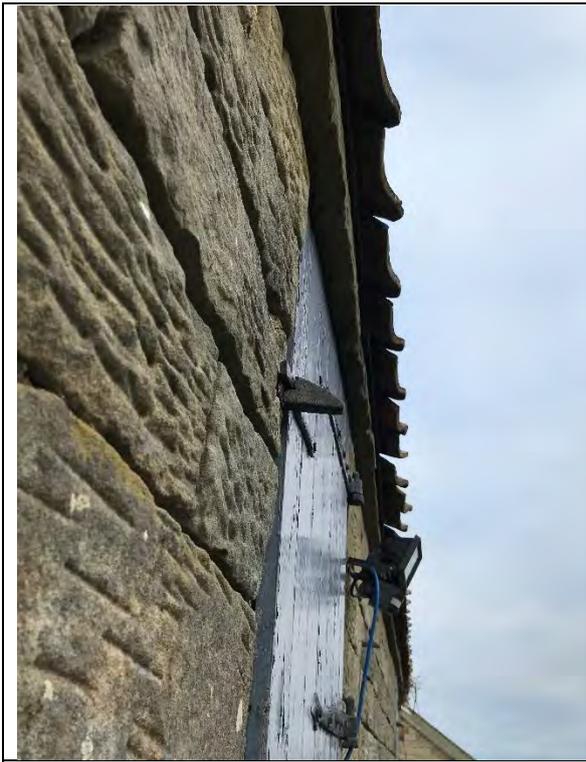
Roof detail
