Design and Access Statement

Conversion of Redundant Farm Buildings
to form 2 Holiday Cottages & 1 Annexe

Beacon Farm, Limestone Road, Scalby, YO13 0RB

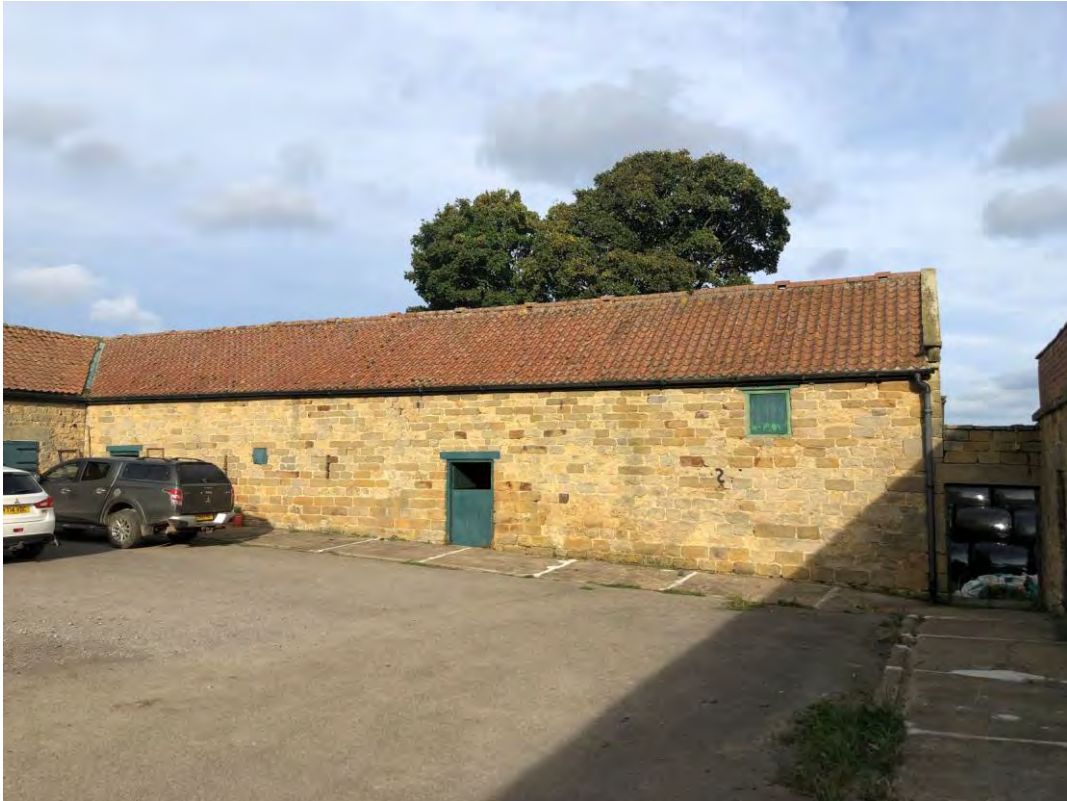
Photograph 1
West elevation, into Farmyard

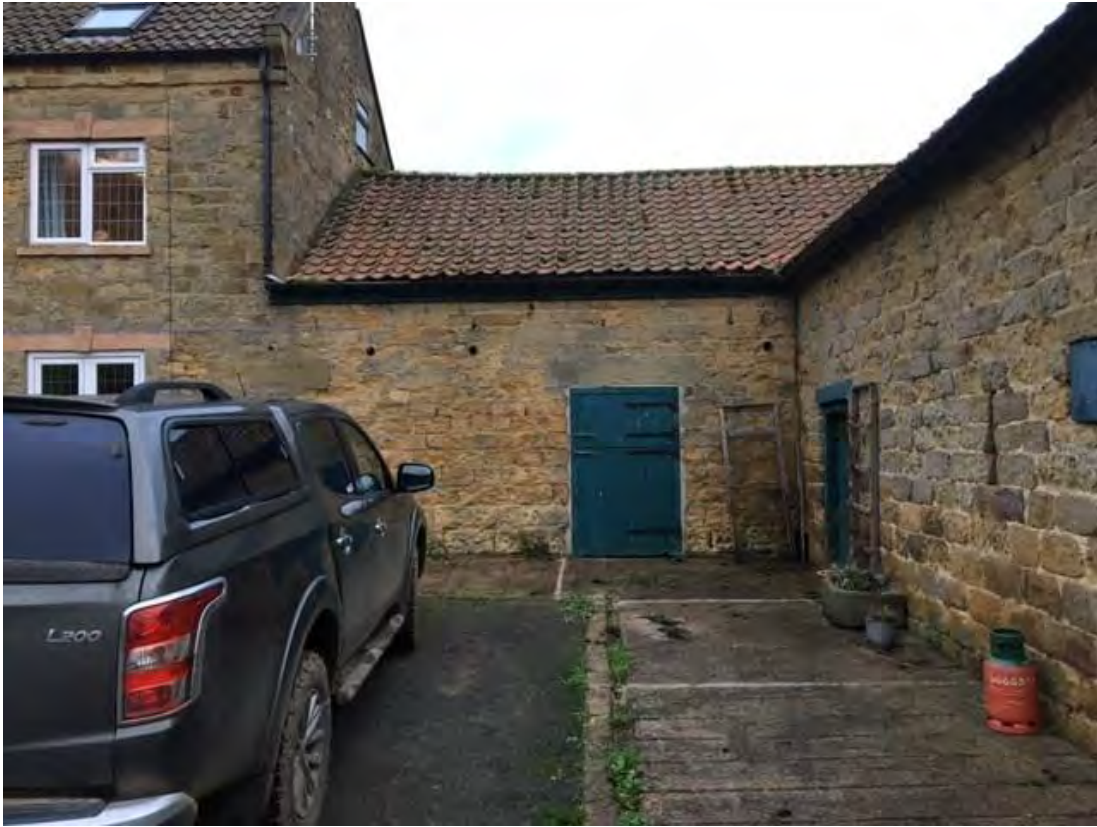
Photograph 2
South elevation abutting farmhouse

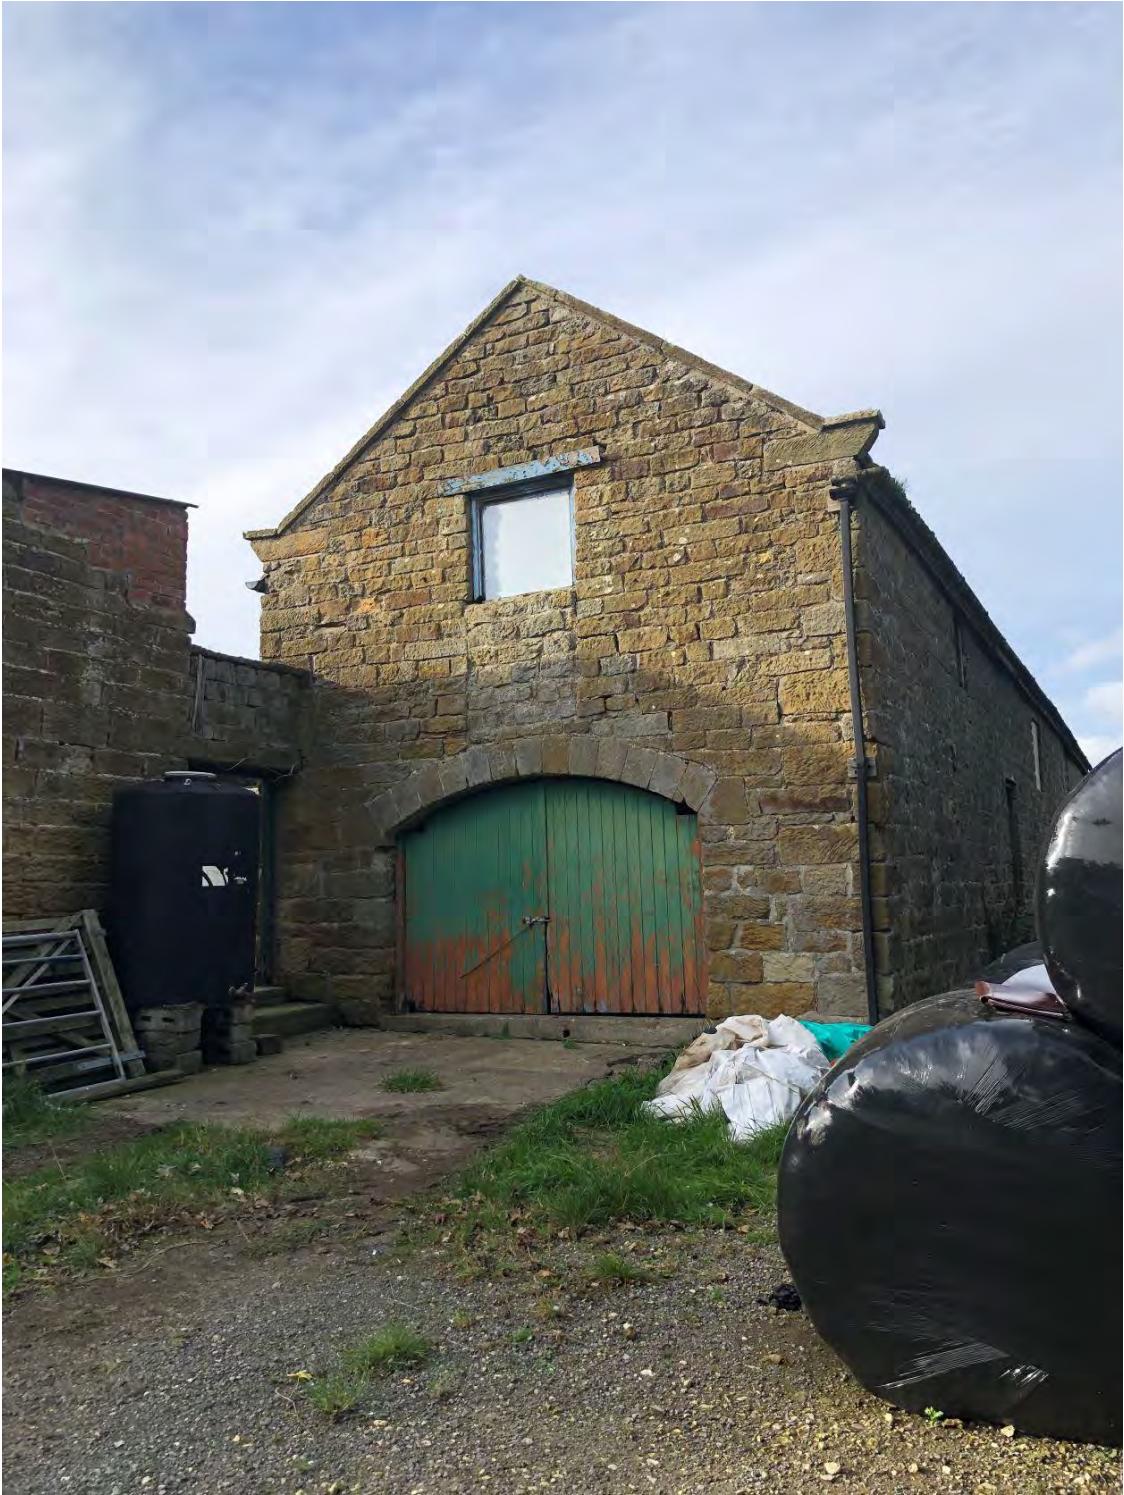
Photograph 3
South elevation, gable end

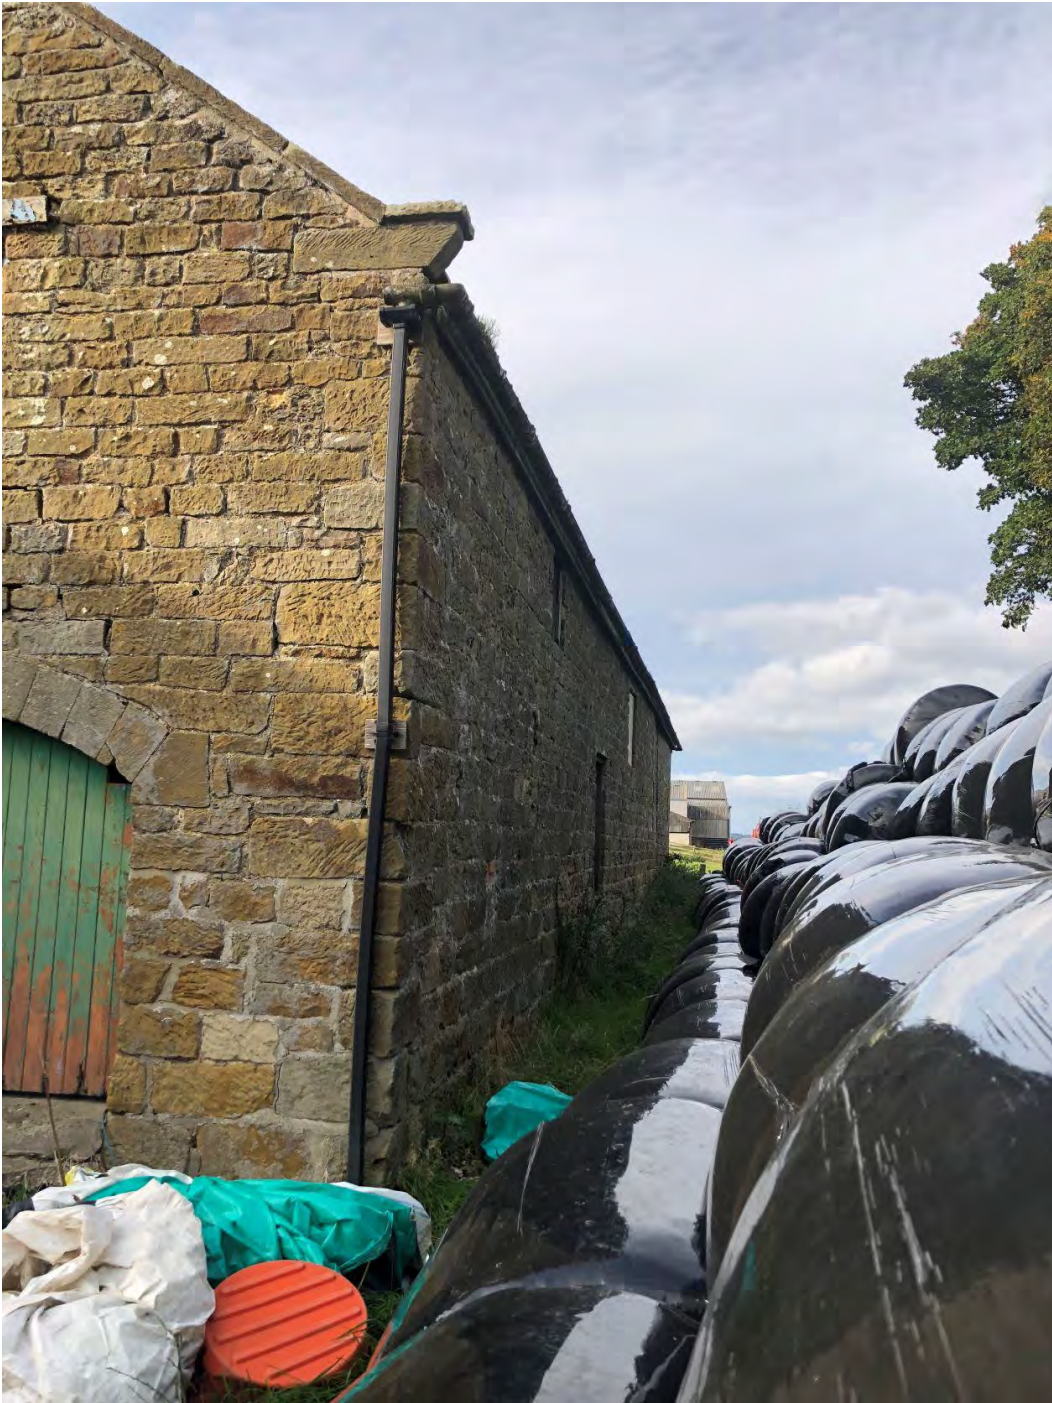
Photograph 4
East elevation

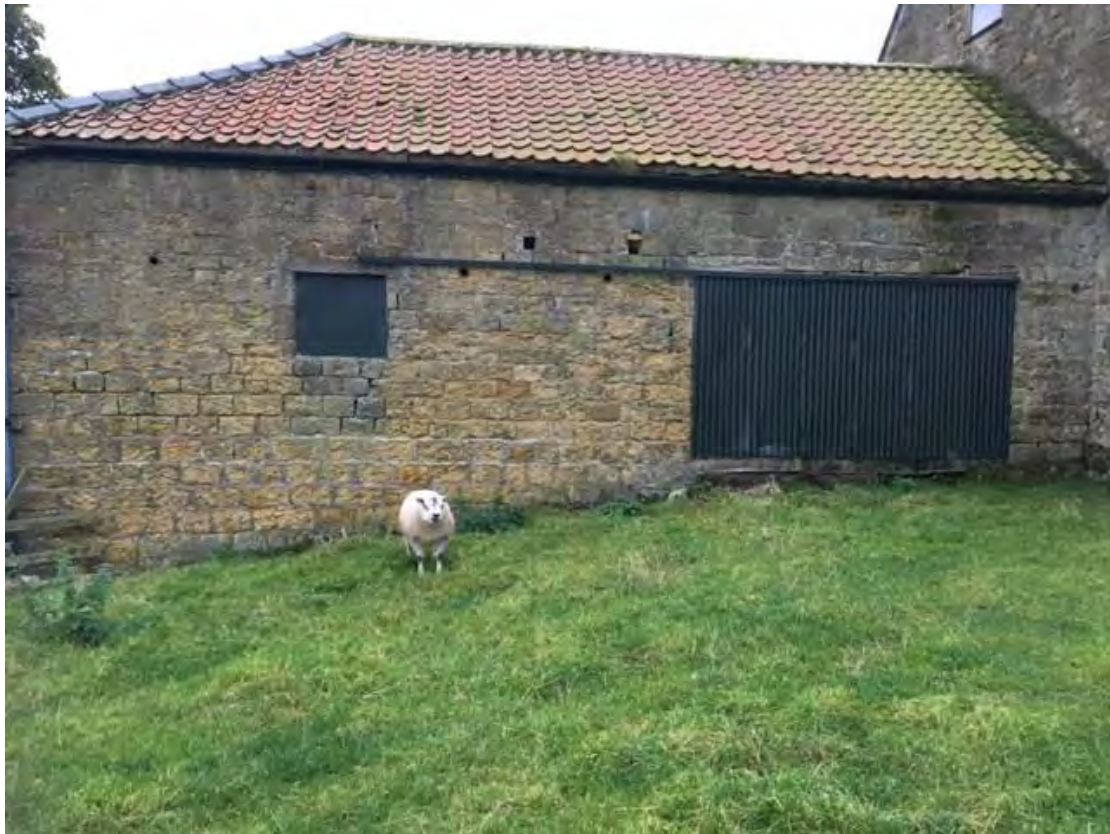
Adjacent to the farmhouse, the north facing elevation, has a window and larger vehicle opening.

Photograph 5
North elevation abutting farmhouse

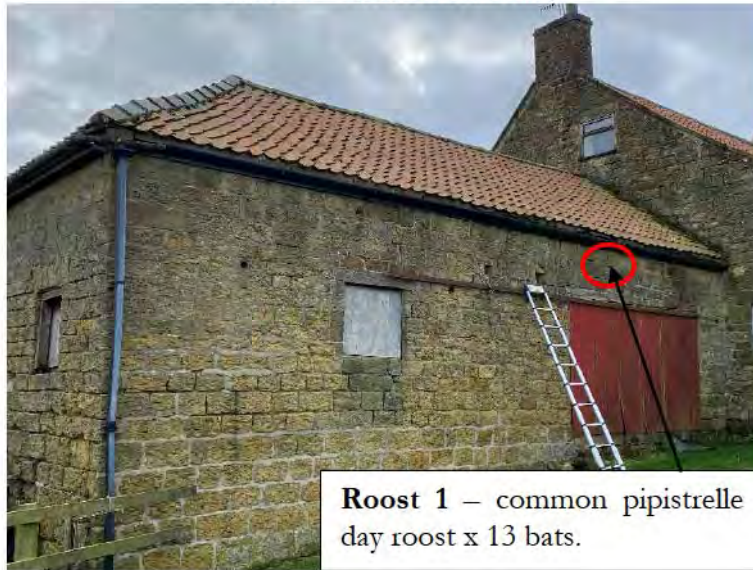
Plate 1 – north elevation.

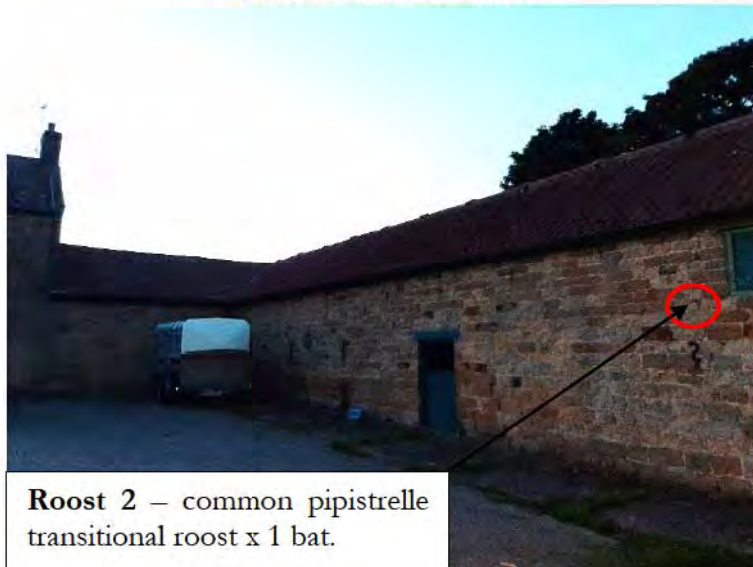
Plate 2 – west elevation.

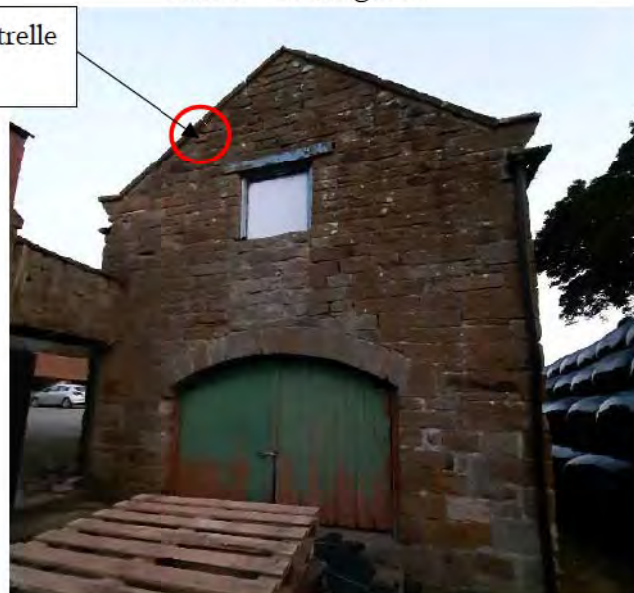
Plate 3 – south gable.

Roost 4 – soprano pipistrelle
day roost x 9 bats.

- Bat activity was good throughout much of the survey with the site used by common pipistrelle, soprano pipistrelle, Brandt's and brown long-eared bats.
- The following bat roosts were observed:
 - **Roost 3** – brown long-eared bat roost located in a gap above the internal partition wall plate inside barn 1. The roost contains 1 bat.
 - **Roost 4** – soprano pipistrelle roost located in a gap in the external stone work on the south gable of barn 1. The roost contains 9 bats (see 5.5, plate 3).

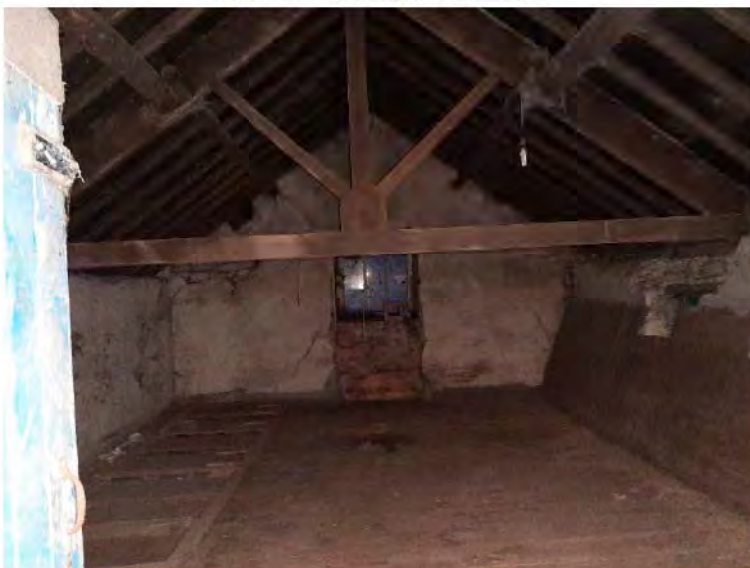
Plate 5 – internal roof void

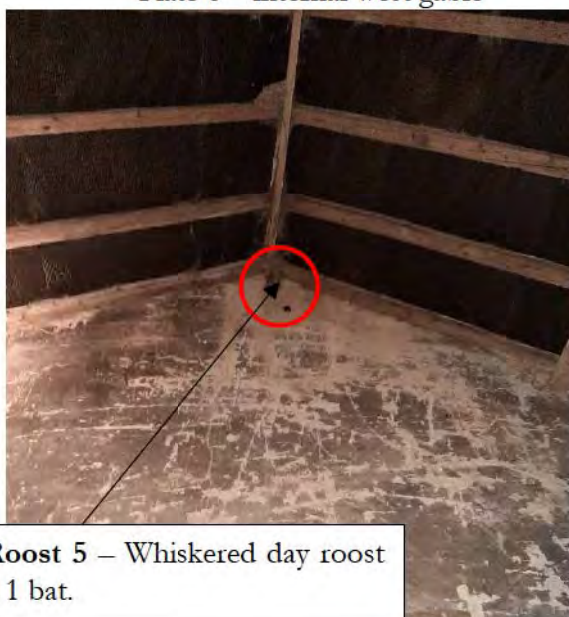
Plate 6 – internal west gable

Roost 5 – Whiskered day roost
x 1 bat.

- The first common pipistrelle bat was detected at 2016. This was close to the anticipated (< 30 minutes after sunset) emergence time and suggests that the bat emerged from a roost close by.
- Common pipistrelle, whiskered and noctule bats were detected and/or observed foraging and commuting around the site in low numbers.
- The following bat roosts were observed:
 - **Roost 5** – whiskered bat roost located in a gap above the internal ridge on the west gable of barn 1. The roost contains 1 bat (see 5.5 plate 6).

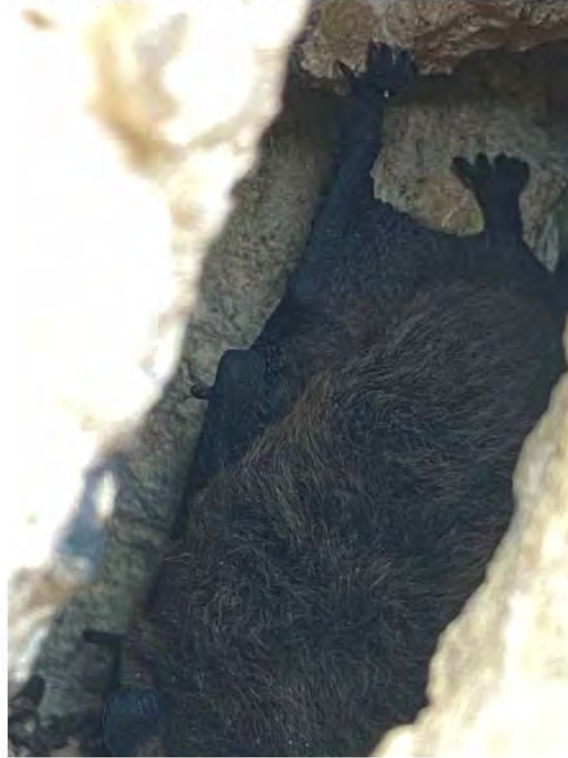
Plate 7 – common pipistrelle located inside roost 2 – November 2020.

- 5.2.3 During the 17th November 2020 endoscope survey, a single common pipistrelle bat was observed in a gap in the stonework on the west elevation of barn 1 (**Roost 2**).

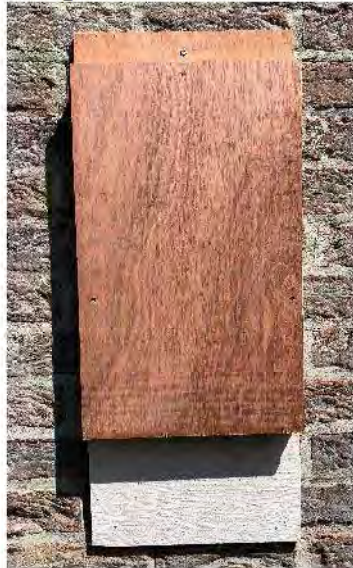
Plate 8 - Example of an open bottomed slot box (Wold Ecology Ltd)

- 7.8.2 Two open bottomed, rough sawn, slot boxes will be sited within the internal roof structure of existing open barns at Beacon Farm; the exact location will be determined by the bat ecologist. These will be constructed from rough sawn soft wood measuring 300mm deep by 450 – 600mm long leaving a narrow space about 30mm wide (see plate 8).
