REV: -	FIRST ISSUE	NA	DMH	AB	30.03.22
REV: -	AMENDMENTS:	DRN:	CHK:	APP:	DATE:
PROJECT: LADYCROSS PLANTATION HOLIDAY PARK WHITBY					
DRAWING TITLE: LIGHTING LAYOUT LUX PLOT DRAWING 1 OF 2					
CLIENT: LADYCROSS PLANTATION HOLIDAY PARK					
DRAWING NUMBER: 27063_04_100_01.1					
REVISION: -	SHEET SIZE: A1	SCALE: 1:500			
STATUS: FOR INFORMATION / APPROVAL					
M·EC Consulting Development Engineers		Telephone: 01530 264 753 Email: group@mec.co.uk Website: www.mec.co.uk		ORDNANCE SURVEY © CROWN COPYRIGHT 2015. ALL RIGHTS RESERVED. LICENCE NUMBER 100055865.

REV	AMENDMENTS	NA	DMH	AB	30.03.22
		DRN	CHK	APP	DATE
PROJECT: LADYCROSS PLANTATION HOLIDAY PARK WHITBY					
DRAWING TITLE: LIGHTING LAYOUT LUX PLOT DRAWING 2 OF 2					
CLIENT: LADYCROSS PLANTATION HOLIDAY PARK					
DRAWING NUMBER: 27063_04_100_01.2					
REVISION:	SHEET SIZE:	SCALE:			
-	A1	1:500			
STATUS: FOR INFORMATION / APPROVAL					
M-EC Consulting Development Engineers		Telephone: 01530 264 753 Email: group@m-ec.co.uk Website: www.m-ec.co.uk ORDNANCE SURVEY © CROWN COPYRIGHT 2015. ALL RIGHTS RESERVED. LICENCE NUMBER 100055865.

**LADYCROSS PLANTATION CARAVAN
PARK 2022.**

PRELIMINARY ECOLOGICAL APPRAISAL.

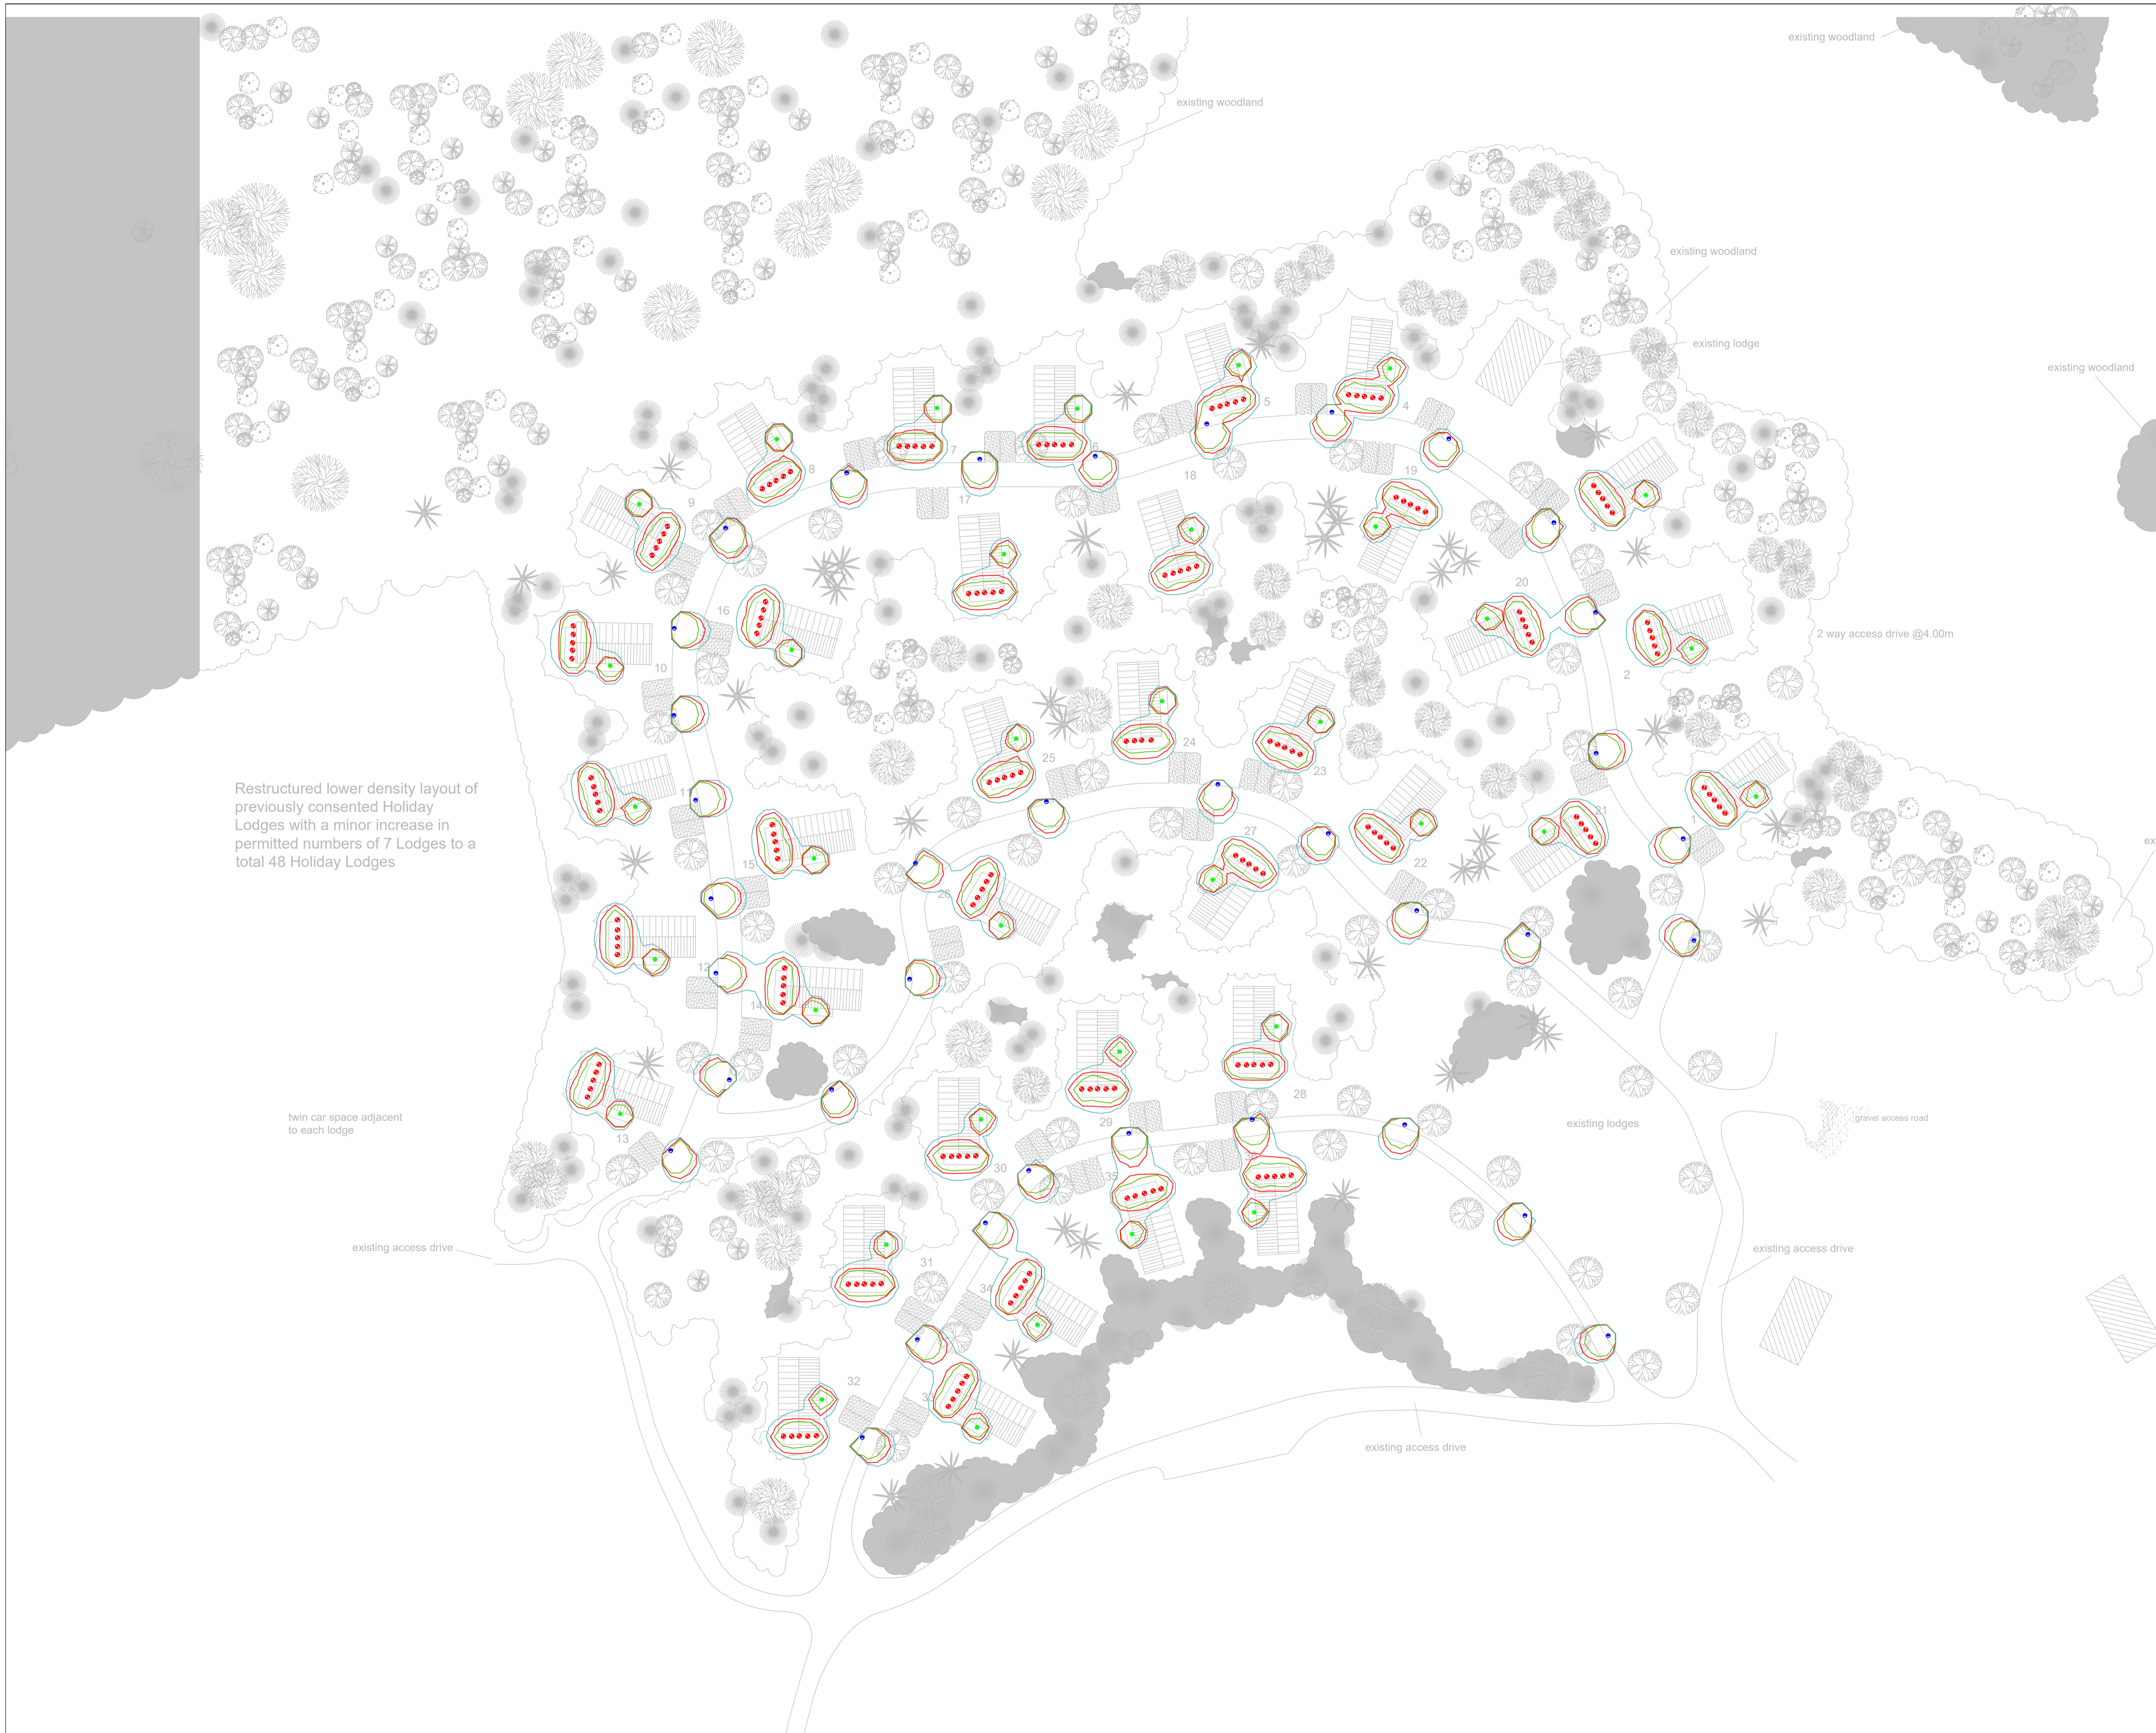
STREET LIGHTING KEY	
	PROPOSED DOWNLIGHT FROM CABIN ROOF LANTERN MANUFACTURER: THORN LIGHTING LANTERN NAME: D-CO LED MINI QUANTITY 180 LAMP TYPE: LED 3000K WARM WHITE WATTAGE: 1W OPTIC: 0.06KLM
	PROPOSED LIGHTING BOLLARD HEIGHT: 1.2m LANTERN MANUFACTURER: COLLINGWOOD LIGHTING LANTERN NAME: WOODEN BESPOKE QUANTITY 36 BOLLARD BLO3 LAMP TYPE: LED 3000K WARM WHITE WATTAGE: 5W OPTIC: 0.25KLM
	PROPOSED DOWNLIGHT ADJACENT TO CABIN DOOR COLUMN HEIGHT: 2m LANTERN MANUFACTURER: THORN LIGHTING LANTERN NAME: CESAR QUANTITY 36 INCLINATION: 0° LAMP TYPE: LED 3000K WARM WHITE WATTAGE: 6W OPTIC: 0.38KLM
	2.0 LUX ISO CONTOUR
	1.0 LUX ISO CONTOUR
	0.5 LUX ISO CONTOUR

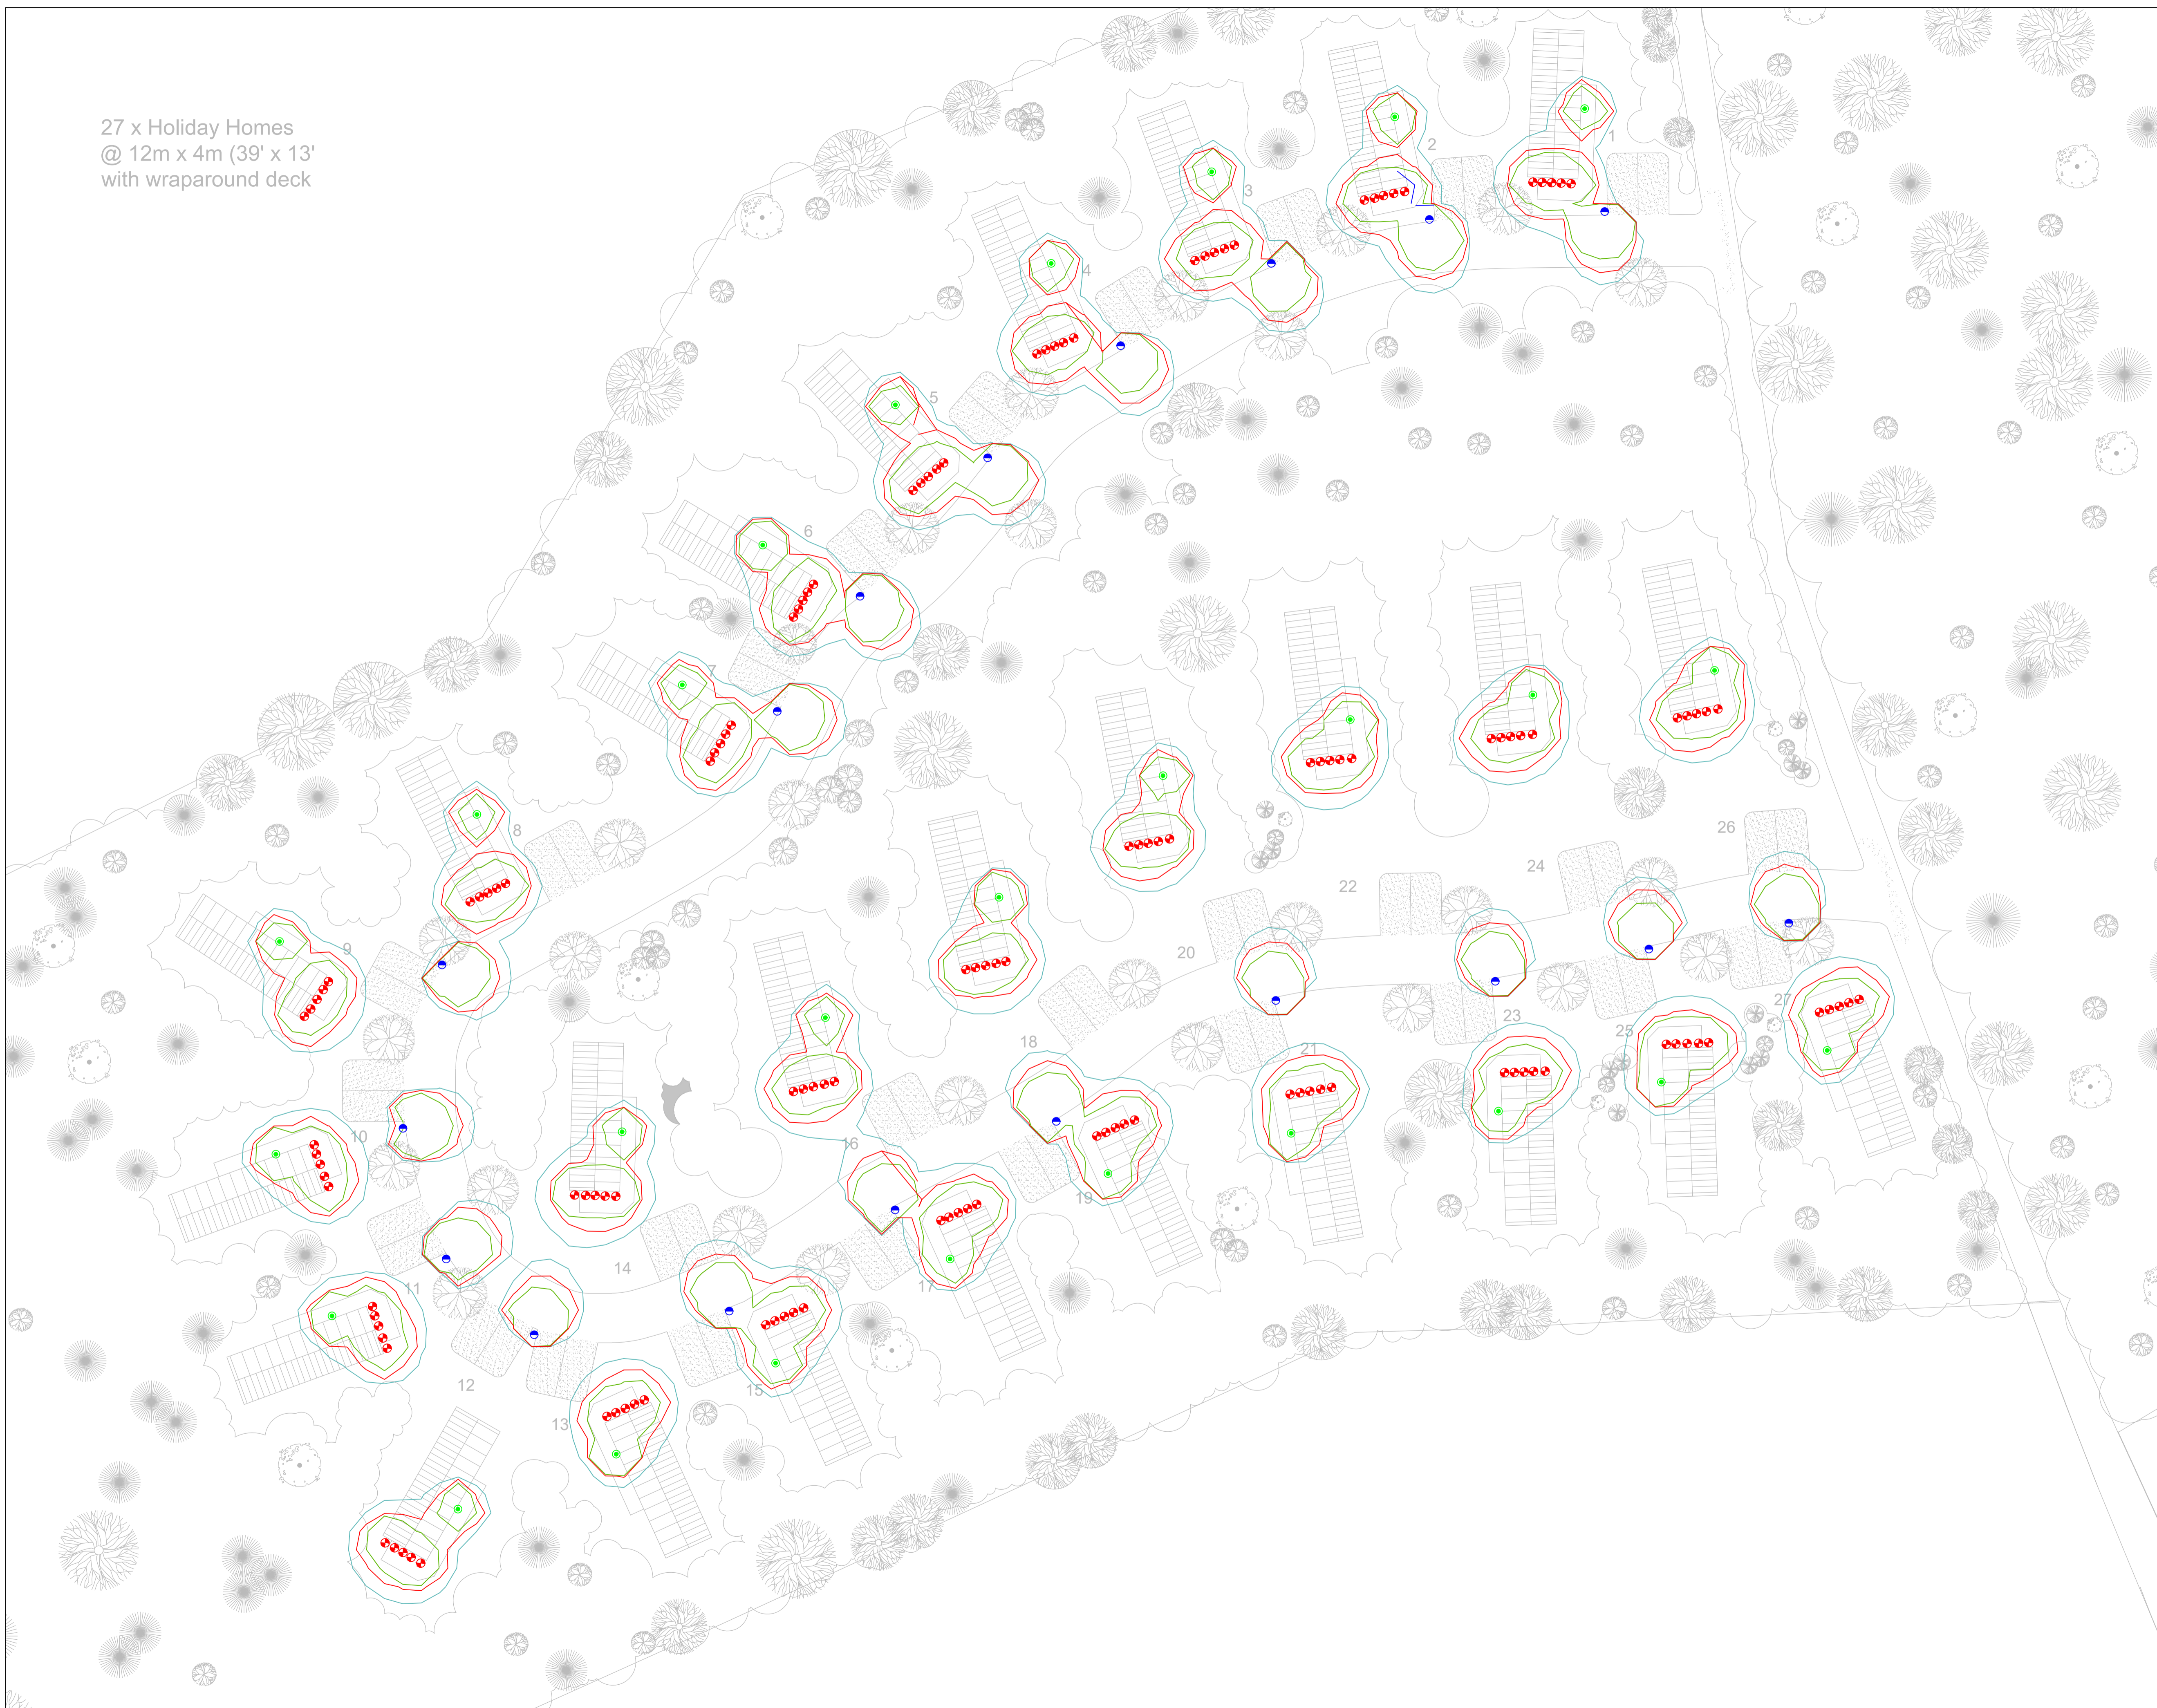
- PROPOSED DOWNLIGHT FROM CABIN ROOF
 LANTERN MANUFACTURER: THORN LIGHTING
 LANTERN NAME: D-CO LED MINI
 QUANTITY 135
 LAMP TYPE: LED 3000K WARM WHITE
 WATTAGE: 1W
 OPTIC: 0.06KLM
- PROPOSED LIGHTING BOLLARD
 HEIGHT: 1.2m
 LANTERN MANUFACTURER: COLLINGWOOD LIGHTING
 LANTERN NAME: WOODEN BESPOKE
 QUANTITY 18
 BOLLARD BLO3
 LAMP TYPE: LED 3000K WARM WHITE
 WATTAGE: 5W
 OPTIC: 0.25KLM
- PROPOSED DOWNLIGHT ADJACENT TO CABIN DOOR
 COLUMN HEIGHT: 2m
 LANTERN MANUFACTURER: THORN LIGHTING
 LANTERN NAME: CESAR
 QUANTITY 27
 INCLINATION: 0°
 LAMP TYPE: LED 3000K WARM WHITE
 WATTAGE: 6W
 OPTIC: 0.38KLM
- 2.0 LUX ISO CONTOUR
 1.0 LUX ISO CONTOUR
 0.5 LUX ISO CONTOUR

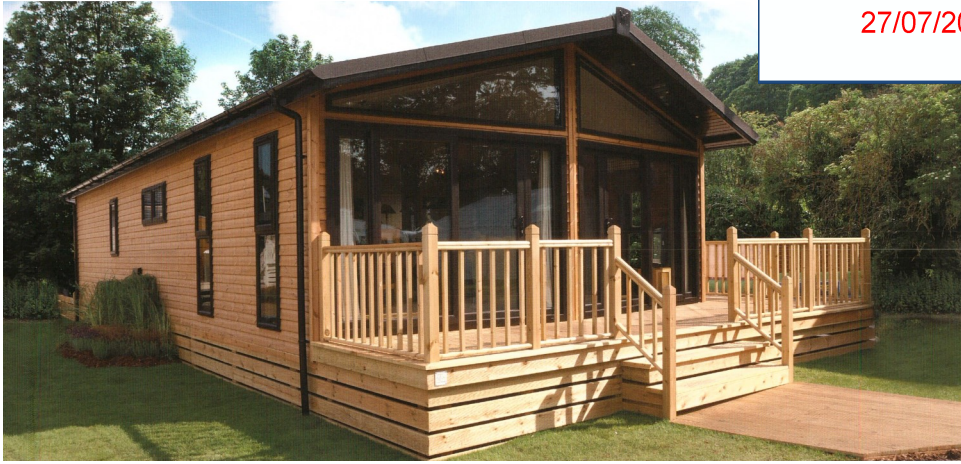
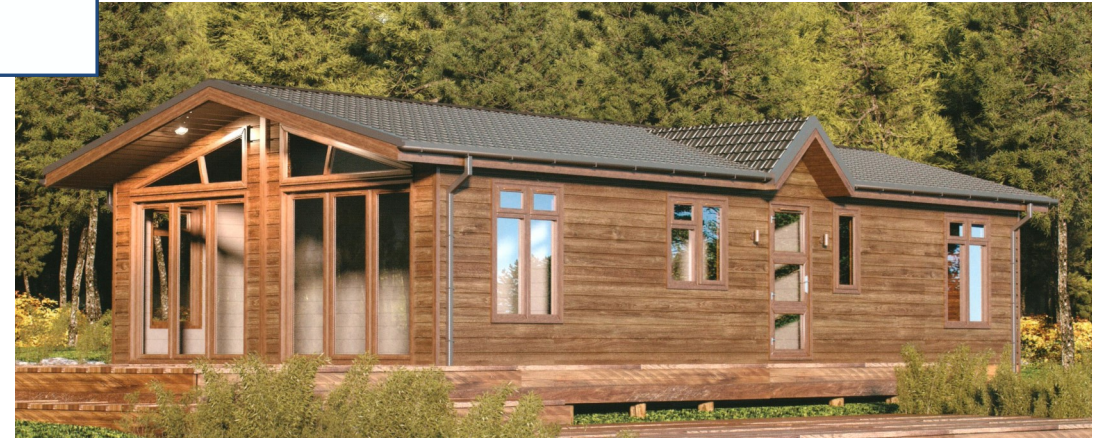
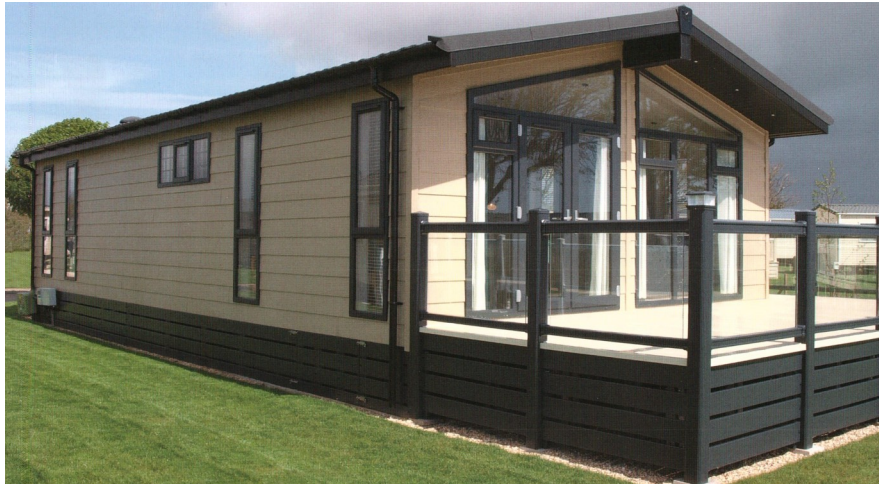
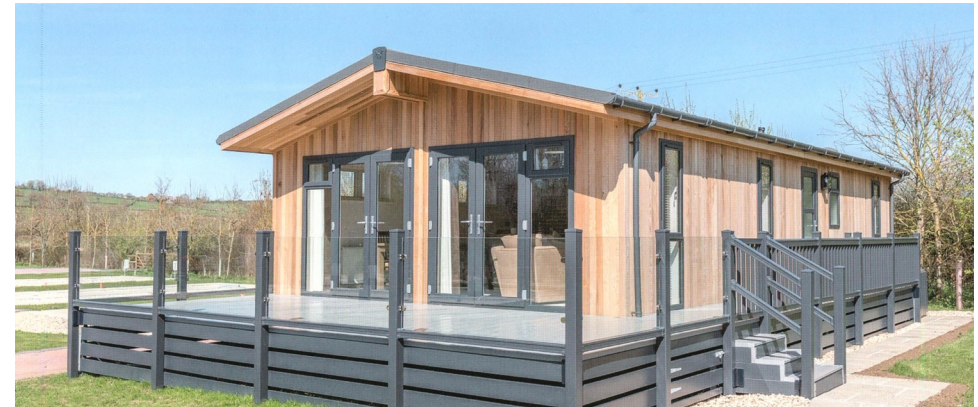
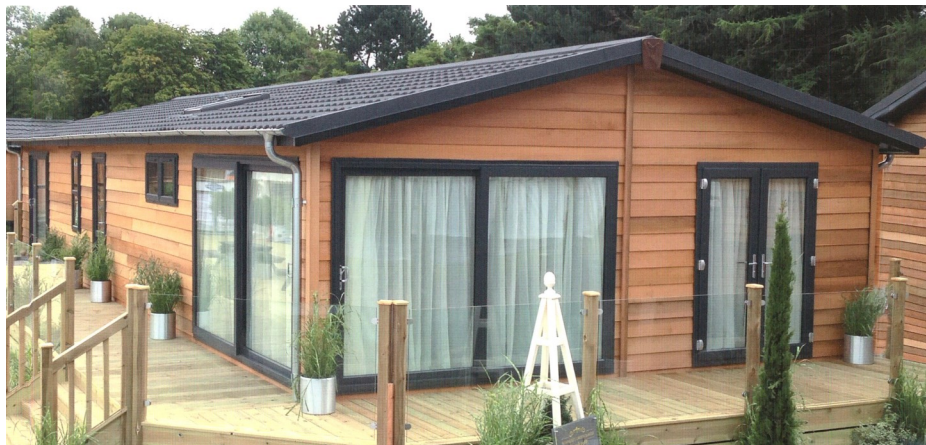
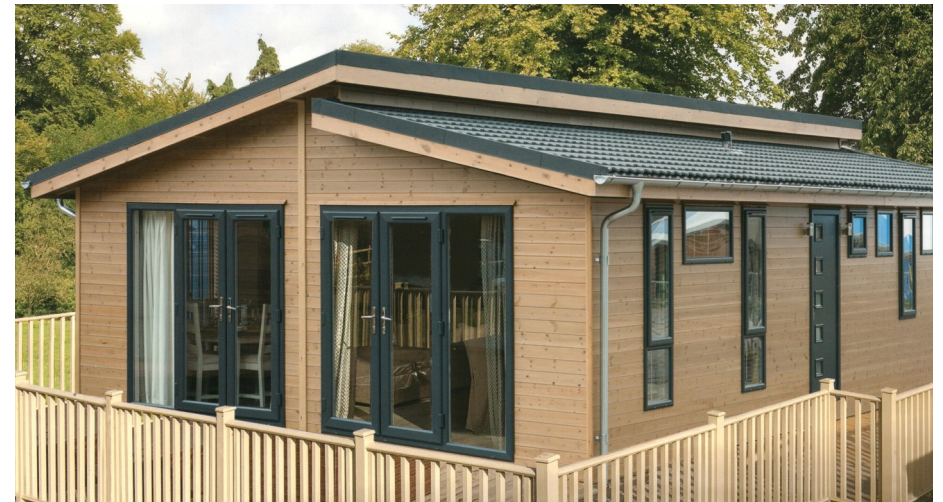
Sample Twin Unit Holiday Lodges

Please note—all lodges would be clad with wood and have anthracite door and windows frames and have a foot print of 12.2 m x 6.2 m to suit the approved planning permission

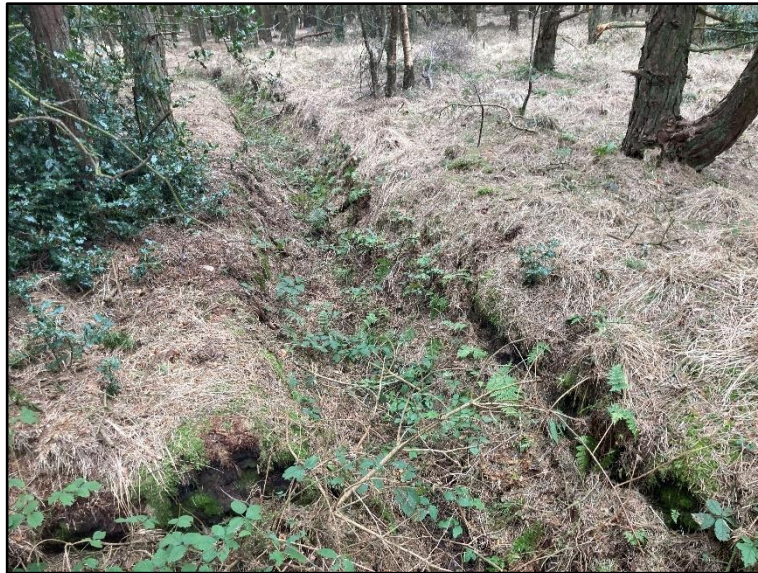
3.3.3.4. There is a network of ditches throughout this woodland. It was not possible to map these due to the complexity of the layout of them. They are predominantly dry and any wet sections of ditch are isolated short sections of very shallow water. The vegetation throughout these channels is a continuity of the woodland ground flora. One section of dry ditch is shown in the photograph below.

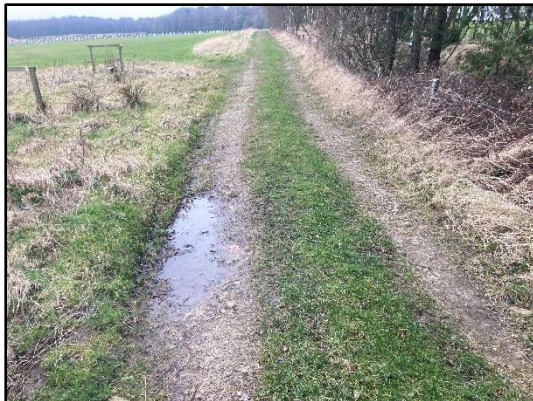
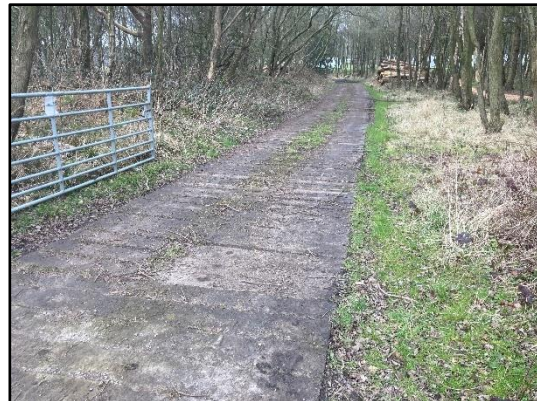
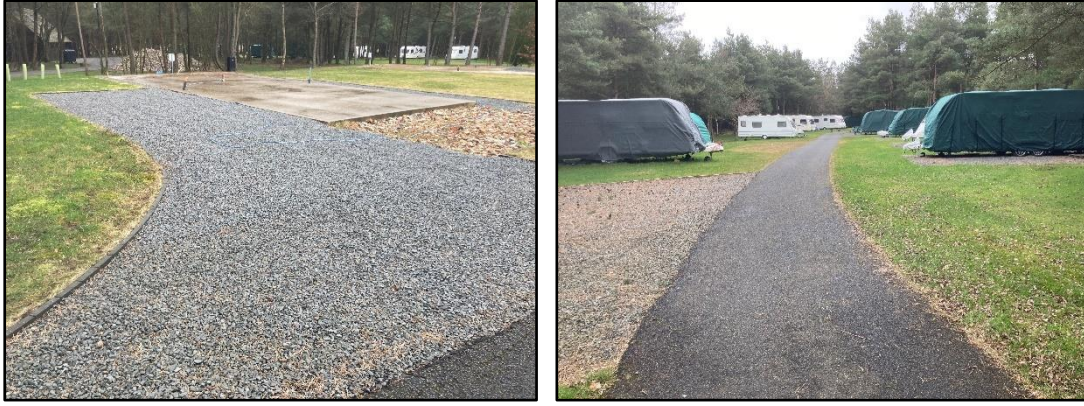
3.3.4. Bare Ground.

This habitat has been mapped where there are existing access roads around the caravan park and existing vehicle access tracks leading to the site. It also includes three concrete pads that have been constructed for the siting of new holiday lodges.
