Emergence survey results – 2022**Survey 1****Holm Garth, Newholme****Date:** 26/07/2022**Start time:** 21:00 **End time:** 22:40 **Sunset:** 21:13**Table 1 – Environmental conditions**

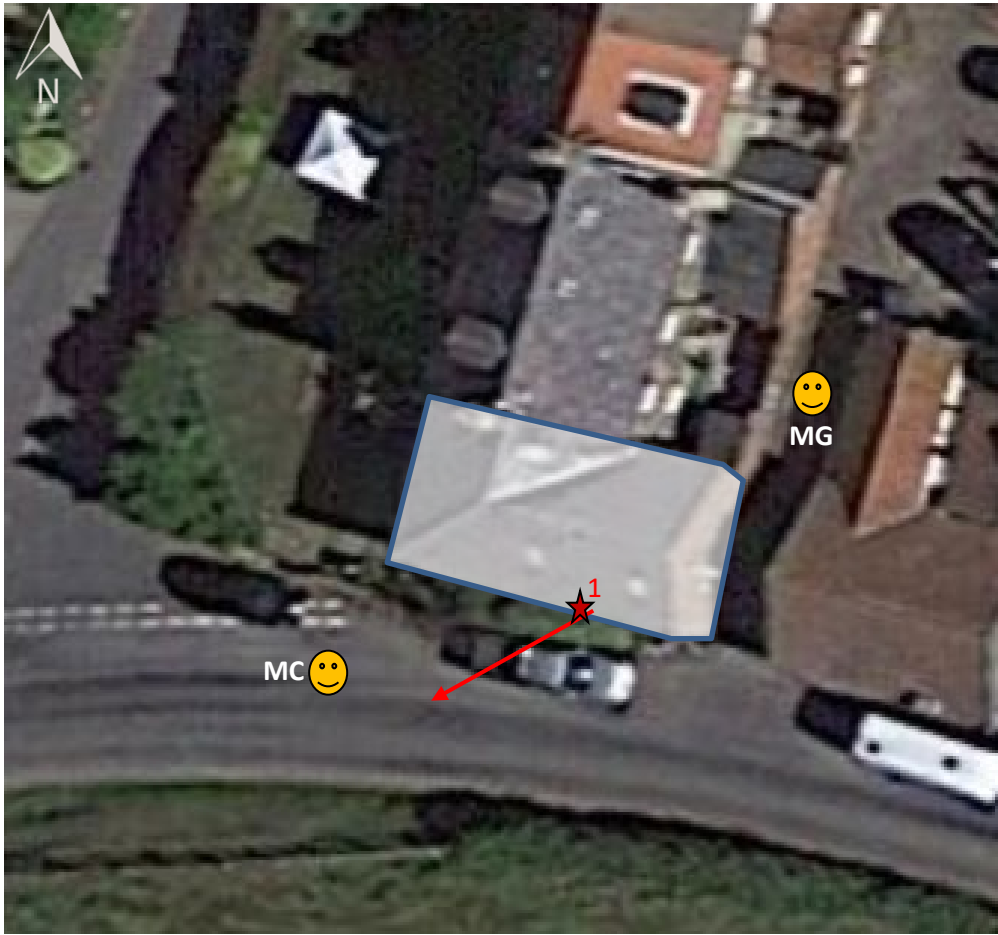
Figure 1 – Surveyor locations and bat activity recorded during survey 1 (26/07/2022).

29 common pipistrelles were seen emerging from a crevice between the top of the wall and the roof tiles, the crevice was around 3 foot long and bats were emerging from all along this area. Common pipistrelles were also seen foraging and commuting in the area.

Building Ref.	Species	Count	Emergence location/access point
1	Common pipistrelle	27	Emergence from crevice between the top of the wall and roof tiles
