Additional information to support works at Old St. Stephens Church, Fylingdales - NYM/2022/0666

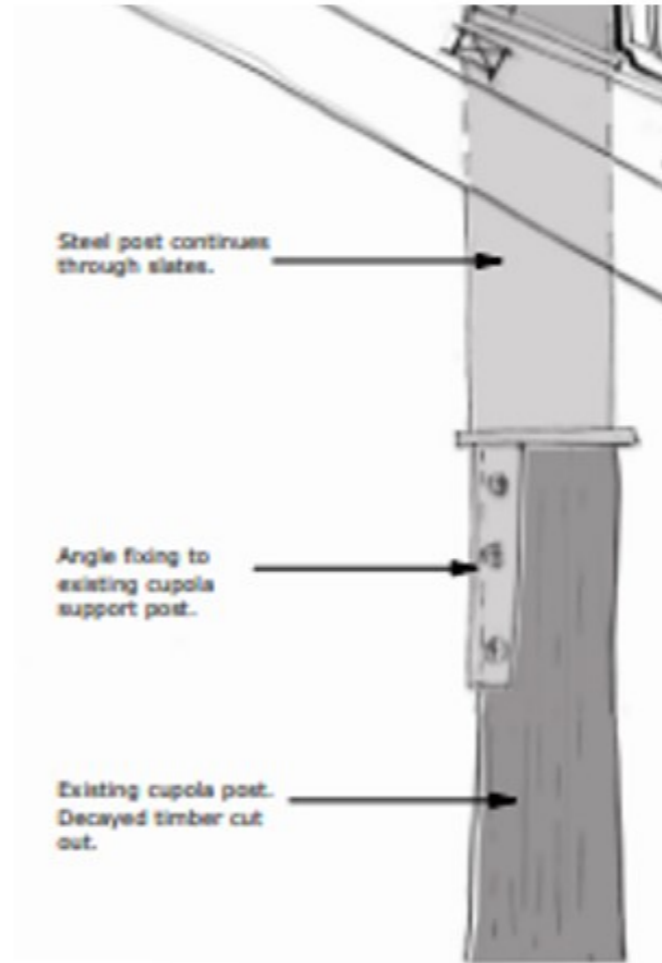
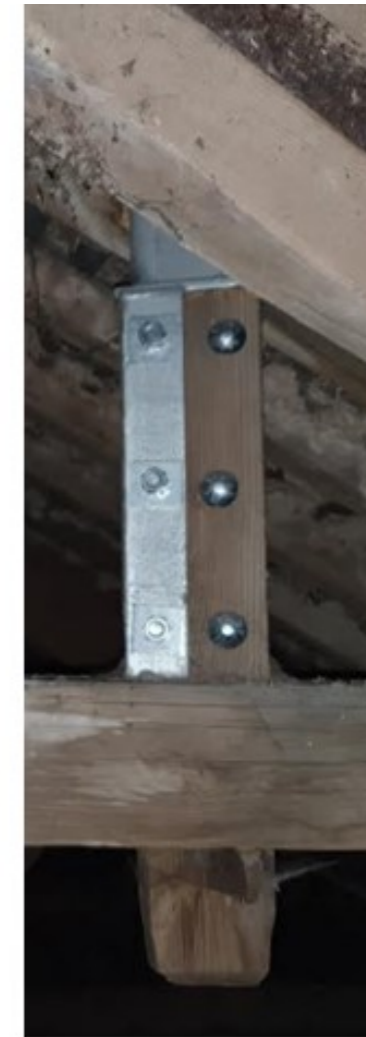
Approved Drawing showing steel angle and photo showing typical installation

- 1.0 This information is to provide information on the cupola installation regarding concerns raised by the LPA in accordance with NYM/2018/0797/LB and is not intended as a publically available supporting document to the current planning application.
- 1.1 Due to access issues It has only been possible to record interventions from inside the roof, showing where the cupola has been attached to historic roof timbers. It is however hoped the following will be sufficient as it is understood concerns are centred around that specific part of the installation.
- 1.2 It is noted that the approved drawing 019, titled *Cupola—Typical Post Repair & Strengthening Sketch* and it is suggested that complete uniformity of steel angles and positioning should not be expected owing to variations in historic timbers, with a certain amount of on-site adjustment of brackets being necessary

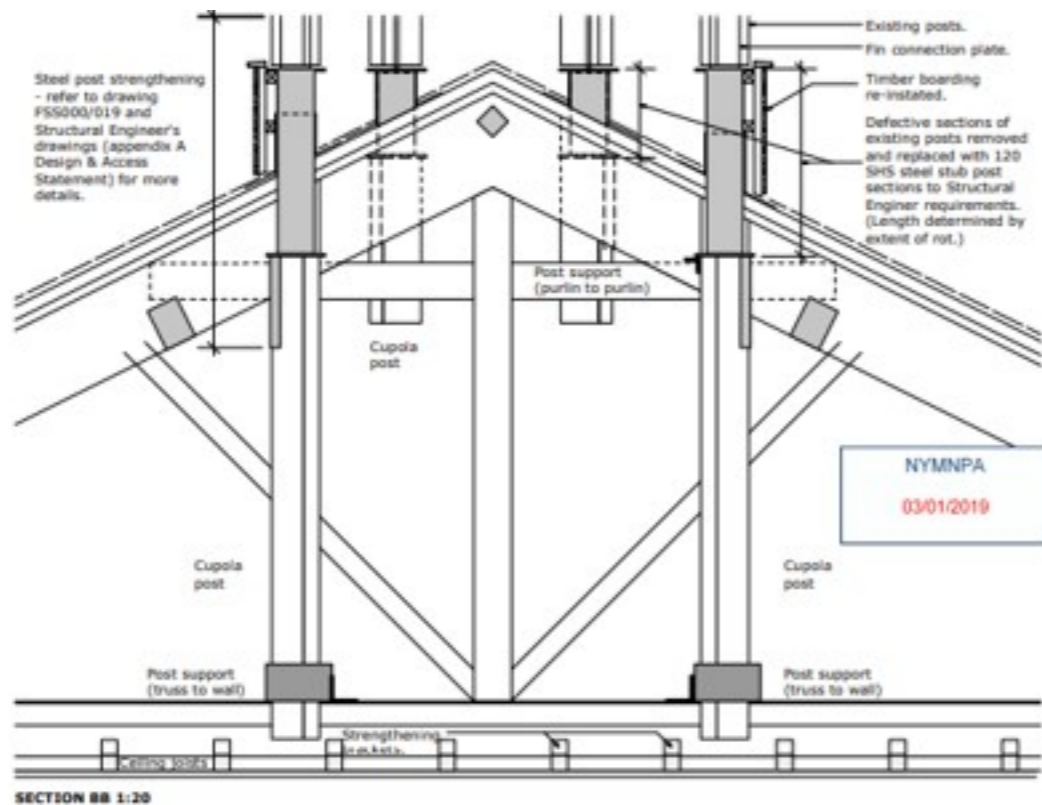
Proposed Drawing submitted with 2018/0797/LB

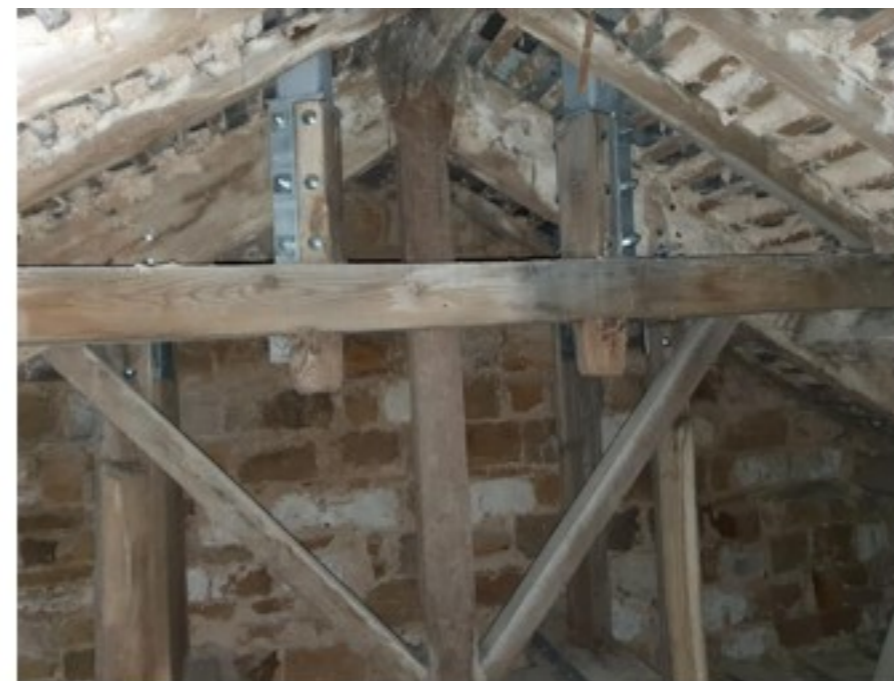
Current situation showing historic timbers and new steel angle
