# **DESIGN AND ACCESS STATEMENT**

CONVERSION OF 3NO. EXISTING OUTBUILDINGS INTO DWELLINGS AT MANOR FARM, SNEATON.

Project No. 2204

# Inspection of Three Barns at Manor Farm, Sneaton YO22 5HS for

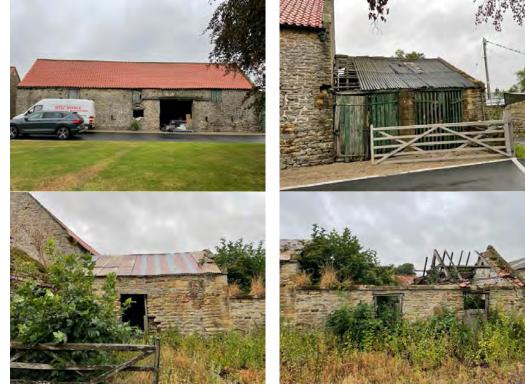
2.2 Buildings A-D are generally in a poor state of repair and in some areas surrounded by overgrown vegetation.

Fig. 2C - Building B

2.3 This proposal seeks to carefully repair buildings A-C, including stonework, pointing, floors, roof coverings and structures, replacement windows and doors and all electrical, plumbing and drainage facilities, in order to create buildings suitable for comfortable 21<sup>st</sup> Century habitation.

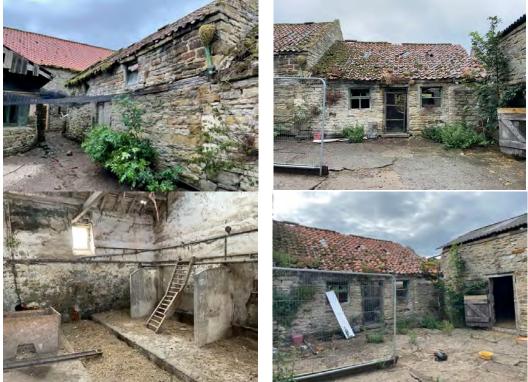
# Fig. 2D - Building C

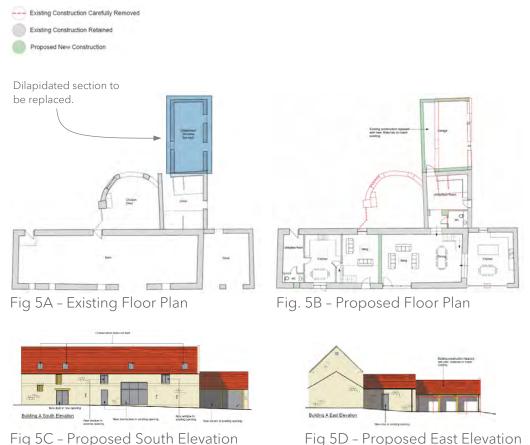
Fig 5D - Proposed East Elevation

5.6 The two proposed dwellings are created utilising all the existing openings in the building, with new penetrations kept to an absolute minimum, preserving the authentic agricultural nature of the building whilst providing two comfortable dwellings suitable for 21<sup>st</sup> Century habitation. The proposed cart lodge, replacing the most dilapidated part of the building, creates off-road parking for three vehicles, shielding them from the wider landscape view. It sits on the same footprint and is approximately the same height as the structure to be removed. As part of the conversion, Building A will be carefully repaired and restored, using natural materials to match the existing, providing longevity for preserving the appearance of the farmstead in the landscape.

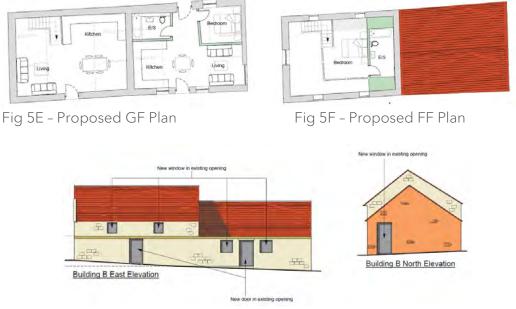
Fig 5G - Proposed East (Front) and North (Side) Elevations

- 5.8 Conversion of Building B to 2no. one-bedroom dwellings has been achieved with no loss of original building fabric. No new external openings are proposed, and no internal walls removed, only the makeshift internal stalls. This proposal completely preserves the building's agricultural style and original architectural intent and provides the smaller homes required by the NYMNPA's Strategic Policy M. The smaller one-bed homes (one of them set entirely at ground level) could potentially provide homes for older people looking for less maintenance, people with restricted mobility, or young individuals looking the leave the family home. In all these circumstances, small homes such as these, serve an important purpose by enabling people to be independent but remain within familiar surroundings.

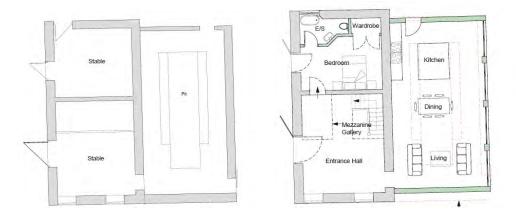
Fig 5H - Building C Existing & Proposed Floor Plans

- 5.9 **Building C** Sits to the north (behind) Building A. It has originally been intended as a stable, comprising two loose boxes with stable doors opening into the farmyard. However, at some point during the building's life it has been extended to the north, using a mix of concrete blockwork and reconstituted stone. This extension is considered to be inappropriate in the landscape setting and to detract from the original architectural intent for Building C, by skewing the roofline and incorporating modern synthetic construction materials. This proposal seeks to convert Building C into a single three-bedroom dwelling and to replace the existing incongruous extension with a more appropriate and legible extension, making use of natural materials and returning the building to an in-keeping agricultural form.

- 5.10 The blockwork extension is replaced with proposed timber clad construction on the same footprint. The North Elevation gives the appearance of a converted cart lodge, with glazed screens between timber posts, providing natural light into the building. This creates a more traditional agricultural aesthetic to the building and makes the original structure more legible. It restores the farmstead's aesthetic quality and provides space to create a comfortable three-bed dwelling. No new openings have been proposed in the buildings original structure.
- 5.11 Surface water from the site will be disposed of through the formation of new below-ground soakaways within the site.
- 5.12 The Government's database for long-term flood risk identifies the site as 'extremely low risk' from flooding from sea, surface water and reservoirs, therefore a flood risk assessment has been deemed unnecessary.

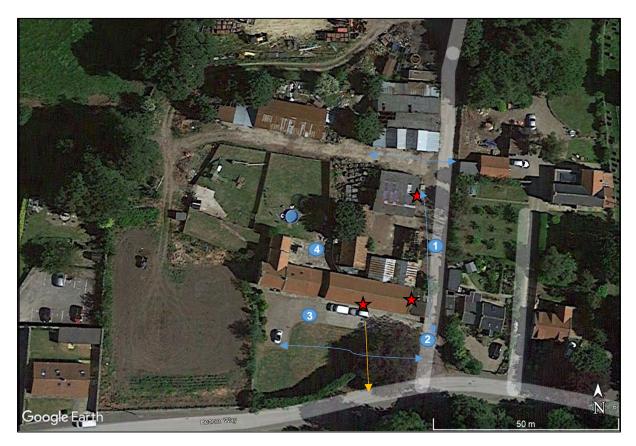
Figure 3. Summary of dusk emergence survey results 26/07/2022.

The first bat was observed was a common pipistrelle at 21:30 which emerged from the main barn door and then returned inside. Between 21:33 and 21:37 the bat foraged within the building with brief periods outside prior to flying south onto the hedgerow.

At 21:48 a common pipistrelle emerged from the small barn (Building 3) form mortar gaps/cracks at the roof apex. From this point onwards constant foraging was observed down the access lane and within the courtyard.

At 22:14 a bat was observed emerging from the eastern gable end of building 1. Given the foraging behaviour observed previously in which bats were entering and exiting the building, it is unclear as to whether this bat had been roosting or just foraging in the building. Similar activity was observed at 22:21 by surveyors 1 and 2, with two bats observed foraging or emerging from the gable end. A further bat was observed emerging from this point at 22:34.

(Orange lines indicate commuting bats; blue arrows indicate foraging; blue dots indicate surveyor locations; red star indicates emergence; yellow dot indicates infra-red camera position).

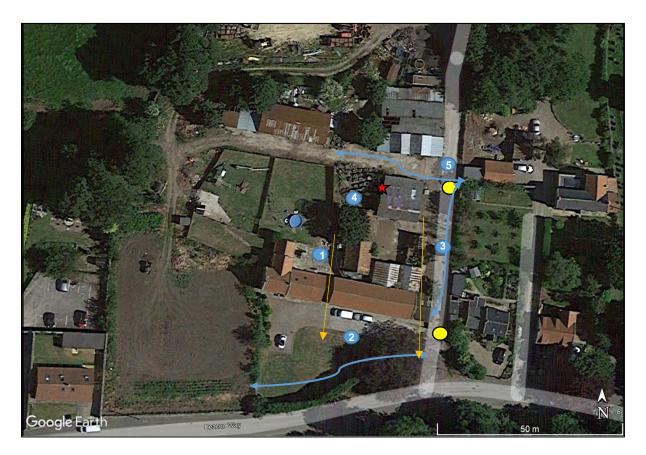
Figure 4. Summary of dawn re-entry survey results 10/08/2022.

At 05:04 a soprano pipistrelle was noted landing on the external wall of the south eastern elevation of main barn by surveyor 2. The bat was then observed to fly off.

At 05:07 a common pipistrelle entered the main barn through the doorway and did not emerge.

(Orange lines indicate commuting bats; blue arrows indicate foraging; blue dots indicate surveyor locations; red star indicates re-entry; yellow dot indicates infra-red camera position).

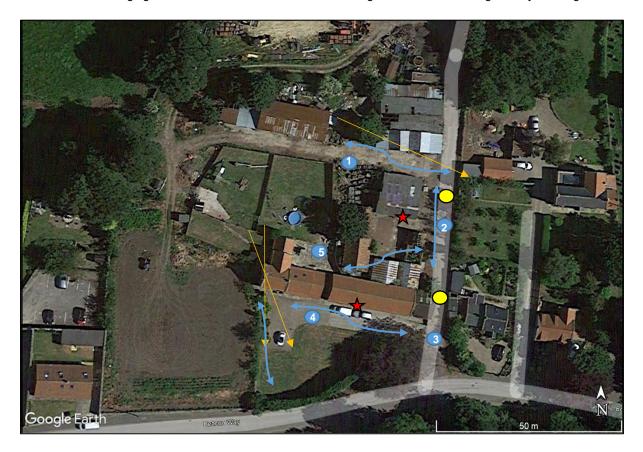
Figure 5. Summary of dusk emergence survey results 01/09/2022.

The first bat was observed at 20:10 which was a common pipistrelle emerging from main barn door and then commuting over the driveway towards road.

At 20:15 a common pipistrelle was observed emerging from the eaves on the southern elevation of building 3 in the courtyard.

From 20:39 common pipistrelles were observed foraging around the main barn, with one noted at 20:50 emerging from the main barn door or from the eaves area in this location.

(Orange lines indicate commuting bats; blue arrows indicate foraging; blue dots indicate surveyor locations; red star indicates emergence; yellow dot indicates infra-red camera position).

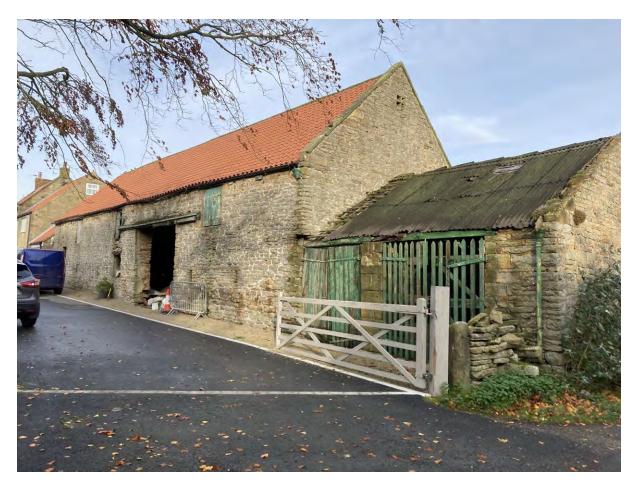
Photograph 1A Barn A

- 2A.1 The south facing elevation can be seen in Photograph 1A. The lower building at the Eastern end is in poor condition but the stonework itself is reasonable, see Photograph 2A. There is some stonework missing on the main building where the lower building meets it. Some cracking was also noted at the eastern end, see Photograph 3A. There are steel beams resting on lintels over the main opening, see Photograph 4A. these beams show signs of corrosion. The lintel over the small central opening has collapsed, see Photograph 5A. The stone lintel over the small opening at the Western end of the building has insufficient bearing, see Photograph 6A. This has caused localised failure of the stonework.

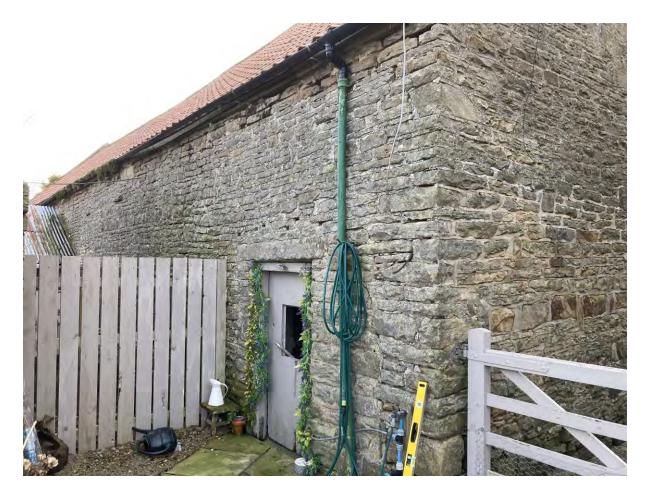
Photograph 8A Barn A

- 2A.2 The West facing gable wall (on the front section of building) is in reasonable condition, see Photograph 7A.
- 2A.3 The North facing elevation (on the front section of the building) can be seen on Photographs 8A, 9A and 10A. The wall is in reasonable condition except for some damage adjacent to the doorway.

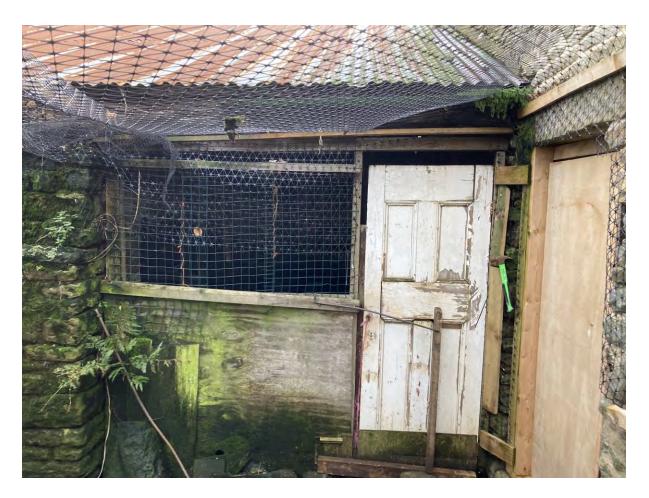
Photograph 11A Barn A

- 2A.4 The rear circular elevation can be seen in Photographs 11A, 12A and 13A. The walls are in reasonable condition.
- 2A.5 There is some localised damage around the doorway at the junction of the circular building and the rear section of buildings, see Photograph 14A.

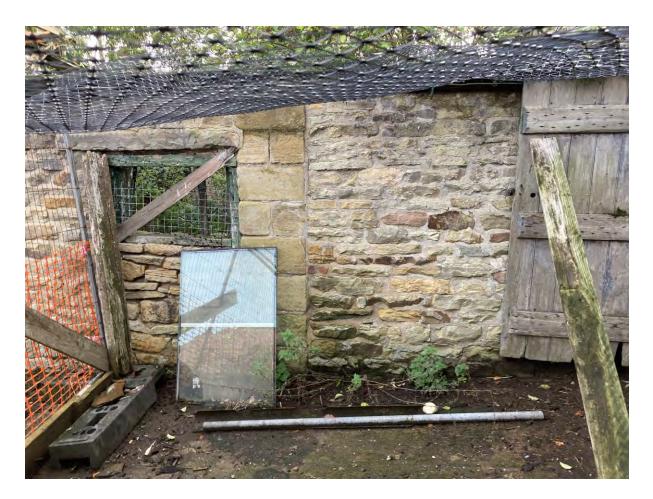
Photograph 15A Barn A

- 2A.6 The West facing elevation (of the rear section of building) can be seen in Photograph 15A and 16A. The walling is in reasonable condition except for some localised instability above and below the window and a lack of bonding between the stone pillars and panel of walling.

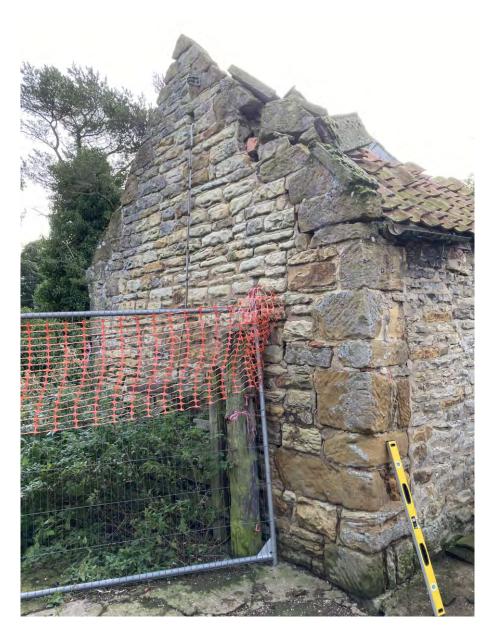
Photograph 17A Barn A

- 2A.7 The rear gable wall (North facing) is in reasonable condition except for some missing stonework on the Western roof edge, see Photograph 17A.
- 2A.8 The East facing wall (on the rear section of the building) can be seen in Photographs 18A, 19A and 20A. The walling is in reasonable condition except for some cracking at the Northern end and slight movement above the openings.

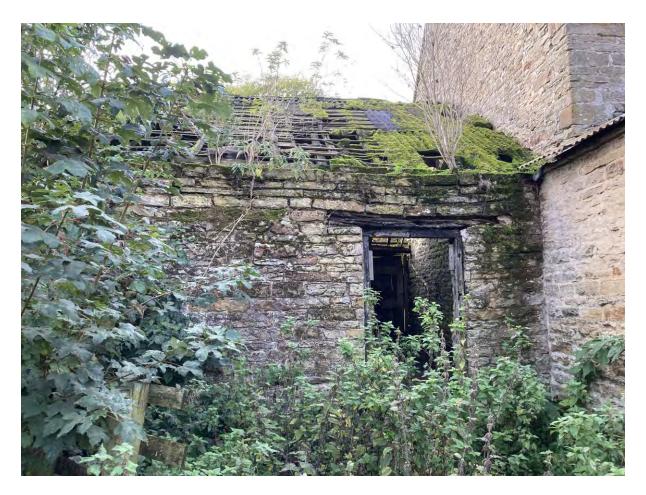
Photograph 21A Barn A

- 2A.9 The North facing elevation (on the front Eastern end of the building) can be seen in Photograph 21A. The wall is in reasonable condition except for the localised failure above the doorway.

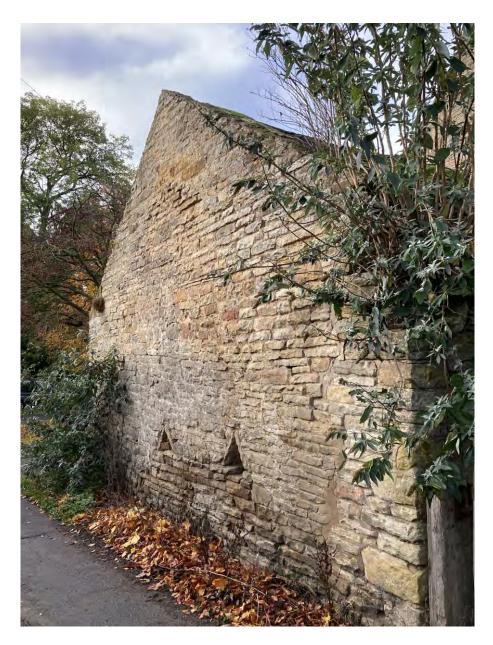
Photograph 22A Barn A

- 2A.10 The East facing gable wall (on the front section of building) can be seen in Photograph 22A. The wall is in reasonable condition except for some damage to the stonework at each end of the elevation, see Photographs 23A and 24A.

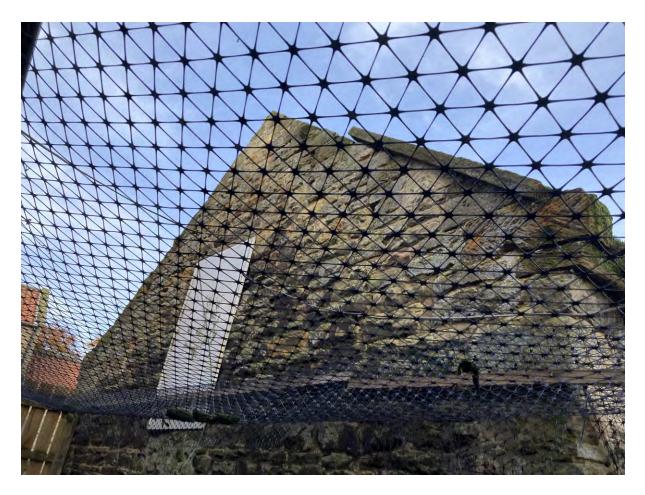
Photograph 2B Barn B

- 2B.1 The South facing gable wall is in reasonable condition, see Photographs 1B, 2B and 3B.
- 2B.2 The West facing elevation (Southern end) is in reasonable condition, see Photograph 4B and 5B.
- 2B.3 The West facing elevation (Northern end) can be seen in Photograph 6B. Some movement has taken place particularly at the Northern end.
- 2B.4 The North facing gable wall can be seen in Photograph 7B. It consists of 225mm thick brickwork with no cavity. There is a timber lintel over the opening, see Photograph 8B. The walling is not properly finished at the top of the wall, see Photograph 9B.

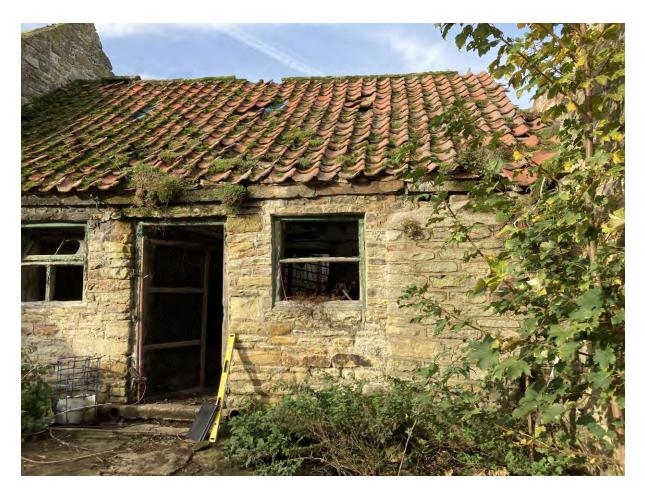
Photograph 10B Barn B

- 2B.5 The Eastern elevation (Northern end) can be seen in Photograph 10B. The wall is in reasonable condition except for the lintel over the openings.
- 2B.6 The Eastern elevation (Southern end) can be seen in Photograph 11B. There is a timber beam at about first floor level and the walling above this is in poor condition.

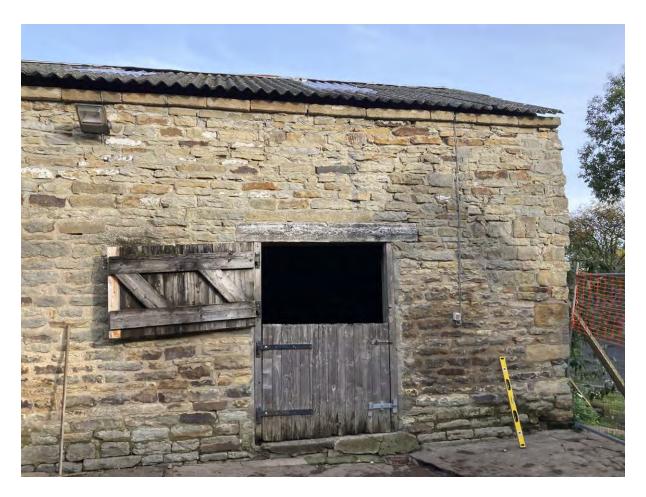
Photograph 2C Barn C

- 2C.1 The South facing elevation is in reasonable condition, see Photographs 1C and 2C except for timber lintels.
- 2C.2 The West facing wall (Southern end) can be seen in Photographs 3C and 4C. The walls are in poor condition with timber lintels over the openings.
- 2C.3 The West facing wall (Northern end) can be seen in Photographs 5C and 6C. The wall consists of concreter blocks which are in reasonable condition.
- 2C.4 The North facing elevation is in reasonable condition, see Photographs 7C and 8C.
- 2C.5 The East facing elevation can be seen in Photograph 9C. The wall is in reasonable condition except for an embedded timber beam, see Photograph 10C and movement in the vicinity of openings, see Photographs 11C and 12C.
- 2C.6 The existing first floor joists are in reasonable condition, see Photograph 13C.
