Heritage Statement/ Planning Statement Combined

Retrospective Listed Building Consent

“Alleged unauthorised internal works to Grade II Listed Building including removal of Yorkshire range and digging out of basement at Cranny, King Street, Robin Hoods Bay”

CRANNY, KING STREET, ROBIN HOODS BAY

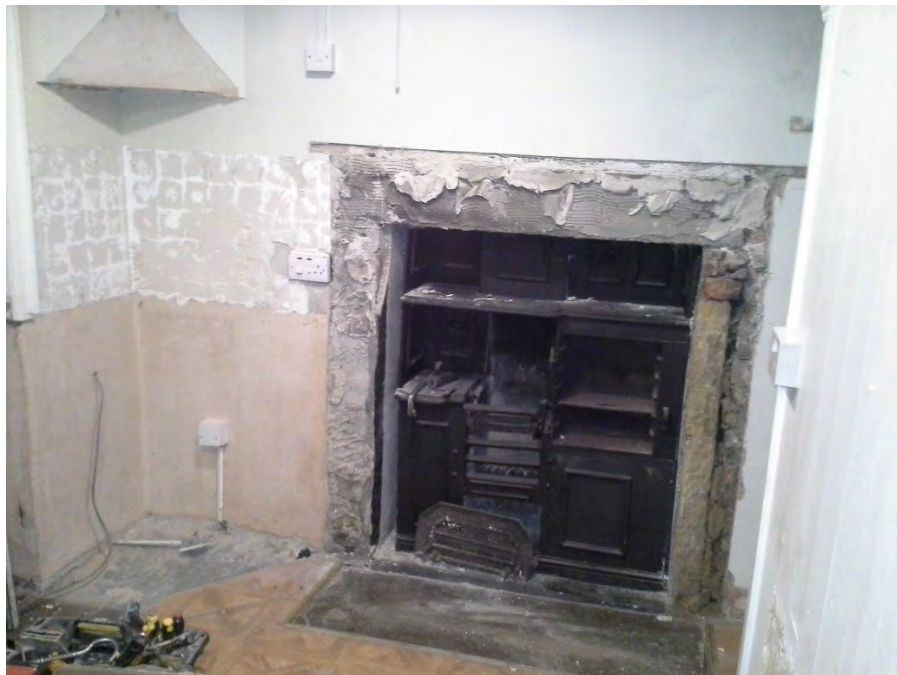
Photo 2. The non-original poorly fitting range after removal of non-original stone surrounds installed by others in 1970'

- The photos also show the stone surround removal. You can clearly see a stone inset heath with tiles on top.
- This is another key indicator this range was not original.

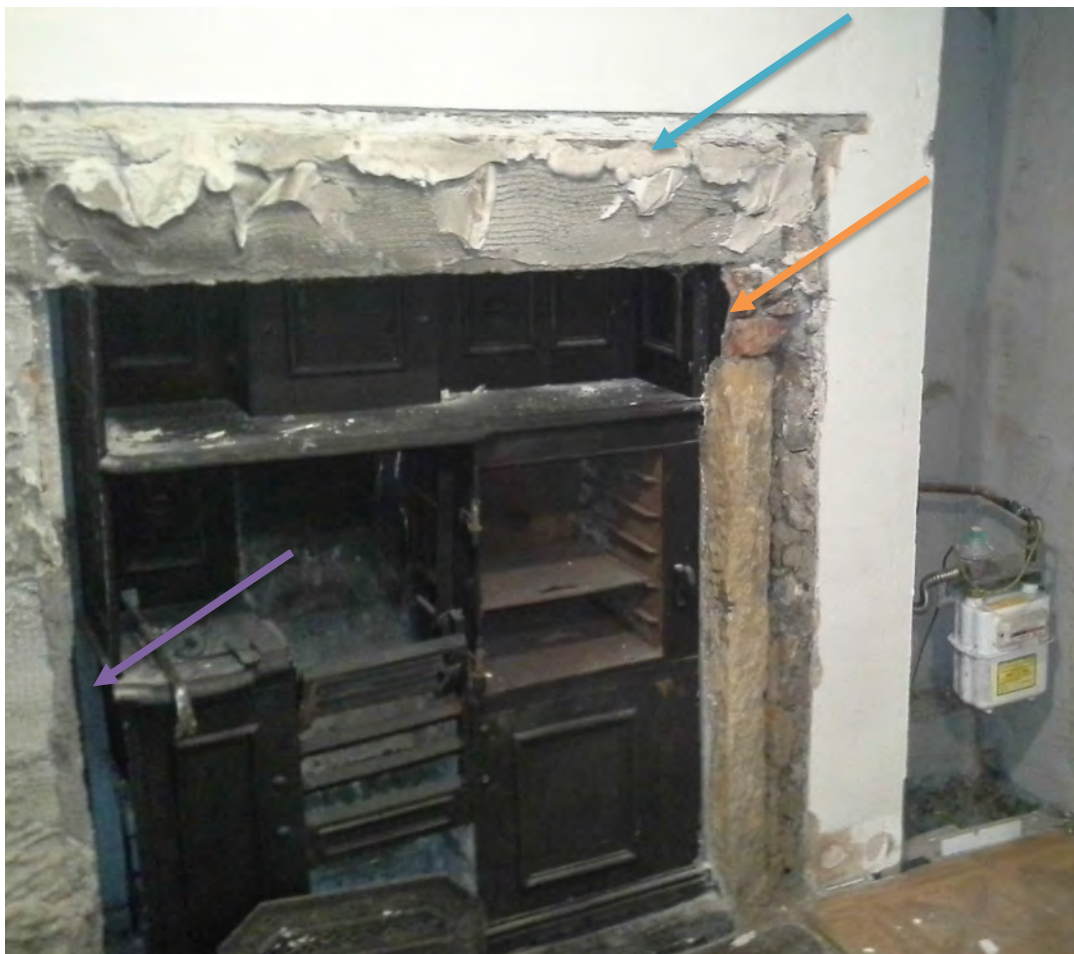
Photo 3. The Poorly fitting non original Range and evidence of previous alterations

A lintel outline is apparent it is unknown if this is original – The level of infill suggest may this opening was made larger.

It appears that a left stone section has been removed to fit the non-original stove.

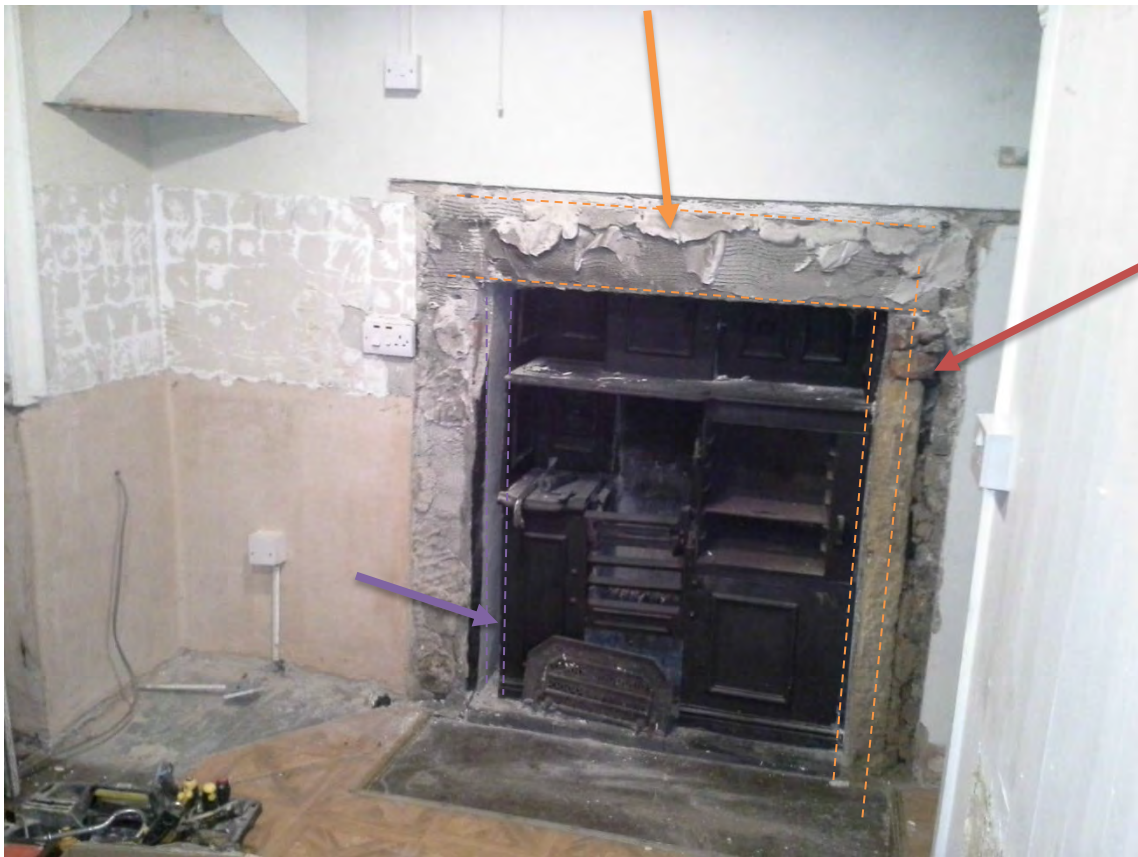
Photo 4. The Poorly fitting non original Range and evidence of previous alterations

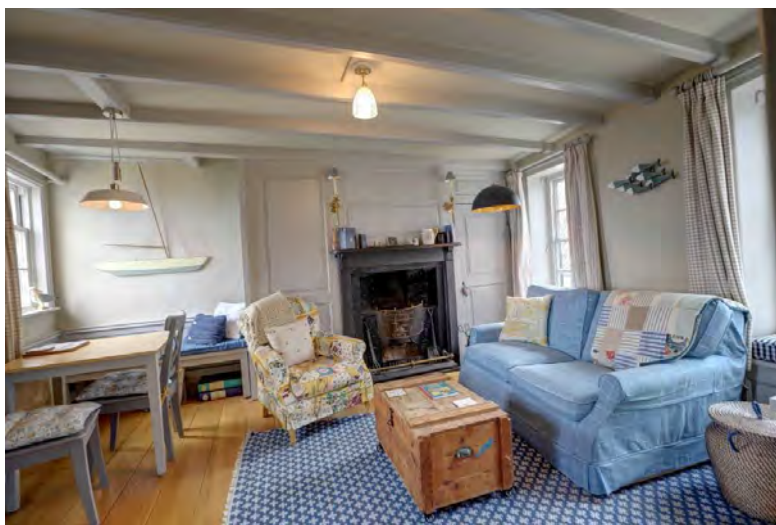
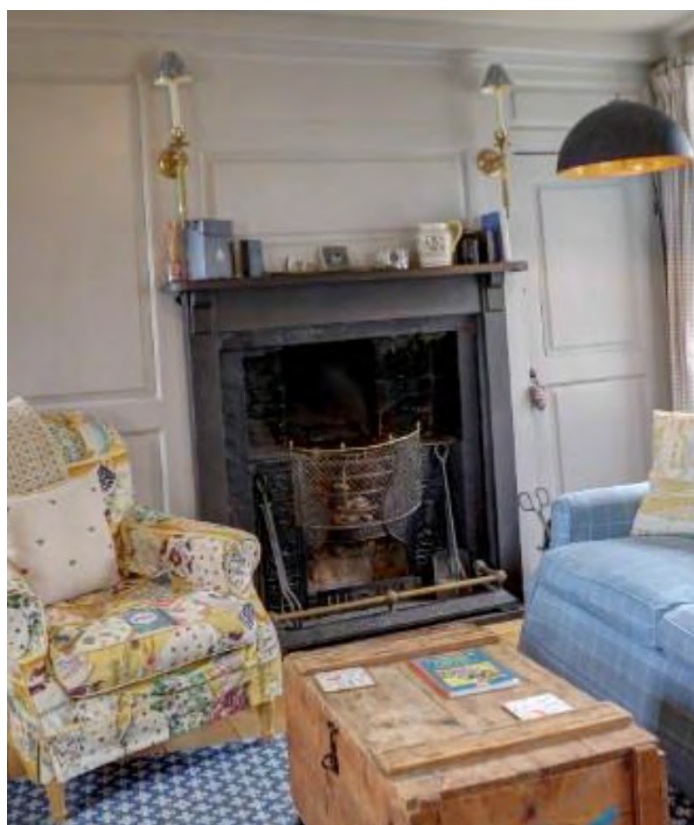
Local properties such as Georgian House, King Street, Robin Hoods Bay, contain examples of what we believe to have been originally present.

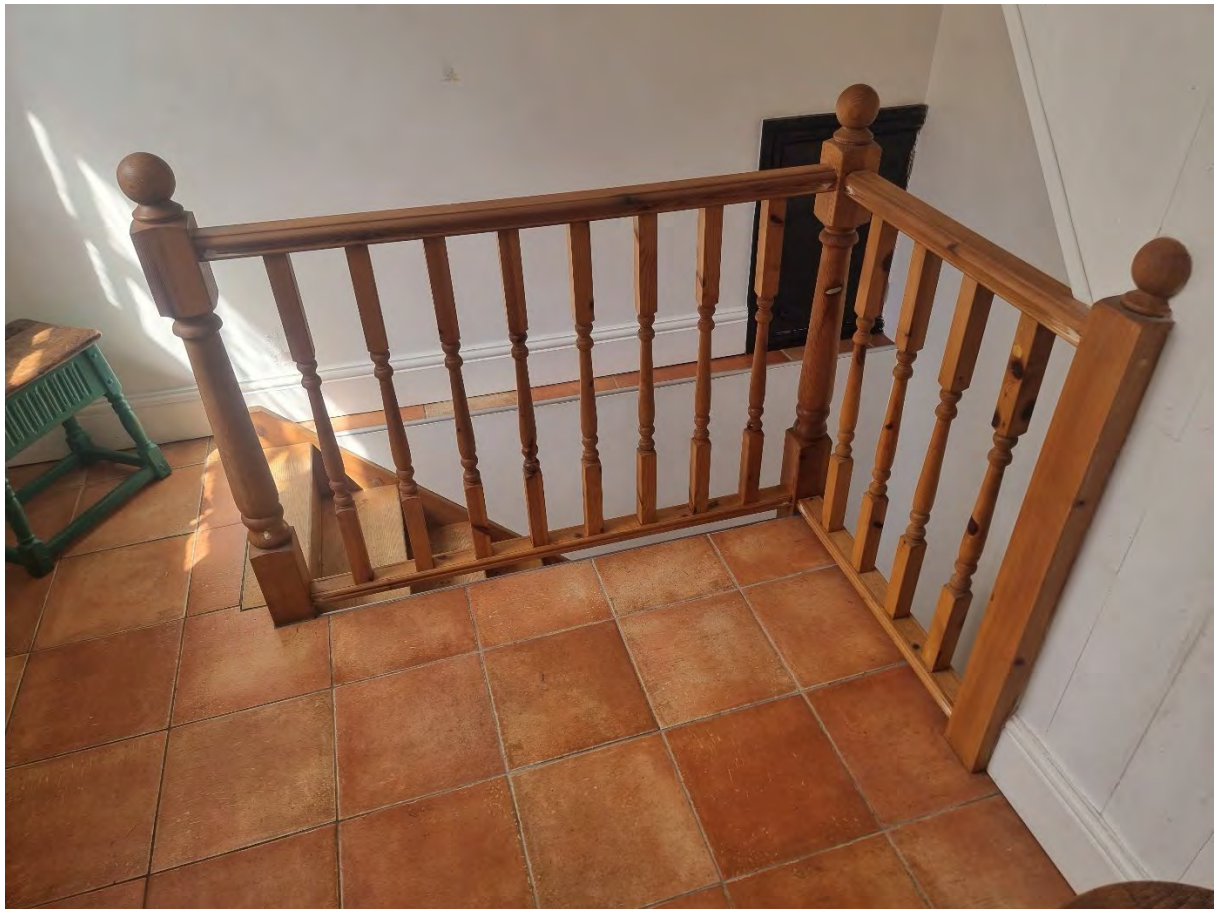
Photo 4. Stair Opening – Option A

Option A is to retain the existing staircase opening, whilst combining with Fireplace Options 1 or 2 (Section 1).

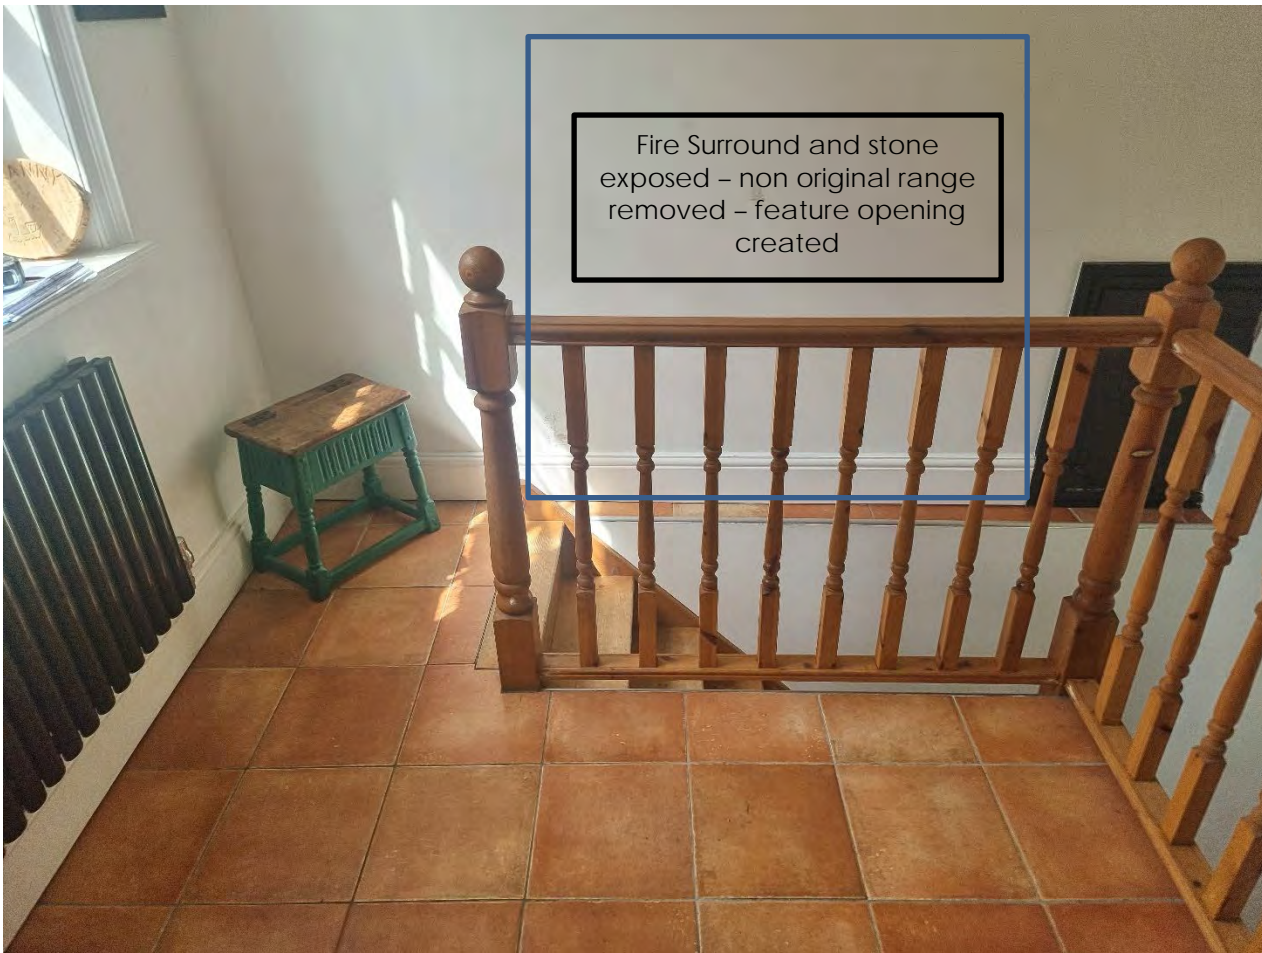
With Option A - the stair will retain the existing position and would be sited in-front of the opened up and cleaned fireplace.

- This may be seen as detrimental to the any intention of reinstating the feature

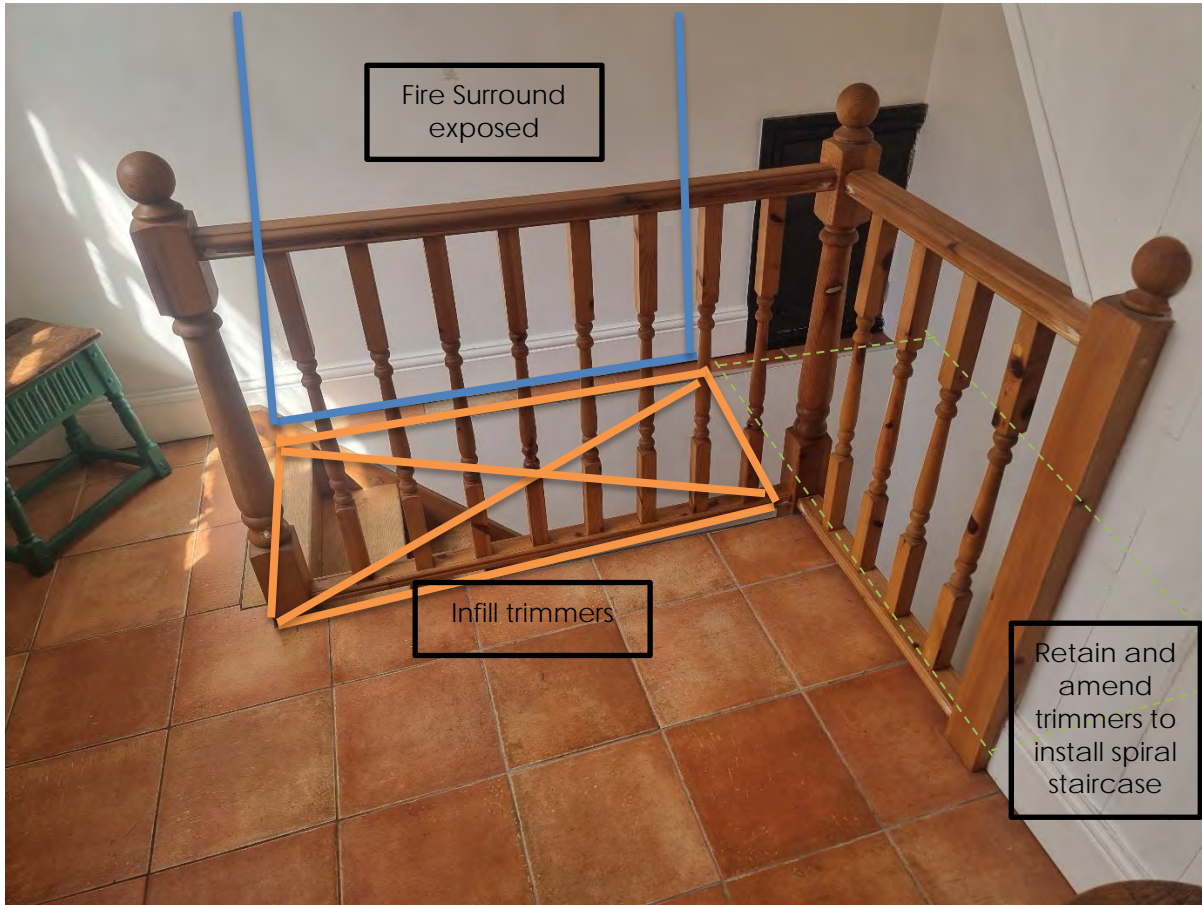
- We will infill partially the trimmer opening to enable the spiral staircase inclusion

- Again, this may be seen as detrimental as spiral staircases are not an original feature of the property.

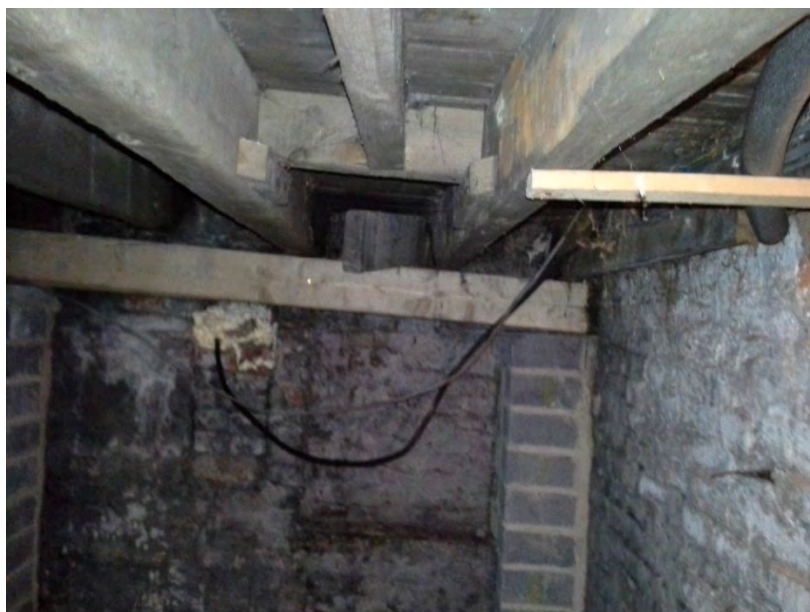
- When the Cranny was purchased by the owners there was significant damp issues with ground water / lateral penetration / Dry Rot and Wet Rot.

- Previous owners had made significant bodge jobs to support the rotting away floors etc.

This would have only got worse if the owners didn't act and invest heavily to provide a solution that will both prevent ongoing structural damage and a viable solution to maintain space for living.

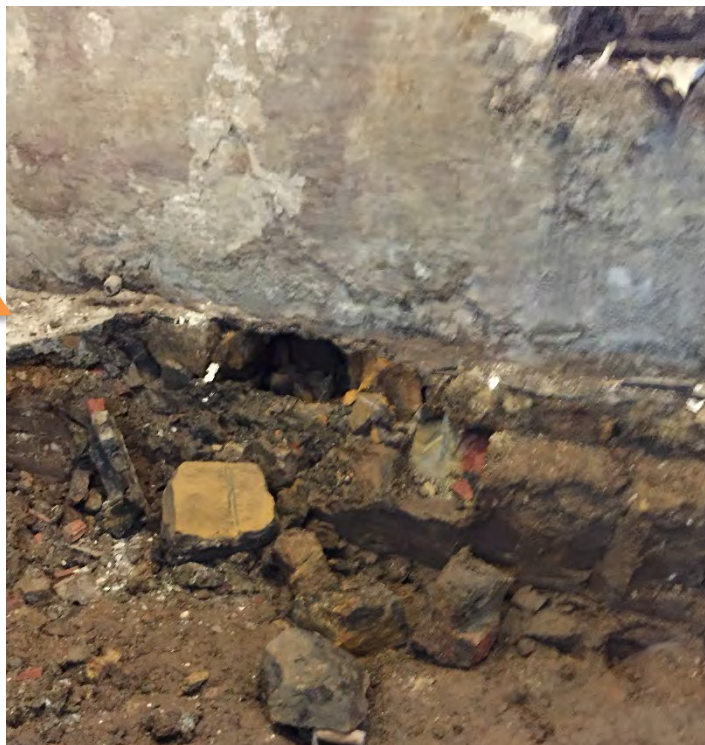
- The clients removed all poorly installed temporary supports (concrete blocks under rotted joists) and repaired flooring as required.
- The existing layer of concrete in the cellar was heavily broken and in poor condition and the poor ground substrate was removed.

Work had to be done to prevent trapped moisture and damp from further effecting the structures above or issues with damp and dry rot would have been yet again prevalent. Without doubt a full collapse would have followed.

The cellar had a new 200mm Concrete slab installed following digging out of loose strata and dry rot treatment.

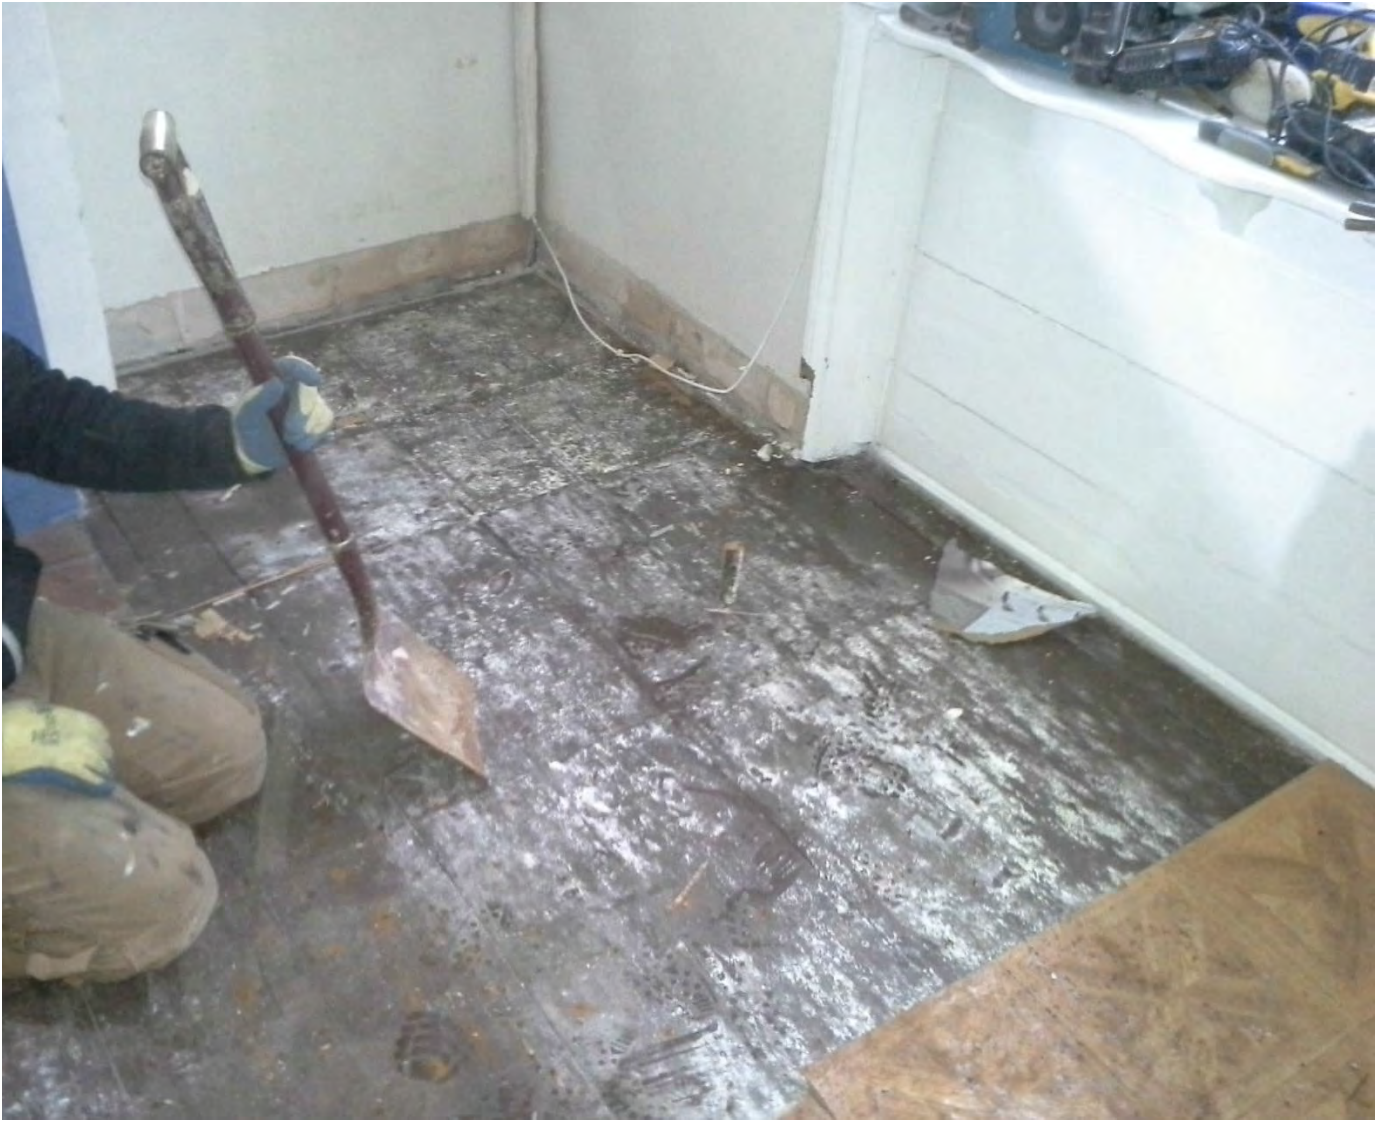
Photo shows the scale of rot to sections caused by moisture in the cellar and Dry / Wet Rot. Unfortunately, photos are lacking this week which would have helped in proving everything raised beyond doubt.

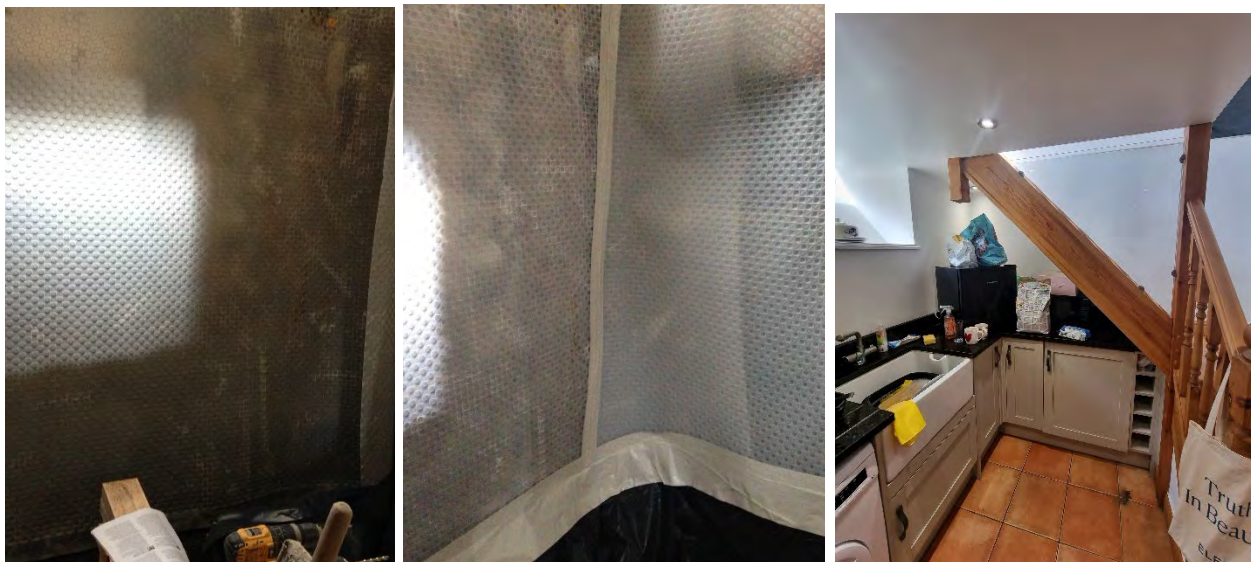
Photos showing membrane installed to walls of rear elevation – Supplied by builders. No further photos are available. The black membrane is the lapping up from the floor membrane of the concrete floor installed.

Completed cellar conversion also shown

Cavity drainage membrane has been used on a huge number of listed buildings (including properties owned by Chatsworth House) over the years and is a passive system.

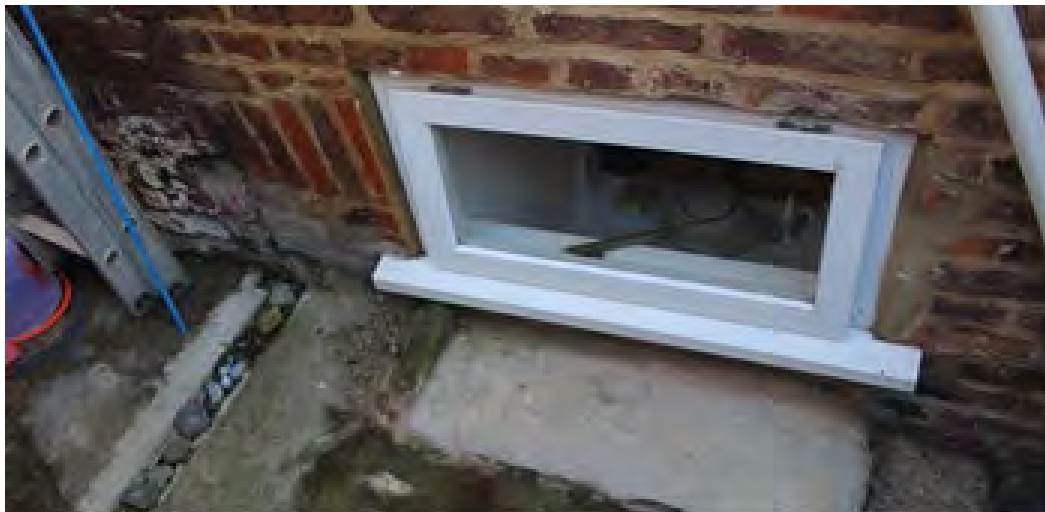
“The storm-proof cellar window required to be replaced with flush fitting window without cill”.

We provide drawings for the window to be replaced to a flush casement without a cill. This window was clearly not the required specification and again we apologise for the unauthorised install.

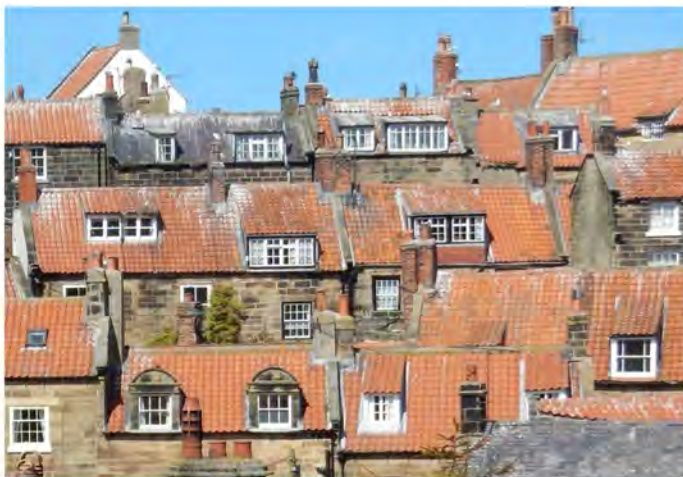
As part of the strategy of building upwards, many cottages have dormers or skylights to take advantage of roof space; where they are Victorian they are sometimes accompanied with barge boarding and finials, but the dormer roofs are mostly pantiles. Georgian and Queen Anne dormers can be set within attractive stone arches and the late 20th to 21st century response has been to use skylights.

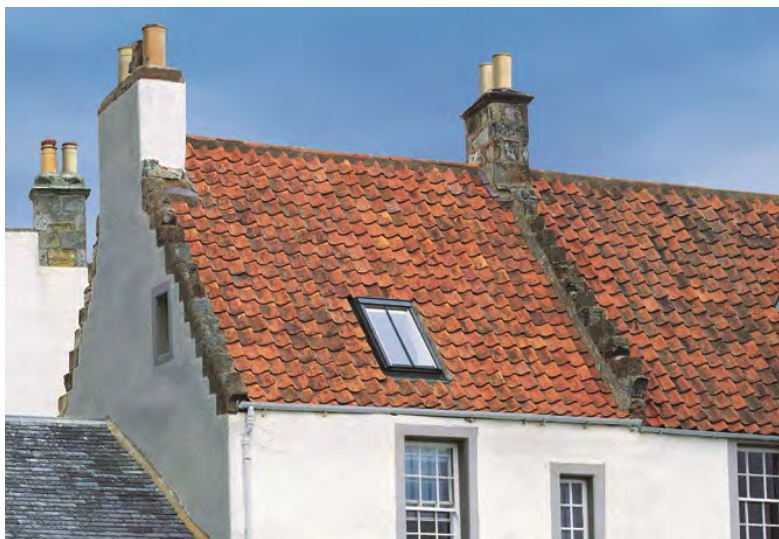
Specification:

flush mounted Conservation Velux to suit existing opening

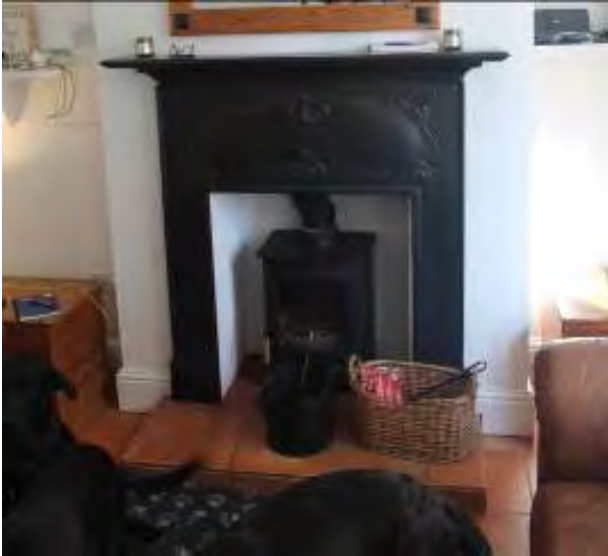
Existing replaced fire surround

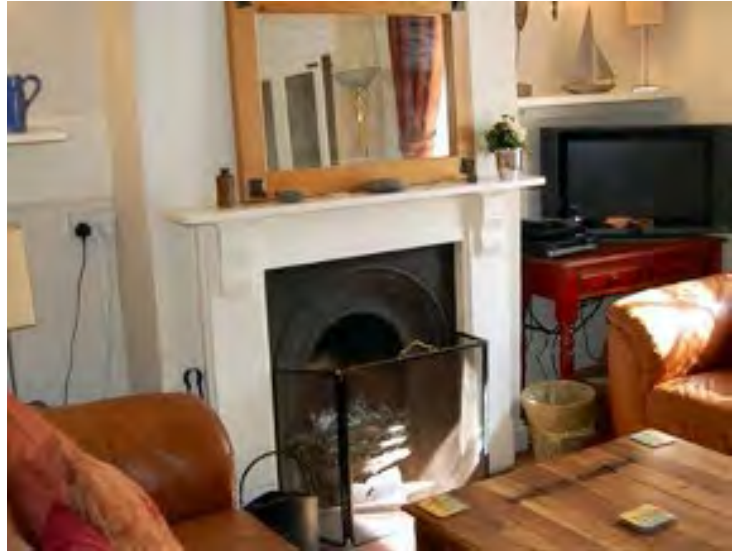
Previous Fire Surround

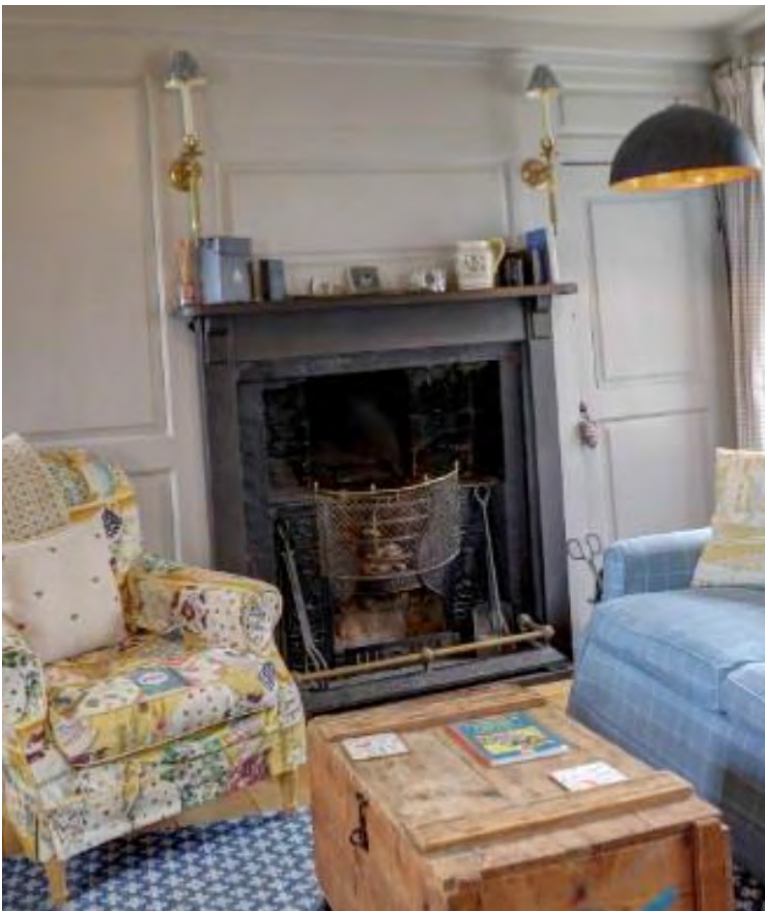
Local properties such as Georgian House, King Street, Robin Hoods Bay, contain examples of what we believe to have been originally present. A simple surround installed around the rectangular opening showing masonry to all sides.

Note: This above would not be permissible by modern HETAS regulations as any open fire needs an 8inch flue and the majority of the chimneys within this area would not take such a flue due to cramped and tightly turning stepped stacks.

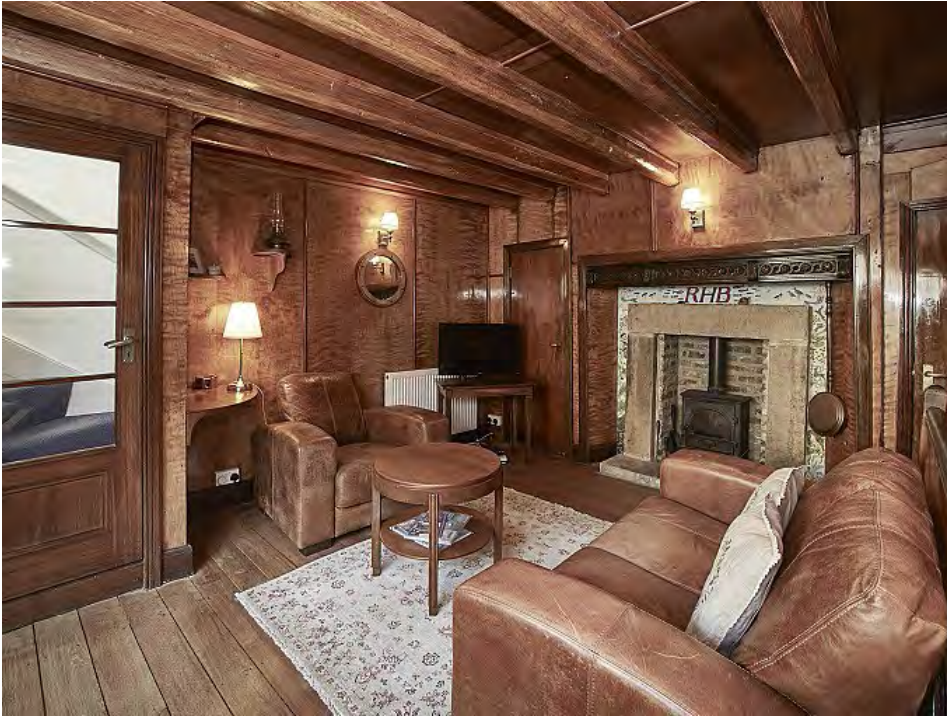
Local properties such as Fisherman's Cottage, Robin Hoods Bay, contain examples of what we believe to be a viable solution.
