Low Laithes Farm,
Hawsker.

SCHEME: Proposed Conversion to Outbuildings.

Bat, Breeding Bird and Barn Owl Scoping Survey
Low Laithes Farm, Hawsker

Author	Jordan Brandrick BSc (Hons)	
Status	Date	Checked by:
Final	18-01-2023	Ione Bateau MCIEEM

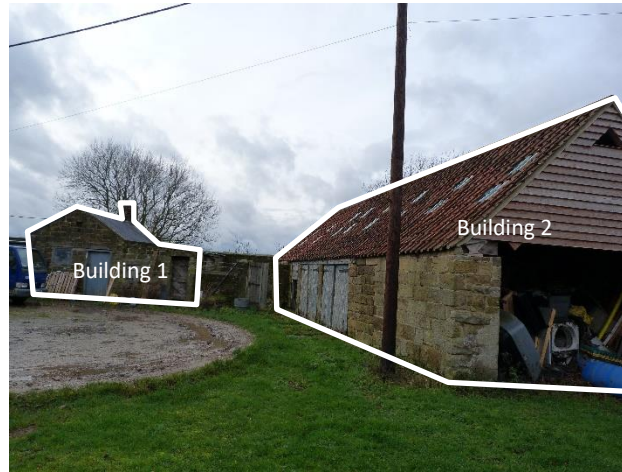
Photo 1: View of surveyed buildings. East aspect.

The surveyed buildings consisted of a small outhouse and an agricultural barn. A full description of the building is given in Section 6.2 Visual Inspection.

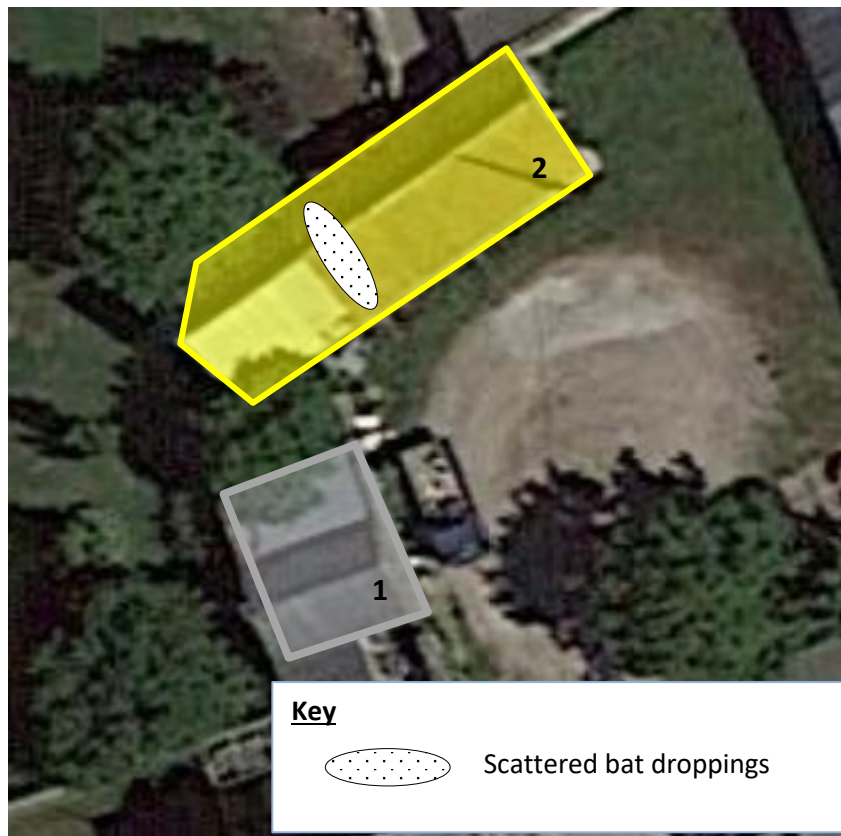
Figure 4: Locations of droppings found during the visual inspection.

Internally, there is PBRH in masonry crevices and wall top gaps. Particularly in an internal gabled wall and there were some (<10) scattered bat dropping identified on the floor of the east section of the building (see Photo 14).

An emergence survey is required in optimal survey season to inform the mitigation for the loss of PBRH in Building 2. If bats are found, a further survey and a Natural England Protected Species License may be required. Mitigation is to involve the installation of bat boxes on site.

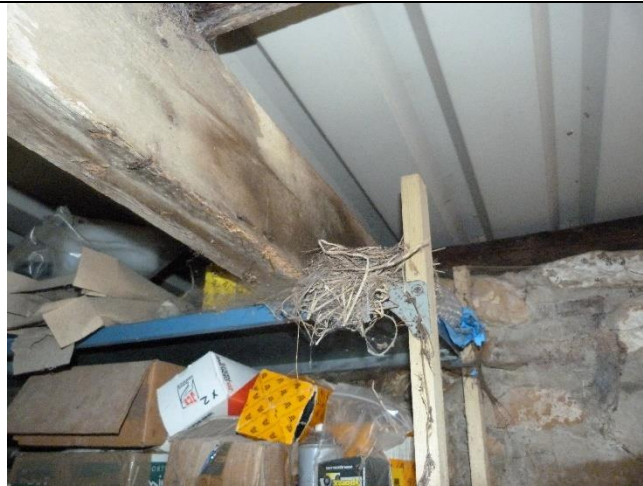
Photo 4: Bird nest.

There was one passerine nest identified inside the building (gabled section).

Two long lasting bird nest boxes are required for the loss of bird nesting habitat in Buildings 1 and 2 as well as an open-sided structure being created or retained on site for barn swallow nesting.

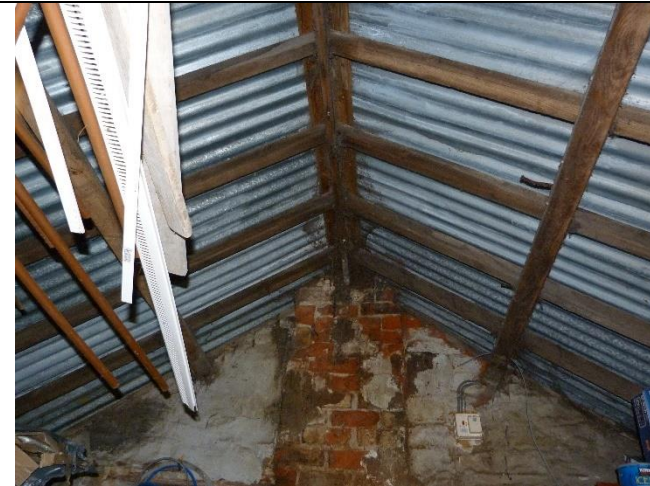
Photo 5: Internal view of the roof of the gabled section. Cobwebs evident at ridge.

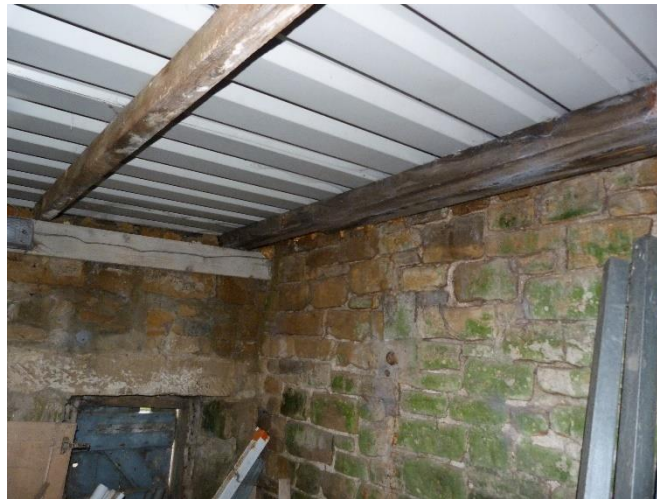
Photo 6: Internal view of flat roofed section.

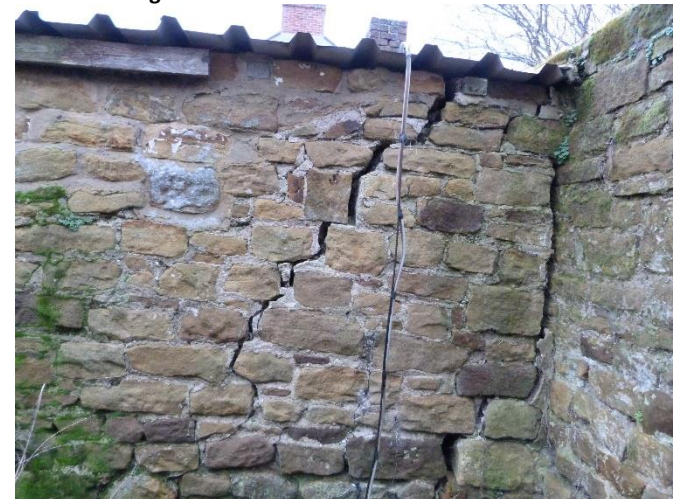
Photo 8: North wall of the building with large masonry crevices.

No further survey is recommended for the works to Building 1 due to the negligible risk of bat roosting. Works should follow good working practices.

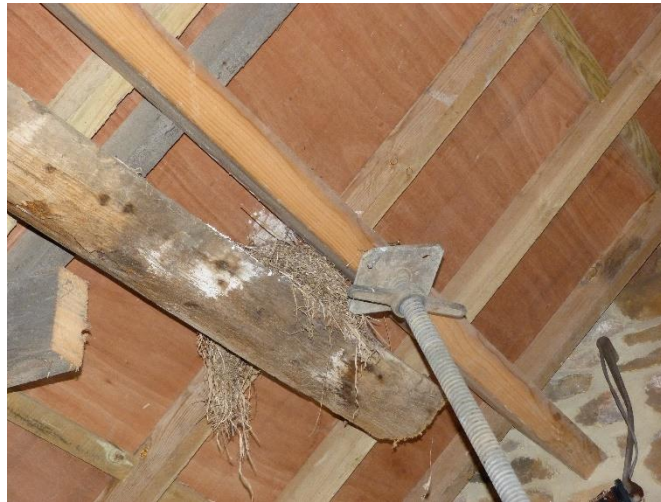
Photo 11: Bird nest (1).

Three passerine nests were identified internally, two of which were barn swallow nests.

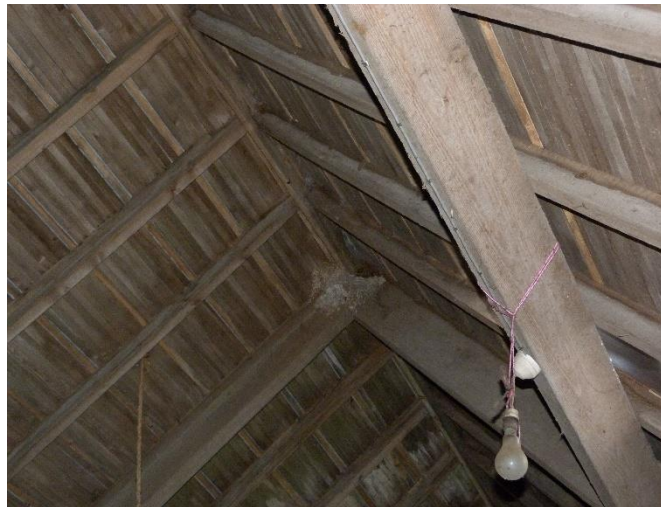
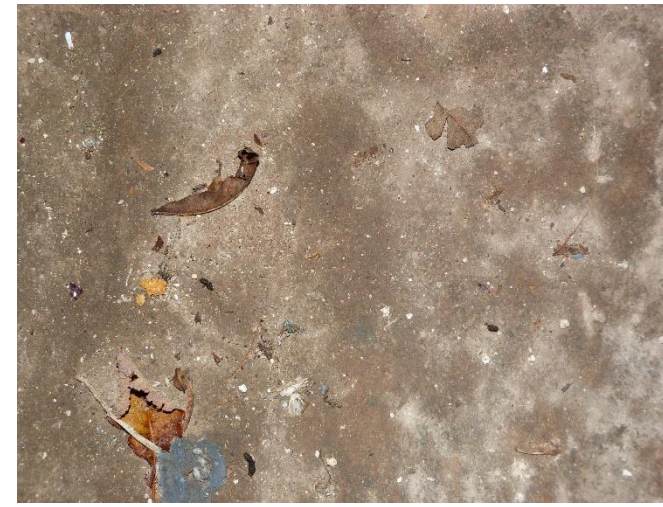
<p>Photo 13: Bird nest (2), barn swallow.</p>   <p>Photo 15: Internal gabled wall, masonry crevices evident.</p>	<p>Photo 14: Bat droppings identified on the floor of the building.</p>   <p>Photo 16: East view of Building 2.</p>	
---	--	---	---	--

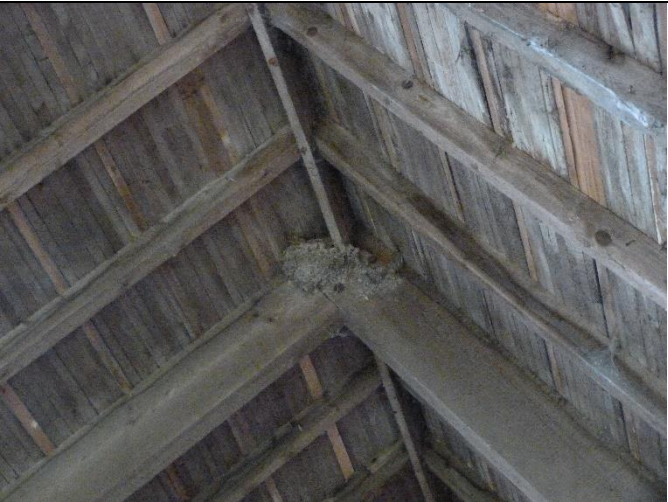
Photo 17: Bird nest (3), barn swallow.

There will be a loss of nesting habitat, particularly for barn swallows which are nesting in the structural timbers of Building 2.

9.2.7 An open sided structure should be created or retained on site to provide alternative provision for barn swallow nesting.
