## Design and Access Statement

### High Farm Ugglebarnby

**Bat, Breeding Bird and Barn Owl Scoping Survey**  
**High Farm, Ugglebarnby**

January 2023

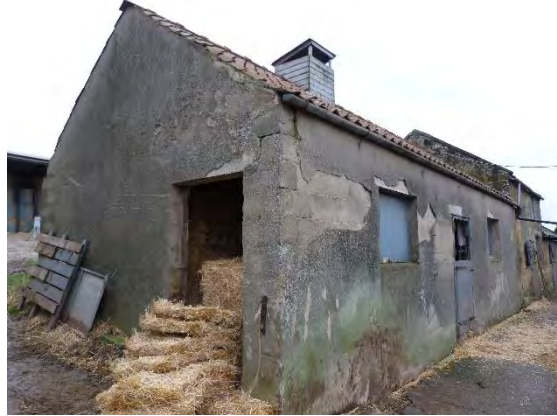
Photo 1: View of the building. South aspect.

The surveyed building was a single storey agricultural building with stone brick and rendered wall sections. A full description is provided in section 6.2 Visual Inspection.

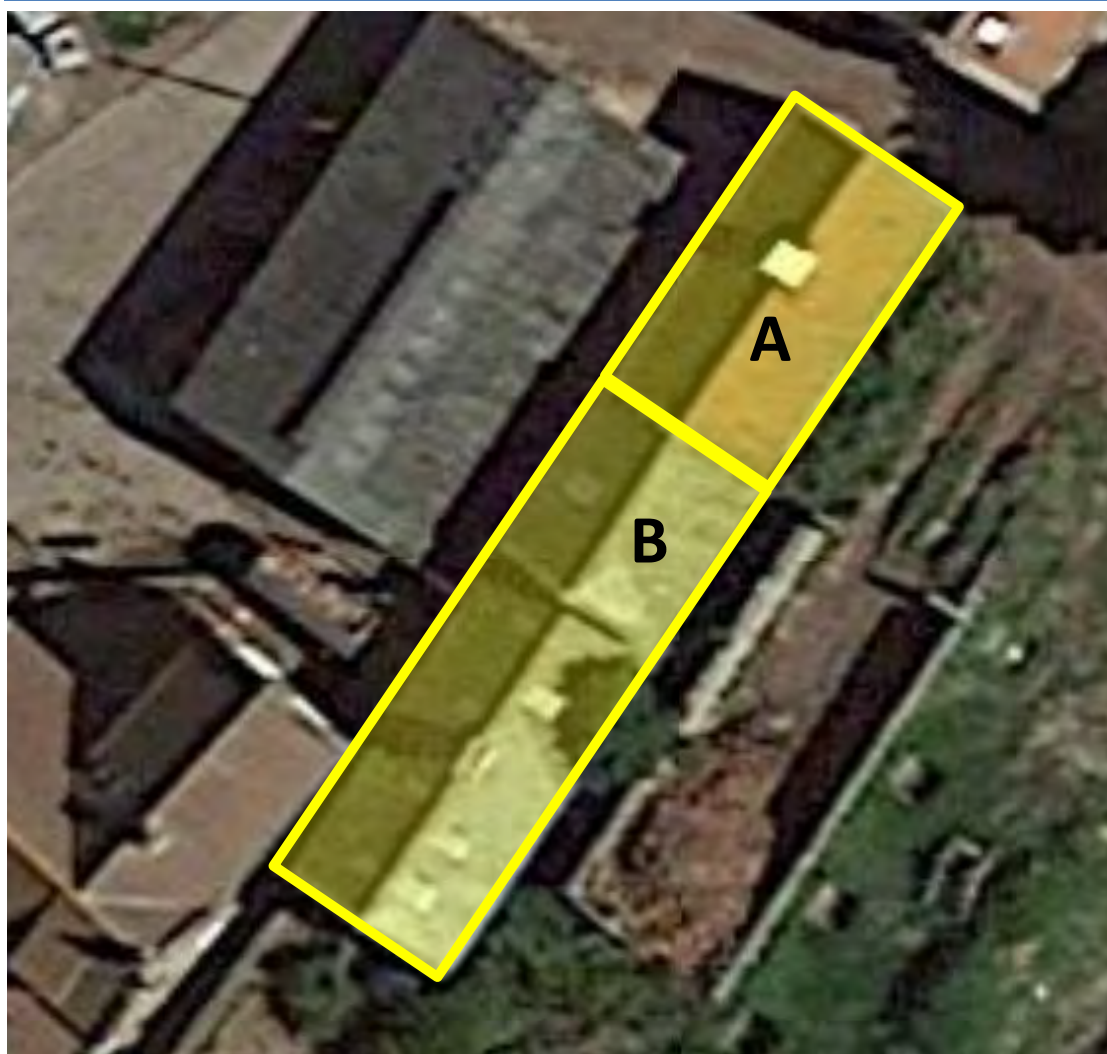
Figure 4: Aerial view of the surveyed building.

Building ref	Description and notes	Photographs	Potential Bat Roost Habitat (PBRH)
<p><b>Section A: Low potential risk of supporting bats</b></p>	<p>Rendered breeze block building with a wooden lined clay pantile roof and clay ridge tiles.</p> <p>Externally, the building is in fair condition. There are some masonry crevices, particularly to the southeast corner of the building however most of these were exposed on both sides. The roof has many lifted roof tiles and there are some sections of missing mortar under the ridge tiles.</p> <p>Internally, the roof lining was in fair condition however there was evidence of damp where the roof has leaked. The structural timbers of the building were cobwebbed suggesting a lack of bat usage.</p> <p>A barn swallow nest was identified within the roof timbers of this building.</p> <p>No evidence of barn owls found.</p>	  <p>Figure 5: External view of the building. Southern aspect. Masonry crevices outlined in red.</p>   <p>Figure 6: Rear view of the building.</p>   <p>Figure 7: Cobwebs on roof timbers.</p>   <p>Figure 8: Missing mortar under ridge tile (2).</p>	<ul style="list-style-type: none"> <li>-Under roof tiles.</li> <li>-Masonry crevices.</li> </ul>

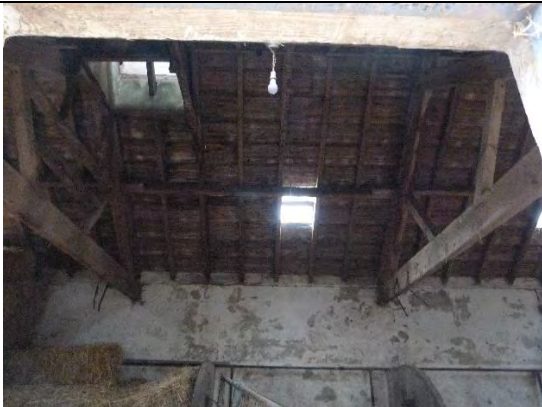
<p><b>Figure 9: Internal view of the building.</b></p>	  <p><b>Figure 10: Bird droppings.</b></p>	
	<p>Stone built building with a slate tile roof lined with bitumastic lining and concrete ridge tiles.</p> <p>The brickwork is in fair condition however there are masonry crevices on the external walls on both the front and rear of the building. The roof is in fair condition with a few lifted roof tiles which may allow access between the tiles and liner.</p> <p>Internally, there is PBRH in wall top gaps in the taller sections wall and in the door lintels. The smaller section has rendered walls on the inside however there is evidence of damp in this section on the walls which reduces suitability for bat roosting.</p> <p>There was a house sparrow observed in this building during the survey.</p> <p>No evidence of barn owls.</p>	  <p><b>Figure 11: Smaller section of the building.</b></p>

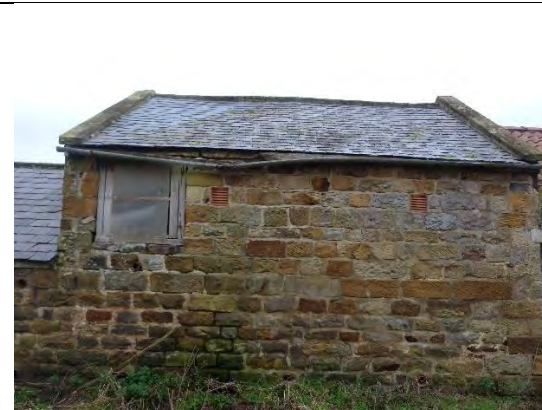
<p><b>Figure 12: Tall section of the building.</b></p>	<ul style="list-style-type: none"> <li>-Wall top gaps.</li> <li>-Between tiles and liner.</li> <li>-Masonry crevices.</li> <li>-Door lintels.</li> </ul>

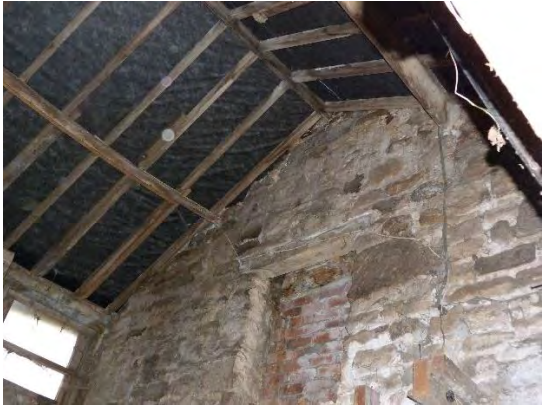
<p><b>Figure 15: Internal view of tall section. Wall top gaps evident.</b></p>	<p><b>Figure 16: Internal view of smaller section. Damp evident.</b></p>

The visual inspection of the building found that it is low risk of potential bat roosting. No evidence of bats was identified however potential bat roost habitat (PBRH) was found both externally and internally in masonry crevices, under lifted roof tiles and ridge tiles, in gaps of door lintels, and wall top gaps. Inspection of the interior of the buildings was not possible due to it containing livestock and hay.

9.2.1 Prior to the commencement of any works to areas where potential bat roost habitat has been identified, bat emergence surveys, in line with current Bat Conservation Trust Good Practice Guidelines will be carried at the appropriate time of year (May-August) and in suitable weather conditions. Bat survey results will inform required mitigation and will be forwarded to the LPA.

9.2.3 Mitigation is likely to involve the installation of two long-lasting woodcrete bat boxes on site.
