Proposed:
WINDOW REPLACEMENTS
at
YORK HOUSE
KING STREET
ROBIN HOODS BAY

REPLACEMENT WINDOWS
at
YORK HOUSE
KING STREET
ROBIN HOODS BAY

Drawing:
EXISTING
WINDOW SCHEDULE W1.

Drawing:
PROPOSED WINDOW
SCHEDULE W1 & W2

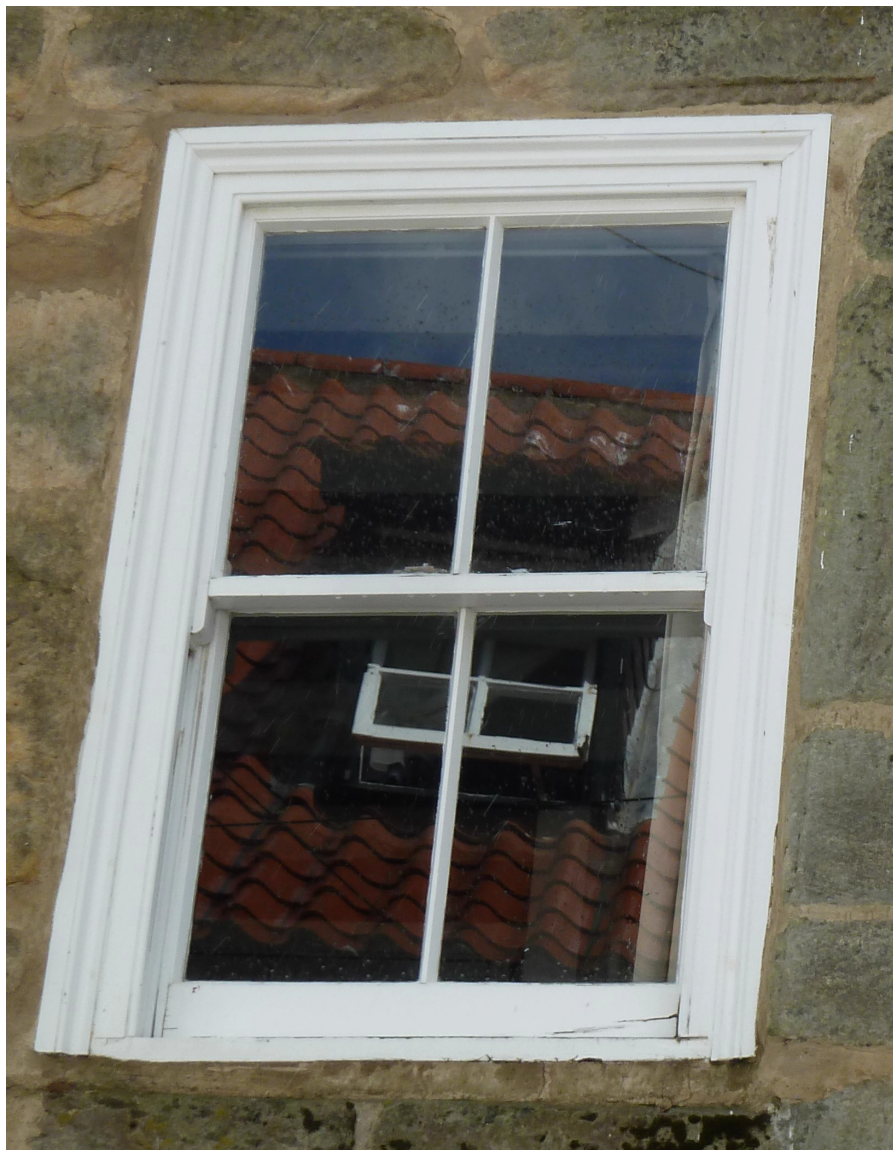
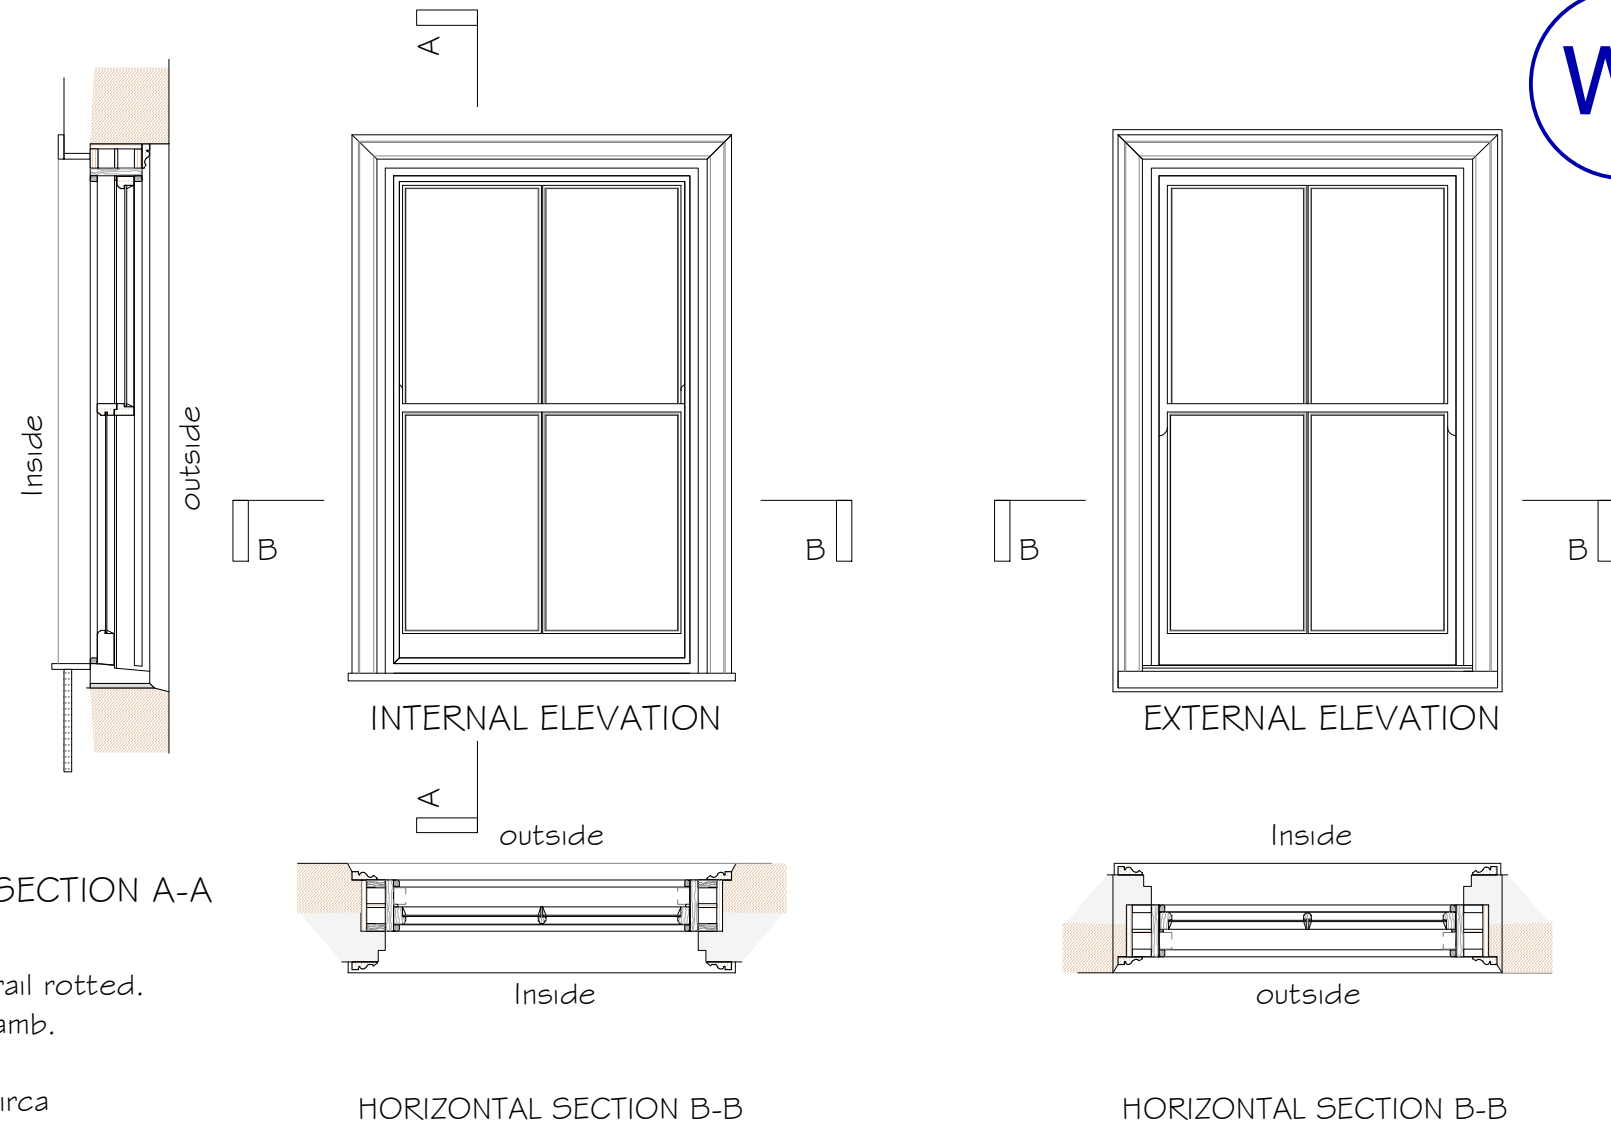
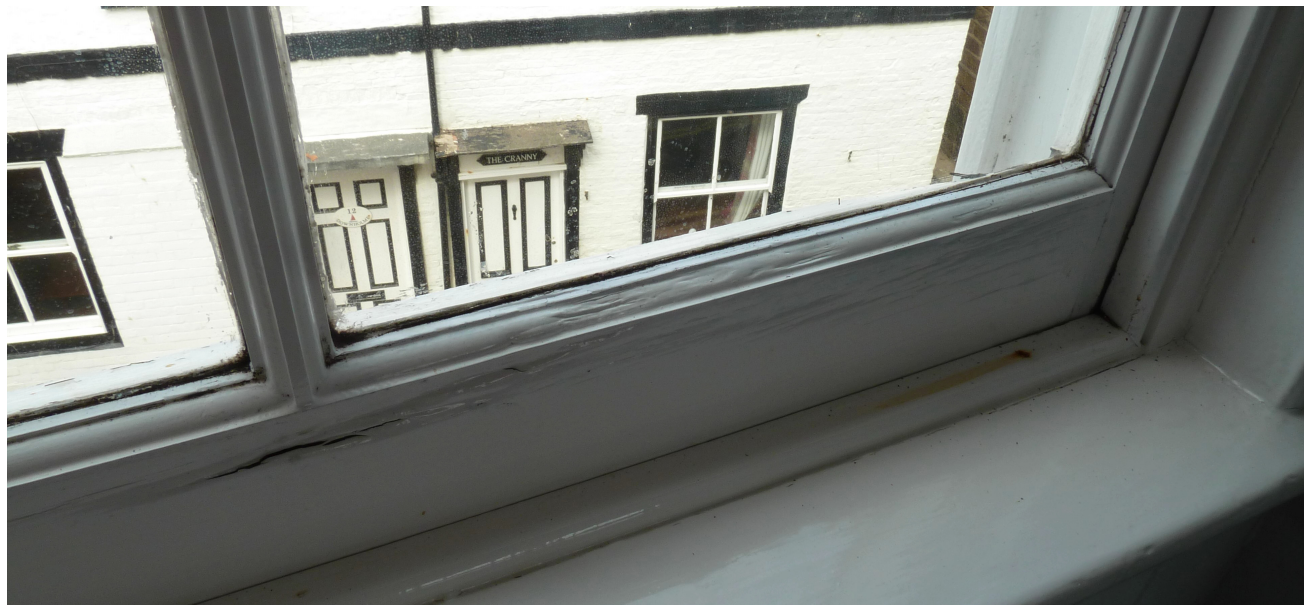
W1

Main visible defects:
Sill, bottom rail and meeting rail rotted.
Staining to rhs upper sash jamb.

Window frame manufacture circa
1980's to 1990's

FIRST FLOOR LEVEL BEDROOM (LHS Viewed Externally).

Cracked paint and surface mould indicates general state of decay throughout the frame components internally & externally. Details of the sash and meeting rails as for W2.

REPLACEMENT WINDOW FRAMES TO BE TIMBER FOR WHITE PAINT FINISH.

INSTALLATION DETAILS TO MATCH EXISTING FOR ALL LOCATIONS.

MODIFY INSTALLATION AS NECESSARY FOR DEEPER BOX FRAME.

FRAME SECTIONS AS J.HALLAM JOINERY 'EGTON' HERITAGE RANGE.

WHERE REQUIRED EXTEND SILL TO PROJECT BEYOND STRUCTURE USING REBATED AND GLUED SECTION.

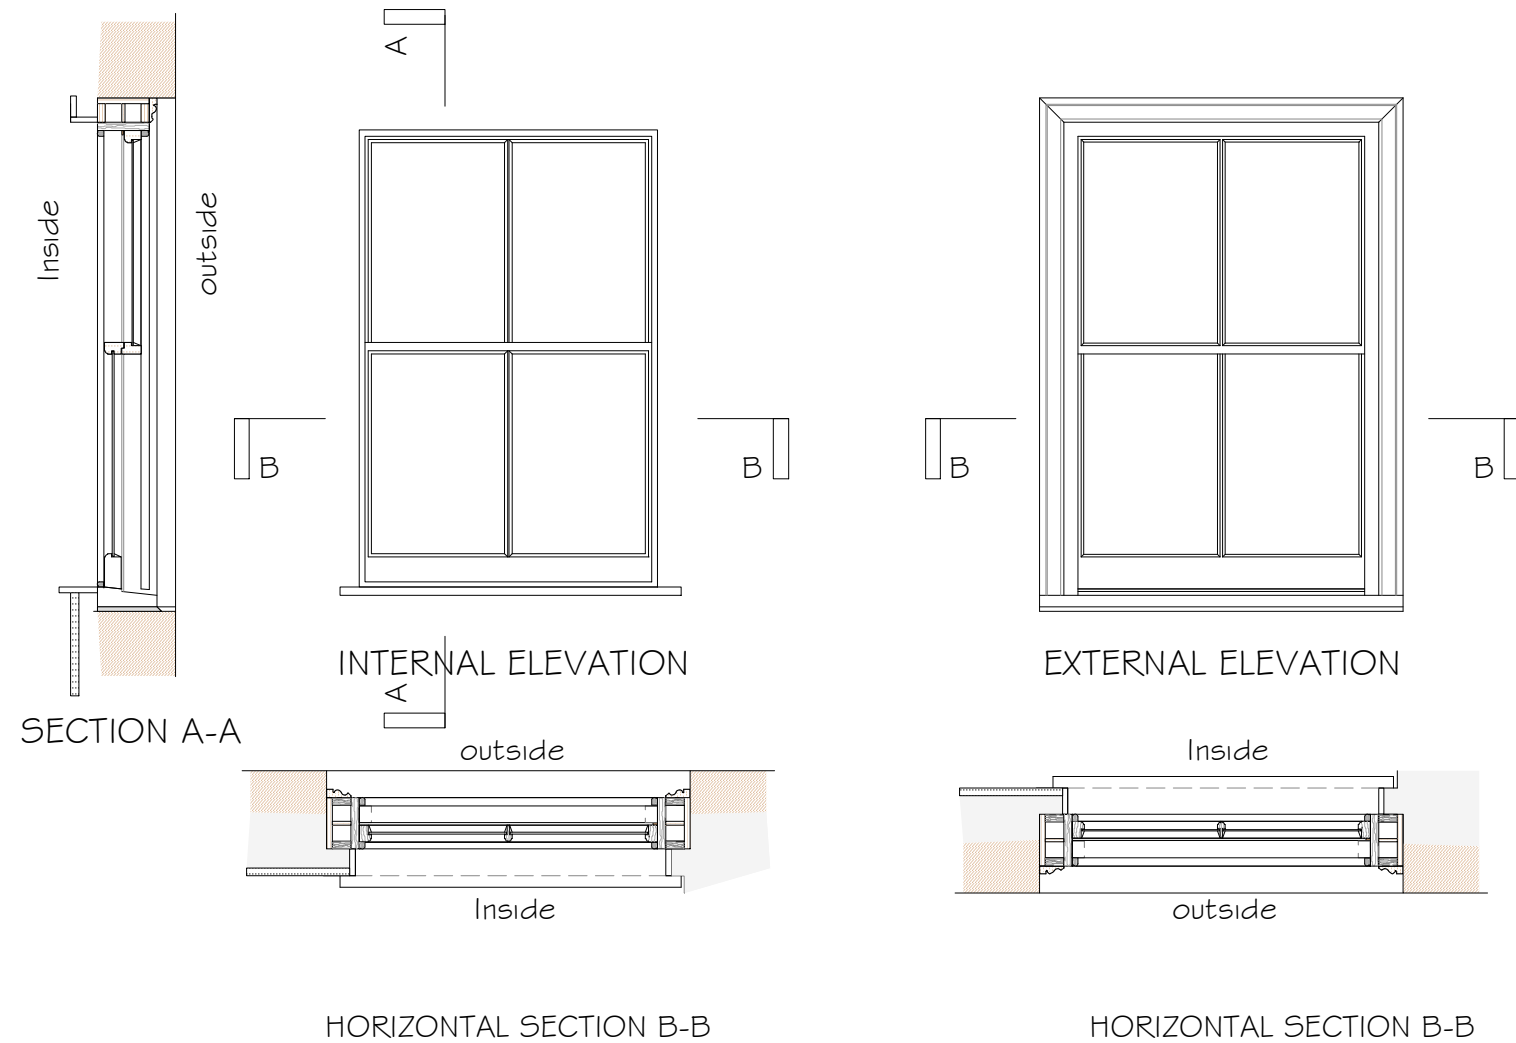
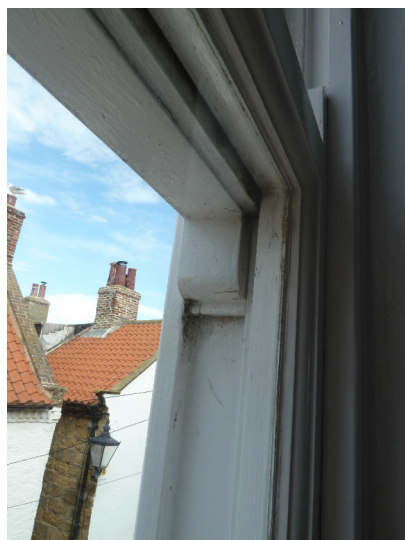
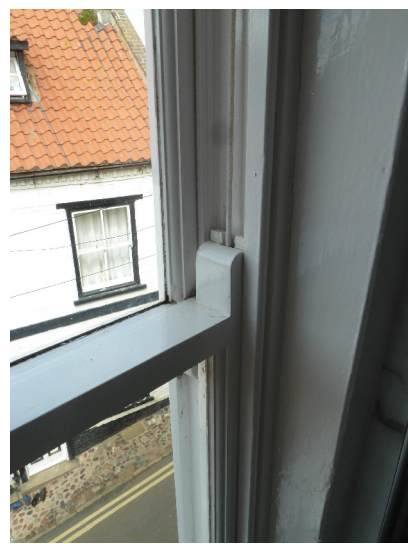
FIRST FLOOR LEVEL BATHROOM. (RHS Viewed Externally).

Cracked paint and surface mould indicates general state of decay. Details at sash horn non-vernacular particularly composite planted sections to sash cord channel. These details also apply to W1.

TILE SURROUND TO WINDOW FRAME IN BATHROOM.

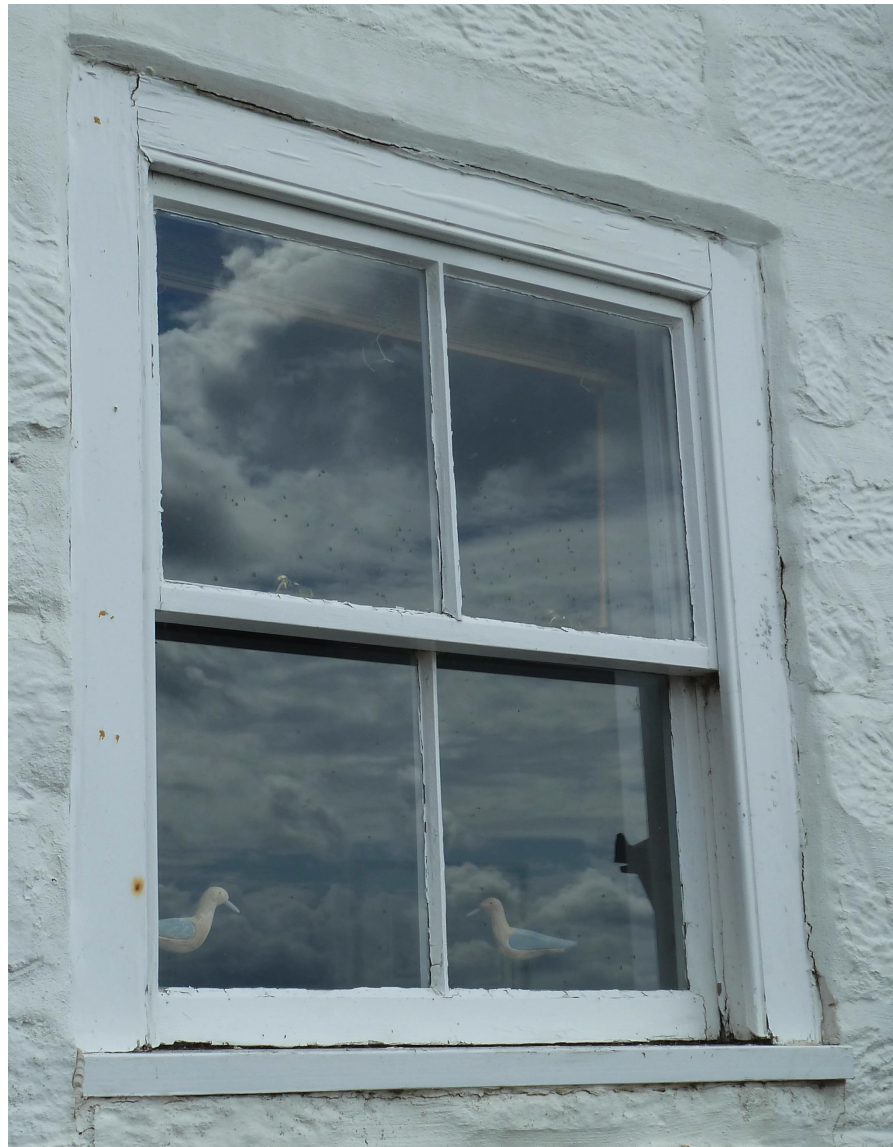
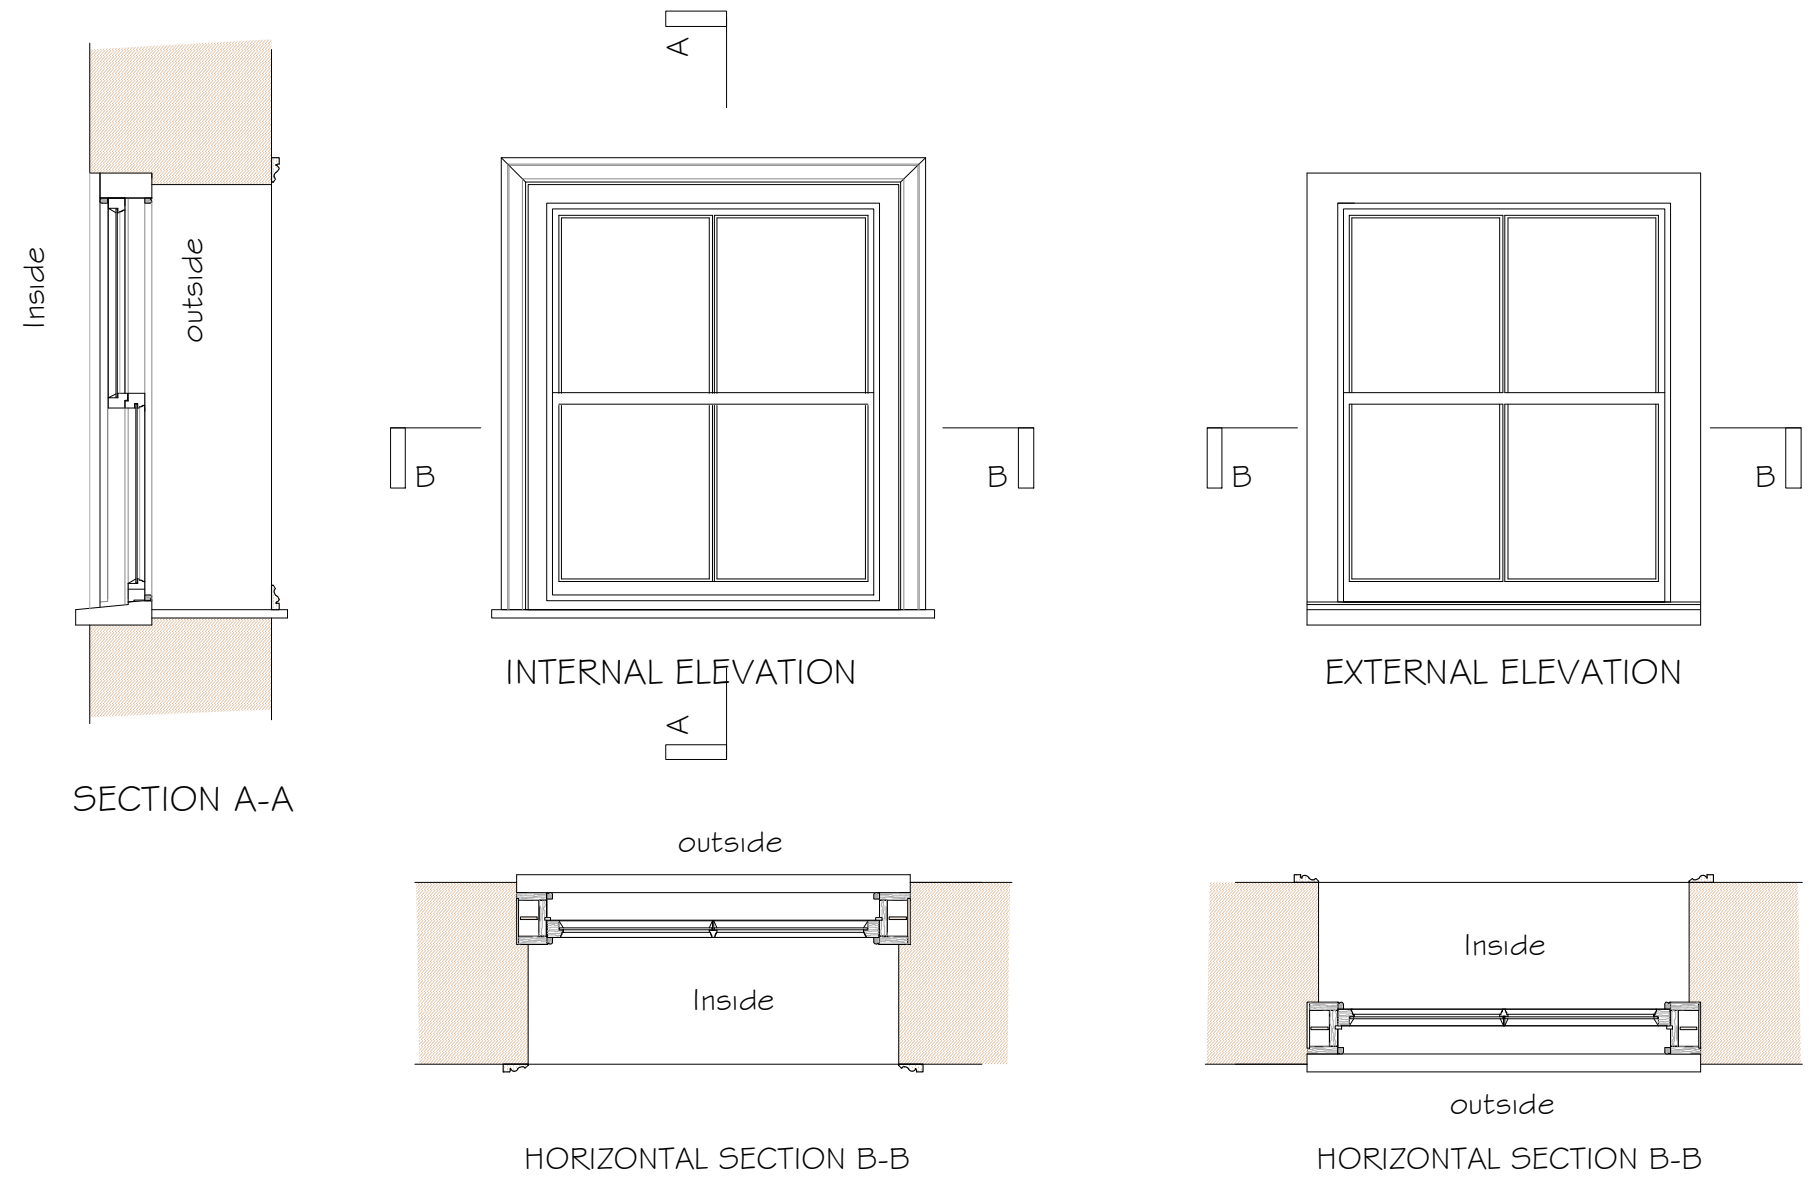
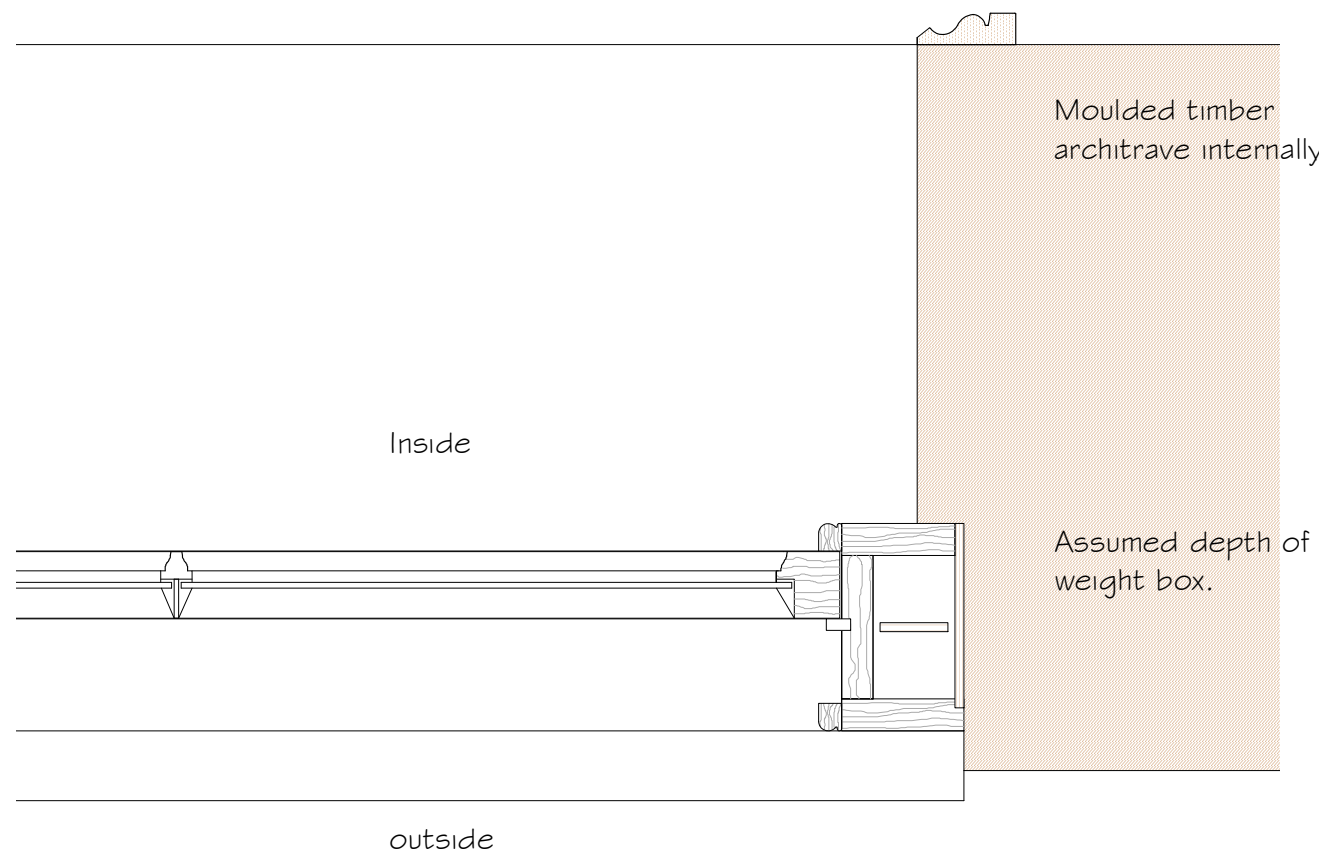
Drawing:
EXISTING
WINDOW SCHEDULE W3.

FIRST FLOOR SITTING ROOM . SIDE ELEVATION

The defects are obvious in this frame as the head of the frame can be seen to be cracked and the paint blistered. The joints have opened and the components of the frame visibly decayed.

TYPICAL DETAILS at JAMB & GLAZING BAR
Scale 1 : 5

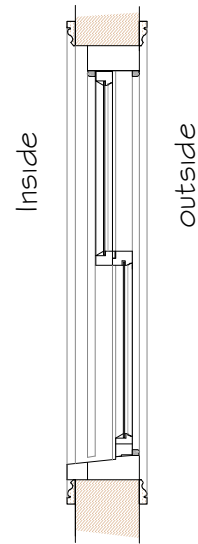
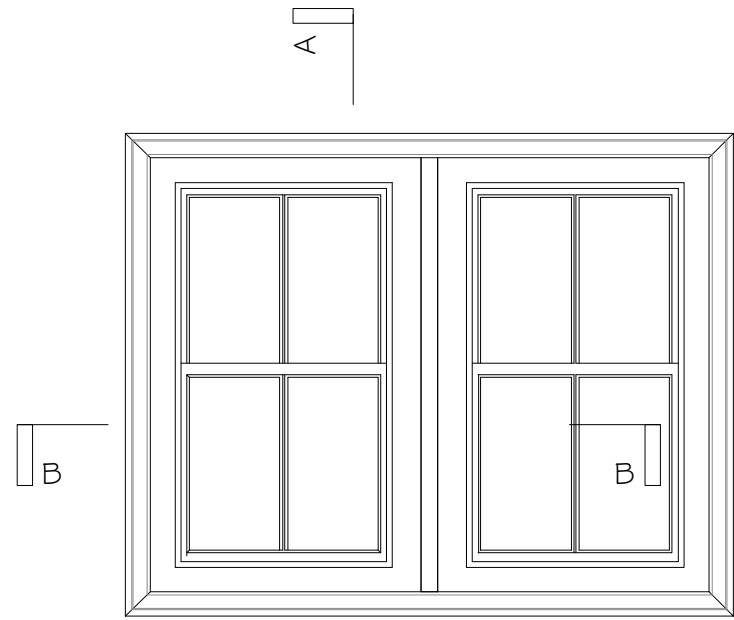
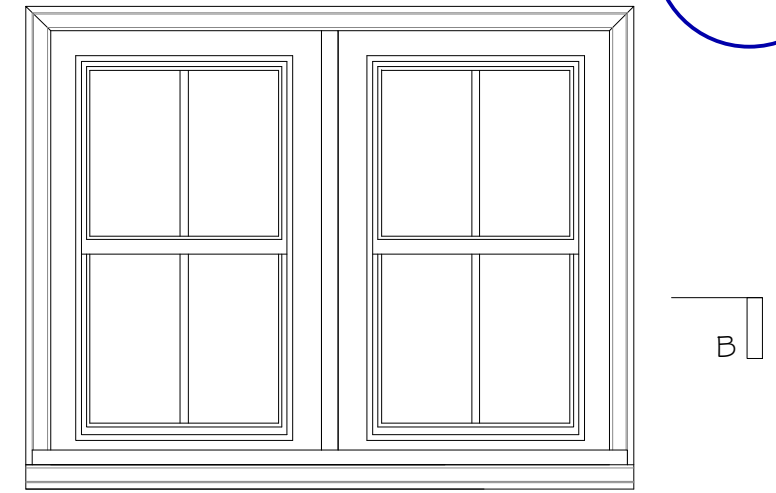
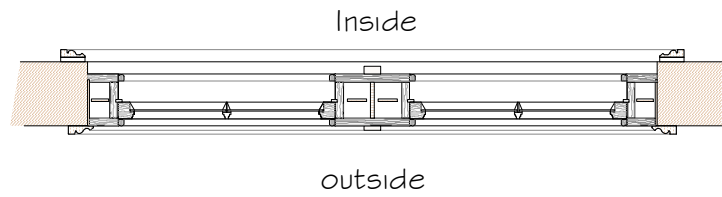
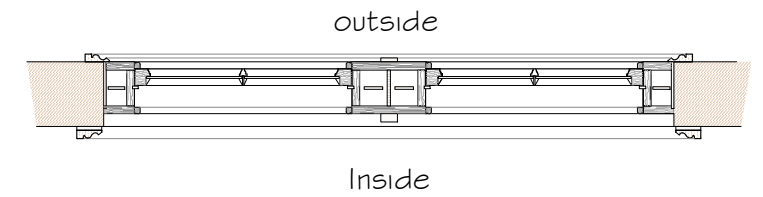
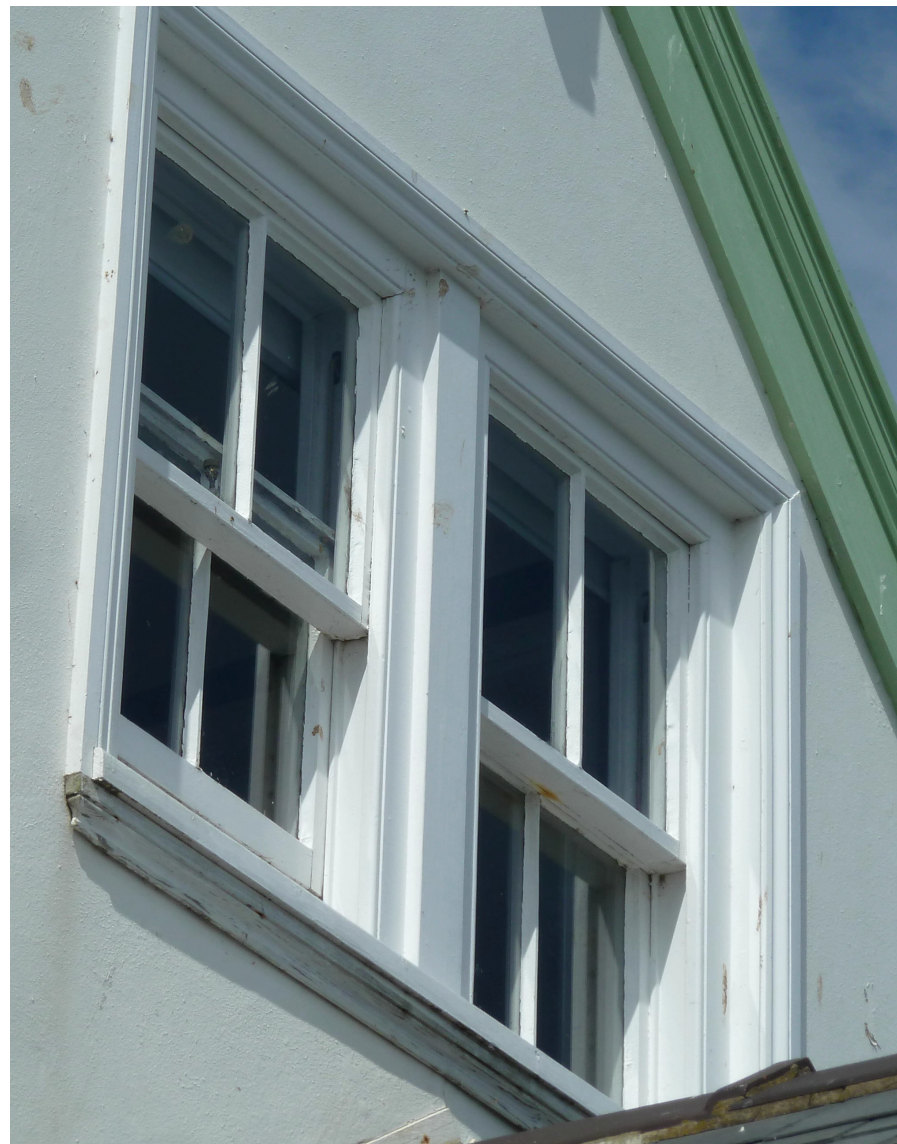
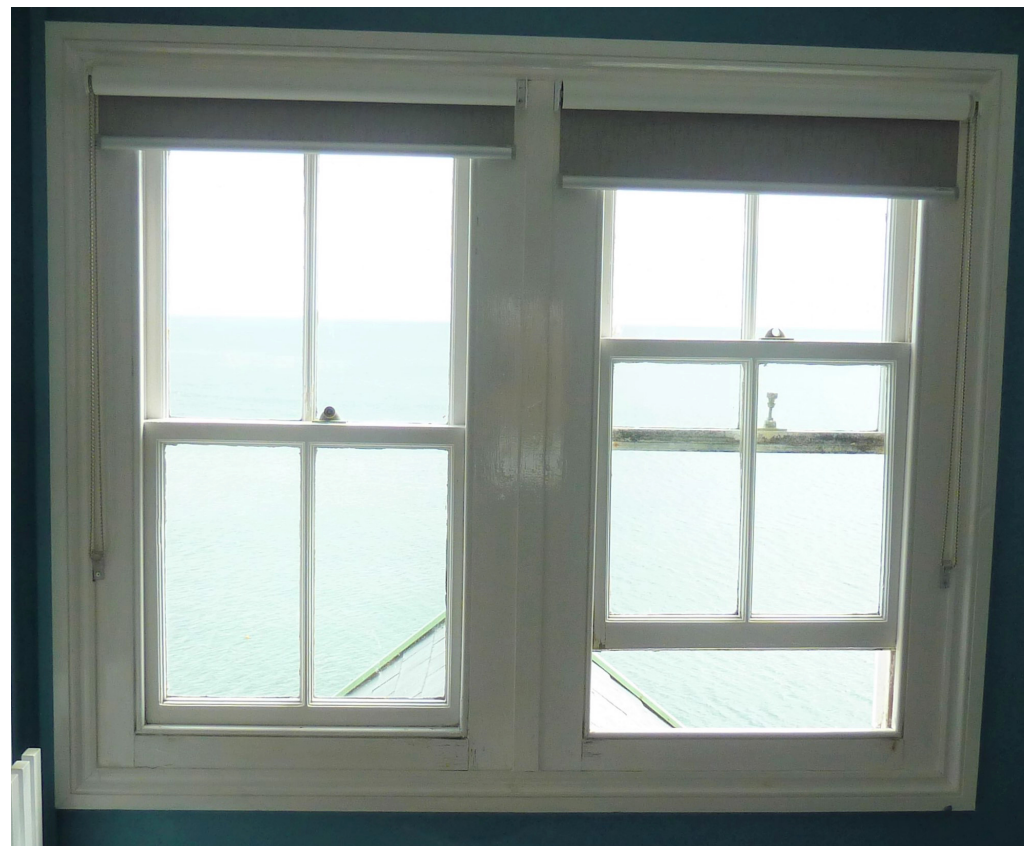
W4

NB. Details of frame components as for W3:
 See 1:5 sections drawing 423.07
 Design & manufacture date assumed to be the same.

Moulded timber
 architrave internally
 & externally.

SECOND FLOOR BEDROOM.
 REAR ELEVATION. EXTERNAL VIEW.

SECTION A-A

HORIZONTAL SECTION B-B

SECOND FLOOR
 BEDROOM.
 REAR ELEVATION.
 INTERNAL VIEW.

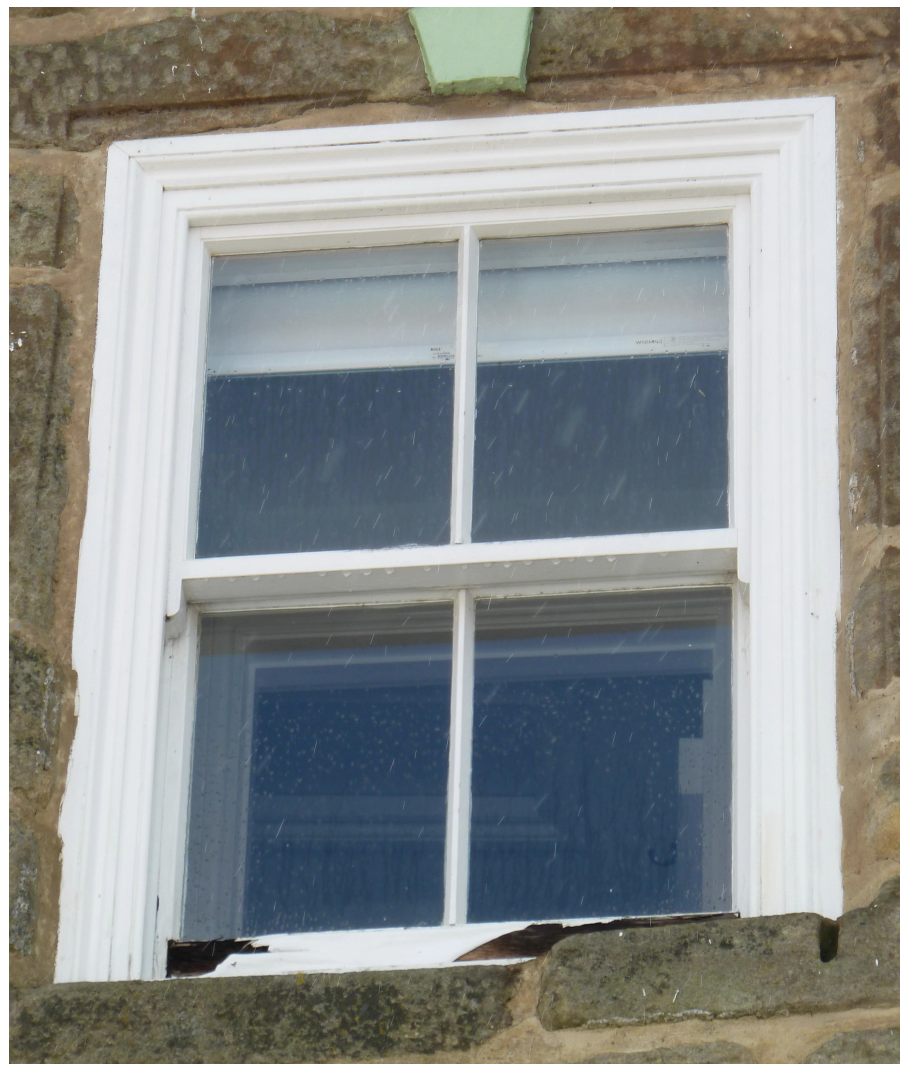
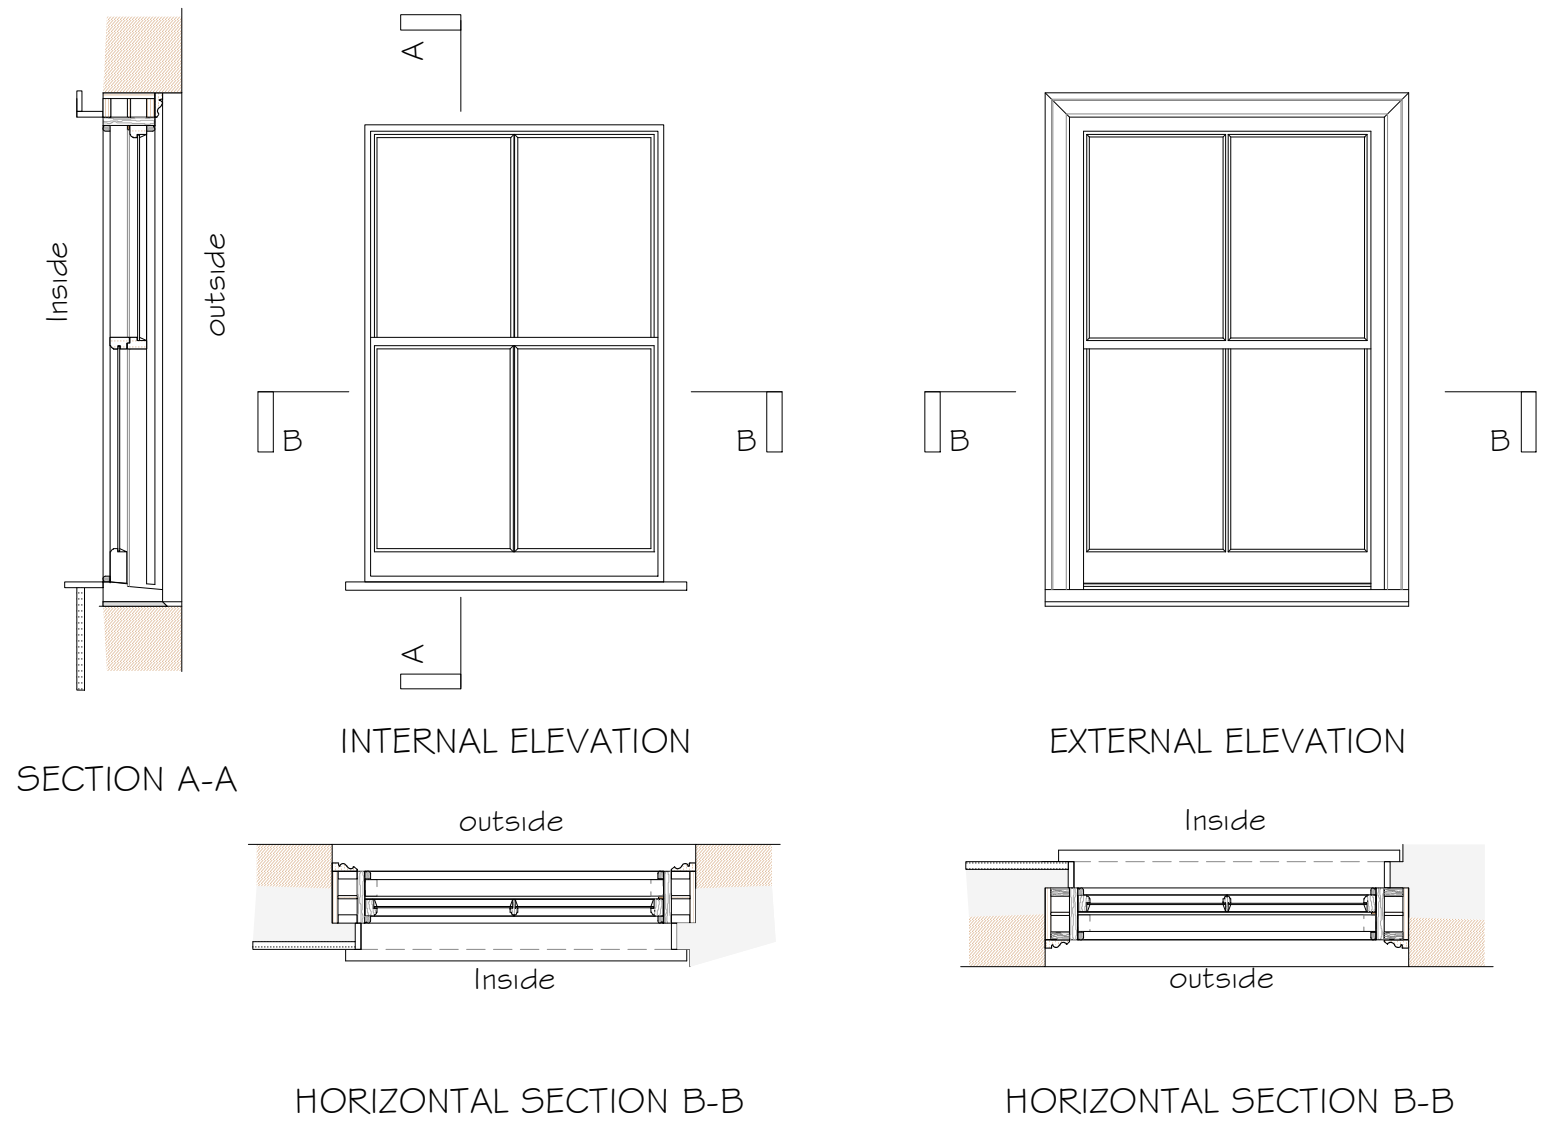
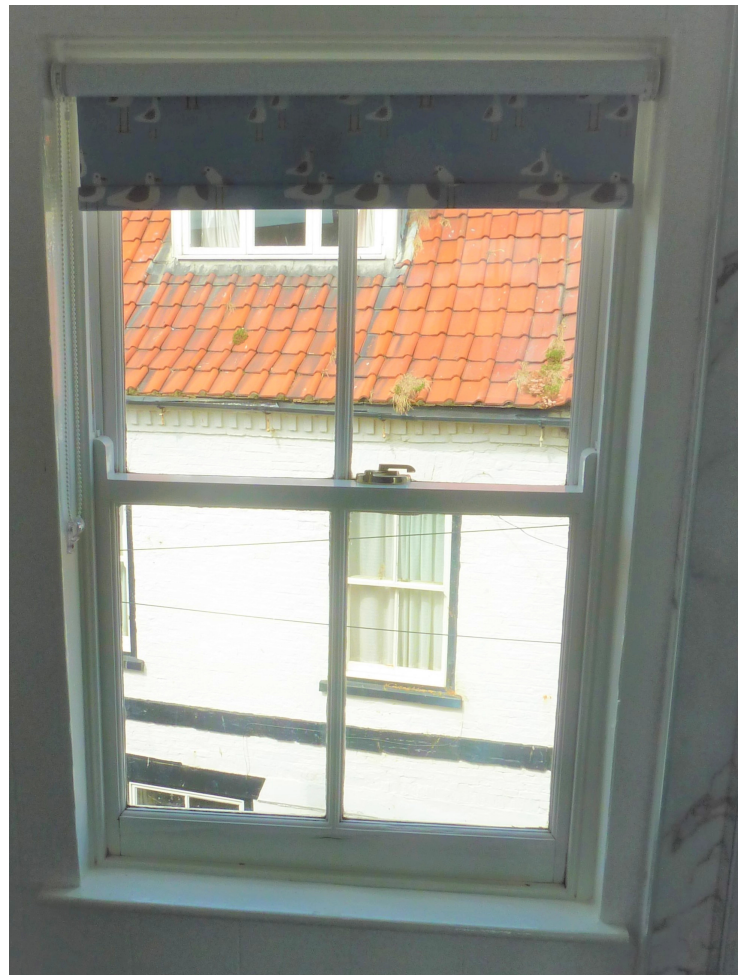
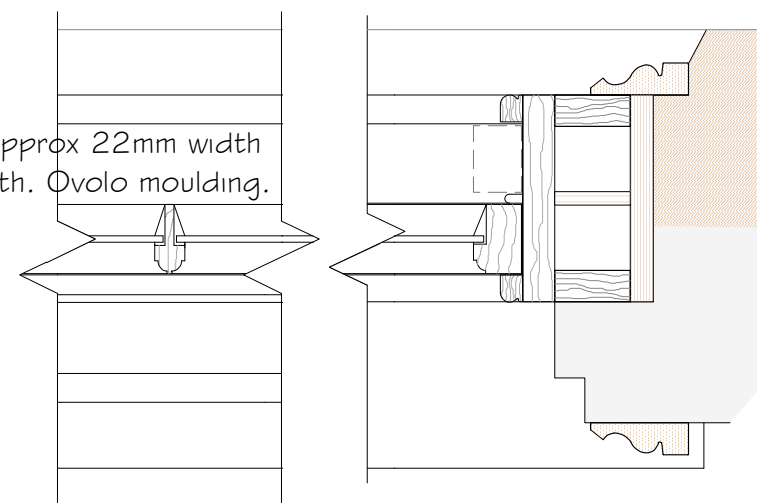
Drawing: EXISTING WINDOW SCHEDULE W5.

SECOND FLOOR SHOWER ROOM. FRONT ELEVATION: INTERNAL.

Heavily decayed sill and jambs of sash box.
Non-vernacular horns and composite section sashes.

CDM Advisory: *do not lift sash.*

Glazing bar approx 22mm width x 44mm depth. Ovolo moulding.

Moulded timber architrave internally.

Assumed depth of weight box.

Moulded timber architrave externally.

TYPICAL DETAILS at JAMB & GLAZING BAR
Scale 1 : 5

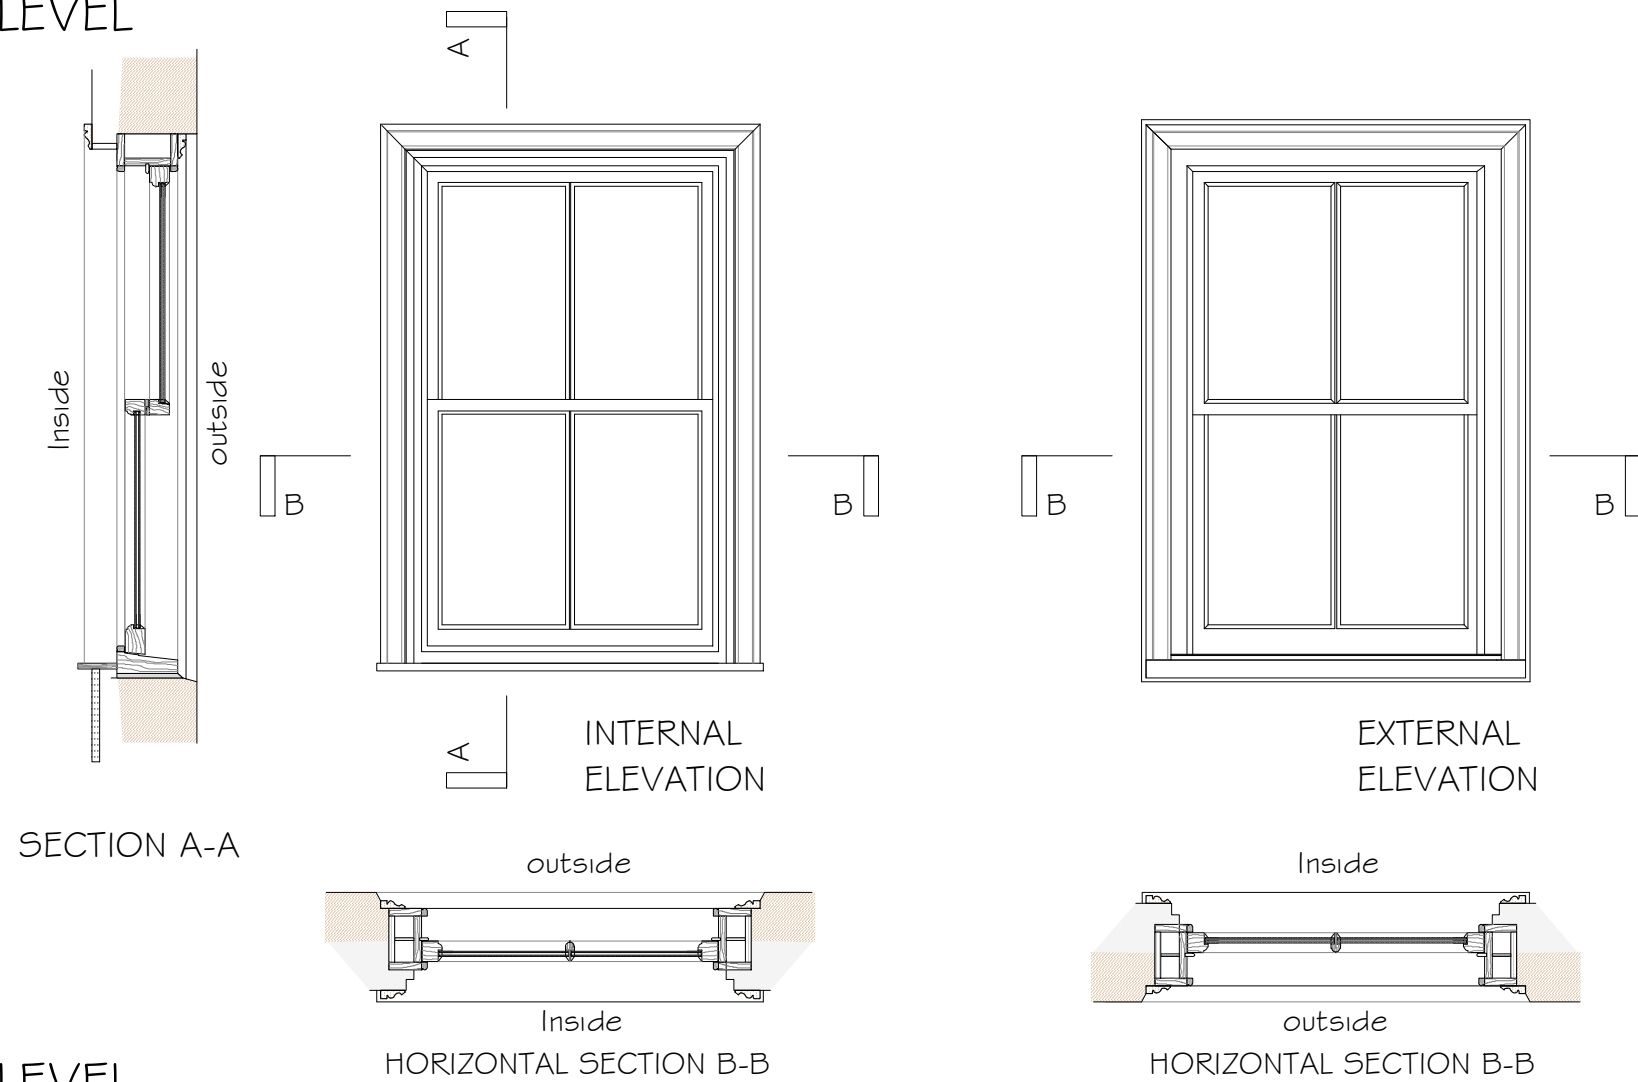
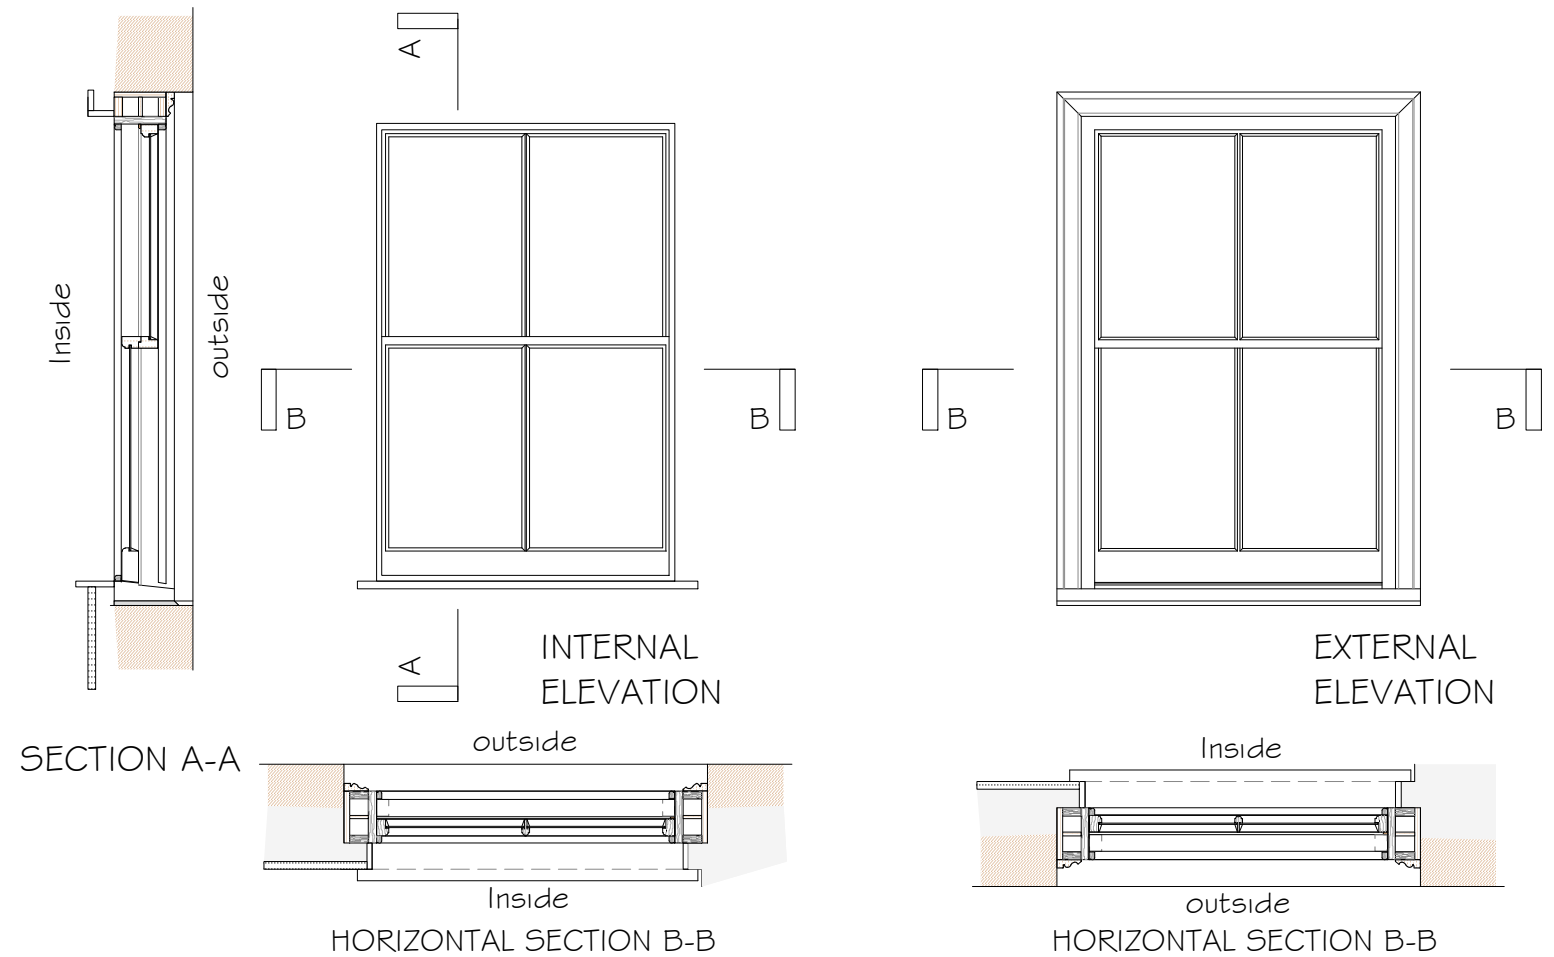
FIRST FLOOR LEVEL
BEDROOM

FIRST FLOOR LEVEL
BATHROOM

REFER TO PHOTOGRAPHS SUBMITTED FOR SPECIFIC DETAILS OF INSTALLATION.
