Proposed:
WINDOW REPLACEMENTS
at
YORK HOUSE
KING STREET
ROBIN HOODS BAY

REPLACEMENT WINDOWS
at
YORK HOUSE
KING STREET
ROBIN HOODS BAY

Drawing:
EXISTING
WINDOW SCHEDULE W1.

Drawing:
PROPOSED WINDOW
SCHEDULE W1 & W2

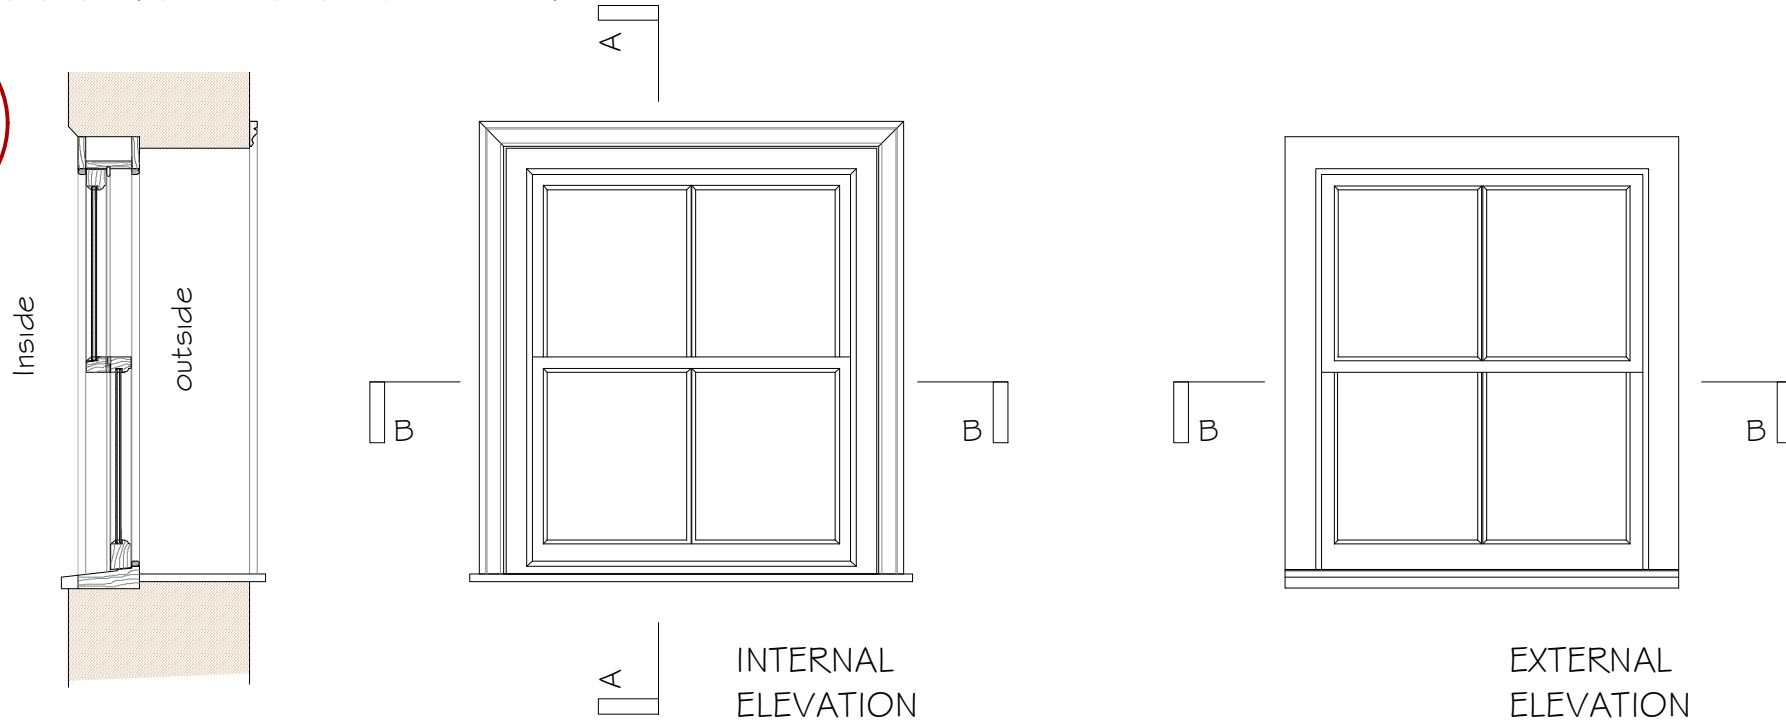
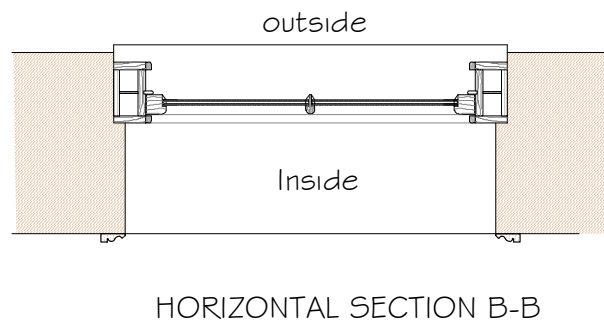
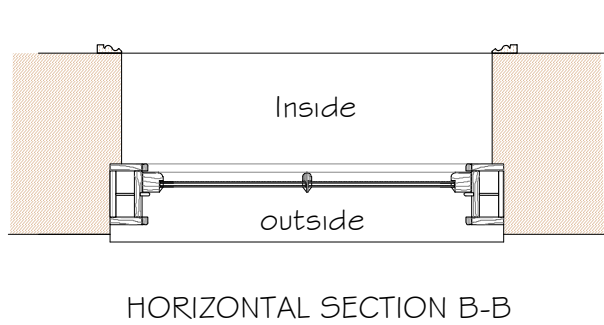
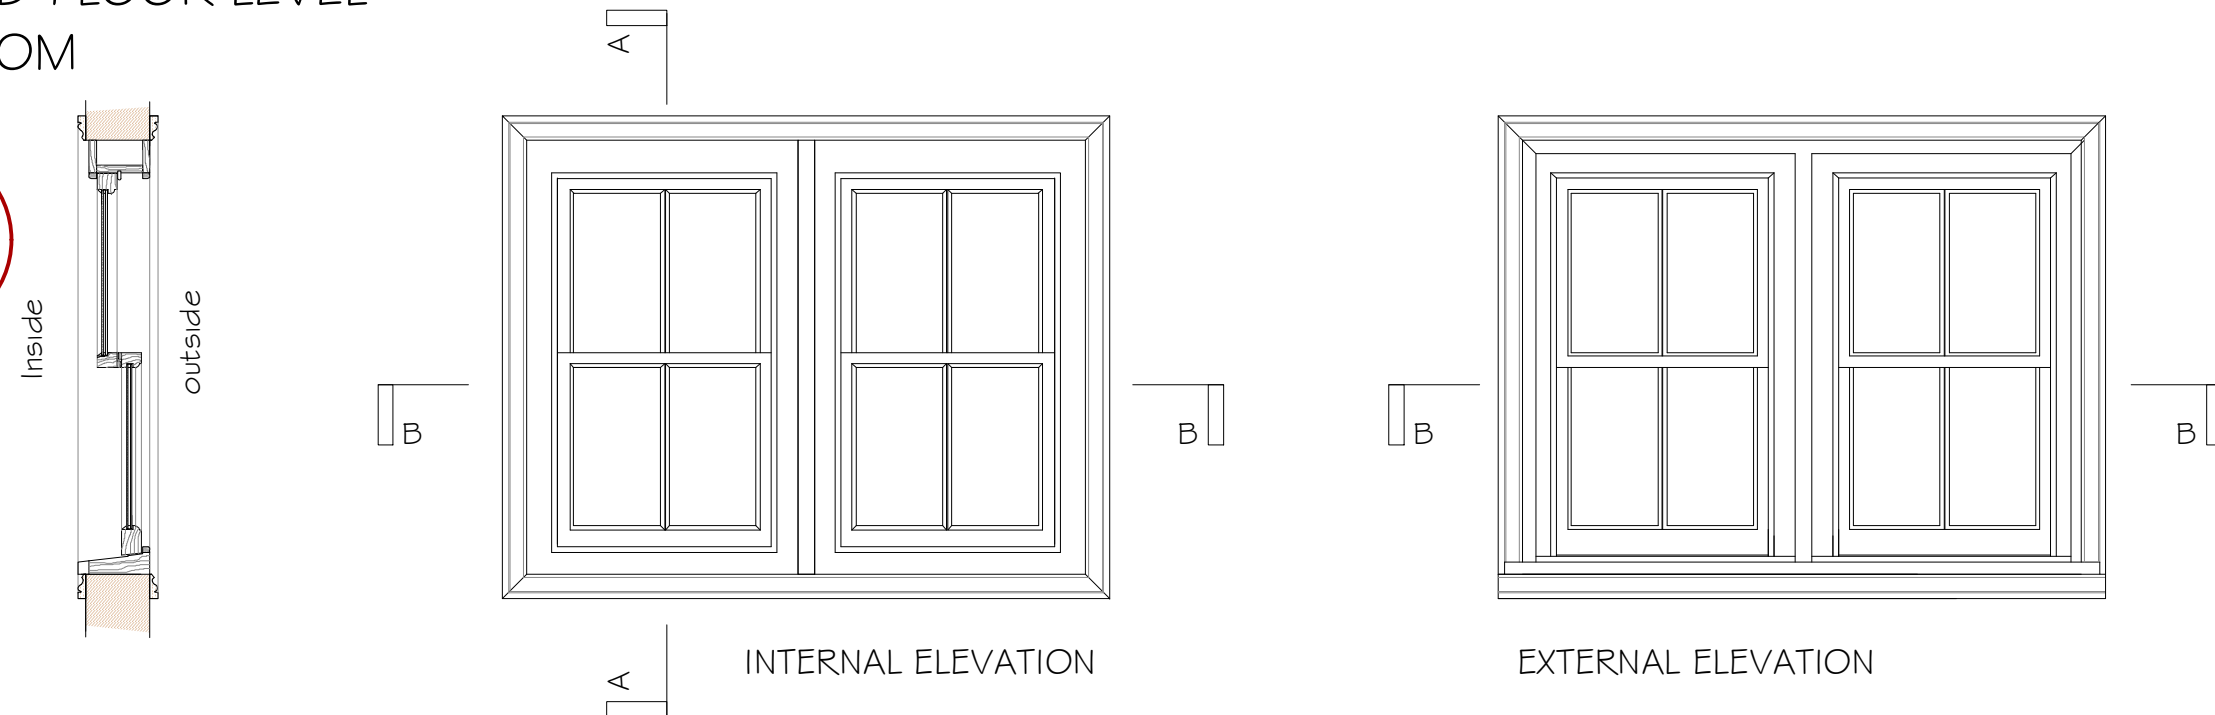
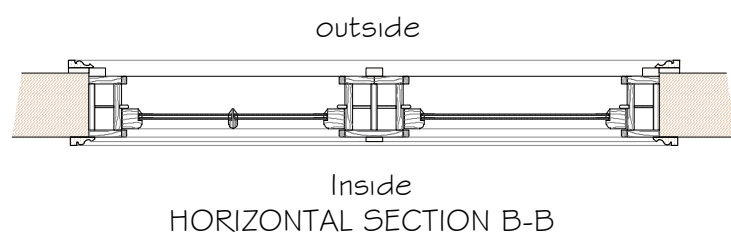
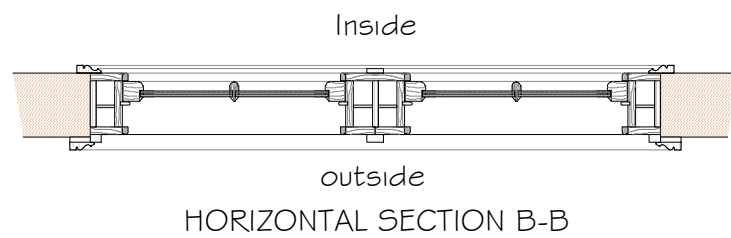
Drawing No. 423/21
Date: AUGUST 2023
Scale: 1/20 Print at A3

FIRST FLOOR LEVEL STUDY AREA

SECOND FLOOR LEVEL BEDROOM

REPLACEMENT WINDOW FRAMES TO BE TIMBER FOR WHITE PAINT FINISH.

INSTALLATION DETAILS TO MATCH EXISTING FOR ALL LOCATIONS.

MODIFY INSTALLATION AS NECESSARY FOR DEEPER BOX FRAME.

FRAME SECTIONS AS J.HALLAM JOINERY 'EGTON' HERITAGE RANGE.

WHERE REQUIRED EXTEND SILL TO PROJECT BEYOND STRUCTURE USING REBATED AND GLUED SECTION.

REFER TO PHOTOGRAPHS SUBMITTED FOR SPECIFIC DETAILS OF INSTALLATION.

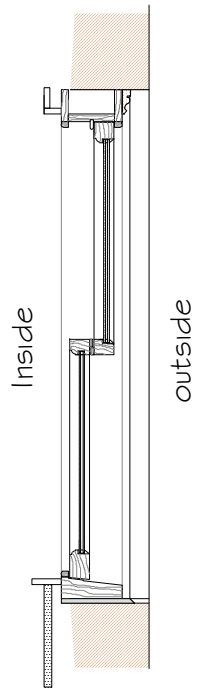
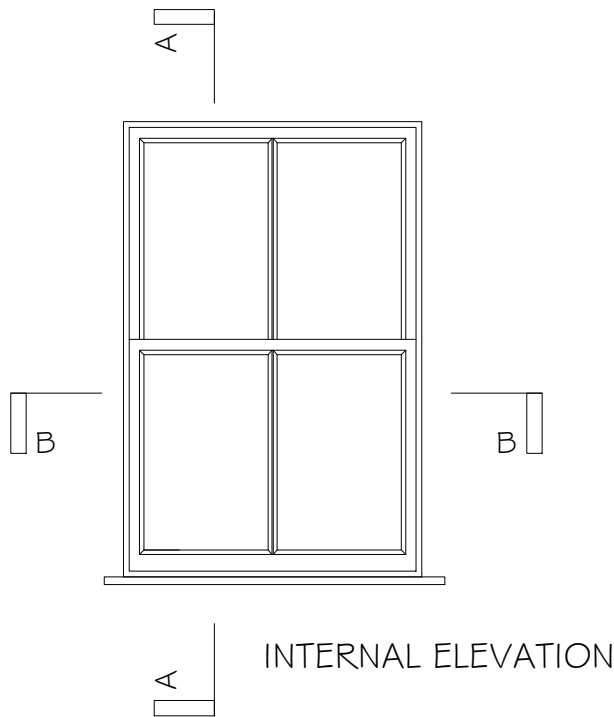
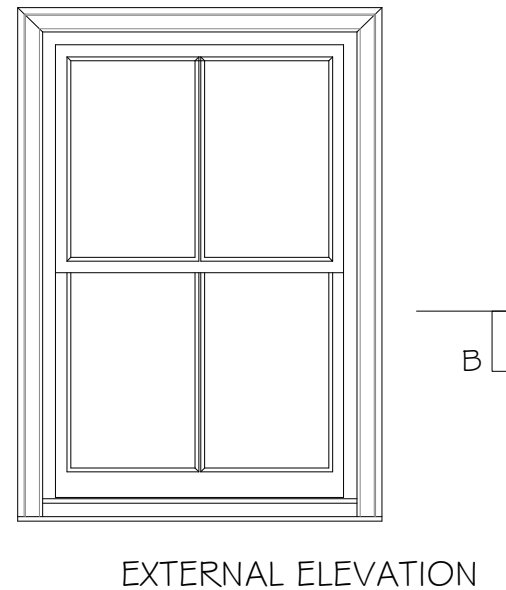
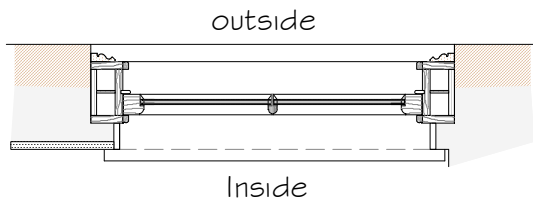
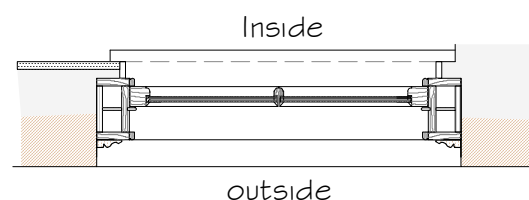
Drawing No. 423/22
Date: AUGUST 2023
Scale: 1/20 Print at A3

SECOND FLOOR LEVEL SHOWER ROOM

REPLACEMENT WINDOW FRAMES TO BE TIMBER FOR WHITE PAINT FINISH.

INSTALLATION DETAILS TO MATCH EXISTING FOR ALL LOCATIONS.

MODIFY INSTALLATION AS NECESSARY FOR DEEPER BOX FRAME.

FRAME SECTIONS AS J.HALLAM JOINERY 'EGTON' HERITAGE RANGE.

WHERE REQUIRED EXTEND SILL TO PROJECT BEYOND STRUCTURE USING REBATED AND GLUED SECTION.

REFER TO PHOTOGRAPHS SUBMITTED FOR SPECIFIC DETAILS OF INSTALLATION.

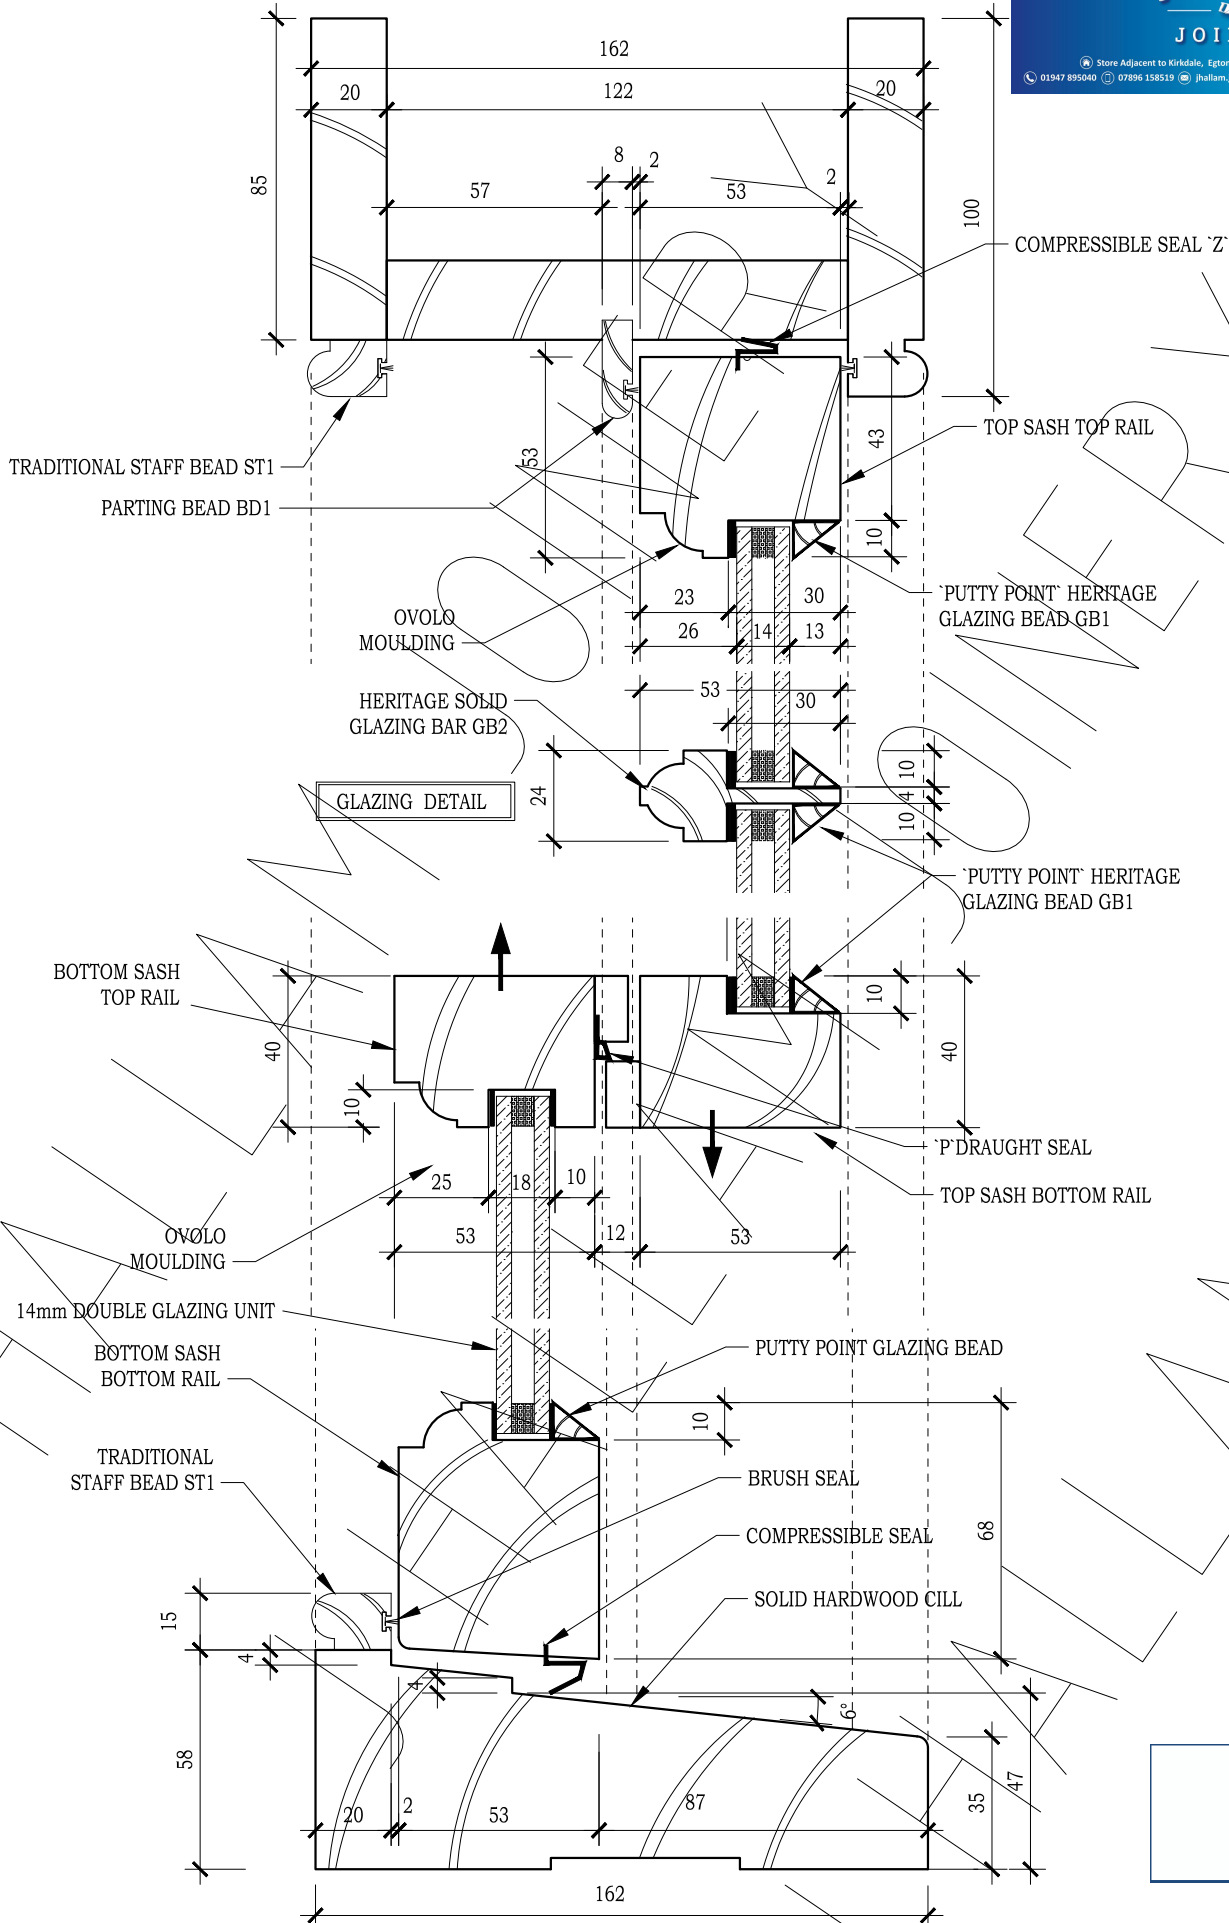
JHJ-ELL-03 rev 0

**JOINERY CONSTRUCTION DETAILS FOR 'BOX' SASH WINDOW -
'EGTON' HERITAGE RANGE**

VERTICAL SECTION A-A SCALE 1:2
