PROPOSED DEMOLITION OF EXISTING
GREENHOUSE AND ADJACENT OUTBUILDING
AND FORMATION OF NEW WALLED GARDEN
WITH GREENHOUSE, TERRACE AND RAISED
PLANTERS

DESIGN, ACCESS AND HERITAGE STATEMENT

Thorpe Hall

Stone + Associates

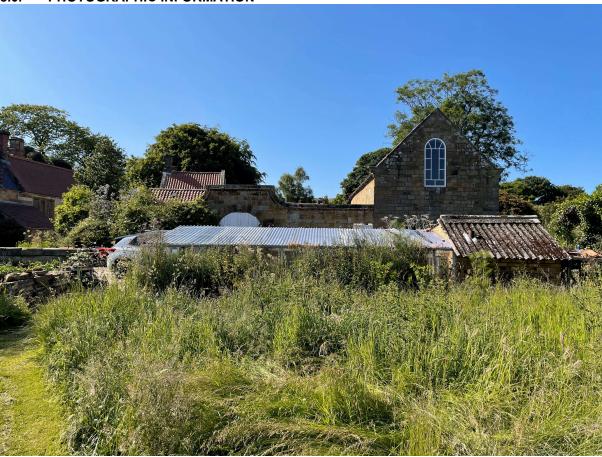
Figure 7 - Southern Elevation

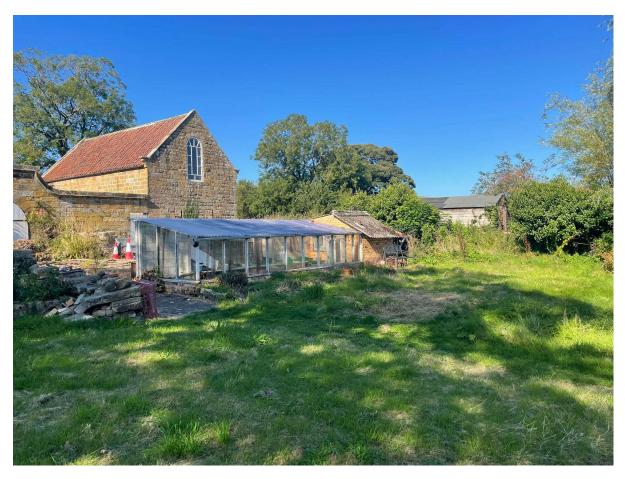
Figure 8 - Greenhouse Structure and Adjacent Outbuilding

- 3.1 The greenhouse is of single storey construction and is constructed from modern concrete blockwork to the north under a polycarbonate roof.
- 3.2 To the southeast and south west the greenhouse walls are constructed of blockwork to cill height with painted timber and glass frames installed over.
- 3.3 To the northeast, adjacent to the greenhouse, is a single storey brick-built outhouse, again of modern construction under a corrugated roof.
- 3.4 The northeast boundary is of mature hedging.
- 3.5 Neither the greenhouse nor the adjacent outbuilding are not of any significant architectural interest and detract from the listed host dwelling. The replacement of these buildings, and the surround development will enhance this area.

- 5.1 This application seeks to remove the existing greenhouse and outbuilding structures and to create a new walled garden / terrace / planting area around a newly constructed traditionally designed greenhouse.

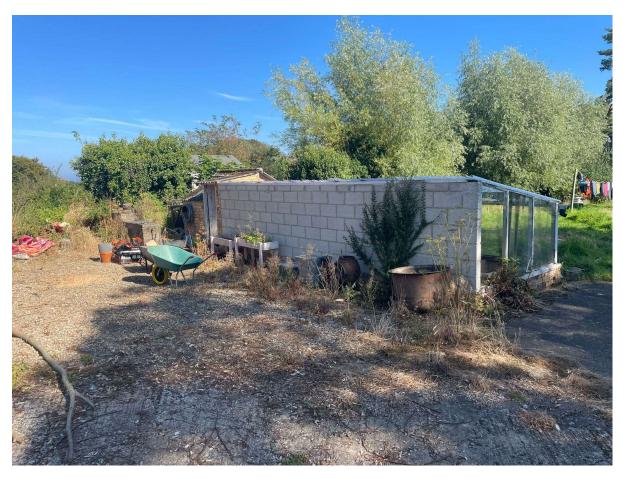
Figure 9 - North Elevation - Greenhouse

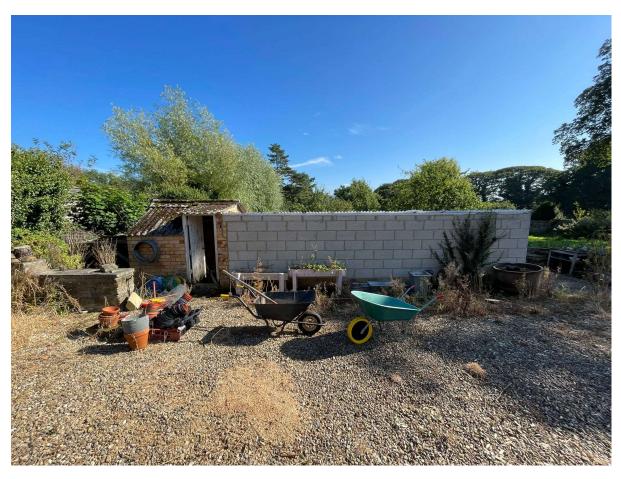
Figure 10 - North Elevation - Greenhouse and Outbuilding

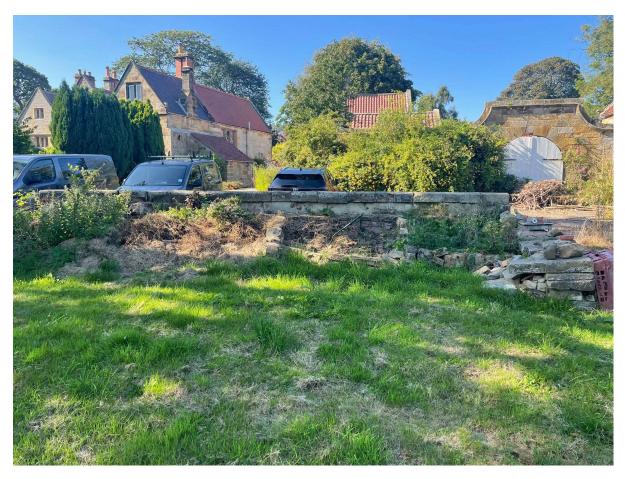
Figure 11 - Stone Wall - To be retained

- 5.4 It is proposed that the existing stone wall, which is currently in situ, is extended in matching stone and returned towards the garden. This will allow for a new composting area to be created.
