## DESIGN AND ACCESS STATEMENT

**PROJECT:** Outbuildings at Partridge Hill,  
Ugglebarnby Lane,  
WHITBY,  
YO22 5HT

**Bat, Breeding Bird and Barn Owl Scoping Survey**  
**Partridge Hill Farm**

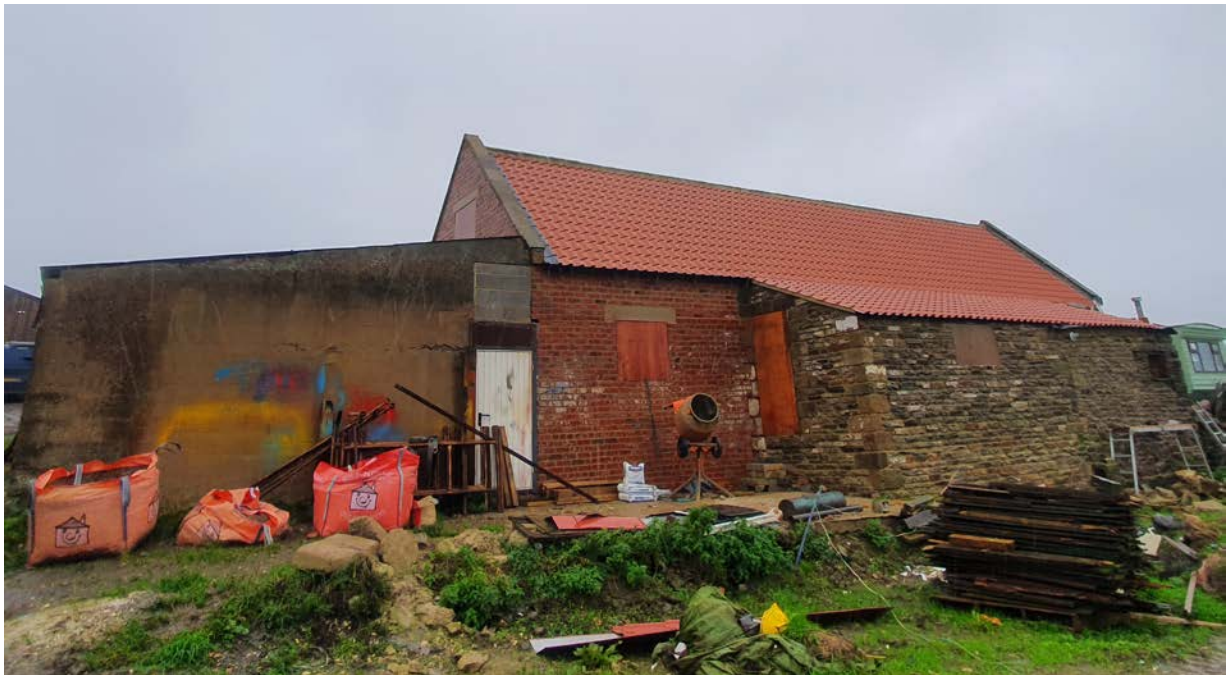
View of the east elevation.

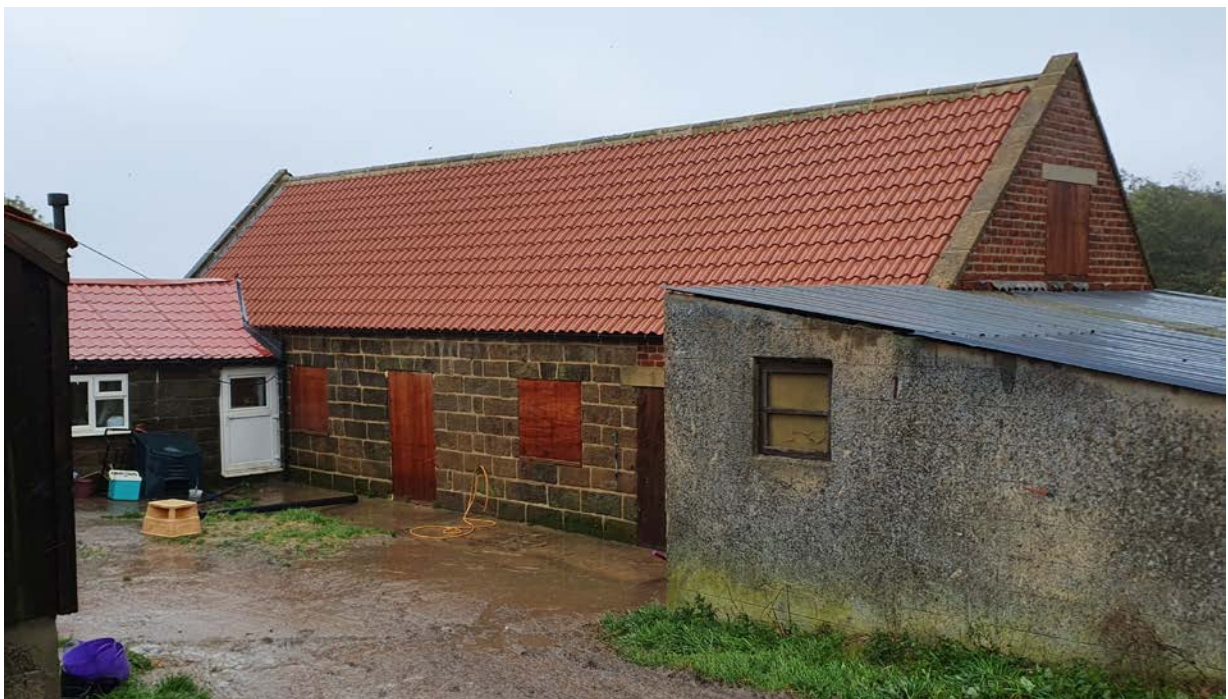
View of the west elevation facing the farm yard with the south brick gable visible over the attached farm shed.

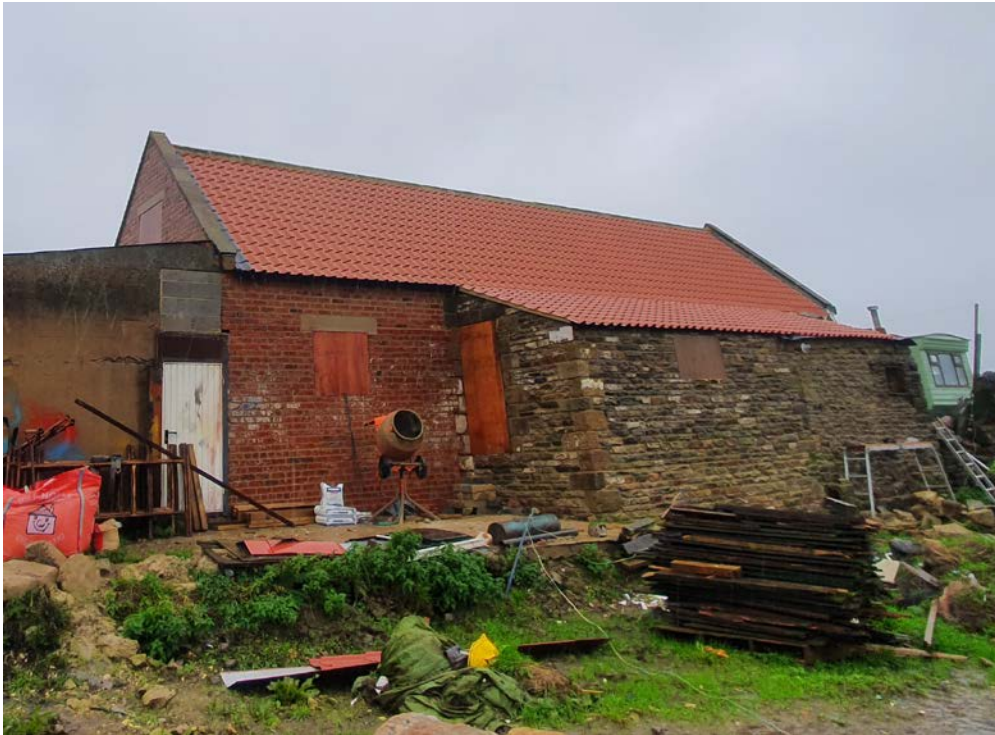
General view of the east elevation

Inspection undertaken both internally and externally. It is positive to see that the walls have been subject to general remedial works particularly where a few of the upper courses have had to be reconstructed alongside the roof reconstruction after collapse. Both the natural sandstone elements and the brickwork have been fully re-pointed in lime mortar and their overall condition is good.

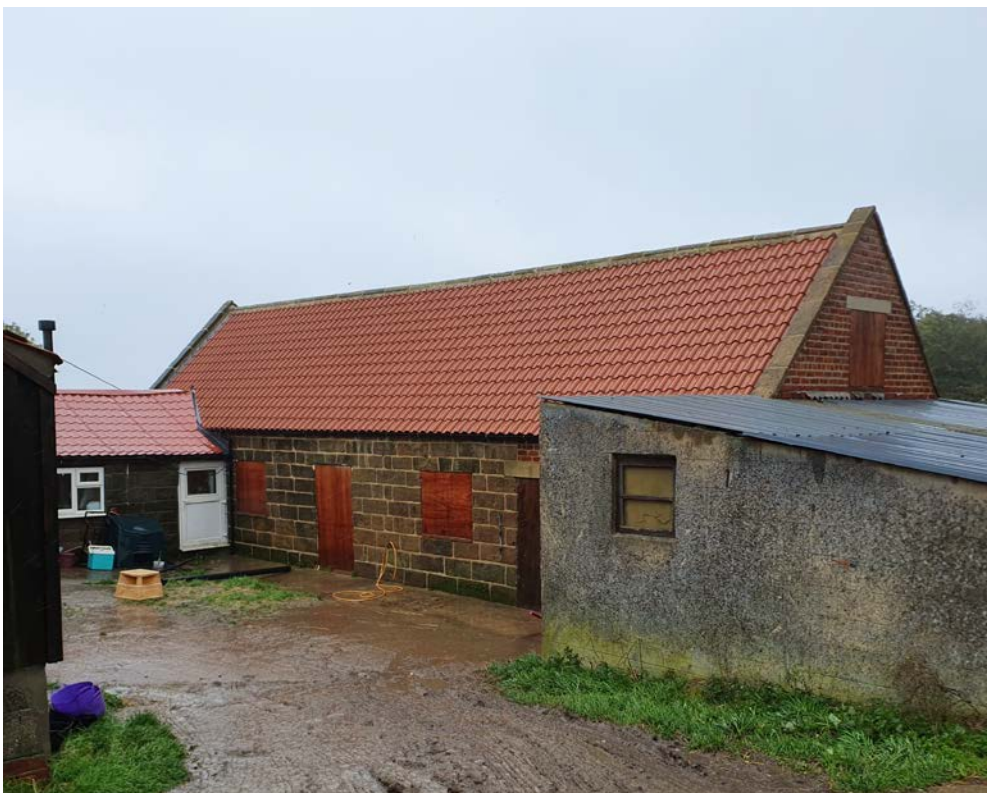
General view of the west and south elevations

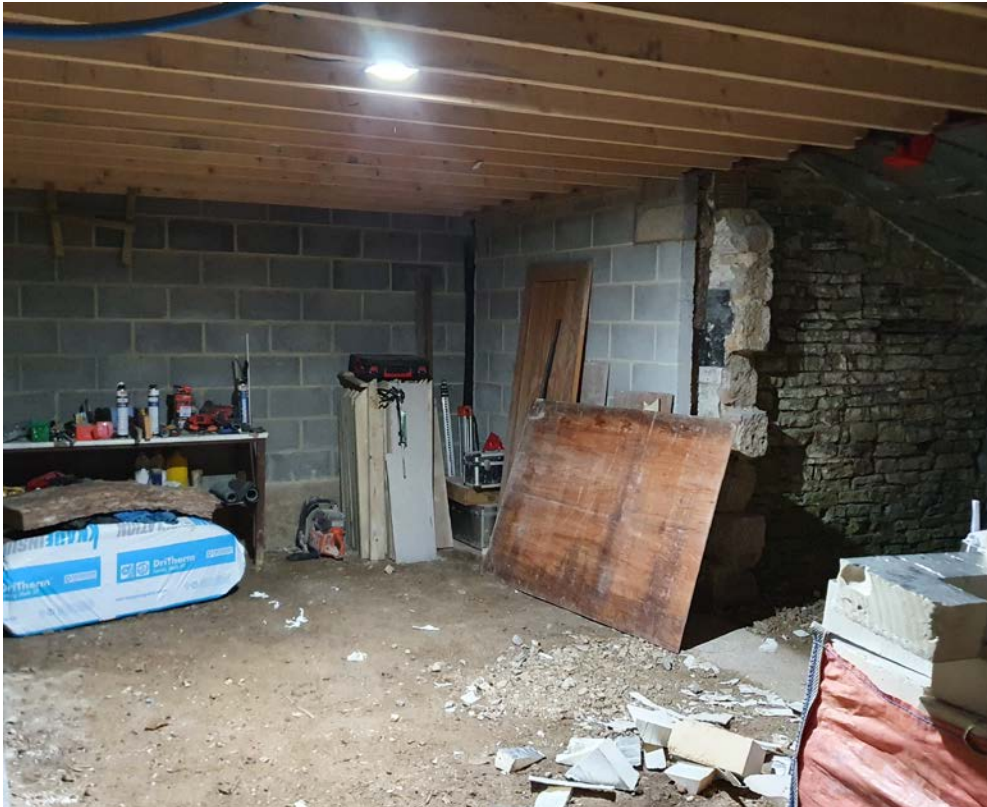
Internal view of the ground floor main room.

Internally strengthening works to the walls has included elements of blockwork linings together with reinstating the intermediate timber floor between ground and first floor section. Intermediate floor comprises a series of softwood joists with chipboard over. This has helped to restrain and tie the outer walls together. It was positive to see no signs of any movement, cracking or distortion from subsidence or settlement.

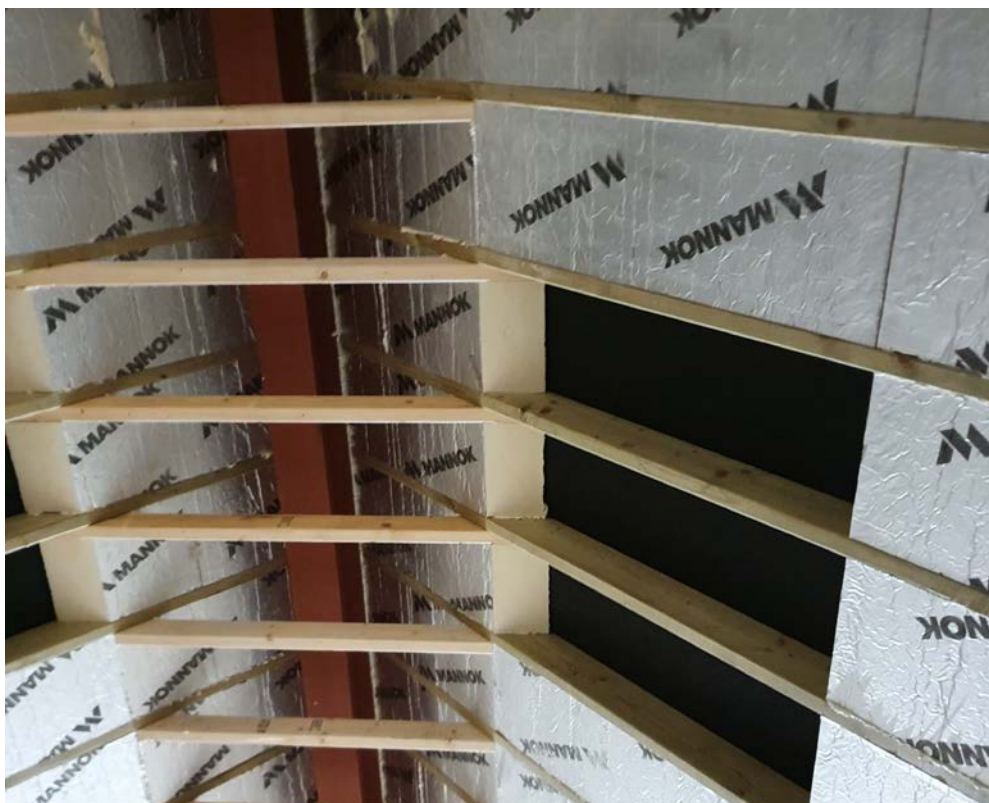
General view of the roof structure with steel ridge beam and timber rafters.

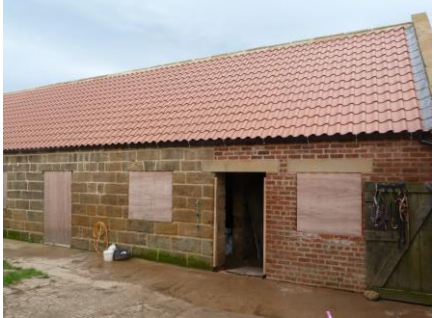
<p>Photo 1: Building - southwest aspect, main doorway is sealed overnight.</p> </div> <div style="width: 50%; text-align: center;">

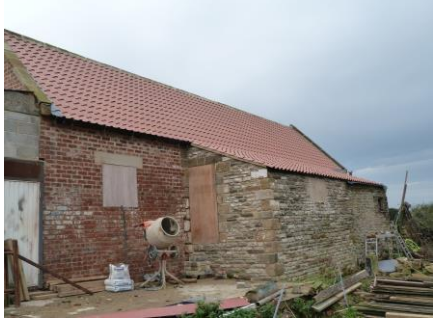
<p>Photo 2: Building - northeast aspect.</p> </div> <div style="width: 50%; text-align: center;">

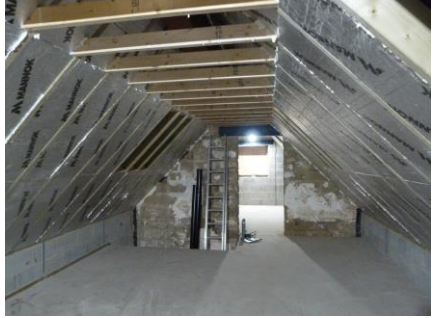
<p>Photo 3: First Floor.</p> </div> <div style="width: 50%; text-align: center;">

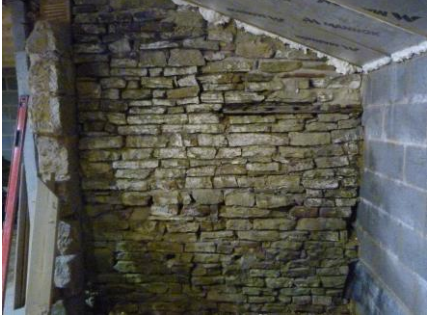
<p>Photo 4: Retained internal wall.</p> </div> <div style="width: 50%; text-align: center;">

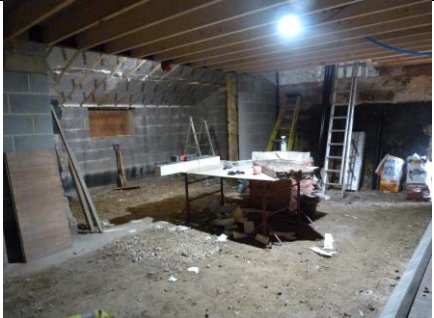
<p>Photo 5: Ground Floor.</p> </div> <div style="width: 50%; text-align: center;">

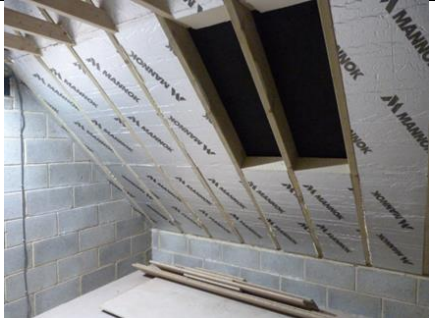
<p>Photo 7: Insulated and lined internal roof.</p> </div> <div style="width: 50%; text-align: center;">

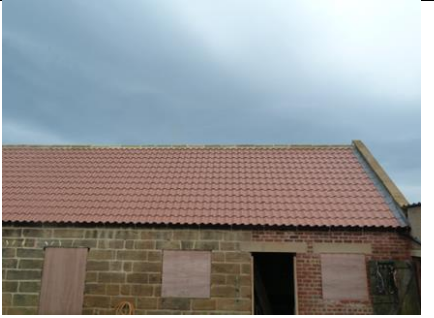
<p>Photo 8: View of well sealed rooftiles.</p> </div> </div>	<p>-NA.</p>

Visual inspection of this site found negligible potential bat roosting habitat due to the construction of the building. The property is well sealed and has no potential access through the roof or masonry. No evidence of bats was identified onsite. No further survey effort is recommended for this site as a result, though it is encouraged that the standard good working practices are followed, as outlined in Appendix 2, due to its proximity to other buildings within the farm complex which may provide habitat for bats.
