Design and Access Statement

Replacement of existing dwelling with new two-storey house
And detached garage
At 45 Eskdaleside, Sleights, Whitby, YO22 5EP

Bat, Breeding Bird and Barn Owl Scoping Survey
45 Eskdaleside, Sleights

January 2024

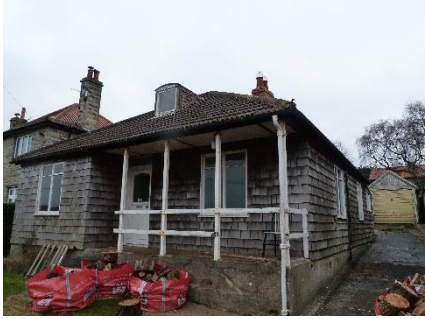
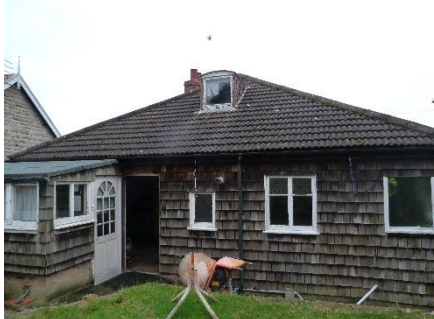
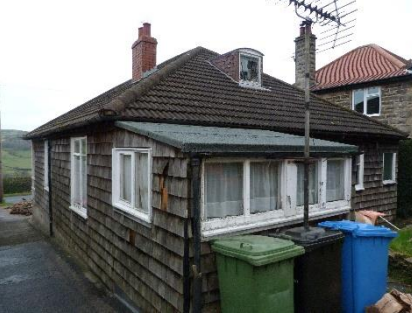
Building ref	Description & photos				PBRH features
Building 1 House : Low risk of supporting roosting bats	Wooden clad, tiled roof building with a bitumastic lining which has occasional tears in it. The wooden cladding is closely fitting with only an a few crevices and lifted tiles revealing the asbestos beneath it. The flashing surrounding the dormer windows and chimney has lifted in some areas. The fascia is generally well sealed with only a few crevices identified. The roof tiles are well fitting, the ridge tiles are also, with only a few lifted ridge tiles identified. No evidence of roosting bats (droppings/feeding remains) identified. No evidence of nesting birds.				Crevices in cladding.

<p>Photo 2: Northern aspect.</p>

<p>Photo 3: Southern aspect.</p>

<p>Photo 4: Southwestern aspect.</p>

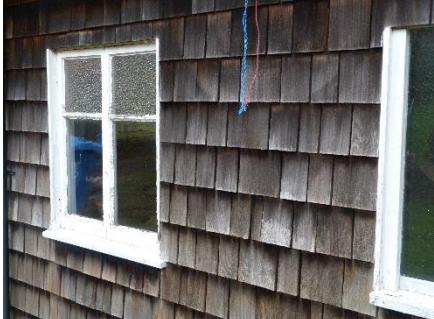
<p>Photo 5: Cladding.</p>	Lifted flashing.

The house was determined to have a low risk of supporting roosting bats. There were some areas of low potential roosting habitat including: lifted ridge tiling, gaps around the flashing and crevices in the cladding. The loft void was inspected and found to be cobwebbed with no evidence of bats identified (dropping or feeding remains), this indicates that it is unlikely any void dwelling bats have been using this site. It is unlikely bats are utilising this site due to its cold conditions, however there is a residual risk of single bats utilising the crevice habitat as a day roost.

9.2.1 Replacement crevice roosting habitat will be provided on site through the incorporation of integral bat bricks into the new build and/or the installation of

professional long-lasting crevice bat boxes on site, in suitable locations to be agreed by the ecologist. It is recommended that a total of two habitat features are provided. Integral bat bricks can include ibstock bat roost entrance brick (leading into a cavity wall) or enclosed bat box 'B'; or Schwegler Type 1FR bat tube. External bat boxes should be Schwegler Type 1FF wall bat roosts which can be affixed to external walls and/or Type 2F general purpose bat boxes affixed to retained trees on site.

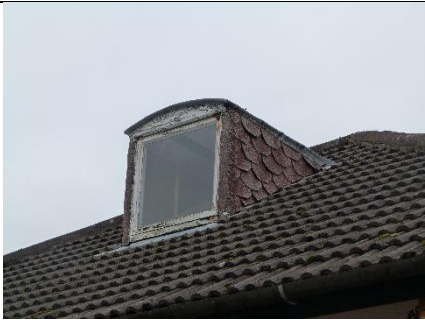
<p>Photo 6: Dormer window with lifted flashing.</p>

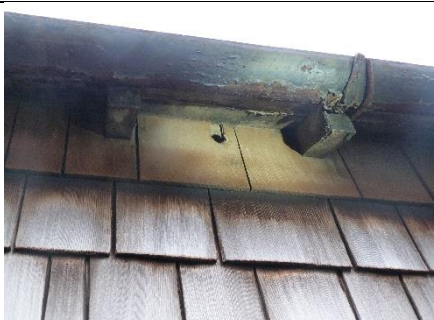
<p>Photo 7: Gap in cladding.</p>

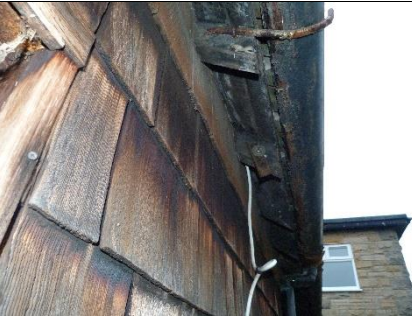
<p>Photo 8: Well sealed fascia.</p>

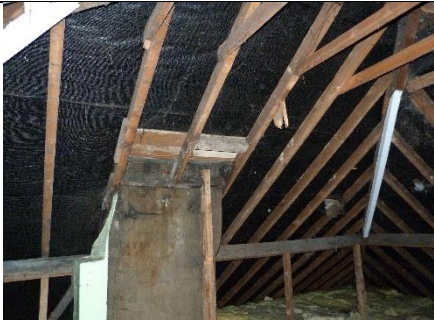
<p>Photo 9: Void structure.</p>	Lifted ridge tile.

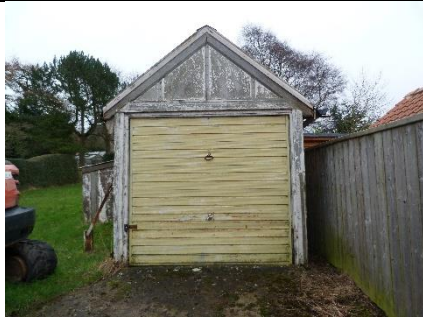
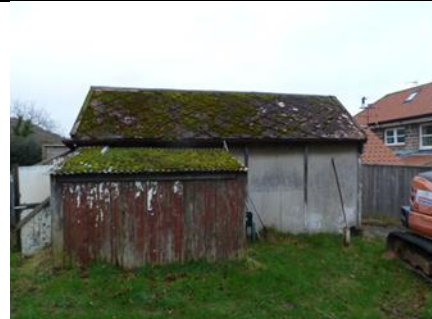
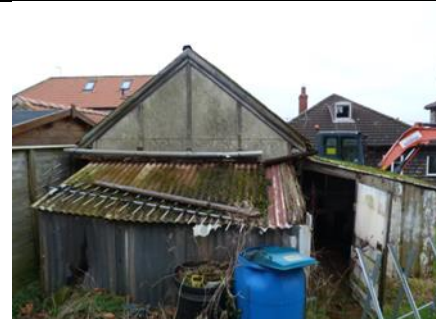
**Building 2
garage :
Negligible
risk of
supporting
roosting
bats**

Detached garage constructed using asbestos and wood soffits with a tiles roof. The building is damp, with the majority of the roof covered in moss. There are some crevices within the building, including an occasional lifted area of flashing and some holes surrounding the fascia due to the wood rotting. No evidence of bats was identified. Some evidence of breeding birds was identified.

Photo 10: Northern aspect.

Photo 11: Eastern aspect.

Photo 12: Southern aspect.

The detached garage was determined to have a negligible risk of supporting roosting bats due to its damp conditions and construction. The garage is fairly well sealed with only a few potential crevices within the eaves due to damage to the wood and a moss covered roof. These crevices were however very damp and therefore sub-optimal for roosting bats. There was some evidence of nesting birds within the adjoining store.

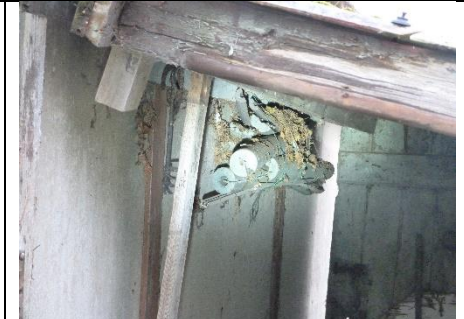
Photo 13: Birds nest.

Evidence of bird nesting was found on site within building two, the detached garage. Therefore, bird boxes will be installed to account for the loss of habitat.

Bird nesting habitat will be lost due to works to building two, therefore a bird nest box will be installed on site.

9.2.5 One bird nest box should be installed on site. This should ideally be integral boxes within the new buildings. Examples include: Schwegler sparrow terrace 1SP or brick sparrow box; Vivara Pro Seville WoodStone Nest Boxes; Swift boxes, e.g. ibstock swift box, Schwegler No. 16 or 1MF (bat and swift), which can be installed under the shelter of overhanging eaves; and 2H Schwegler Robin Box.
