# Design and access statement for demolition of existing dwelling and proposed replacement dwelling

Two Gates, Prospect Field  
Robin Hoods Bay, YO22 5RH

**Bat and Breeding Bird Survey**  
**Two Gates, Robin Hood's Bay**

November 2023

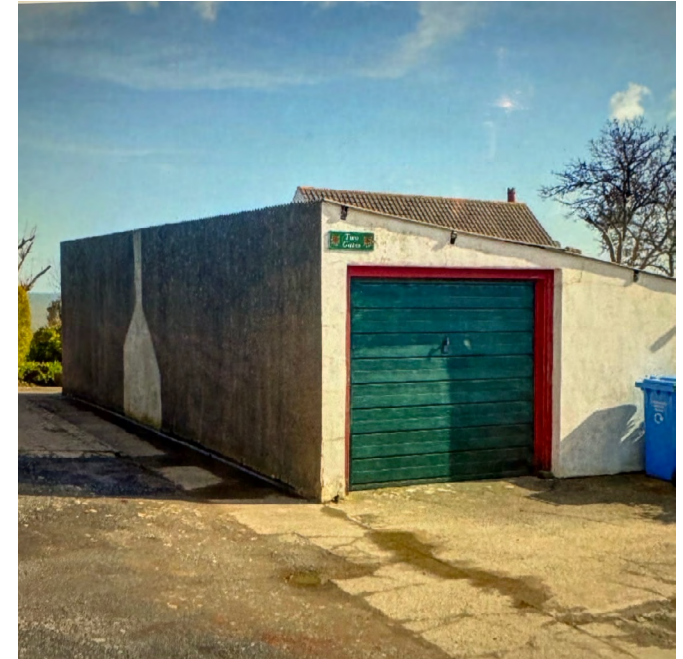
**Fig 3.**  
Track frontage from the front, showing the old garage very close to track and a lack of parking space

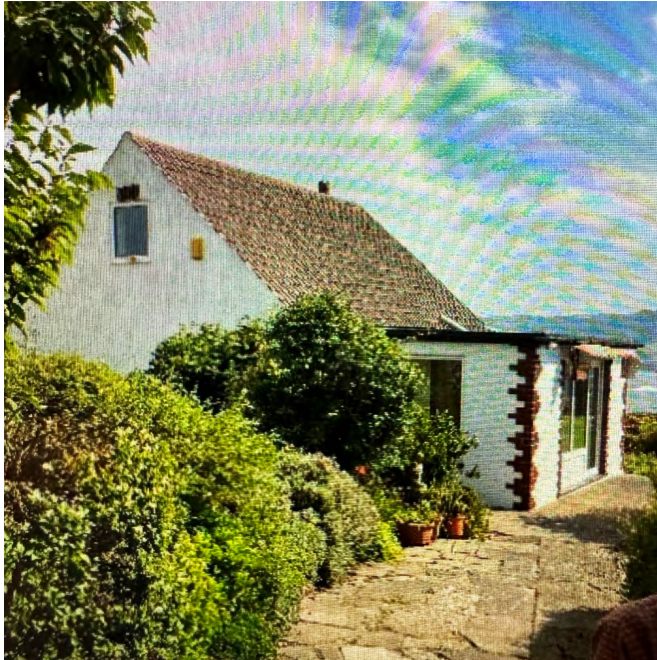
**Fig 4.**  
Existing dwelling

The existing dwelling contributes little to the area and its repair/improvement is not financially viable, as its lifespan is limited due to its location to the cliff edge on the east. It is confirmed that residential use has not been abandoned, but it is a dwelling that lacks basic amenities, has many problems not compliant with current building standards, and is not of architectural or interest. The house and the garage block would therefore be demolished and replaced.

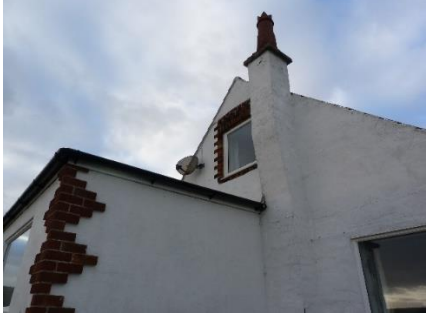
<p>Photo 1: Building with flat roof extension</p>

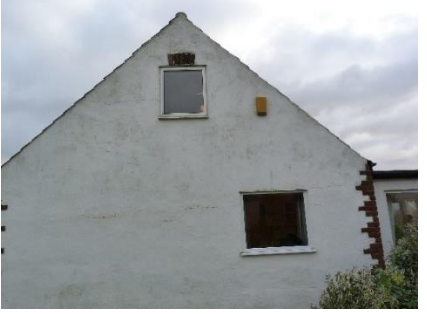
Building ref	Description & photos				PBRH features	
<p>Building 1: Negligible risk of supporting roosting bats</p>	<p><b>Bungalow built of brick with concrete close fitting roof tiles. Ridge tiles are well sealed. No masonry crevices and the majority of the building is rendered. Two flat roof extensions with well sealed soffits. The roof is unlined and in the upstairs bedrooms the attic eaves showed no sign of bat usage</b></p>					<p>N/a.</p>

<p>Photo 2: Building 1.</p>

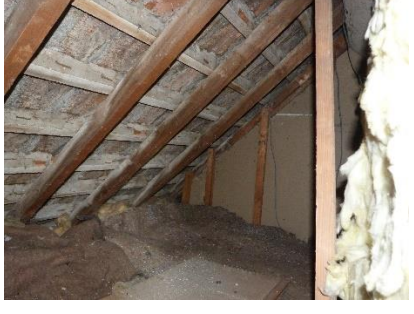
There was no evidence of bats within the two eaves attics and if bats were accessing the property at the eaves there would be visual evidence in these areas.

<p>Photo 4: Internal attic spaces</p>

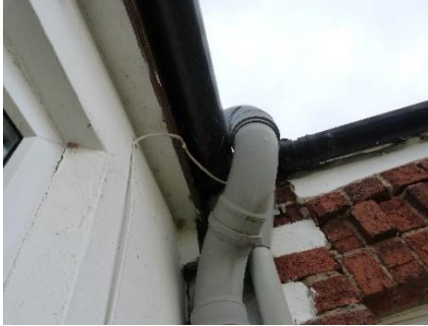
<p>Photo 5: Flat roofs – no gaps</p>

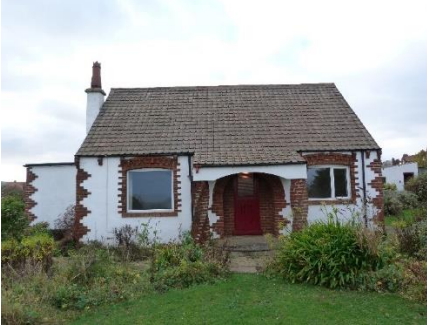
The development will involve demolition or refurbishment. The bungalow has close fitting roof tiles and no roof lining. Eaves of the roof are well sealed and the soffits around the flat roofs are also close fitting.

<p>Photo 6: Close fitting roof tiles</p>

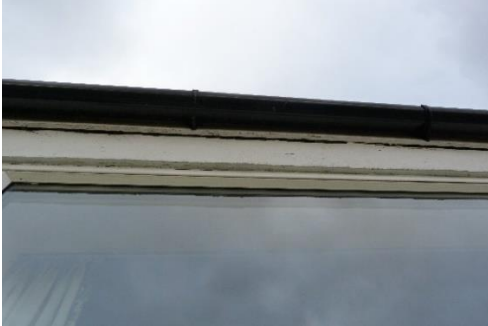
<p>Photo 7: Soffits well sealed</p>

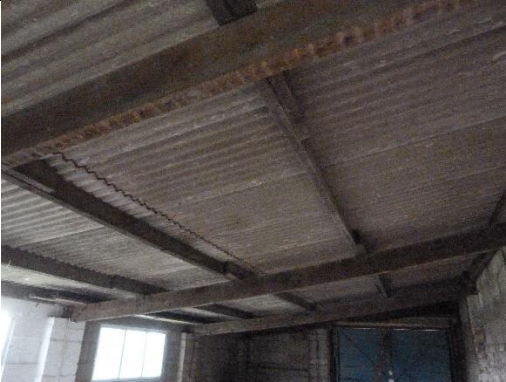
The garage also had no potential bat roost habitat or evidence of bats. We can, therefore, rule out usage of both buildings by bats.

<p><b>Building 2:</b> Low risk of supporting roosting bats</p>	<p>Garage rendered breeze block with corrugated asbestos roof.</p>			<p>N/a</p>

<p>Photo 8: Garage</p>	<p>Photo 9: Corrugated roof</p>
