## COMBINED DESIGN & ACCESS STATEMENT AND HERITAGE STATEMENT

### To support an application for Planning Permission and Listed Building Consent for the re-roofing of Low Staindale Cottage, Dalby, Pickering YO18 7LR

## **Bat, Breeding Bird and Barn Owl Scoping Survey**

### **Low Staindale**

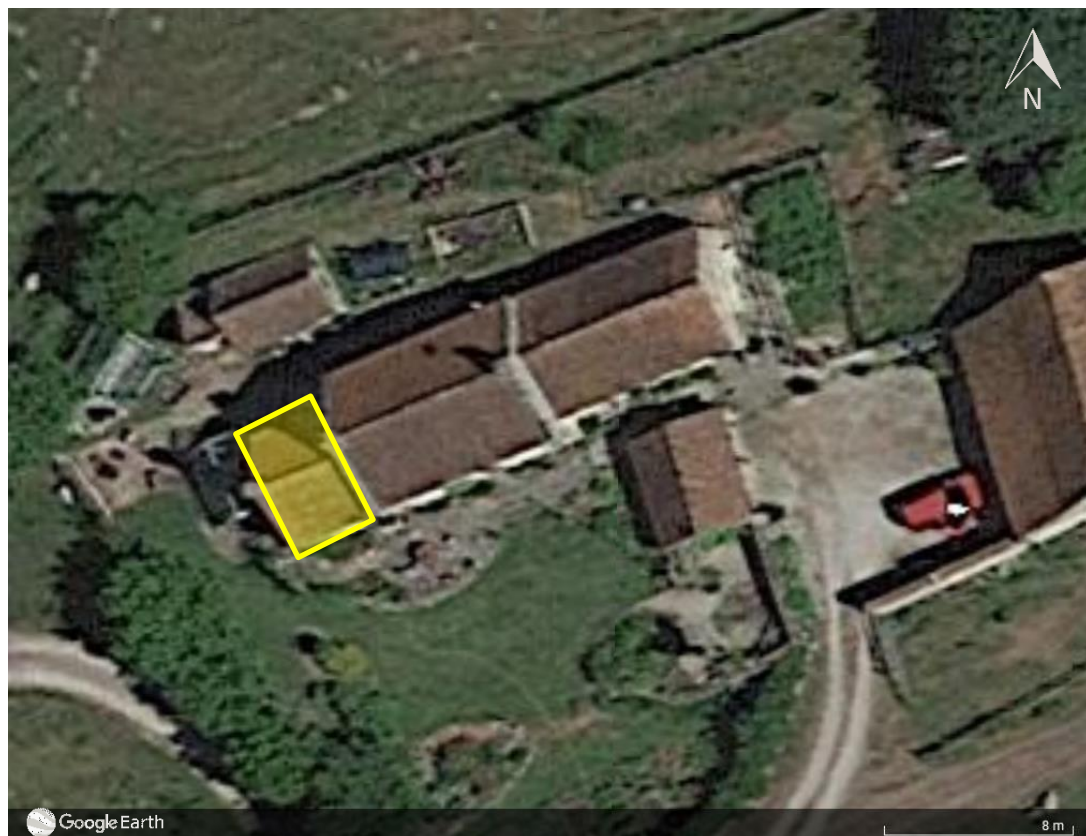
**Figure 3. Surveyed building.**

Building ref	Photographs			Description and notes on breeding birds	Potential bat roost habitat (PBRH)
<p><b>Low potential risk of supporting bats</b></p>	  <p>Photo 1. South aspect</p>	  <p>Photo 2. North and west aspects</p>	  <p>Photo 3. West aspect</p>	<p>Single storey side extension. Stone built with clay pantile roof. No loft void.</p> <p>Some gaps under lifted pantiles on south aspect. North aspect looks in good condition.</p> <p>On gable end, masonry is well-sealed overall, as is the chimney stack. Few surface crevices.</p> <p>No evidence of bats. No evidence of breeding birds.</p>	<p>Lifted roof pantiles on south aspect.</p>

The area of works is located near to some low risk PBRH identified under lifted roof pantiles on the south aspect. While these works will not directly be affected by the proposed works, they may be subject to some disturbance. To mitigate this impact, works will be undertaken using hand tools only and not machinery, taking care during works and stopping should any evidence of bats be found. These areas will also not be obstructed during works.

Works should be undertaken with care, following good working practices (Appendix 2) and be mindful of bats. The areas of PBRH (roof on south aspect) will also not be obstructed during works. Should any bats be found, works should stop, and a suitably qualified ecologist contacted.
