Newton Haye – Proposed installation of 3no Luxury Glamping Pods/Chalets

Report Type: Arboricultural Method Statement inc. Impact Assessment

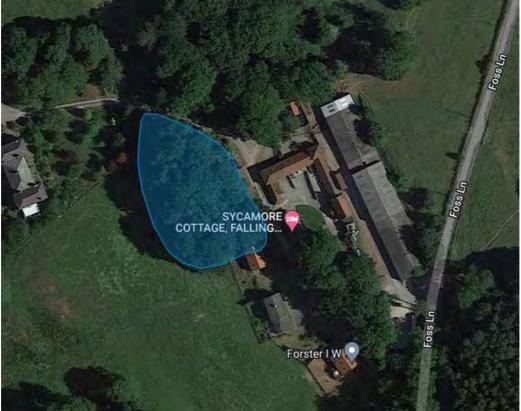
Figure 1: Area Covered (highlighted)

2.1 The area surveyed and the extent of which is covered by this method statement is within the property of Newton Haye, Sneaton. Figure 1 shows the extent of the area.

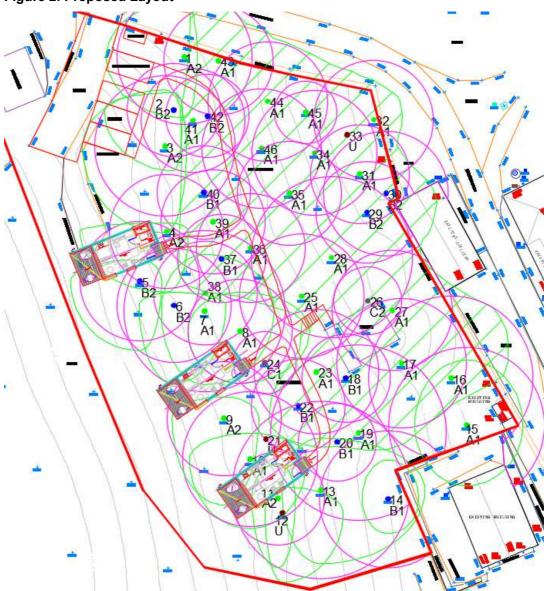
Figure 2: Proposed Layout

- 4.1 This section concentrates on the proposed development and how it relates to the current tree population within the site. Any conflict issues between the proposed layout and existing trees are discussed and remedial options, where possible, suggested.
- 4.2 As displayed within Figure 2, and in greater detail within Appendix 4, it is proposed that three lodges with supporting infrastructure including parking, access paths and utilities will be constructed within the site.

4.3 Conflict 1: Loss of trees due to the proposed layout

Whilst none of the trees would require removal to enable construction of the proposed layout, we would recommend the removal of a small number of poor-quality trees to abate possible safety issues.

Mitigation / Countermeasure: Tree numbers 12, 21 and 33 are recommended for removal due to being either dead or in a state of advanced physiological decline. It would not be appropriate to retain these trees whilst introducing new structures and guests in close proximity.

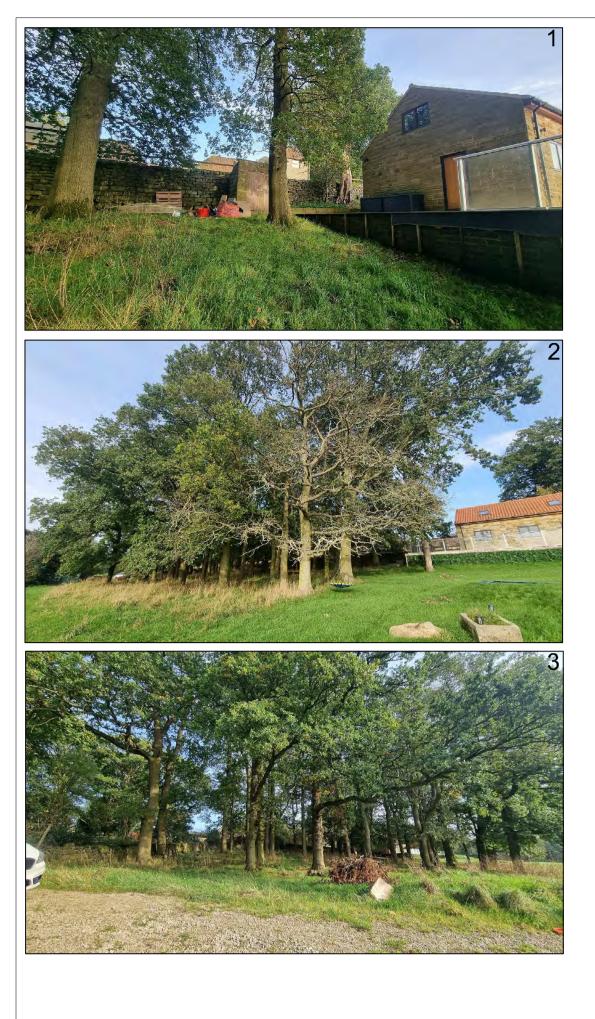
<image/> <image/> <text></text>
 Tree Position Showing Crown Extents and BSS837 Category A Tree Position Showing Crown Extents and BSS837 Category B Tree Position Showing Crown Extents and BSS837 Category C Tree Position Showing Crown Extents and BSS837 Category U Root Protection Area - to remain free from disturbance Group of Trees Tree/Group BS5837 Retention Category Photo Number, Position and Aspect
APPENDIX 3 Drawing Title: Tree Constraints Plan Project: Newton Haye, Sneaton Drawing Number: ARB/CP/3234/TCP Date: October 2023 Scale: 1:200 @ A1

- 3.2.1 **Category A** (coloured green) trees are those of high quality and value, and of a condition whereby they could make a substantial contribution to the site. The retention of Category A trees should be considered during the design phase and afforded adequate physical protection during the construction phase in accordance with BS 5837:2012 where retained. This means keeping proposed features and alterations to ground levels outside of root protection areas and crown spreads so as to ensure that the tree remains in an adequate condition post-development. Root protection areas and crown spreads are displayed upon the Tree Constraints Plan, Appendix 3. Twentynine trees were classified as Category A.

- 3.2.2 **Category B** (coloured blue) trees are those of moderate quality and value, and of a condition that they make a substantial contribution to the site. The retention of Category B trees should be considered during the design phase and afforded adequate physical protection during the construction phase in accordance with BS 5837:2012 where retained. Twelve trees were classified as Category B.

- 3.2.3 **Category C** (coloured grey) trees are considered to be of low quality and value, but of an adequate condition to remain in the short-term. Trees with a stem diameter of less than 150mm (measured at 1.5m above ground level) are classified as Category C; these trees should also be retained where possible but where they form a significant constraint to development their removal should be permitted. Where they are to be retained, they should be afforded adequate consideration during the design phase and physical protection during the construction phase in accordance with BS 5837:2012. Two trees were classified as Category C.

- 3.2.4 **Category U** (coloured red) trees are of such a condition that any existing value would be lost within 10 years. As a result it is recommended that Category U trees are not considered a constraint for development and are removed prior to construction commencing. Three of the trees were classified as Category U.

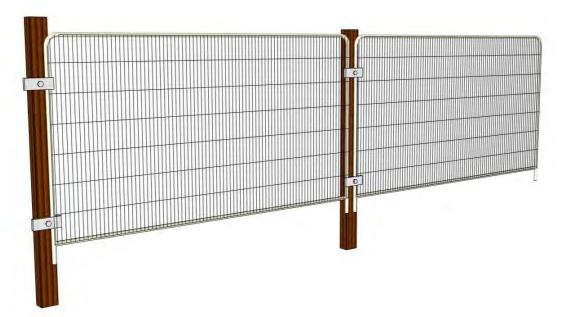
Appendix 5: Protective Fencing Specification

Weldmesh fence panels attached together using fence couplers bolted to 100mmx100mmx2400mm treated timber fence posts driven 500mm into the ground. Use of plant to assist with erection only from outside of root protection area.

- 5.3.1 The barriers need to be installed according to the locations found on the Tree Protection Plan, Appendix 4 and conform to the specification within Appendix 5, unless a suitable alternative is agreed with the Local Planning Authority. All weather notices should be attached to the fencing marked with the following: *'Construction Exclusion Zone - Keep Out'* (a notice is provided within Appendix 8).

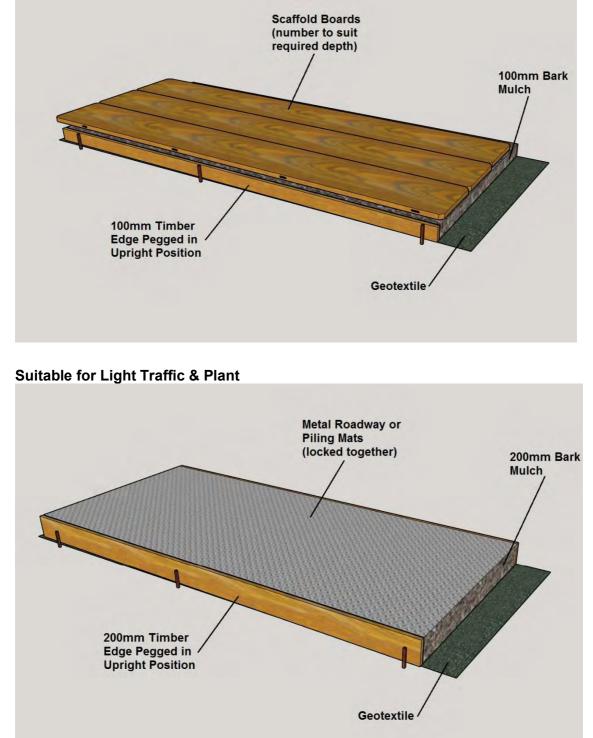
Appendix 6: Access within Root Protection Areas

Ground Protection to Enable Access within Root Protection Areas

For Pedestrians Only. (Scaffold boards can be replaced by robust sheet material)

Where erecting scaffolding within areas of protected ground. The geotextile should be laid and then the scaffold footings placed on boards to spread the load. Ground protection as above should then be installed if access beneath the scaffolding is required.

A 3-metre-wide area of ground protection will be installed around the footprint of each lodge prior to construction to reduce compaction of the soil. A specification for the ground protection is provided within Appendix 6, with the areas needing to be covered noted upon the Tree Protection Plan (Appendix 4).
