RE: PLANNING APPLICATION TO DISCHARGE CONDITION NO3 (BAT SURVEY) OF PLANNING PERMISSION NYM/2023/0523 (AS AMENDED BY NYM/2024/0205) FOR THE DEMOLITION OF EXISTING SINGLE STOREY EXTENSIONS AND ERECTION OF NEW EXTENSIONS TO EXISTING DWELLING

LOCATION: THE LILACS, SCAR LANE, WEST BARNBY, WHITBY, YO21 3SD.

Bat, Breeding Bird and Barn Owl Survey

The Lilacs, West Barnby

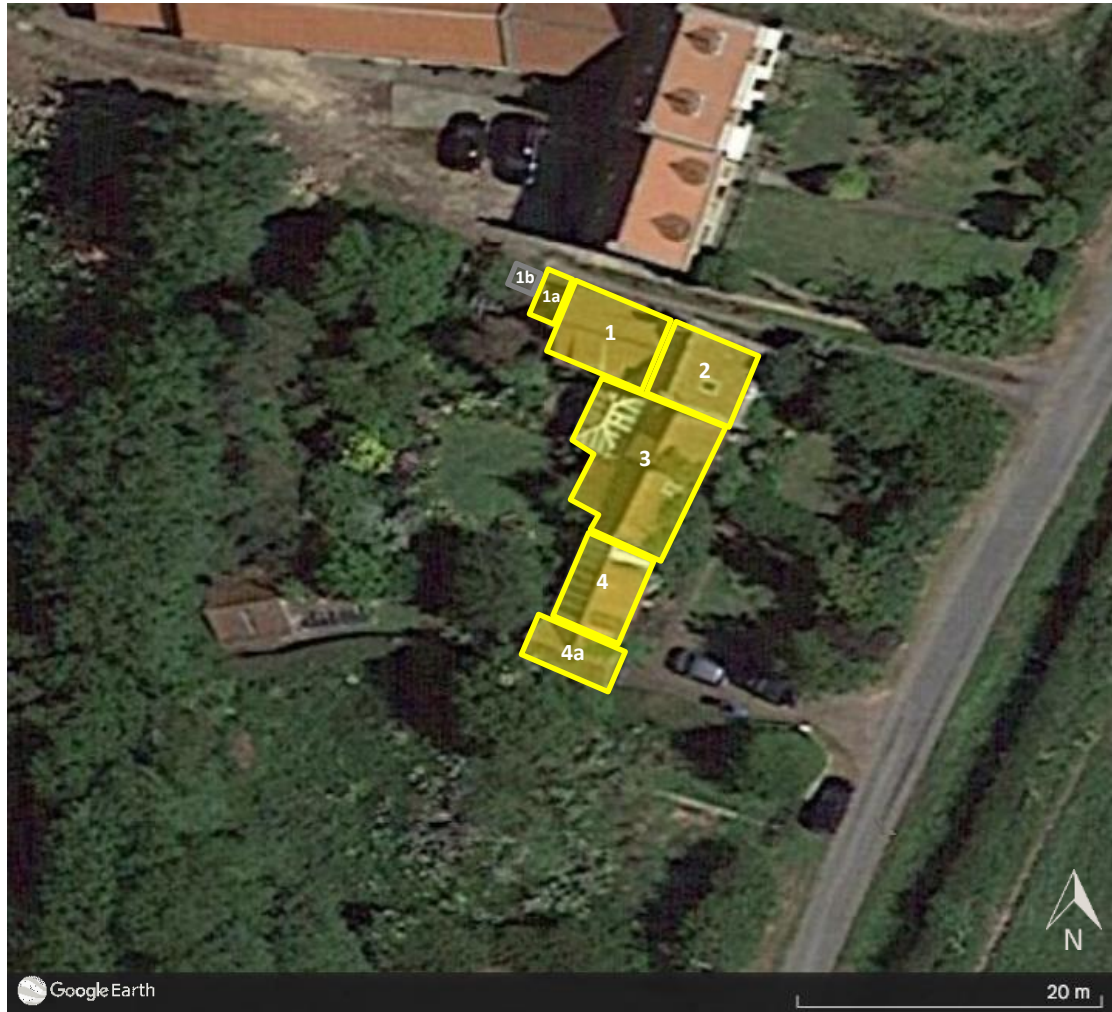
Figure 4. Visual Inspection Results. Google Earth 2023.

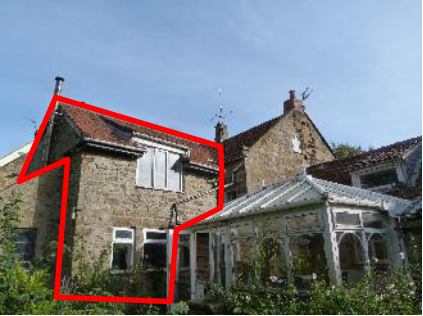
Building ref	Description & photos	PBRH features
<p>Building 1: Low risk of supporting roosting bats</p>	<p>Traditional 2-storey farmhouse, with stone walls and a bitumen lined, clay pantile roof. Abundance of gaps between roof tiles, gaps between tiles and liner. Gaps along wall tops under the fascia on the east elevation. Gaps within the fascia on the north elevation gable end. Loft void is small, and low height with exposed timber trusses, heavily cobwebbed. No evidence of roosting bats (droppings/feeding remains) identified. No evidence of nesting birds.</p>

<p>Photo 3: Building 1 - west aspect.</p>

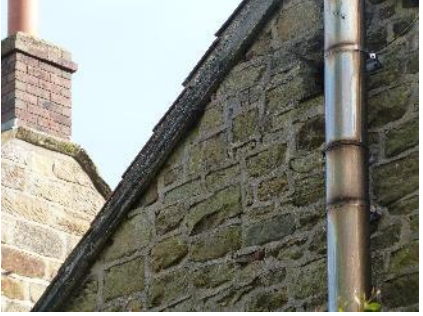
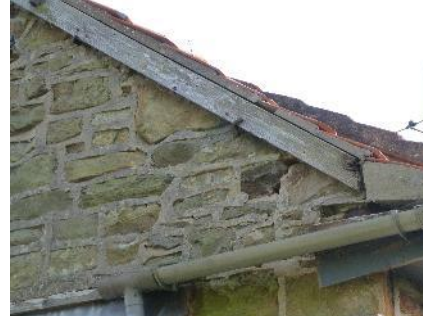
<p>Photo 4: Gable end gaps.</p>

<p>Photo 5: Gable end gaps.</p>

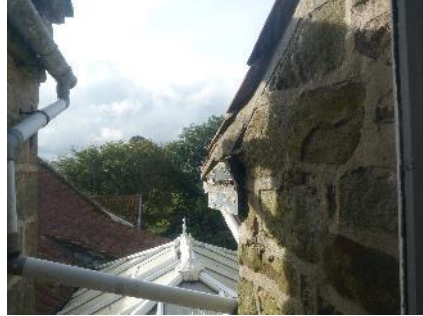
<p>Photo 6: Fascia crevices.</p>

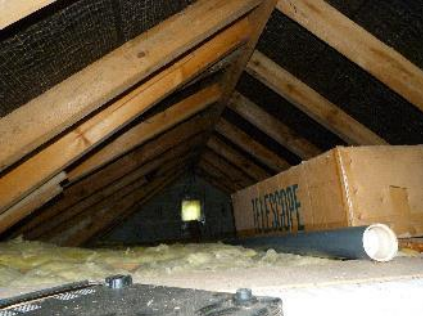
<p>Photo 7: Internal roof structure.</p>

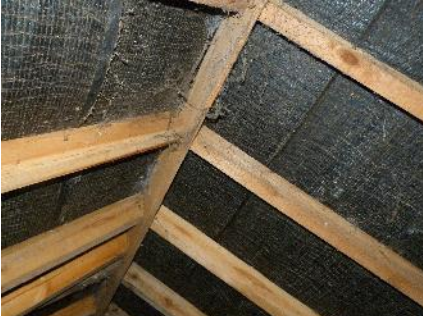
<p>Photo 6: Internal roof structure.</p>

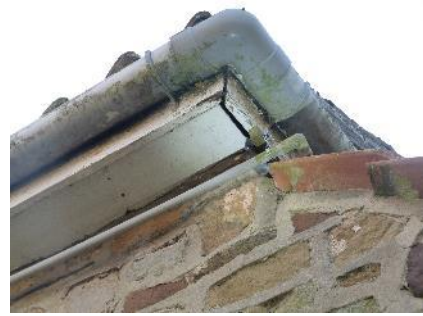
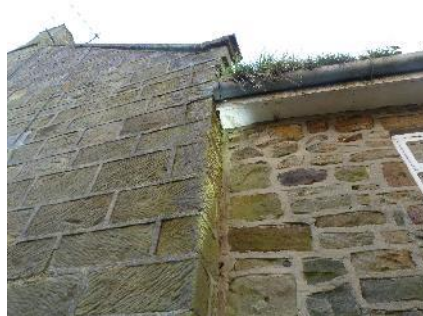
<p>Photo 7: Gaps in fascia on the north aspect.</p>

<p>Photo 8: Gaps in fascia on the north aspect.</p>	<p>Gaps between clay pantiles and liner</p> <p>Wall top gaps under fascia.</p>

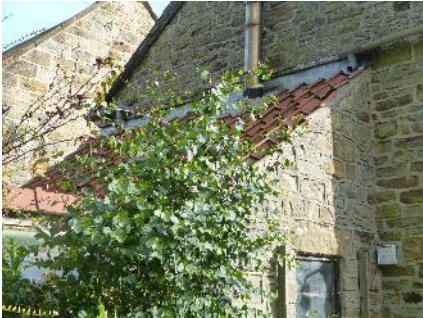
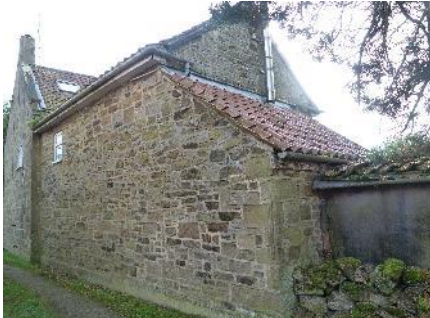
<p>Building 1a: Low risk of supporting roosting bats</p>	<p>Single-storey cinder block and traditional stone, clay pantile roofed extension which is bitumen lined. Masonry is in good condition, however there are several lifted clay pantiles as well as gaps under the lead flashing. No evidence of roosting bats (droppings/feeding remains) identified. No evidence of nesting birds.</p> <div style="display: flex; justify-content: space-around;"> <div style="text-align: center;">

<p>Photo 9: Building 1a - west aspect.</p> </div> <div style="text-align: center;">

<p>Photo 10: Building 1a - north aspect.</p> </div> <div style="text-align: center;">

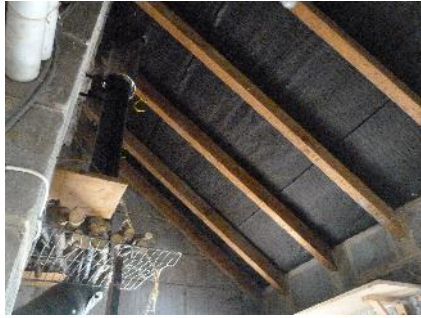
<p>Photo 11: Internal roof structure.</p> </div> <div style="text-align: center;">

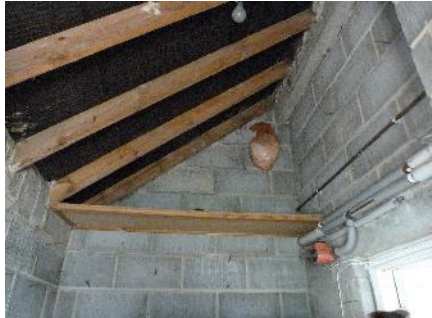
<p>Photo 12: Internal roof structure.</p> </div> </div>	<p>Gaps between tiles and liner.</p>
<p>Building 1b: Negligible risk of supporting roosting bats.</p>	<p>Single-storey traditional stone, half clay pantile roofed extension. As half of the roof is glass, this would be suboptimal for roosting due to the fluctuating temperatures. There is a lot of vegetation growing within and on the exterior of this structure, with a heavy layer of moss on the tiled portion of the roof and is damp. Heavily cobwebbed throughout. No evidence of roosting bats (droppings/feeding remains) identified. No evidence of nesting birds.</p> <div style="display: flex; justify-content: space-around;"> <div style="text-align: center;">

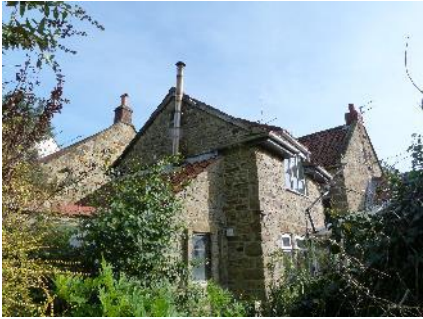
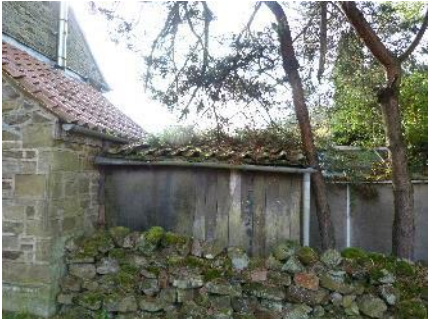
<p>Photo 8: Building 1b.</p> </div> <div style="text-align: center;">

<p>Photo 9: Building 1b – north elevation.</p> </div> <div style="text-align: center;">

Building 1b was determined to have negligible risk of supporting roosting bats based on its construction; the glass roof and vegetation throughout provide sub-optimal conditions for roosting bats.

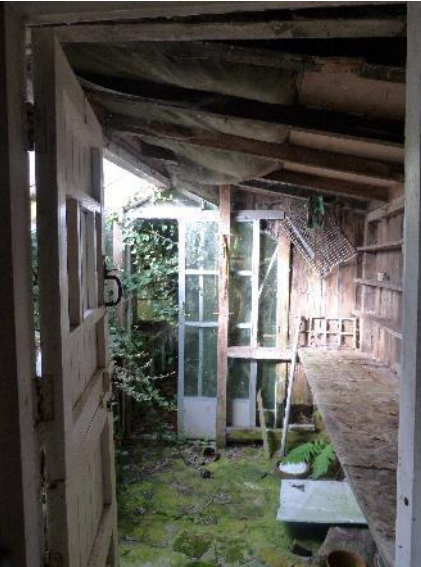
<p>Photo 10: Internal roof structure.</p> </div> <div style="text-align: center;">   <p>Photo 11: Internal roof structure.</p> </div> </div>	<p>No PBRH</p>

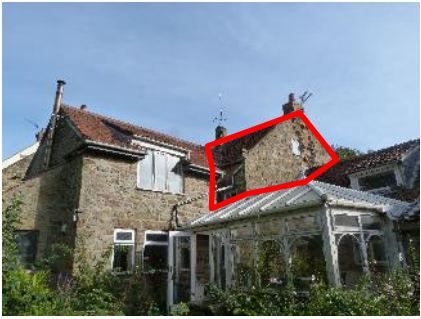
<p>Photo 12: Building 2.</p> </div> <div style="text-align: center;">

<p>Building 2: Low risk of supporting roosting bats</p>	<p>Two -storey original stone built, clay pantile roofed farmhouse with a converted loft area. The loft is lined with wood. On the exterior, there are many areas of potential bat roost habitat (PBRH), including crevices within the chimney, within the masonry above the windows as well as several lifted clat pantiles. No evidence of bats was identified. No evidence of breeding birds was identified.</p> <div style="display: flex; justify-content: space-around;"> <div style="text-align: center;">

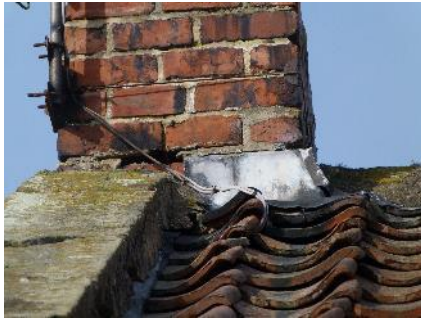
<p>Photo 14: Crevise in chimney.</p> </div> <div style="text-align: center;">

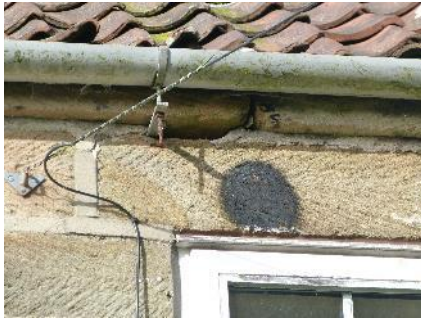
<p>Photo 14: Masonry crevice.</p> </div> </div> <div style="text-align: center; margin-top: 20px;">

<p>Photo 15: Internal roof structure.</p> </div>	<p>Lifted clay pantiles.</p> <p>Masonry crevices near wall tops.</p>

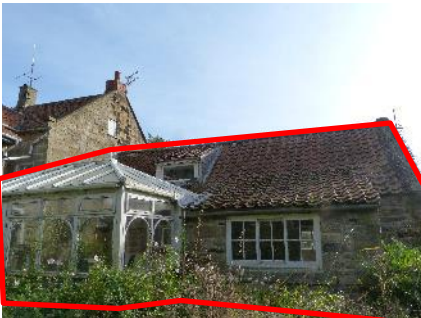
<p>Photo 16: Building 3.</p> </div> <div style="text-align: center;">

<p>Building 3: Low risk of supporting roosting bats.</p>	<p>Traditional stone built extension to the south of the original farmhouse (2) with an adjoining conservatory. Lifted clay pantiles provide access into the roof structure as well as wall top gaps. Internally there is no loft space as the room has been converted, the ceiling is well-sealed with boards. No evidence of bats was found. Some evidence of breeding bird nests was identified underneath clay pantiles on the east elevation.</p> <div style="display: flex; justify-content: space-around;"> <div style="text-align: center;">

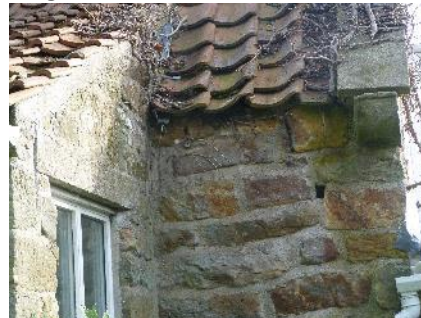
<p>Photo 17: Masonry Crevice.</p> </div> <div style="text-align: center;">

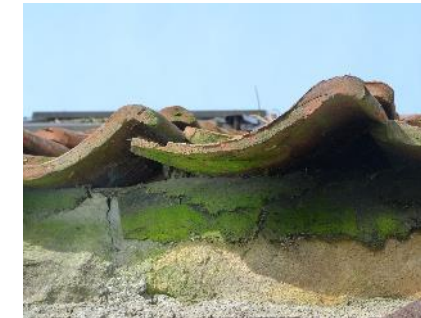
<p>Photo 19: Lifted tiles, nesting evidence within.</p> </div> </div>	<p>Gaps between clay pantiles, wall tops gaps and masonry crevices.</p>

Some evidence of bird presence was identified in Buildings 3 and 4. Potential nesting habitat is located under lifted pantiles across the buildings, such as for house sparrows or swifts. Therefore, four bird boxes should be installed. No evidence of barn owl was found.

9.1.4 A total of four bird nest boxes should be installed on site. These should ideally be integral boxes within the new buildings and should specifically include at least one sparrow terrace box and one swift box. Example options include: Schwegler sparrow terrace 1SP or brick sparrow box; Vivara Pro Seville WoodStone Nest Boxes; Swift boxes, e.g. ibstock swift box.

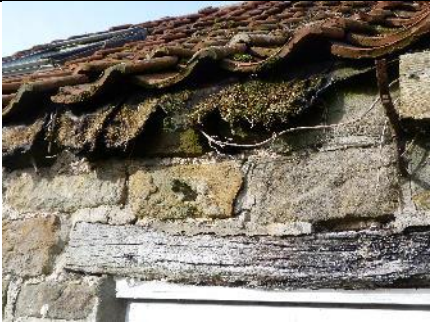
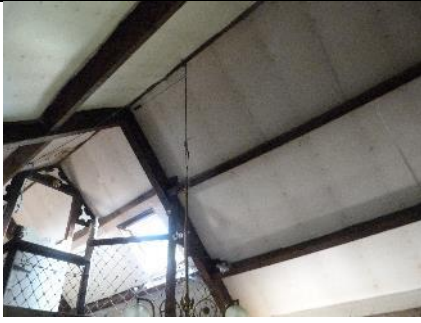
<p>Building 4: Low risk of supporting roosting bats.</p>	<p>Single-storey extension, stone built with clay pantiles and a clear plastic roof on the west elevation. Partially lined in a breathable underlay. Some vegetation has grown internally providing potential nesting habitat for birds. Lifted clay pantiles and wall top gaps were identified mostly to the eastern elevation, as well as some gaps along the ridge where mortar has come away providing access. Plastic roof offers negligible roosting features. No evidence of bats was found. No evidence of breeding birds was identified.</p>			<p>Gaps between clay pantiles, along the ridge, and wall tops, mainly on the east elevation.</p>
<p>Building 4a: Low risk of supporting roosting bats.</p>

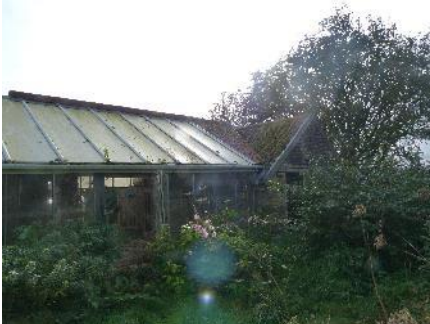
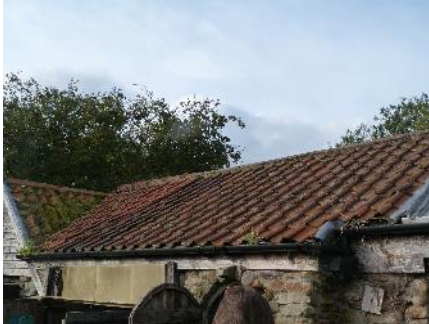
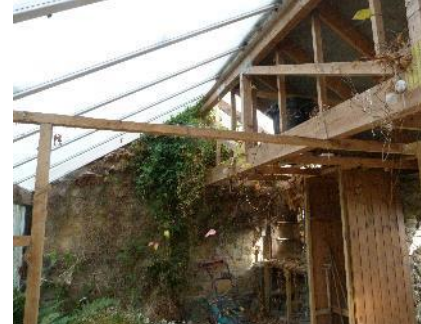
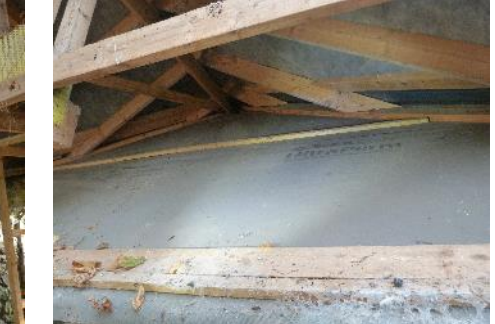
<p>Photo 23: Building 4 – West elevation.</p>	<p>Photo 24: East elevation.</p>	<p>Photo 25: Interior.</p>	<p>Photo 26: Internal roof structure.</p>

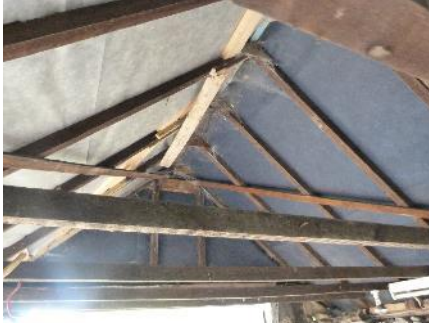
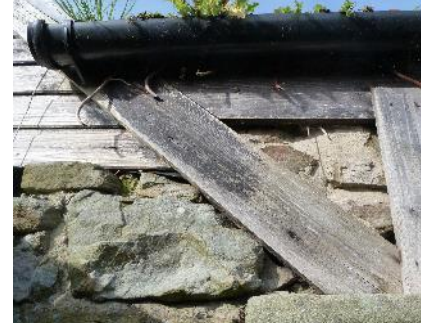
<p>Single-storey extension, stone built with wooden panelling, lined clay pantile roof. Some lifted tiles and crevices underneath boards providing some potential roosting habitat for bats. No evidence of bats was identified. No evidence of breeding birds was identified.</p>			<p>Gaps between clay pantiles and liner, crevices under boards.</p>

<p>Photo 27: Building 4b.</p>	<p>Photo 28: Internal roof structure.</p>	<p>Photo 29: Crevices identified.</p>

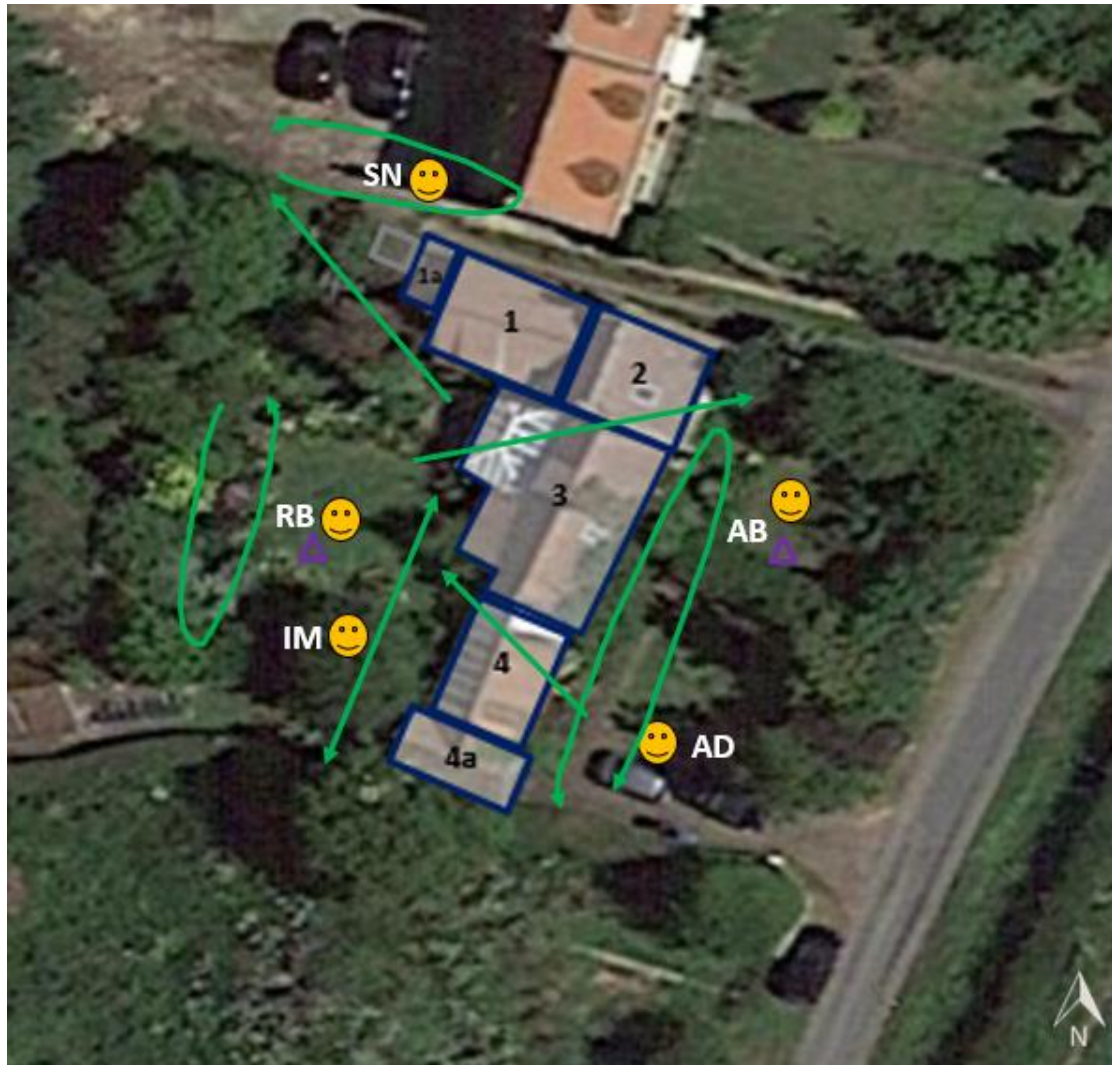
Summary: No bat roosts were identified within any of the buildings. Bat foraging and commuting activity around the site was moderately high.

Figure 5 – Surveyor locations and bat activity recorded during survey.

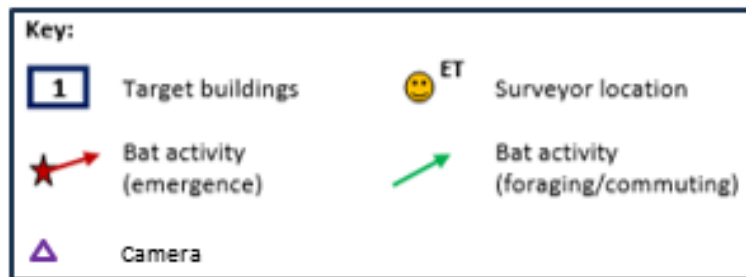
RB		22.34	Common pipistrelle	1	Not seen	 
IM		22.34 – 22.42	Myotis	1	Foraging	 
AD		22.39	Myotis	1	Commuting	 
RB		22.40	Brown long eared	1	Foraging	 
RB		22.42	Common pipistrelle	1	Foraging

A summer emergence survey of all buildings identified no roosting bats. Bat foraging and commuting activity around the site was moderately high throughout the survey. No evidence has been found during the visual inspection or emergence survey to suggest the proposed works will impact bats, however, works to the buildings with identified risk of roosting bats will result in the loss of a low level of PBRH.
