Protected Species Scoping Survey Report

Blue Bank Garage
Coach Road
Sleights
North Yorkshire
YO22 5EN

Date: 11th August 2016

Reference no CE 0216

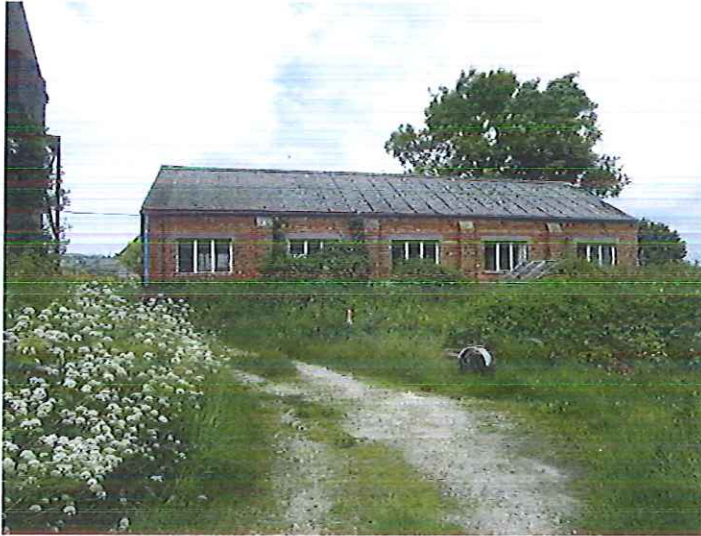
Plate 1 Building 1 viewed from the south looking north

A detached single storey building, with solid red brick walls with an unlined single skin standard asbestos roof.

The external walls were generally in a reasonable condition, mortar decay was present in occasional places but was only superficial with no deep holes or gaps present. The roof structure was supported upon angel iron roof trusses with timber purling to which is fixed the standard asbestos sheeting and crack crown ridge sheeting. The majority of the roof cover was in reasonable condition, however in the centre of the northern roof aspect a vertical row of the asbestos sheeting were missing, along with a single broken sheet towards the western gable, possibly caused from previous storm damage.

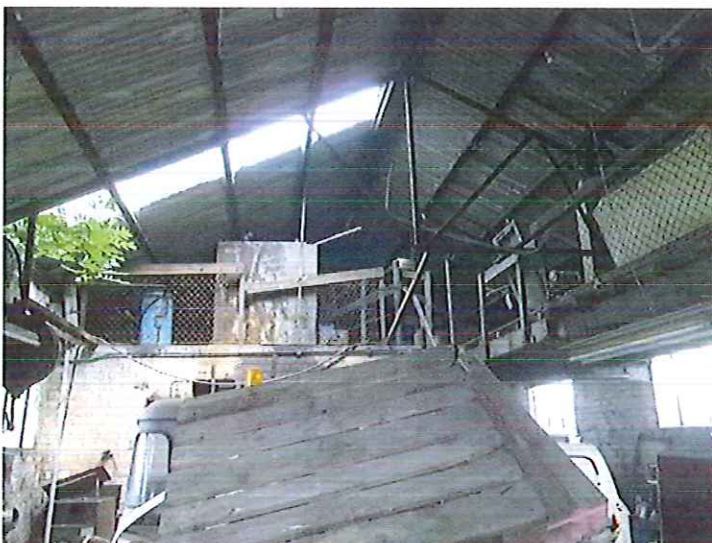
Plate 2 internal view of the roof structure

Internally the building was light and draughty due to the missing roofing sheets. The internal brick walls were in good condition with no holes or large cracks noted. There is a small room towards the eastern part of this building which forms a low mezzanine level above, which is used for storage of items used in a garage, as was the lower floor area.

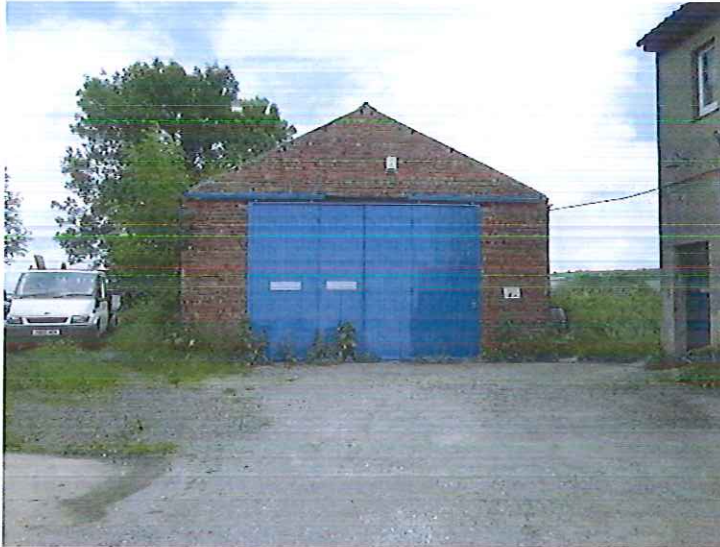
Plate 3 western gable

The windows were glazed and the metal frames were a good fit to the surrounding brickwork. In the western gable is a large set of timber sliding doors, which were in a reasonable condition, however as with most doors of this type there was a slight gap around the door and the brick work at the top and along the sides.

There was no evidence of historical habitation with this building for bats and nesting birds. Therefore from all the observations made this building has been assessed as having negligible potential for bats. There was no historical evidence or active bird nesting within the building at the time of the scoping survey.

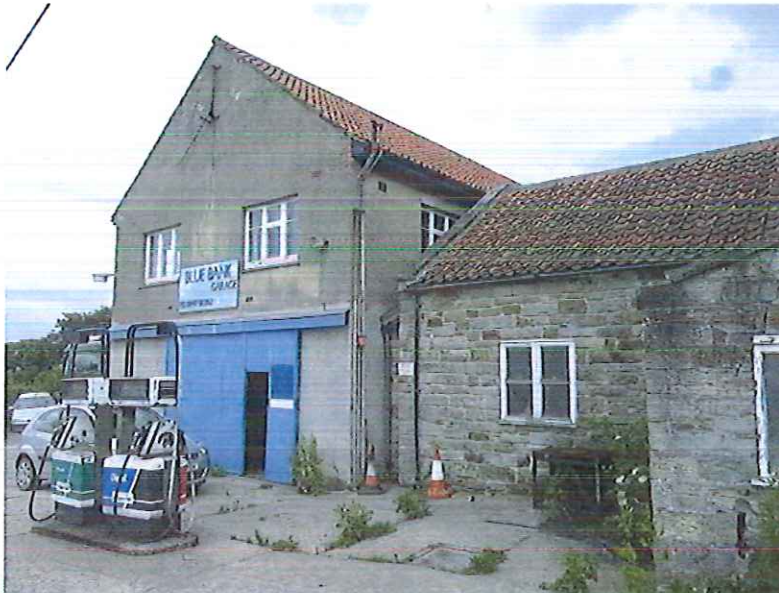
Plate 4 Building 2 and 3 viewed from the south west.

A two storey high building which forms the majority of the former automotive garage, with most of the associated automotive machinery still present. On the first floor level is the former living accommodation of the deceased owner, with a large roof void found above.

The external solid brick walls are all cement rendered, occasional superficial decay to the render found in occasional places, otherwise all were in good condition. The glazed timber framed windows found on the first floor were all a good fit to the walls as were all the ground floor metal framed windows. The main garage timber doors were again in a reasonable condition with only a slight narrow gap found down each side between the door and external wall. The roof covering of red pantiles and ridge tiles were in good condition and a good fit with only a couple of slipped tiles observed on the southern roof aspect in the south western corner. Along, mainly the northern roof eaves, it was noted that some of the mortar fill on the last row of pan tiles was missing and again in only one or two places along the southern eaves level. All the ridge tiles were well bedded as were both gable verges with not holes or large cracks observed. The chimney stacks were again all cement rendered and in good condition as were the surrounding lead flashings. The timber fascia and soffit boards found on the north and southern elevations were all in good condition and a good fit to the external walls, with not holes/ rot noted.

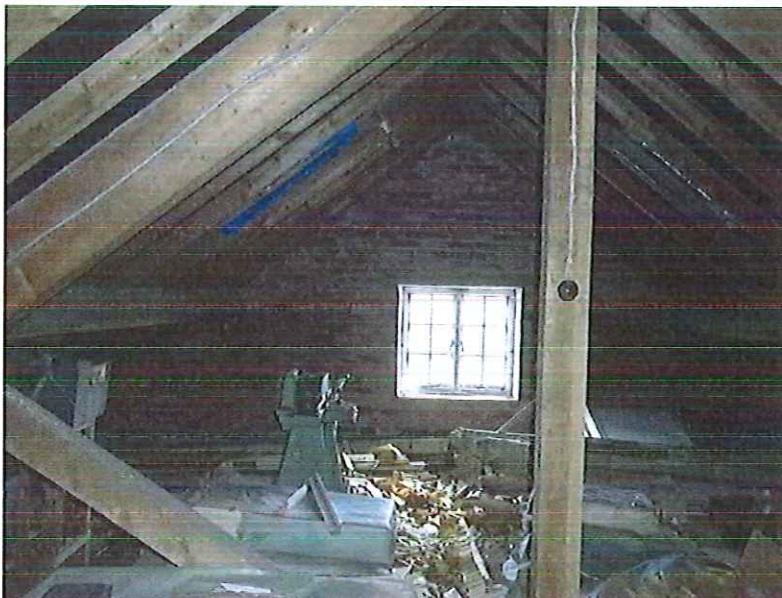
Plate 6 Roof void above the living accommodation within building 2

Internally the large roof void was relatively light due to the glazed window within the eastern gable. The floor area is insulated with Fibreglass and is also part boarded out and has been used for storage of the former businesses' documentation and lightweight garage equipment. The roof structure is supported upon two King post trusses, which support the timber purlings, rafters and ridge board, with traditional bitumastic roofing felt present over the whole of the roof line which again was in good condition.

There was no historical evidence of internal bat habitation and the only external potential was found within the south west corner on the southern roof aspect and possibly the missing eaves fill cement which was minimal. As a result of these findings this building has been assessed as having Negligible to Low potential for bat habitation. However there is a small Swift *Apus apus* colony nesting in the northern roof aspect using several of the holes found along the eaves

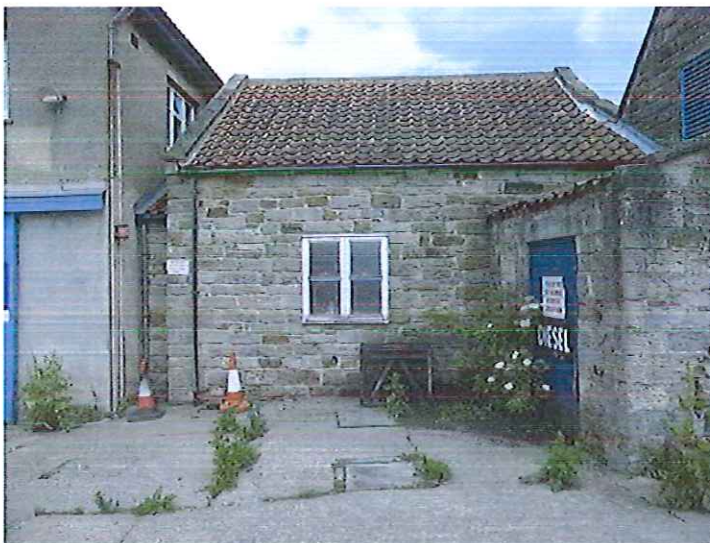
Plate 8 western elevation of building 3 with the stone facing

The external walls on the western elevation are breeze block with an external stone facing course which is in good condition, whereas the eastern and southern gables are both constructed from breeze blocks all of which are in a good condition with no holes/cracks or gaps apparent.

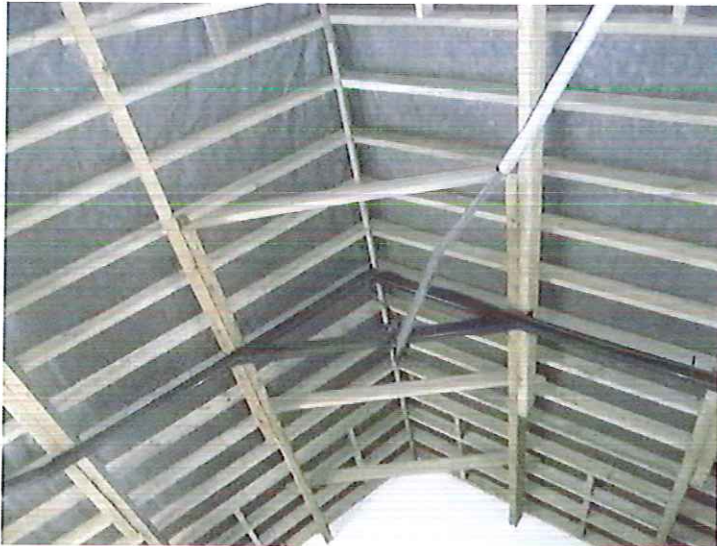
Plate 9 Internal view of the roof structure.

The roof structure is supported upon two steel box section A framed truss, with timber purlings fixed into the gable walls and rafters which are fixed to the wall pan and a central timber ridge board. Breathable Roofing Membrane which is in good condition is found throughout the roof structure. Internally the floor was concrete and the walls were again in good condition with no holes/ gaps or cracks observed.

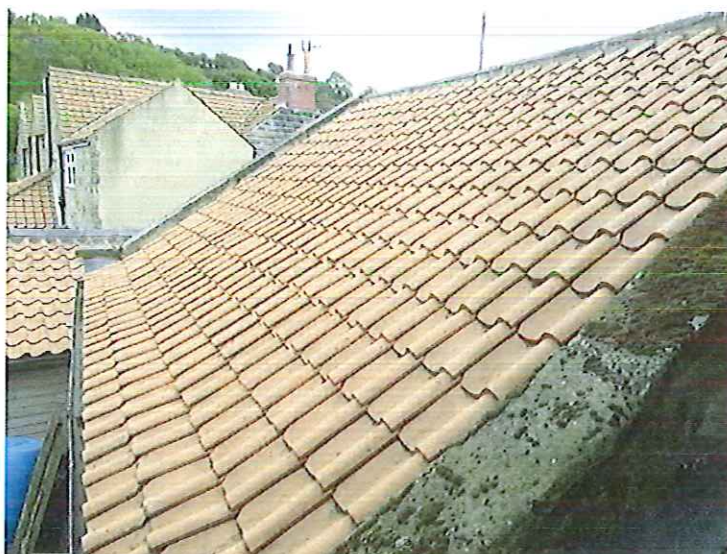
Plate 10 The new roof covering found on the eastern aspect of building 3, viewed from the upper floor of building 2

The eastern roof covering is of new pantiles in good condition and a tight fit as are the ridge tiles and associated lead flashings and valley. However the western roof covering appears to be the reclaimed original handmade pantiles which on the whole are a good fit, but occasional slightly lifted tiles are noted on this roof aspect, especially just below the ridge and along the eave where a single tile was missing. The lead flashings on the western roof aspect are a good fit as are the gable capping stone.

There was no historical evidence of bat or nesting bird habitation within this part of the former garage. However due to the several lifted tiles on the western roof aspect, this building has been assessed as having Low potential for bat habitation. There was no evidence of historical or active nesting birds within this building.

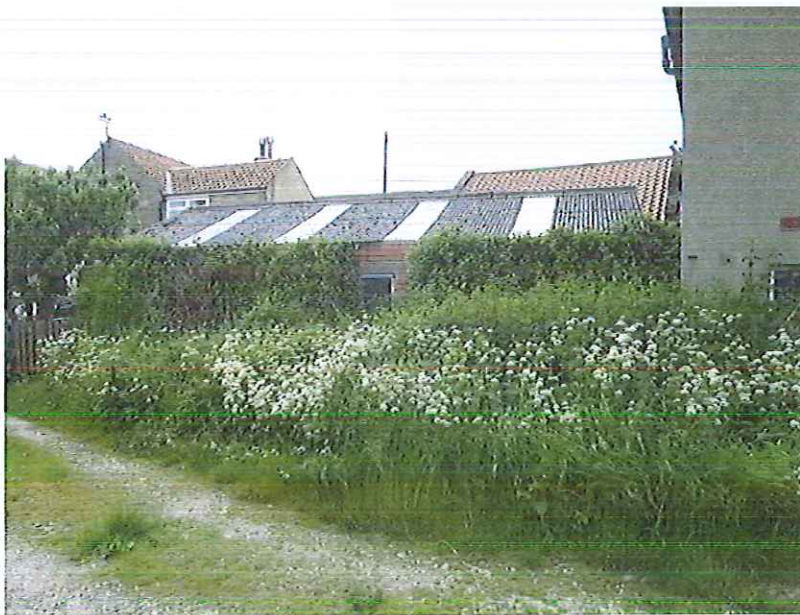
Plate 11 building 4 viewed from the east looking west

Again this single storey building is accessed via the southern elevation of the main garage (B2). Building 4 is built with single brick thick external walls with lightweight steel roof trusses, timber purlins and a standard asbestos roof covering with crack crown asbestos ridge tiles.

The external wall on the eastern elevation was part covered by vegetation, however the majority of this wall was assessed and was in reasonable condition with superficial spoiling but no deep gaps or holes noted, as were the remaining external walls. The asbestos roofing sheets, clear roofing light sheets along with the crack crown ridge covering were in good condition with no broken sheets or ridge tiles observed. The verge on the southern gable did have a slight gap where the asbestos roof sheet had curled up slightly over the brick work but not sufficiently to provide a roosting location.

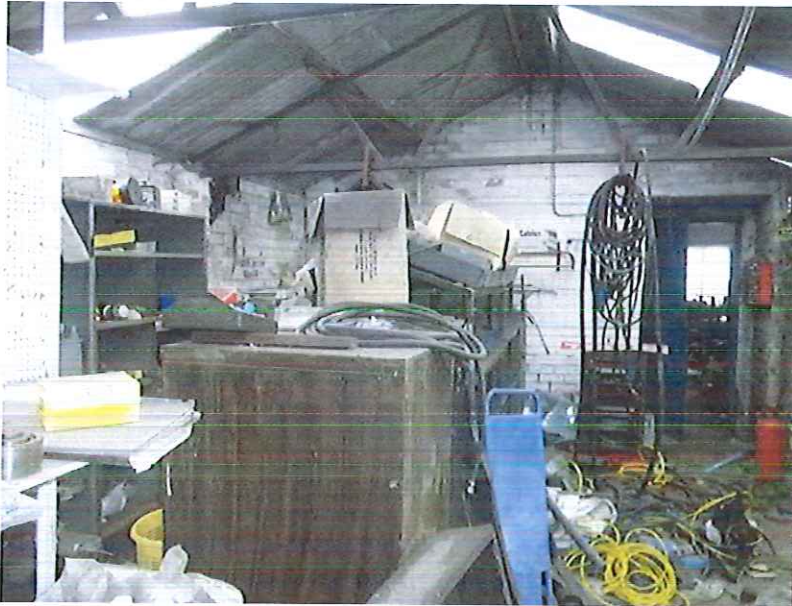
Plate 12 Internal view of building 4

Internally this building had been used for storage of items associated with a working automotive garage. The interior was extremely light due to the number of roof lights present. The walls were in good condition and the eave timber pan was sealed internally with a modicum of cobwebbing present throughout this building. There was no historical evidence of bat habitation nor has evidence of nesting birds within, therefore this building been assessed as having Negligible potential for roosting bats. There was no evidence of historical or active nesting birds within this building.

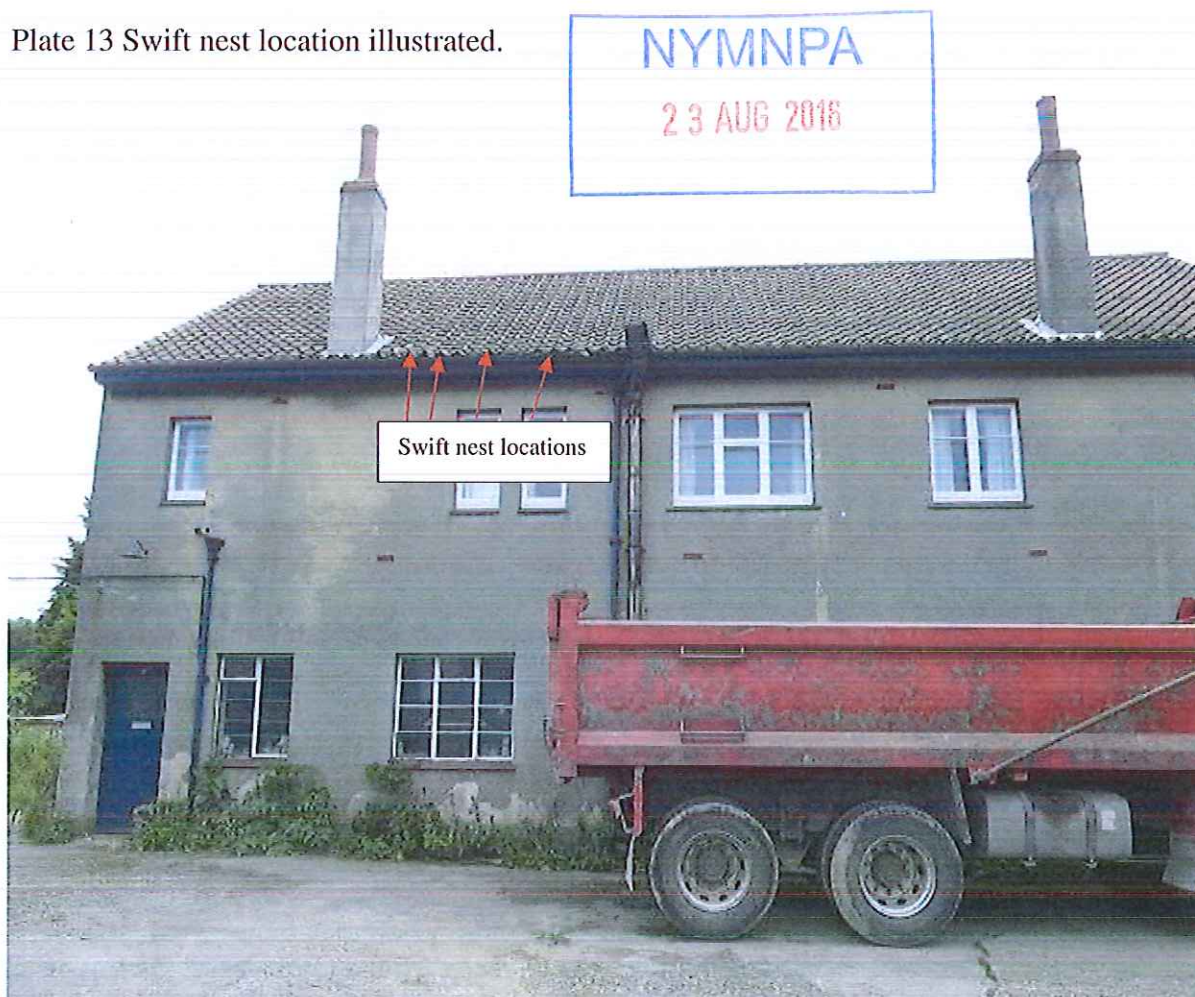
Plate 13 Swift nest location illustrated.

During the survey period 4 locations were identified within Building 2 on the northern roof aspect with the bird entering the nesting sites via the missing cement on the last row of pantiles at eaves level, found along the northern elevation of this building. Swifts *Apus apus* were generally active within the area throughout the length of the site visit, also Swallows were present, again within the general area all of which appeared to be foraging. During the site visit of the 26th June 2016, Swift *Apus apus* activity was greatly reduced, with only 1 nesting site being identified within Building 2 and no further nesting sites observed within any of the remaining buildings. However there were no historical or active Swallow *Hirundo rustica* or House Martin *Delichon urbica* nests found within any of the study buildings during the site visit of the 6th June 2016 and again during the Scoping survey site visit of the 24th June 2016.

Without suitable mitigation the demolition phase of the proposed development associated with Blue Bank Garage would result in the destruction of the existing nesting site found within Building 2 for a small colony of Swifts *Apus apus* which are a rapidly declines birds species. Also an opportunity exist within the new development for installations for nesting features for two further bird species which are in rapid decline, the Swallow *Hirundo rustica* and House Martin *Delichon urbica*. Therefore to address this situation and to enable both the Continued Ecological Functionality and to maintain the Favourable Conservation Status of these bird species the following recommendations have been made.

Site clearance works and demolition of the buildings should be undertaken outside the bird nesting period 1st March – 31st August inclusive. However if works to clear the site are undertaken during the bird nesting season then the development footprint and immediate surrounding area should be checked by a suitably qualified ecologist prior to any work taking place. If any active nests are found they will be identified they should be left untouched until either the young have fledged or the nest is naturally abandoned.

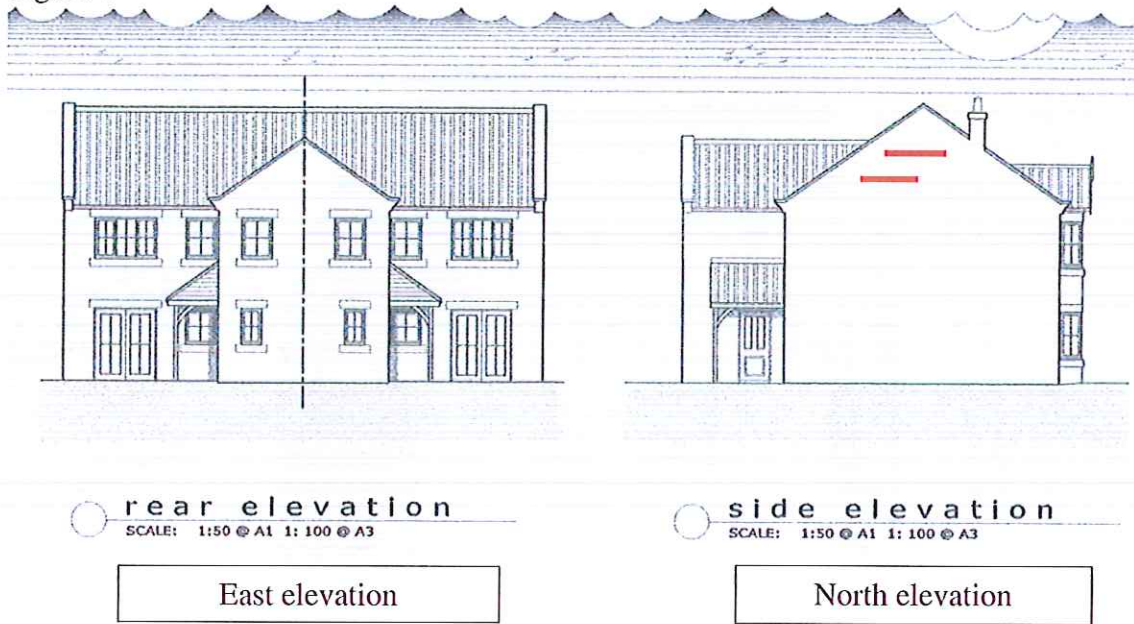
Figure 4

Proposed elevations of the new dwellings with the Swift box proposed location illustrated by the red lines within the north elevation

1. 2 x Schweglar Swift box no17 triple cavity as illustrated within Appendix 2 & Appendix 3 Figure 4.
2. 2 x Swallow Nesting bowls as illustrated within Appendix 2 & Appendix 3 Figure 5
3. 2 x Schweglar House Martin Terrace no 11 as illustrated within Appendix 2 & Appendix 3 Figure 6

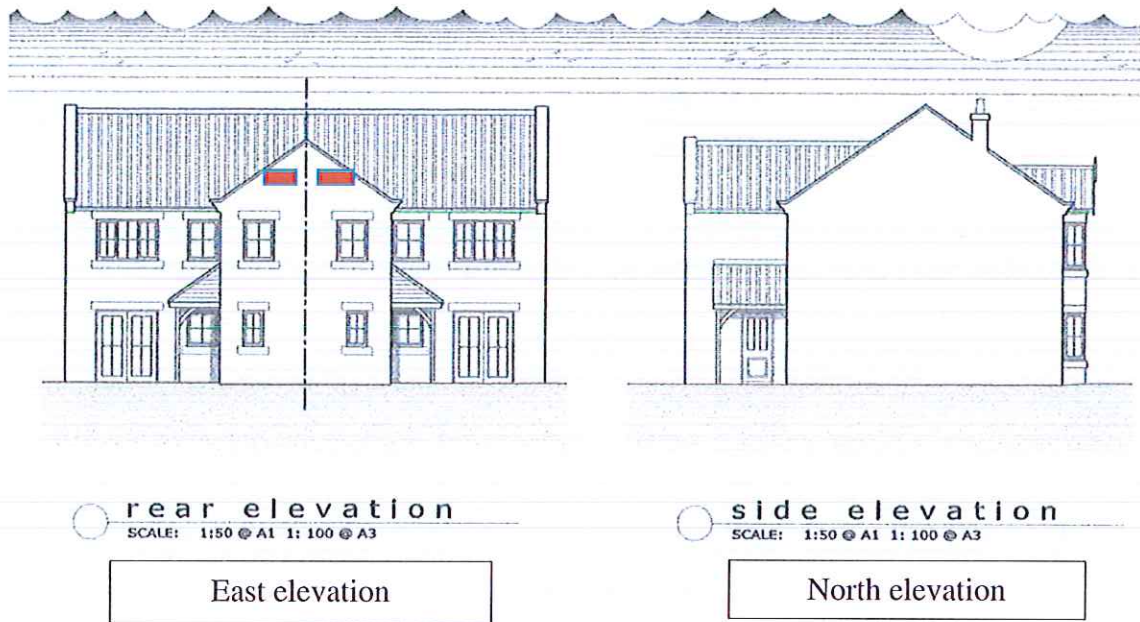
Figure 6.

Proposed elevations of the new dwellings with the House Martin nest bowls proposed location illustrated by the red rectangle within the eastern elevation.

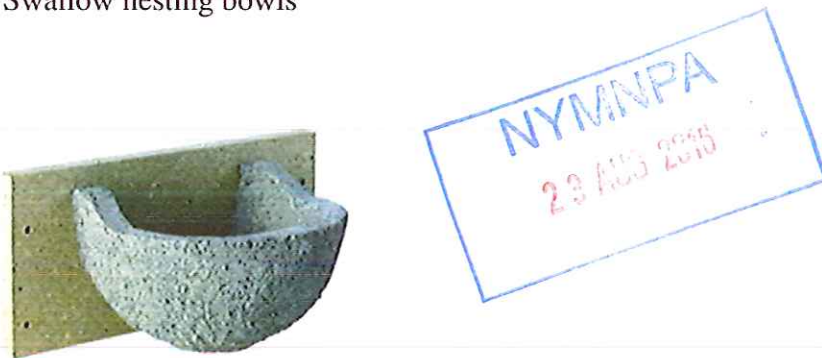
Swallow nesting bowls

This nesting bowl should be fitted on an north facing external wall at a minimum of 6 cm below the eaves level to allow for adequate entry by the birds into the nest bowl.

These nesting bowls should be placed approximately 1 m apart

Dimensions: Height: 11 cm, length: 25 cm and depth: 14 cm

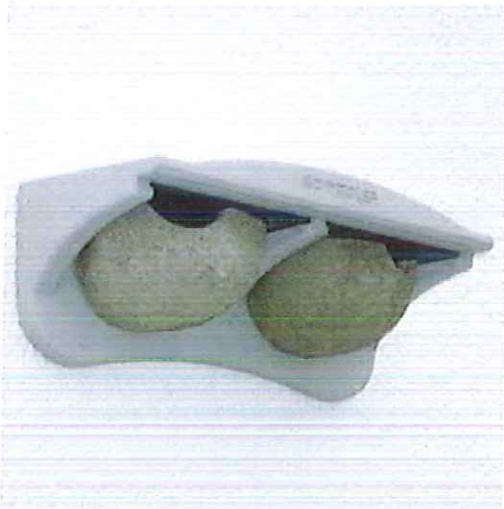
Schweglar House Martin Terrace No 11

The pair of nesting bowls have been specifically designed to incorporate an artificial eave above the bowls and can therefore be installed on an east facing gable wall without an overhanging soffit board.

Dimensions 11.5 cm H x 3.8 cm W x 1.6 cm D
