## DESIGN & ACCESS STATEMENT

FYLING HALL SCHOOL, ROBIN HOODS BAY, NORTH  
YORKSHIRE

**HERITAGE STATEMENT  
FYLING HALL SCHOOL, ROBIN HOODS BAY,  
NORTH YORKSHIRE.**

Client Name : Fyling Hall School Trust c/o Quadra Claims Services  
Project Title : Rebuilding the courtyard wall at Fyling Hall School.  
Project Number: 5006262

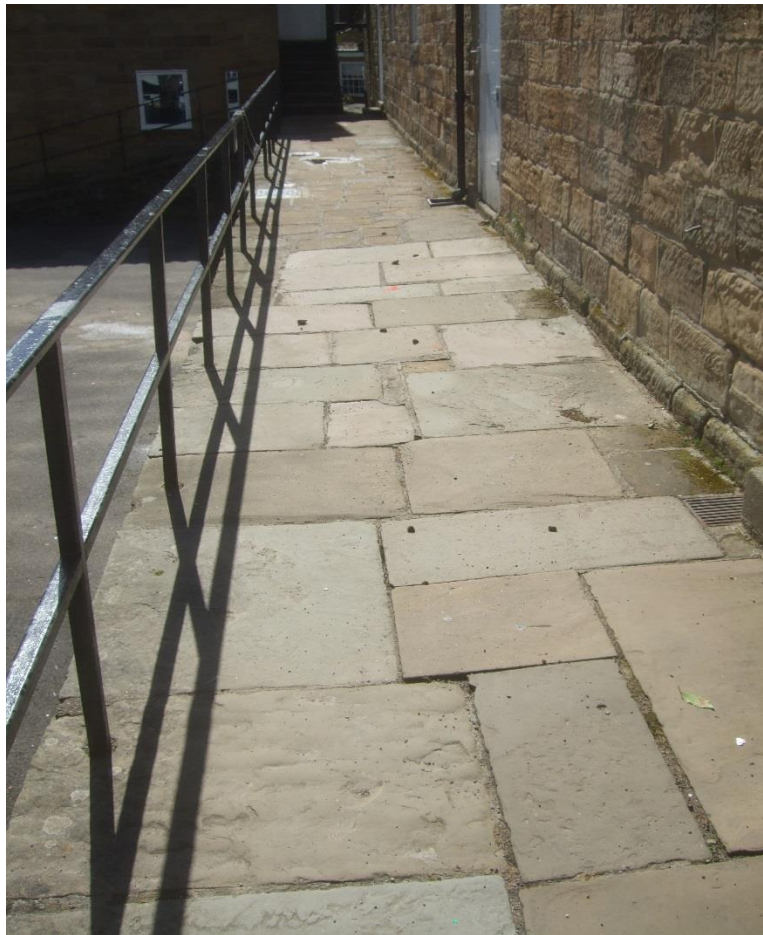
Photograph 1 – the raised walk-way with stone flag top and side railing

The stone wall forms part of the original complex and raises the access level in the courtyard giving a suitable platform to enter the adjacent buildings. (see photograph 1 in the Appendix) It is built in natural random stonework with a lime-based mortar and has a rendered section at low level. The rendering appears to have been a maintenance item from a number of years ago. The top of the wall has a natural stone flag capping and there is a vertical feature which conceals a drain. The drain is encased in a pre-cast concrete cover (see photograph 6 in the Appendix)

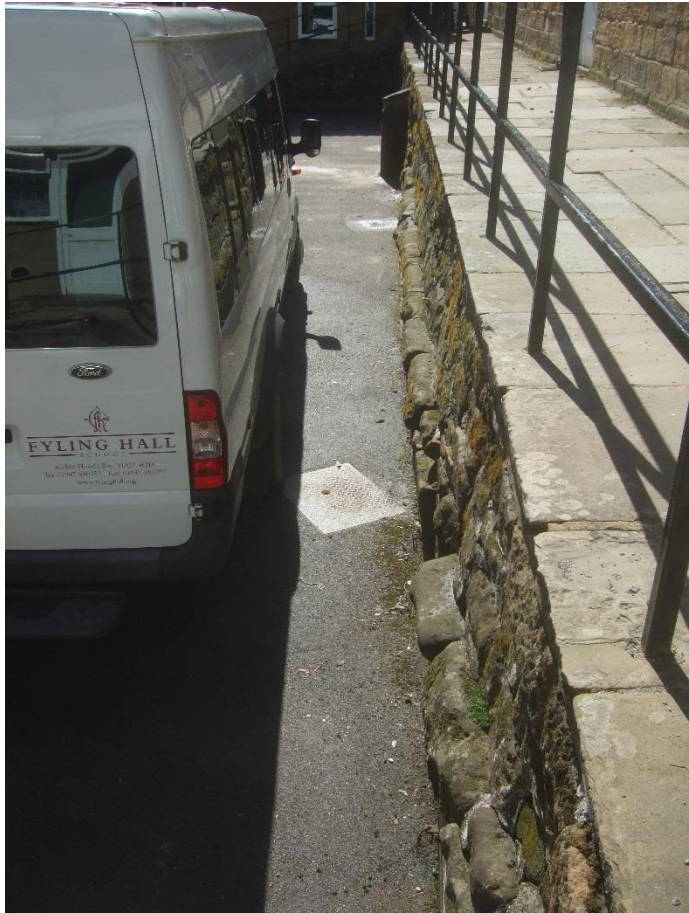
Photograph 2 – lower wall built in natural stone

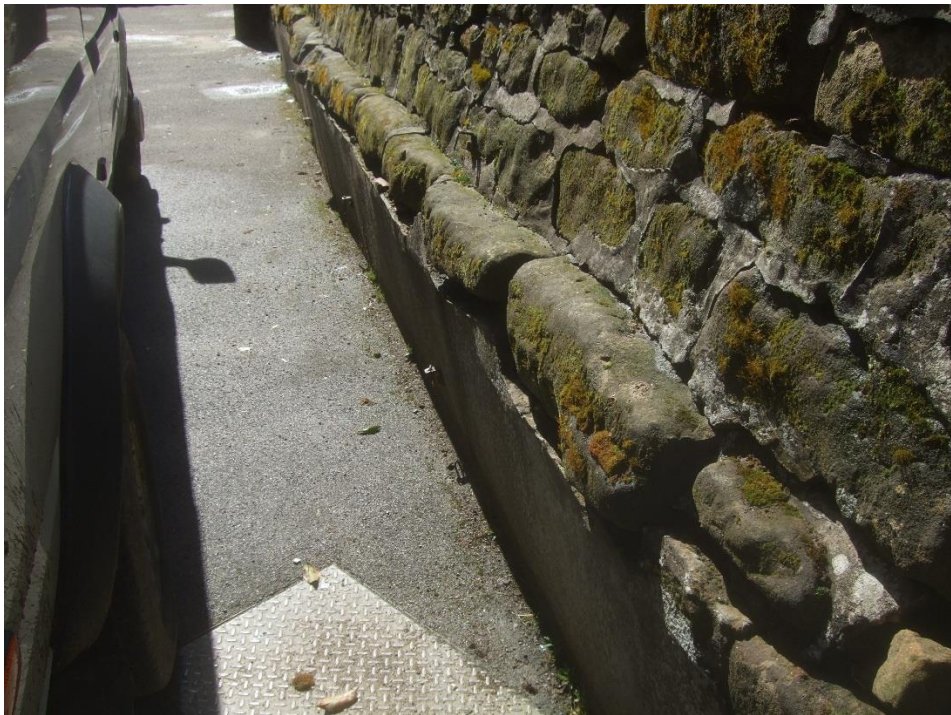
Photograph 3 – outward movement at the base of the wall(recently increased)

Due to the recent increased movement within the wall face, the works have become urgent and therefore organised to coincide with the school holiday period. The school broke up on the 7<sup>th</sup> July and returns on the 4<sup>th</sup> September.

The base of the wall will remain as it is currently constructed and the new work will be built on top of the substructure. The stone face and blockwork backing will be tied together to provide additional stability. The current rendered area will be replaced by natural stonework which would have been used originally.

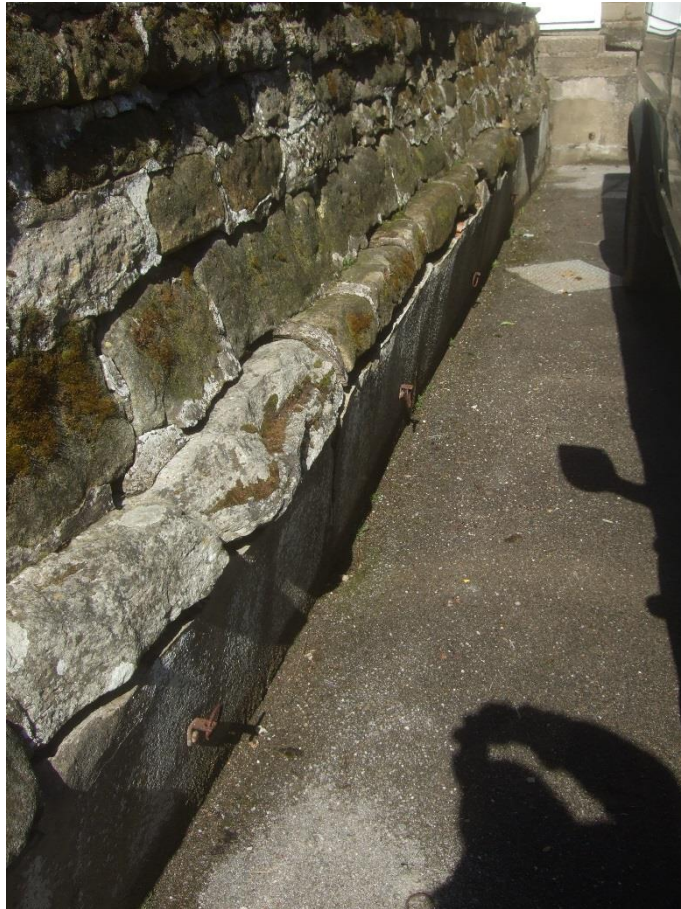
Photograph 4 – ‘creasing’ course with lower rendered section

There will be an additional benefit from the rebuilding work, in that the lower rendered area of the existing wall will not be reproduced. This creates a project that not only adds support to the wall but aesthetically returns the wall to it's original design.

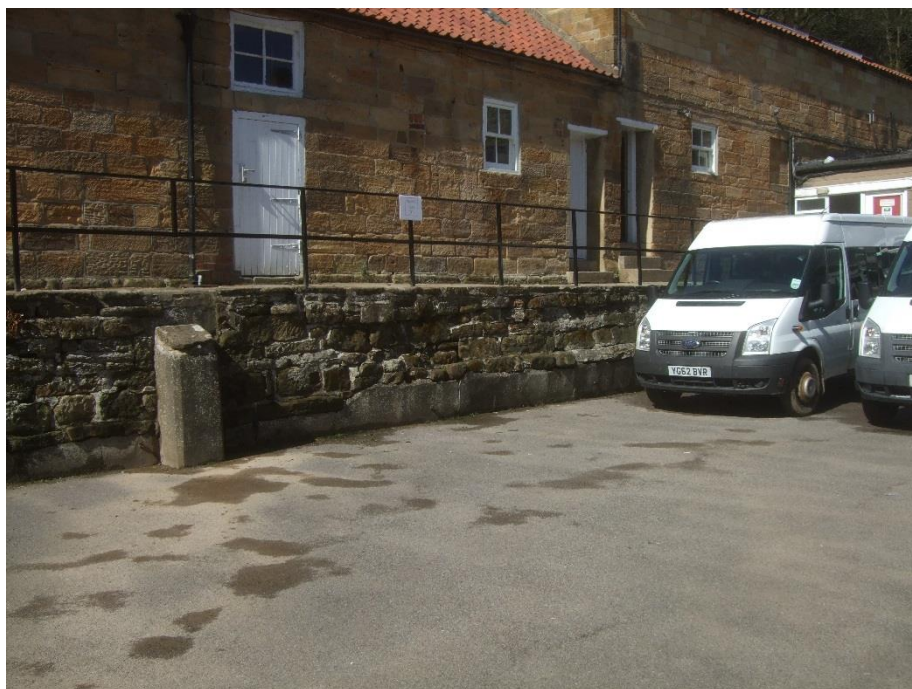
Photograph 5 – general view of the stone wall and railings

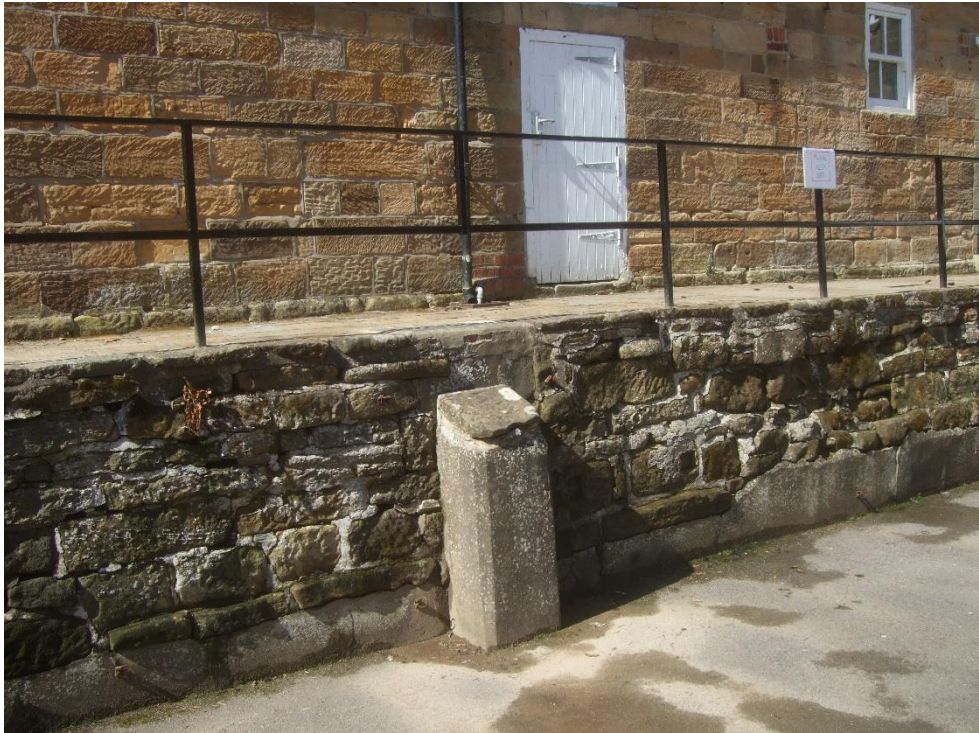
Photograph 6 - cover to vertical drain run(drain runs below the building)

There is a drain running beneath the adjacent building which takes storm water from the roadway. The outlet is contained in the vertical pre-cast concrete cover.

- 2.1.4 Take down the existing vertical cover stonework section in which it is assumed there is a drain pipe. Set aside for refitting once the wall has been rebuilt. Take off the two inset metal inspection chamber covers and gully grids to the downpipes and retain on site for refitting.
